# Hydrologic Regime, Vegetation, Impact Analysis, and Restoration Concepts for the Rodeo Beach Wetland complex: Golden Gate National Recreation Area, California

David J. Cooper, Ph.D., Evan C. Wolf, M.S.  
Department of Forest, Rangeland and Watershed Stewardship  
Colorado State University, Fort Collins, CO 80523

*September 2008*

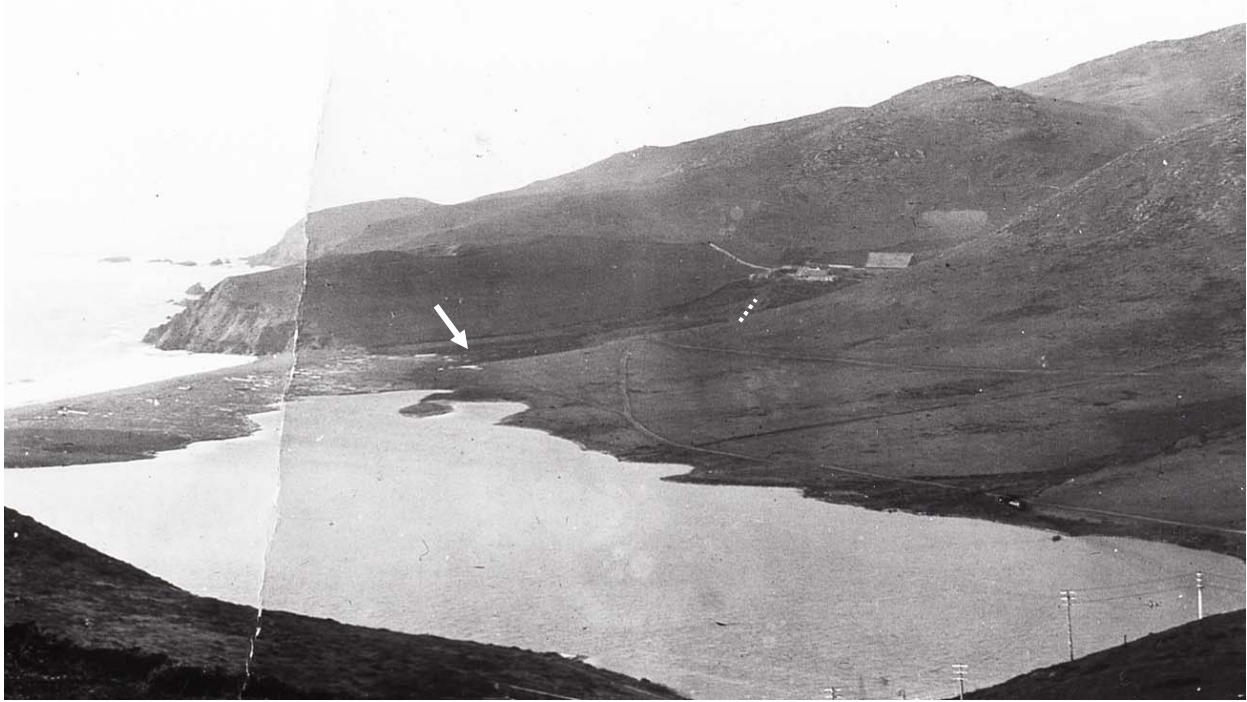
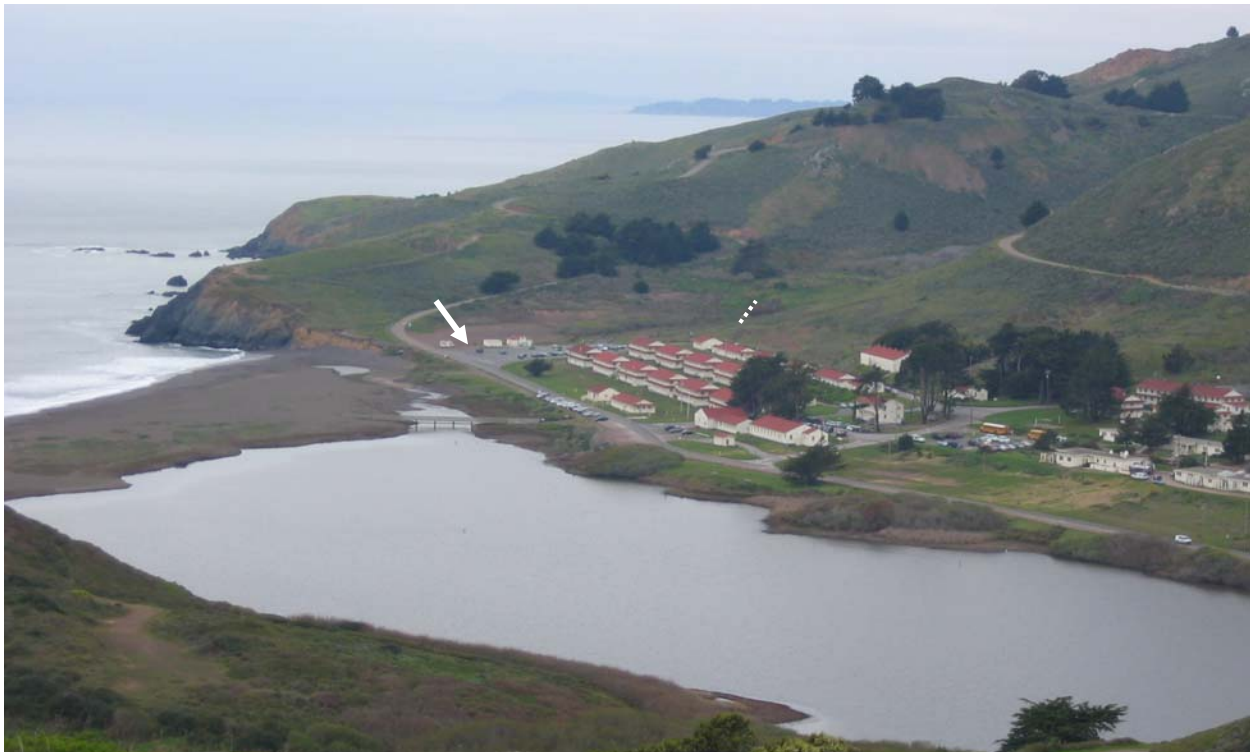
**Figure 1.** 1913 photo (top) of the Rodeo Beach wetland complex and ranch buildings, matched in March 2007 (bottom). White arrows indicate the location of the Surfer parking lot, which appears to have been a wet meadow in 1913. White dotted lines indicate the transverse ranch road location.

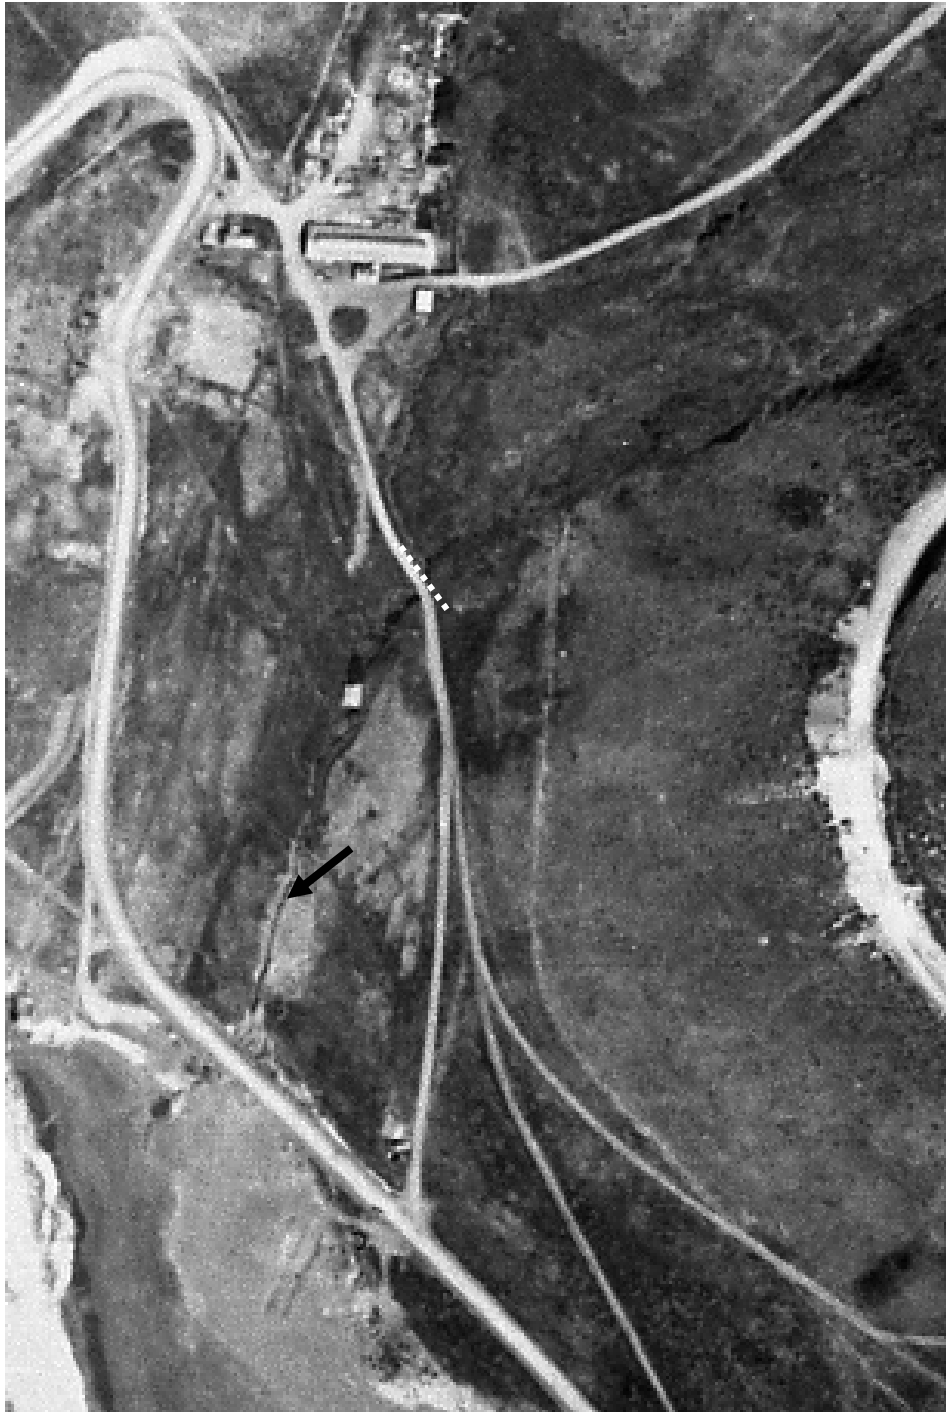
**Figure 2.** 1940 air photo (north is up). White dotted line indicates the location of the headwall, black arrow indicates a drainage ditch. Note the small building between the arrow and headwall that is visible in figures 3 and 4.

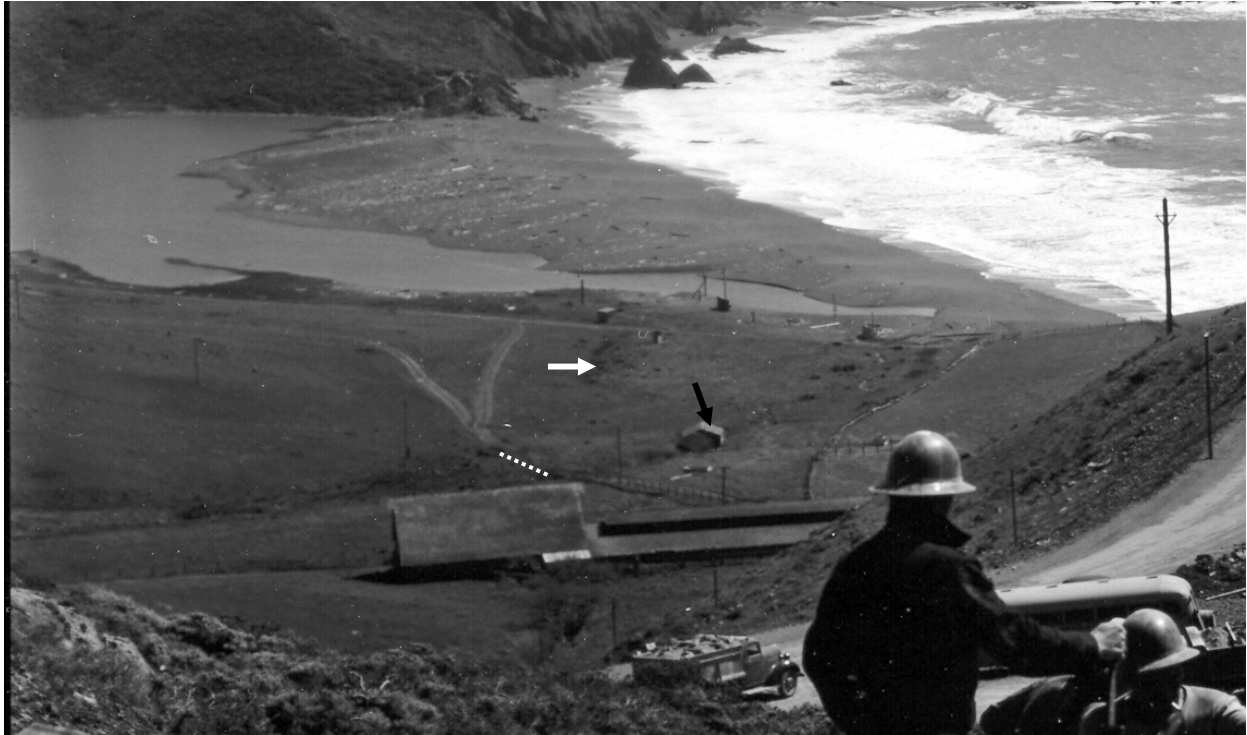
**Figure 3.** March 25, 1938 oblique ground photo looking south, showing the transverse road crossing (white dotted line) and a building (black arrow) next to a willow-lined channel. The channel extends beyond the building towards the ocean as seen prominently in figure 2. The white arrow highlights a channel in what appears to be the topographic low and natural historic main drainage area.

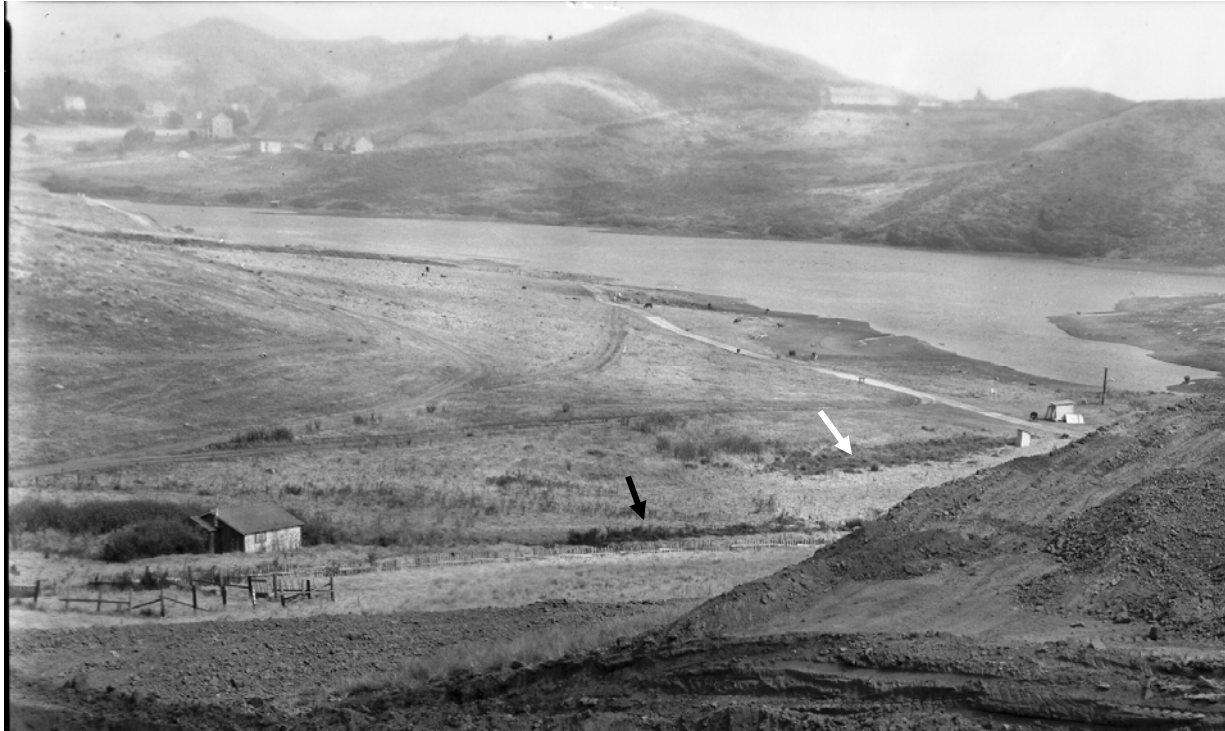
**Figure 4.** August 31, 1938. Looking southeast to the area down valley (south) of the ranch road (out of frame left). Arrows highlight drainage features visible in Figures 2 and 3. Black arrow shows a ditch below the small building. White arrow points to a natural historic drainage.

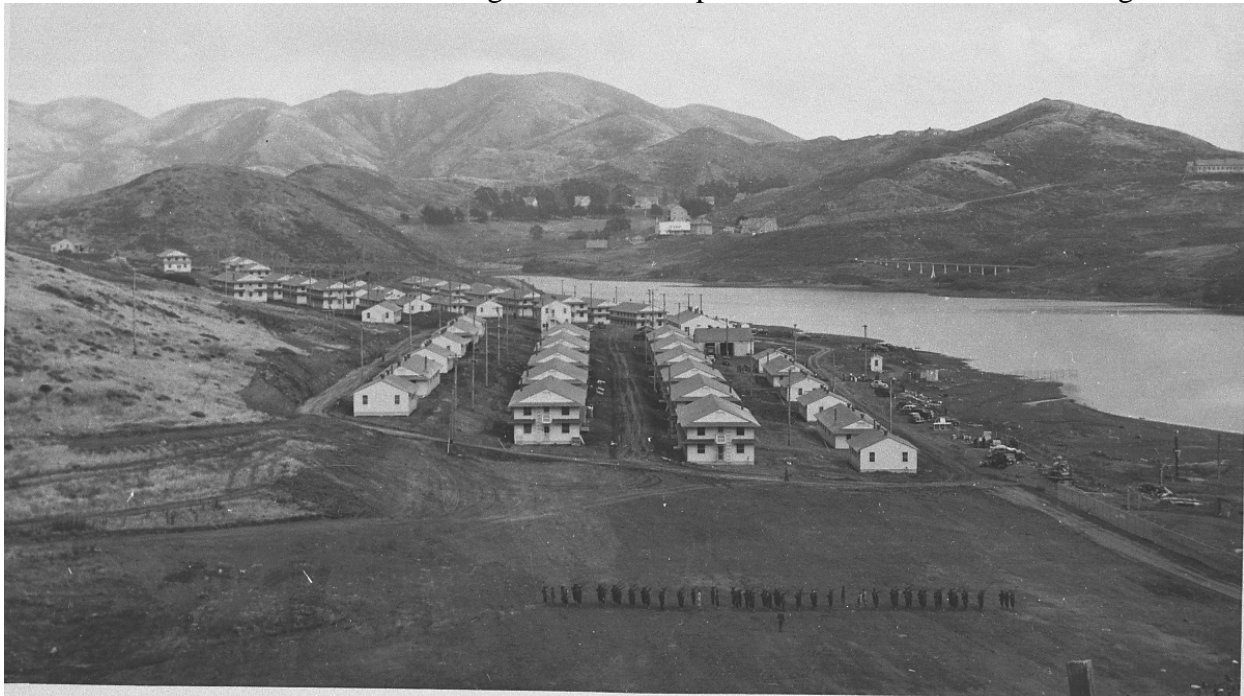
**Figure 5.** June 24, 1941. Showing entire lower wetland graded for use as a parade ground. No drainage features are apparent and it is likely that at this time the discharge from the headwall culvert (out of frame to the left) was conveyed to the lagoon (at right) in a buried culvert.

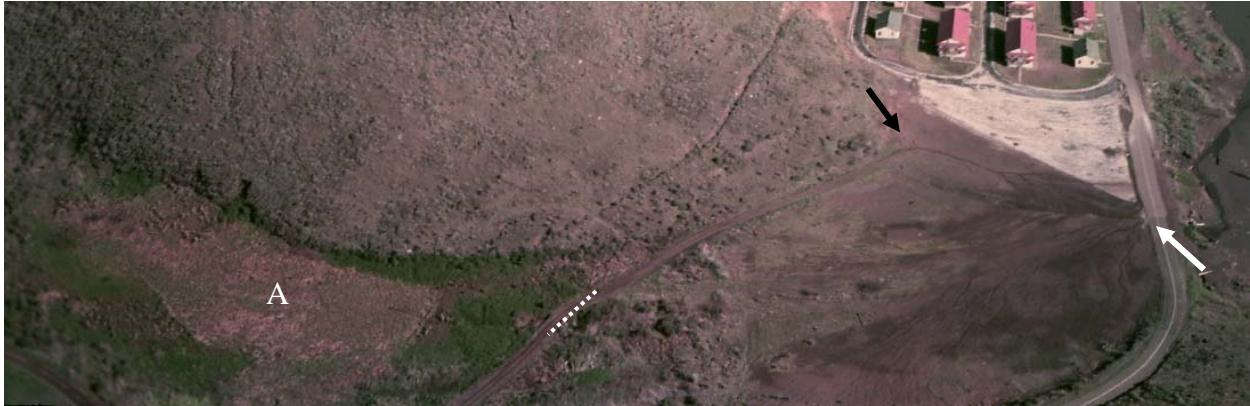
**Figure 6.** *Ca.* 1980 oblique airphoto. North and upvalley are to the left. Note the transverse road and headwall crossing (white dotted line), and large rectangular zone (A) in what is now perennial wetland that in the photo appears dry and surrounded by green-vegetated, linear-edged features that may be remnant drainage ditches. Note also that the transverse road ends near the black arrow and the drainage pattern below it suggests that a ditch running along the road conveyed water to this point. The larger drainage network, across the bare area that is now the gravel parking lot, drains to a low point marked by the white arrow, roughly in the same location as the natural drainage seen in Figures 3 and 4.

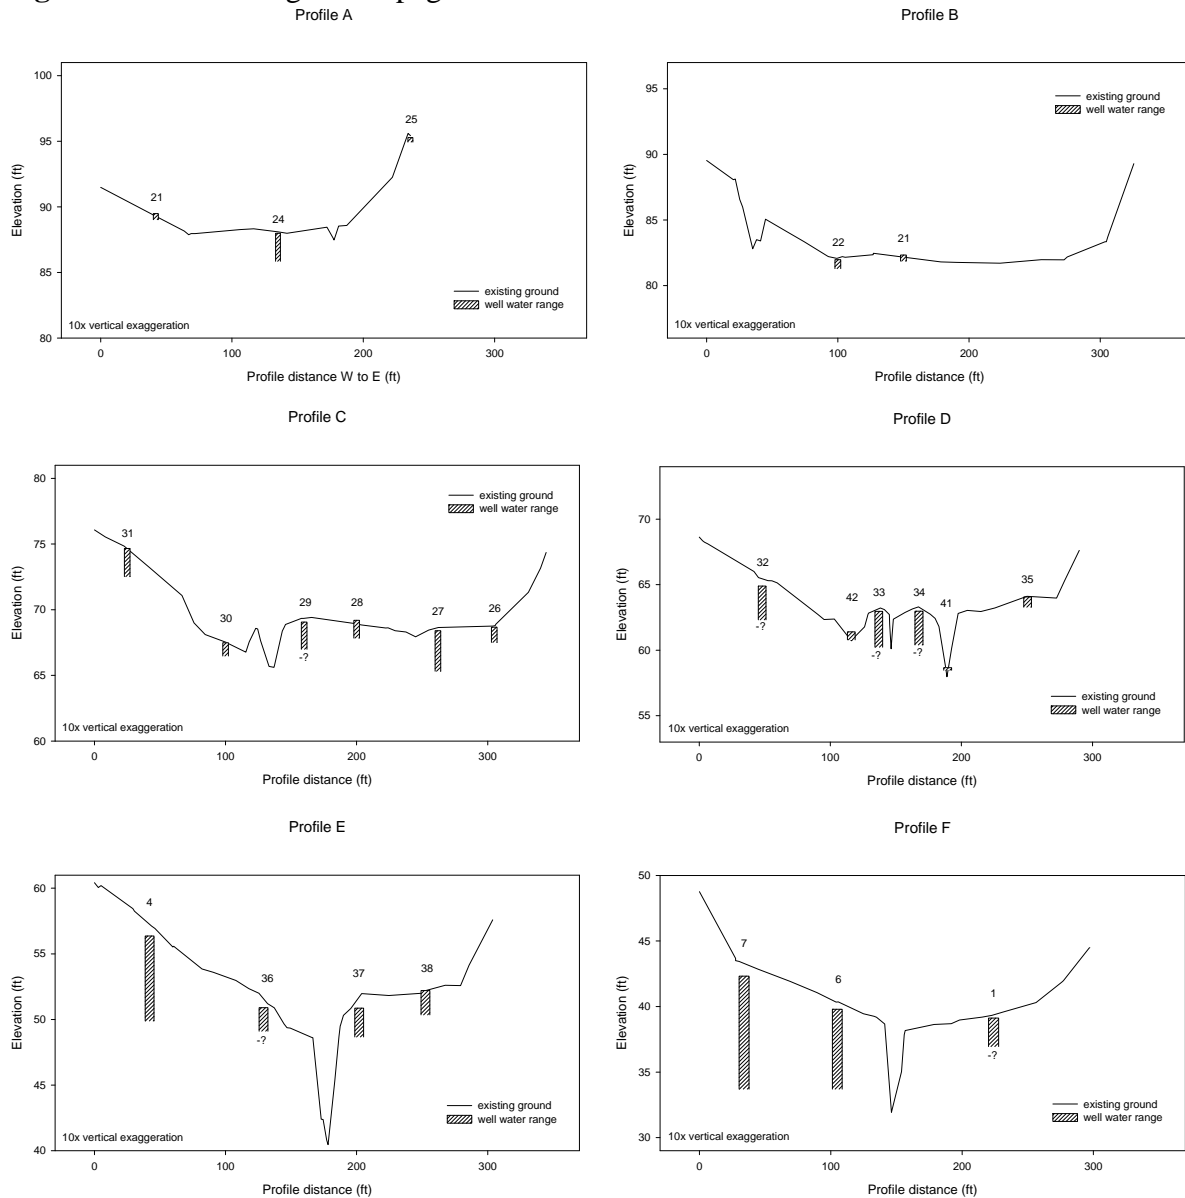
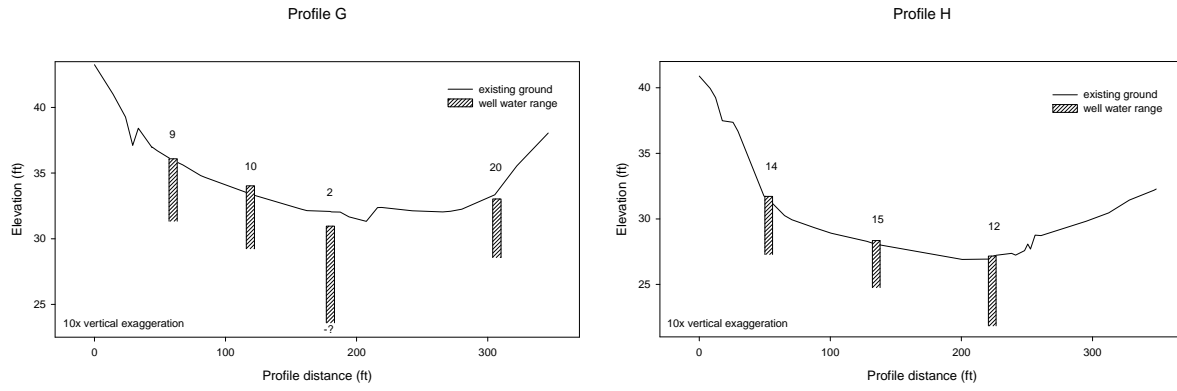
Topographic data were used to create a detailed map of the existing topography (Figure 7). We accurately surveyed ditches, channels, areas of incision, culverts and other obstructions or changes to water flow. We compared well hydrographs for the relatively intact area above the head-cuts and ranch road to areas below the head-cut and road to identify hydrologic changes that have occurred due to channel incision and other hydrologic impacts. Cross sections A and B (Figures 7 and 8) are through the largely intact upper meadow and wells along these transects show relatively small water level ranges throughout the 16 month sampling period. Cross sections C and D are above the ranch road and headwall but cross several headcutting channels that have eroded into the upper wetland. Staff gauges 41 and 42 show relatively constant shallow water flowing in these channels (although these hand-read data did not include analysis during rain events, see Figure 10 for a discharge curve showing peak flows). Several wells in transect C and all but the easternmost well in D, well 35, have water level ranges of 3 feet or more. The water table at these transects drops further due to the presence of the headcutting channels, which rapidly drain the surrounding soil. A relatively intact sheet flow system with no major channels persists along the east side of the meadow and maintains high water levels in well 35. Cross sections E and F are located below the ranch road and headwall and cross the gully that formed below the headwall culvert. The water level on the east side of the gully is higher than on the west, indicating that the eastern sheet flow system maintains higher water levels than occur on the west side of the gully. On the west, water levels drop up to 8 feet below the surface due to the ranch road intercepting sheet flow from the upper meadow, which would have irrigated this western area, and directs this water through the culvert and into the gully. Profiles G and H cross

the Surfer parking lot and have widely variable water tables that were near the ground surface on some dates and up to 8 feet below the ground surface on other dates. A longitudinal (N to S) profile of the study area (Figure 9) illustrates the level of incision from the headcutting streams above the headwall and the gully below it.

**Figure 8.** Rodeo wetland valley cross-sections A through H, for map location see Figure 7. Westernmost point along each transect is at 0 on the X axis. Solid line is existing ground surface, diagonal-stripped bars indicate full water level range (minimum to maximum water levels) as measured in the indicated well numbers located along each transect. The ‘-?’ below some wells indicates that the well went dry and the lowest water level may have dropped lower than we were able to measure.

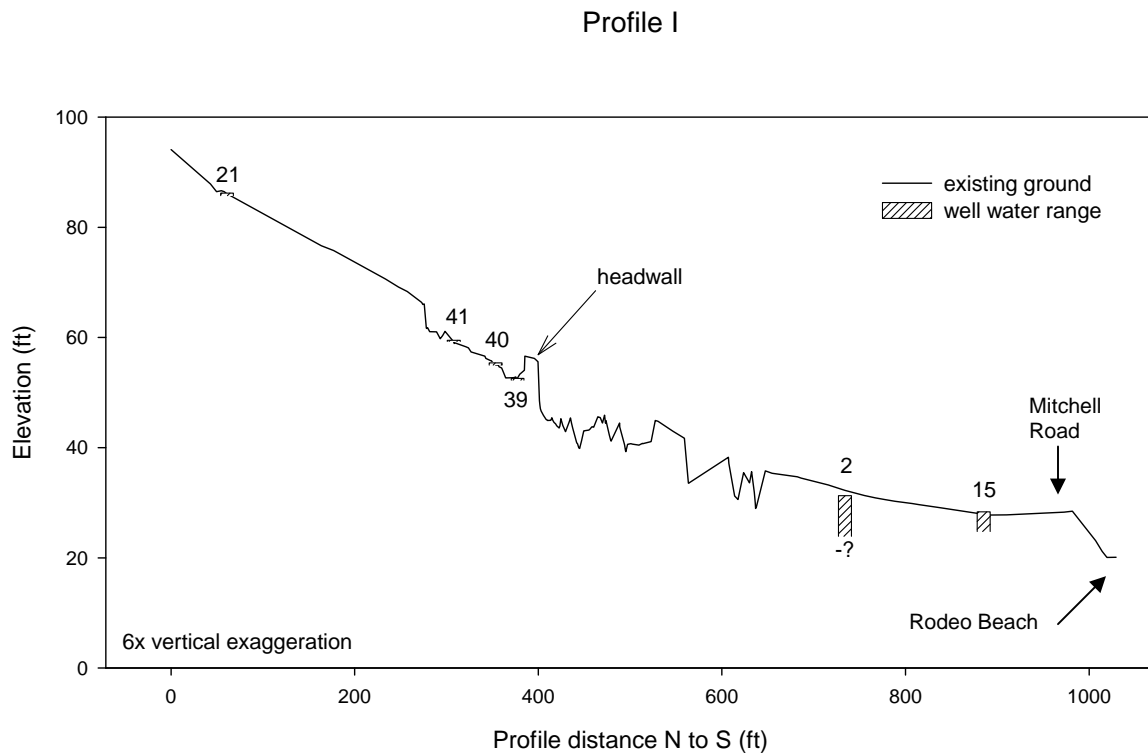
**Figure 9.** A longitudinal profile (see Figure 7) of Rodeo wetland that shows the relatively smooth and gradual upper wetland slope from well 21 to well 41, the head cutting channels at staff gauges 39 to 41, the headwall below 39 and the large erosion gully below, and the even parking lot with deep low-water water table at wells 2 and 15.

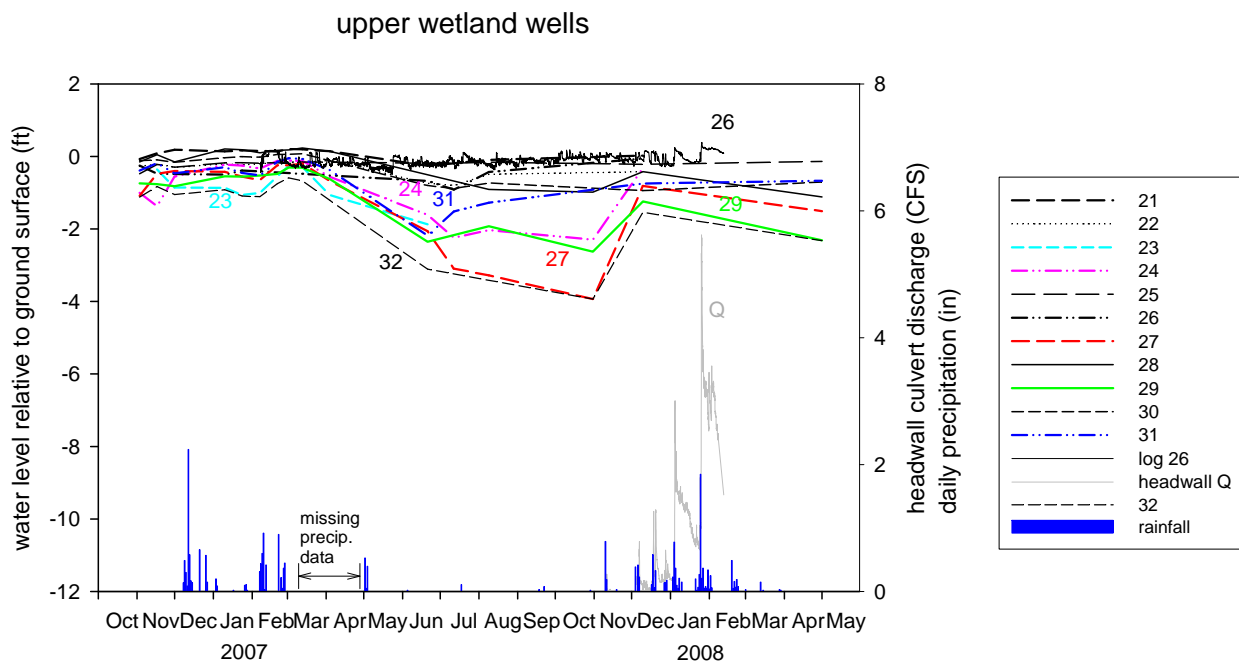
Well hydrographs for the study period illustrate that the wetland area above the ranch road and culvert (Figure 10) has relatively stable, shallow water tables when compared to the lower wetland (Figure 11) and parking lot (Figure 12). There is a marked seasonality of water levels in all wells except in the upper wetland, where water levels are stable year around. During the dry season water levels drop and quickly rise to near the soil surface when the rainy season begins. In the unresponsive upper wetland wells, water levels remain perennially high, and show only a small response to rain events, because they are kept permanently saturated by groundwater flow. Discharge measured at the headwall culvert is dominated by storm runoff peaks where water concentrated by the ranch road and head cutting channels passes through the culvert and into the eroded gully.

**Figure 10.** Hydrographs for the wells of the upper wetland. Precipitation and discharge measured at the headwall culvert from Nov 2007 to Feb 2008 are shown at the bottom and reference the right Y-axis.

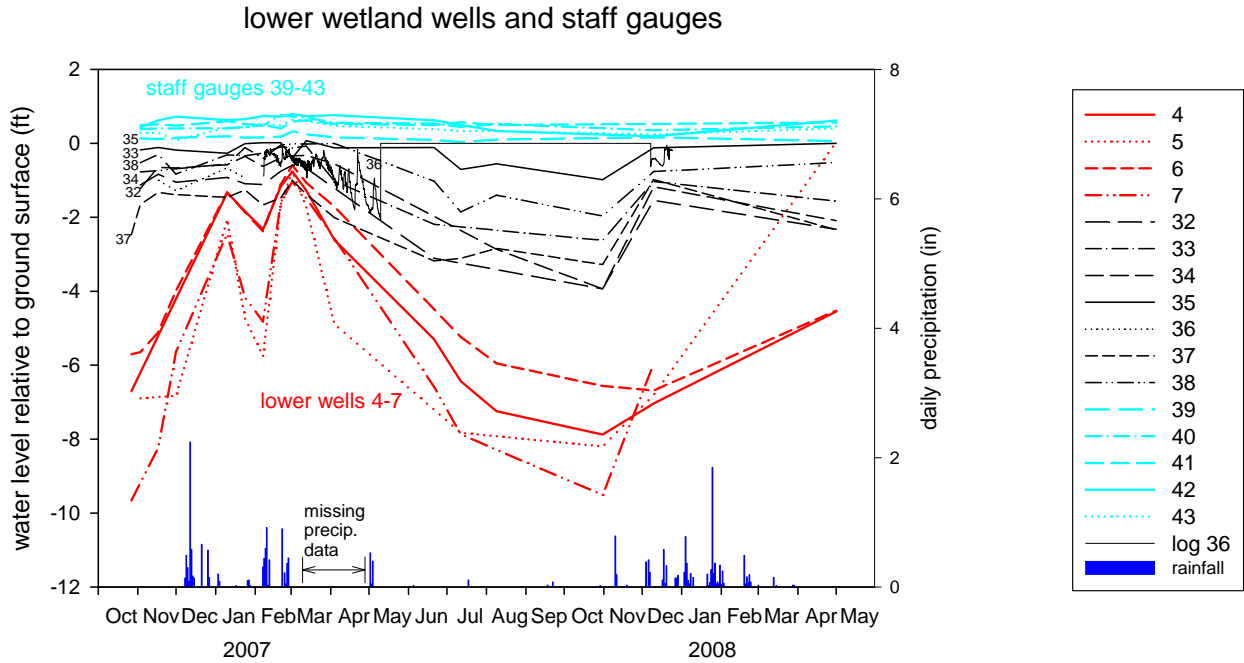
**Figure 11.** Hydrographs for the wells of the lower wetland. Precipitation is shown at the bottom and references the right Y-axis.

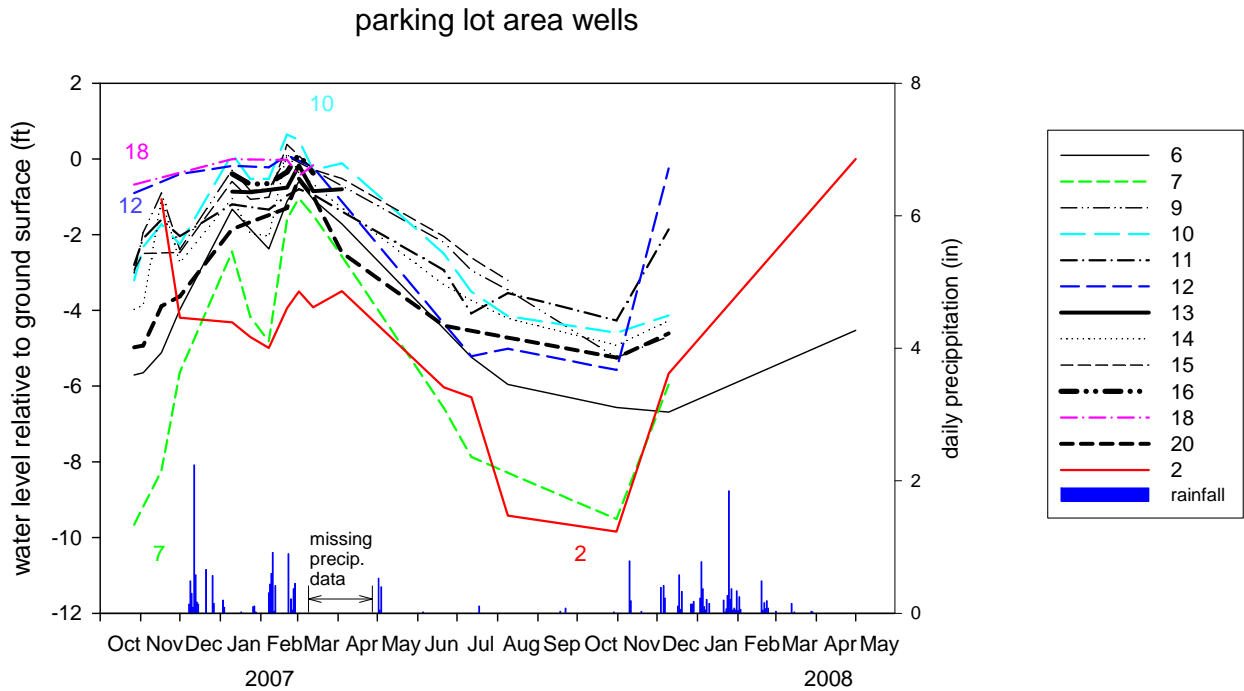
**Figure 12.** Hydrographs for the wells of the parking lot area. Precipitation is shown at the bottom and references the right Y-axis.

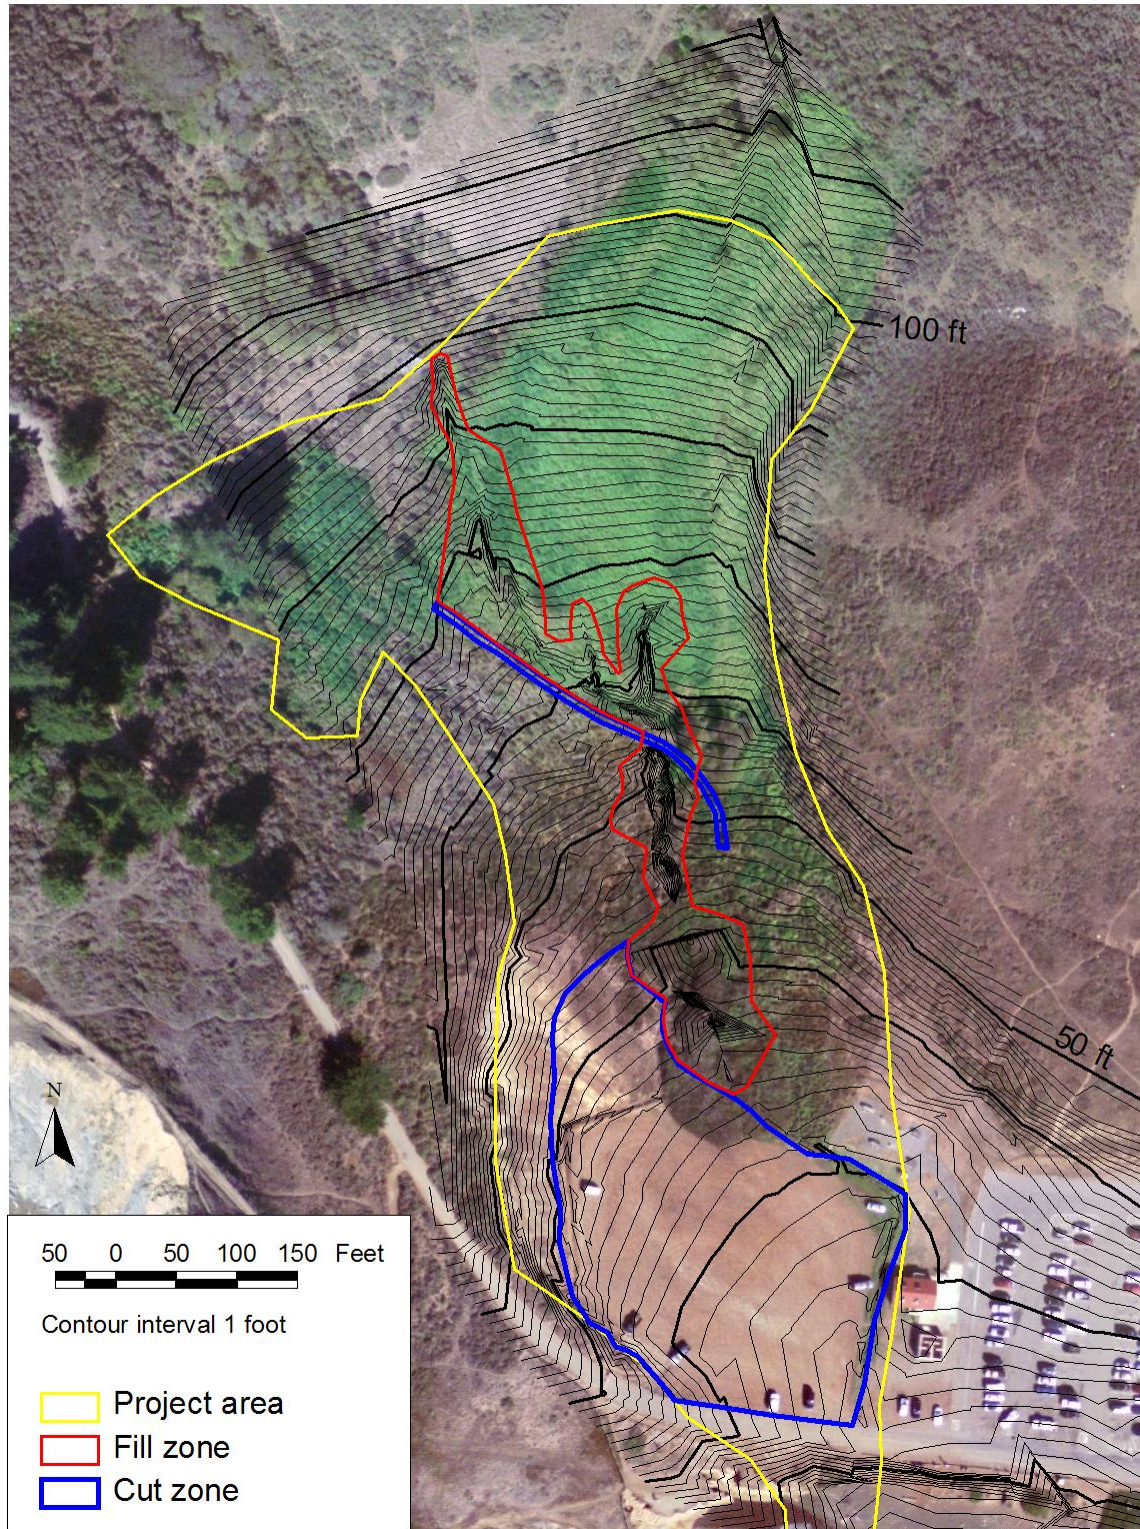
**Figure 13.** Topographic map showing the existing land surface for Rodeo wetland. The area in red delineates the fill zone where gullies and holes will be filled, and the areas in blue are cut zones where material will be removed.

To restore the Rodeo wetland, existing water diversion features such as culverts, ditches, and the ranch road must be removed, and erosion gullies must be filled. Historically, this landscape supported a sheet flow system and the wetland extended from above the ranch road to the beach. Currently, water is prevented from sheet flowing down valley by the ranch road. Water that contacts the road is channeled into a culvert in the headwall road-crossing, where it has had sufficient energy and time to destroy most of the culvert and erode a large gully. Smaller head-cutting channels extend above the headwall into the intact wetland (Figure 13). The filling of these gullies and the removal of the ranch road and headwall are critical to restoring the hydrologic regime of the Rodeo wetland.

We recommend that the primary restoration goal be to reestablish the sheet flow hydrologic system extending from the upper wetland above the transverse road down to Mitchell Road. To achieve this hydrologic restoration all channels, gullies, ditches, and other water conduits need to be filled in and the ground surface leveled across the valley (Figure 14). This will allow water to sheet flow down valley saturating the entire valley width and preventing channelization and erosion to occur. The areas to be filled (shown in red) will require 2100 cubic yards of compacted soil material. However, the cutting and regrading of the gravel parking lot and the transverse road will generate 2000-2300 cubic yards of material that can be used to fill the gullies. If additional fill material is required for the gully filling, or if less material than expected is generated on-site, an off-site mitigation project approximately 1 mile from Rodeo wetland will be generating significant suitable fill material. In addition, planting of seedling *Scirpus microcarpus* and other taxa are needed immediately following the grading.

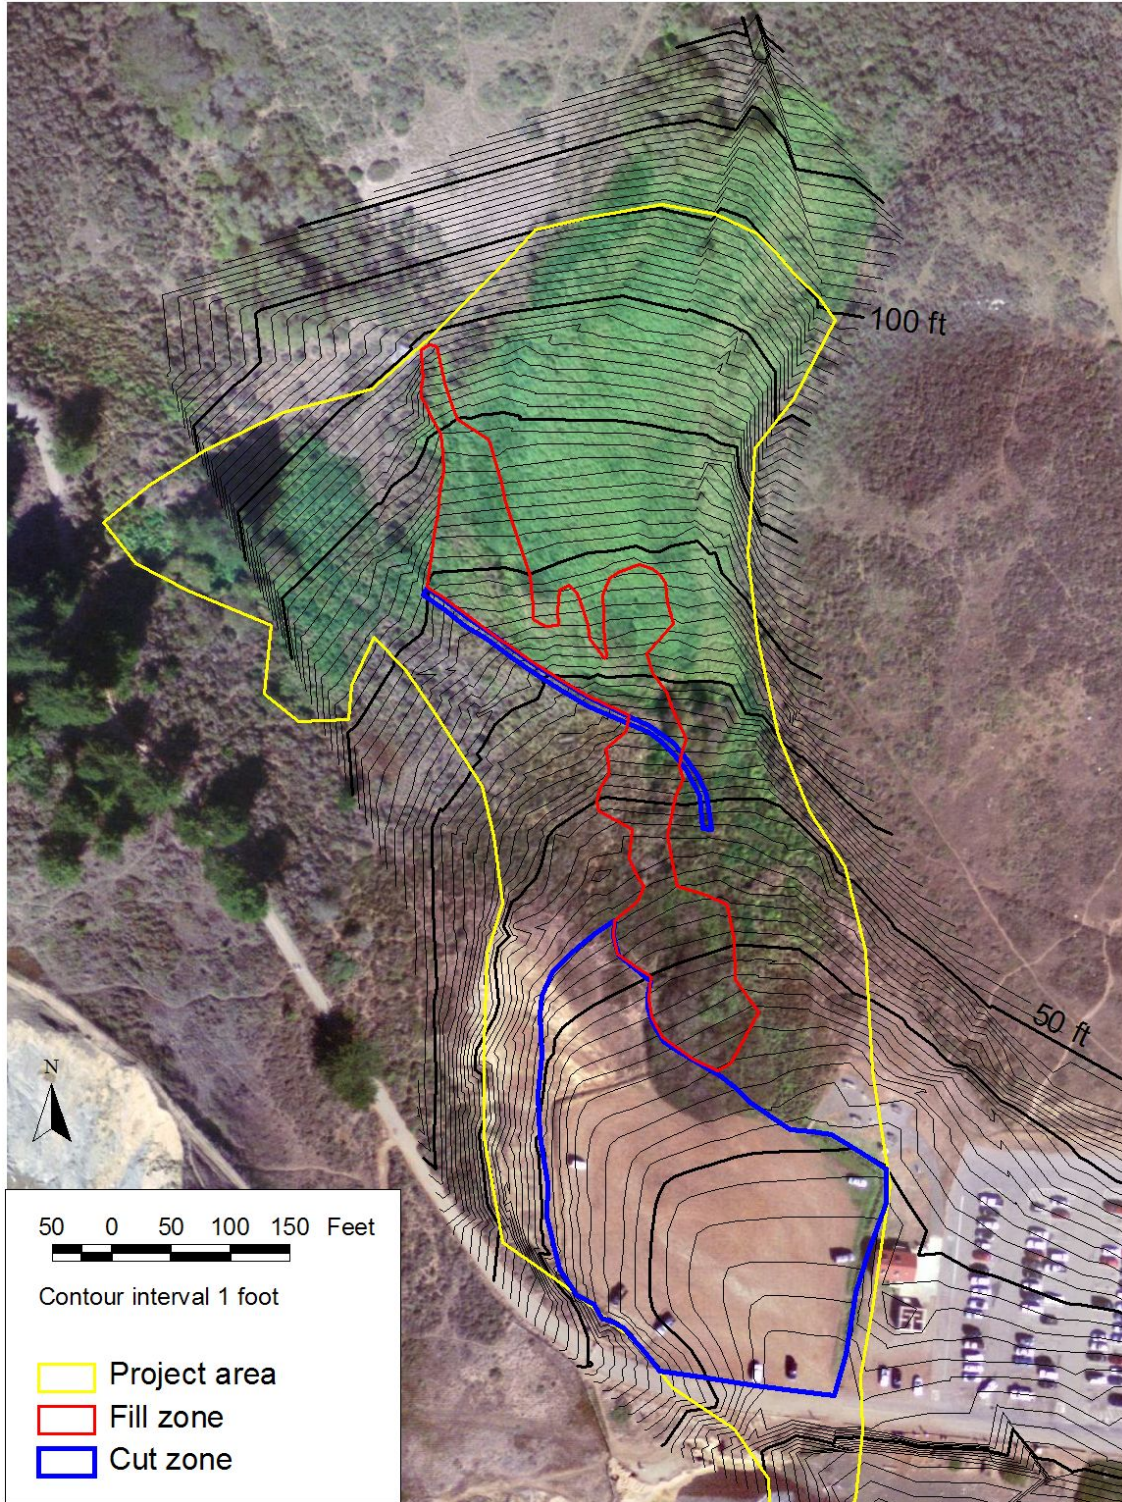
**Figure 14.** Topographic map showing the proposed post-construction land surface configuration for Rodeo wetland. The area in red delineates the fill zone, the areas in blue are cut zones where material will be removed.

In addition, a portion of the lower valley that is now the gravel parking lot should be graded to allow sufficient flat-valley width for a continuous sheet flow system. Historically, the Rodeo wetland would have been wider than the parking lot in an eastern direction. However, this area now is the paved parking lot and has public bathrooms. If these constructed features are left in place, as is likely, some expansion of the wetland to the west side of the gravel parking lot can be achieved in order to restore a similar area of wetland as occurred historically. A permanent berm along the eastern edge of the wetland where it abuts the bathrooms and paved lot may need to be built and maintained to prevent flooding of these facilities. Currently a ditch runs along this boundary keeping water from flooding the structures. The water in this small ditch, along with most of the water that comes down the gully from the upper wetland, is collected in two culverts that pass under Mitchell Road and drain to the beach. Point collection features such as culvert inlets are undesirable because they concentrate water, making it more energetic and likely to cause erosion.
