Grant Kohrs Ranch Fence Report

**Philip B. Davis
Dr. Lisa Rew**

**Montana State University
Department of Land Resources and Environmental Sciences**

March 2011

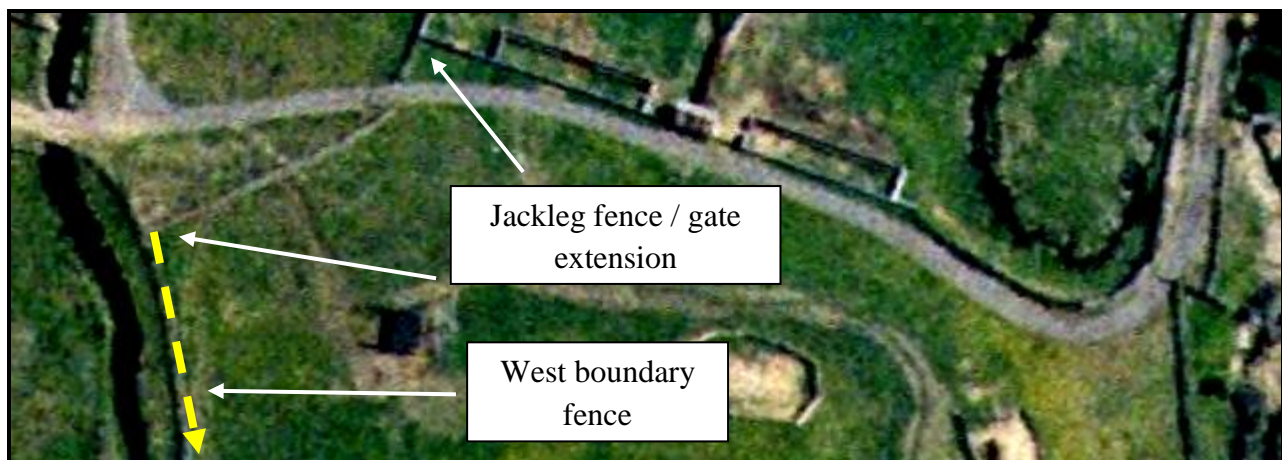
extending from it to a wood gate that crosses the Clark Fork River Bridge Road, and another section of jackleg that connects the gate to the north boundary fence (Photo 1). Although the exact date of this installation is unknown, it was after the construction of the west fence in 1996. Its intended purpose was the same as the west fence, to facilitate efficient livestock management ⁽¹²⁾. The presence of the west boundary fence likely eliminates any adverse impacts to the Kohrs-Manning ditch because it restricts access by cattle from Stuart Field. Because of this, and the fact that these fences and the gate facilitate cattle management (e.g., pasture rotation and enhancing visitor contact with the animals) ⁽¹⁹⁾, as per their original intention, these sections are not recommended for removal. However, if GRKO is true to its mission of preserving the historical integrity of the ranch, these sections should be removed because they were installed by the NPS ⁽¹⁹⁾. If this is done, alternatives should be developed (e.g. hiring more staff) to ensure that management goals can still be achieved without the fence ⁽⁹⁾.

Photo 1. Northwest corner of Stuart Field with jackleg fence and gate extension from the west boundary fence.

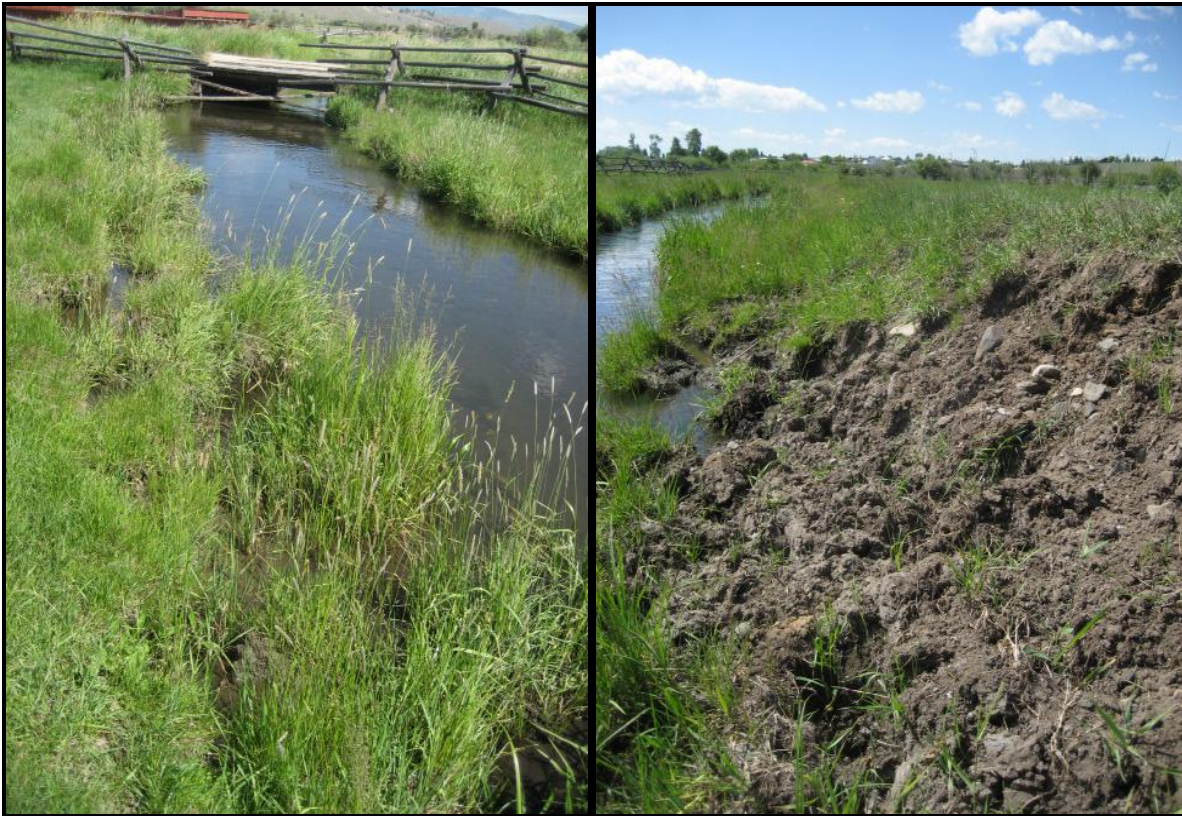
The fence on the east boundary of Stuart Annex, just beyond the Kohrs-Manning Ditch serves as the barrier to Stuart Field. Because the majority of the length of the ditch in Stuart Annex appears to be in good condition, and it provides cattle access to water, a fence is not recommended currently. However, there are two locations that were identified as areas of concern and should be monitored to ensure that further damage is not incurred. The first section is on the north end of the ditch, where it appears that excessive widening of the channel is occurring due to pugging and hummocking. Pugging and hummocking result from grazing on moist soils, and cause soil compaction and uplift, respectively (Photo 2). These are undesirable characteristics because they can reduce land quality and usefulness. The second damaged area is near the middle of the field where cattle cross the ditch, thus exposing the soil (Photo 3). The

Photo 2. Pugging and hummocking along the Kohrs-Manning Ditch in the Stuart Annex Field at the Clark Fork River Bridge Road.

Photo 3. Exposed soil where cattle cross the Kohrs-Manning Ditch in Stuart Annex Field.

If damage along the streambank increases to an unacceptable level, and because Stuart Annex is subjected to greater grazing pressure than Stuart Field, a more appropriate location for the fence might be on the west side of the Kohrs-Manning Ditch. With the inclusion of water gaps in the new fence, overall impact to the streambank might be reduced. That said, this is an irrigation ditch and therefore, its purpose is not to represent a natural system but rather, to serve as a tool for water movement on the ranch. Thus, damages to this channel can be repaired with a backhoe.

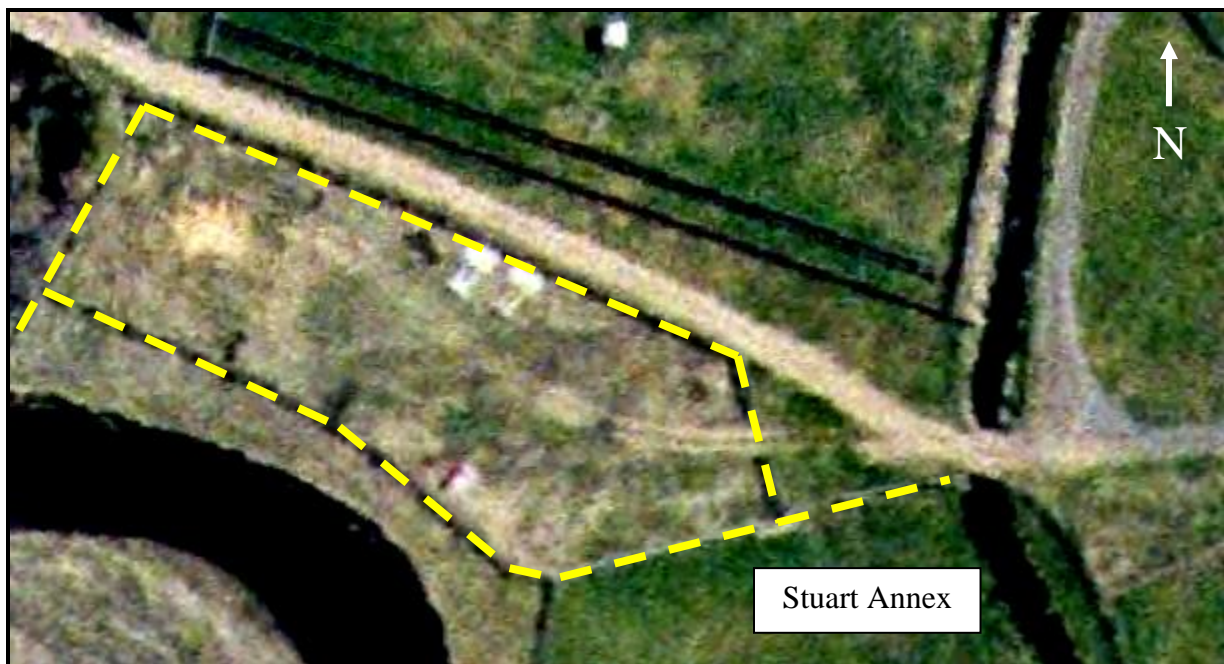
Photo 4. Non-historic fenced area between the north side of Stuart Annex and the Clark Fork River Bridge Road.

Through conversations with GRKO staff, there are conflicting thoughts about this area. One staff member indicated the desire to remove the portion of the jackleg fence along the Clark Fork River Bridge Road because it impedes visitors' ability to view the historic farming

equipment ⁽⁸⁾. Conversely, this section facilitates effective cattle management ⁽¹⁹⁾, similar to fences in Stuart Field. The jackleg fence used is consistent in type with the majority of fences used in this area historically. Consequently, it does not impede greatly on the ability to interpret the history of the ranch as GRKO intends. However, if the difficult viewing of the machinery is of major concern to the park, there are two potential compromise solutions between the two opposing viewpoints presented above. First, GRKO could relocate the farming equipment to an area that is more readily apparent, and keep the fence. Second, GRKO could remove the portion of the fence along the road, thus enhancing viewing of the equipment, and simply erect a temporary fence when it is needed to protect hay. The removal of this fence would not greatly affect cattle management because the gate on the south boundary (north boundary of Stuart Annex) of this area would serve as the barrier to prevent cattle from leaving or entering Stuart Annex.

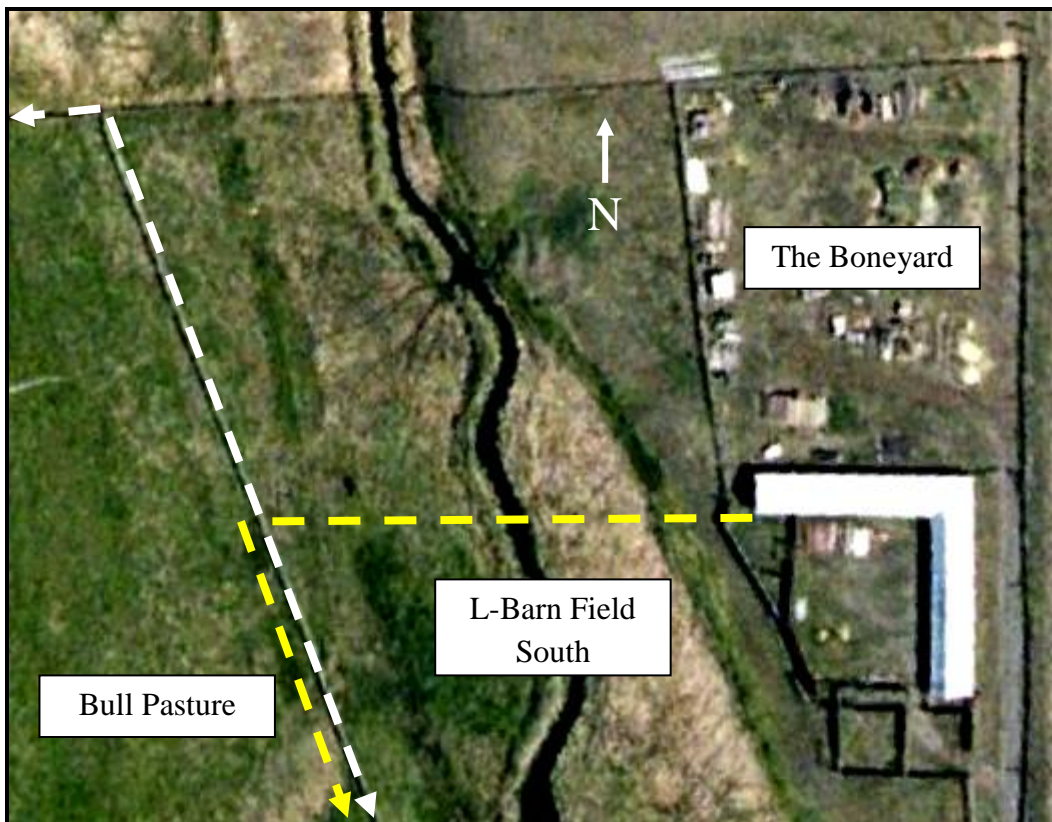
Photo 5. Historic (yellow line) and current (white line) boundaries of the Bull Pasture and north historic boundary (yellow line) of L-Barn Field South.

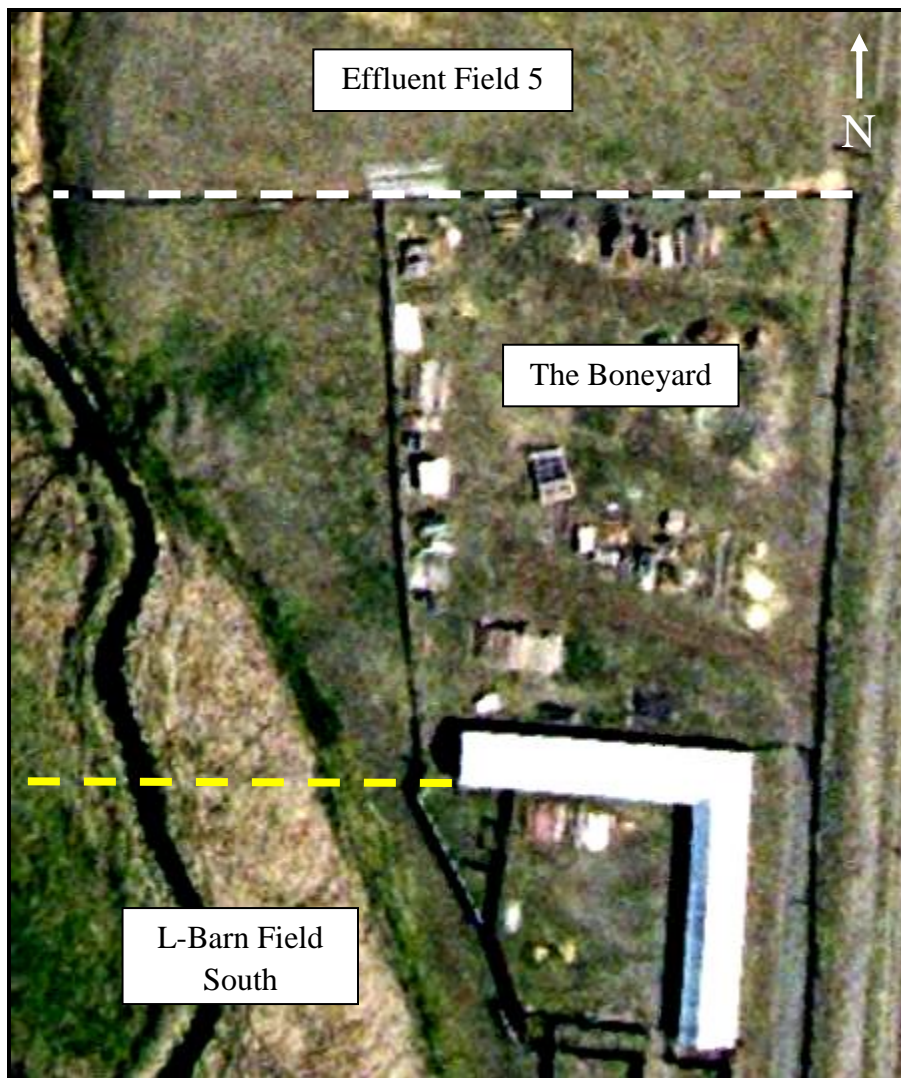
Boneyard, the south boundary fence of Effluent Field 5 was moved north from the L-Barn, to where it lies currently (Photo 6). Although the creation of The Boneyard is within the period of significance, it is a NPS installation and therefore is not historical.

Photo 6. Historical and current southern boundaries (yellow and white lines, respectively) of Effluent Field 5.

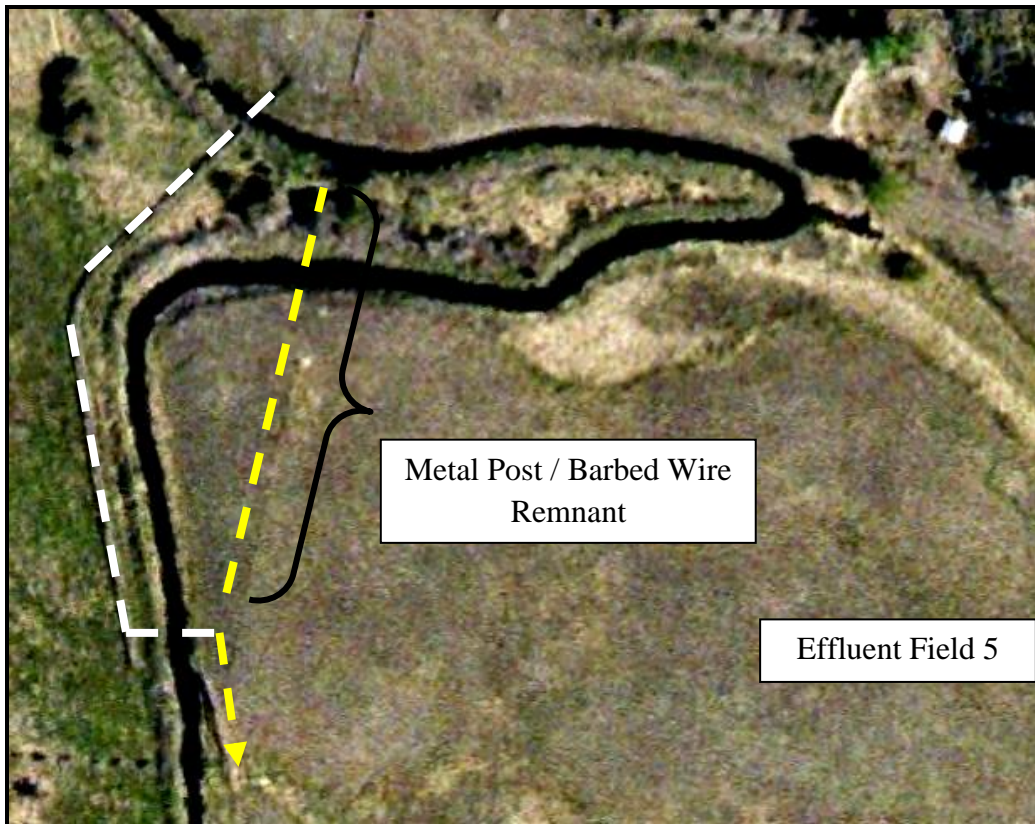
Photo 7. Metal post and barbed wire remnant and existing fences (yellow line) and jackleg fence (white lines) in the northwest corner of Effluent Field 5.

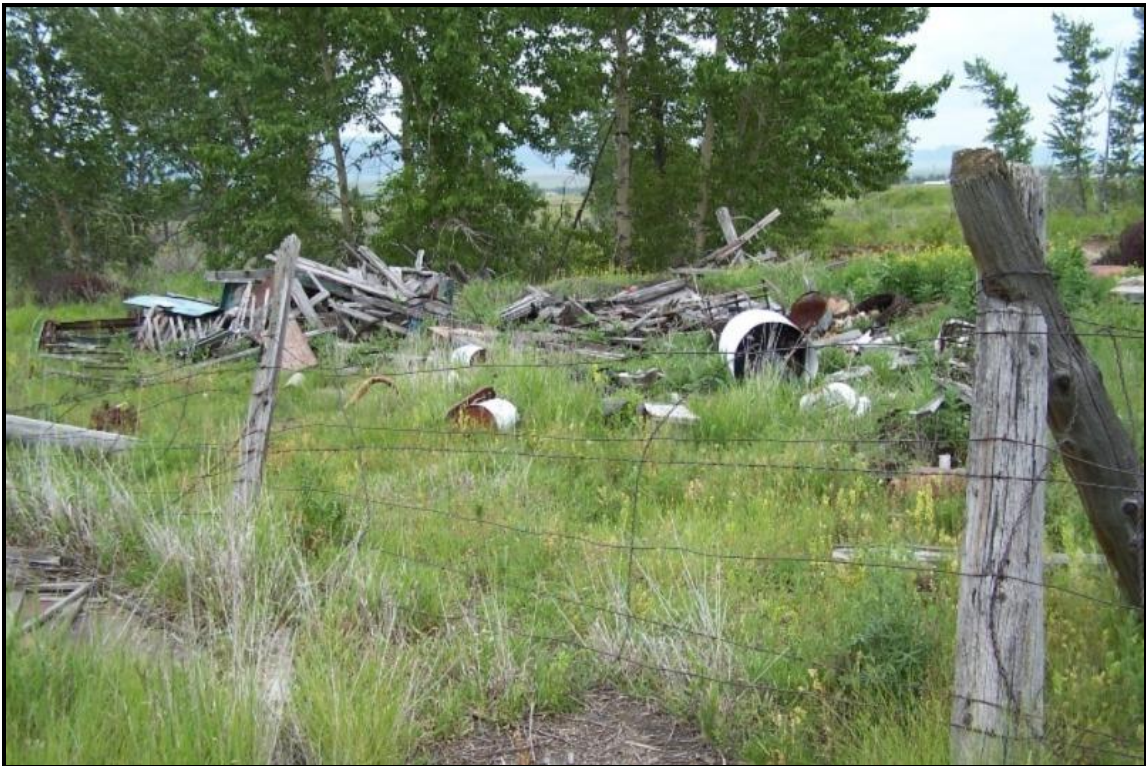
Photo 8. Fence around The Dump before replacement by Montana Conservation Corp in summer 1995.

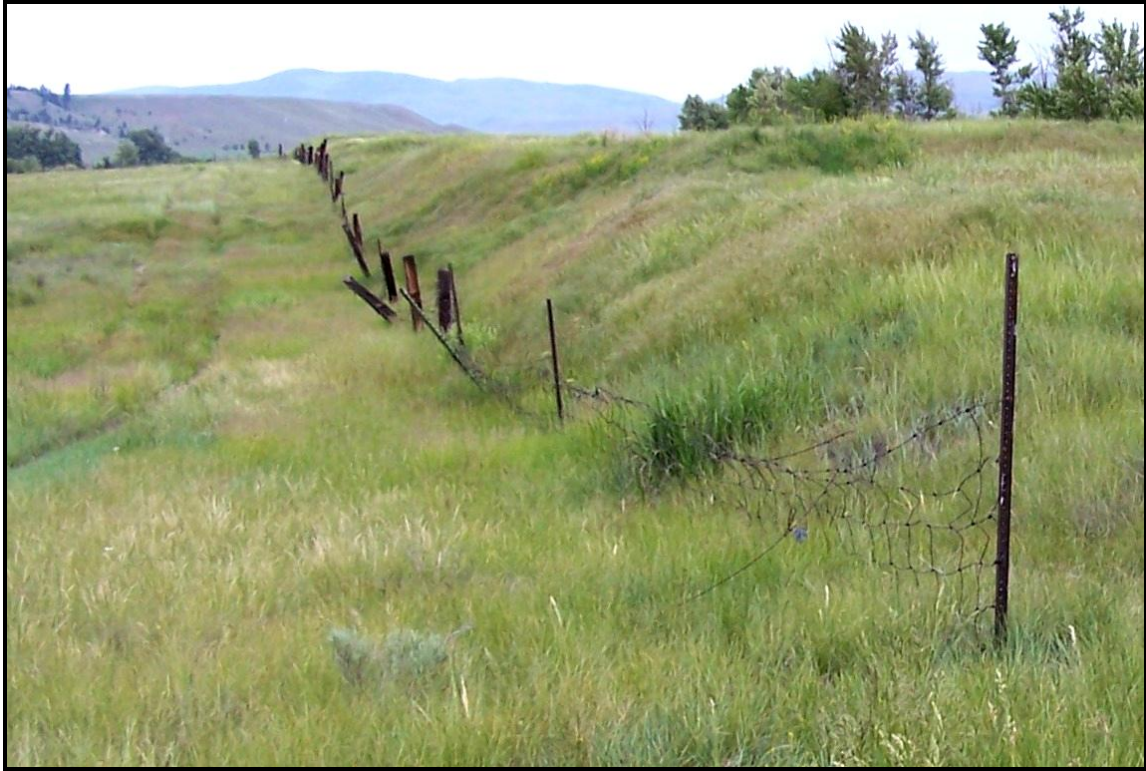
Photo 9. Old fence north of The Dump before replacement by Montana Conservation Corps in summer 1995.

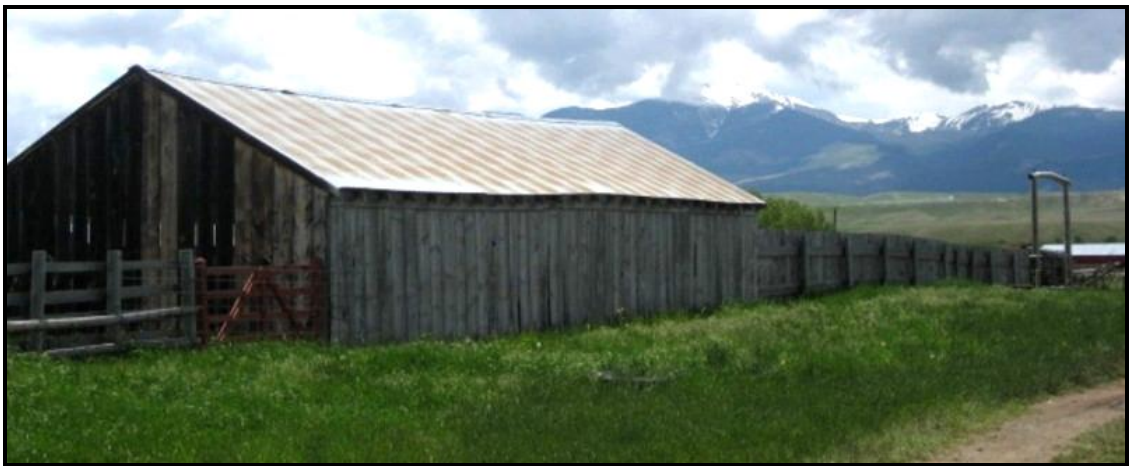
Photo 10. South boundary fence types of Effluent Field 1, east of the entrance gate.

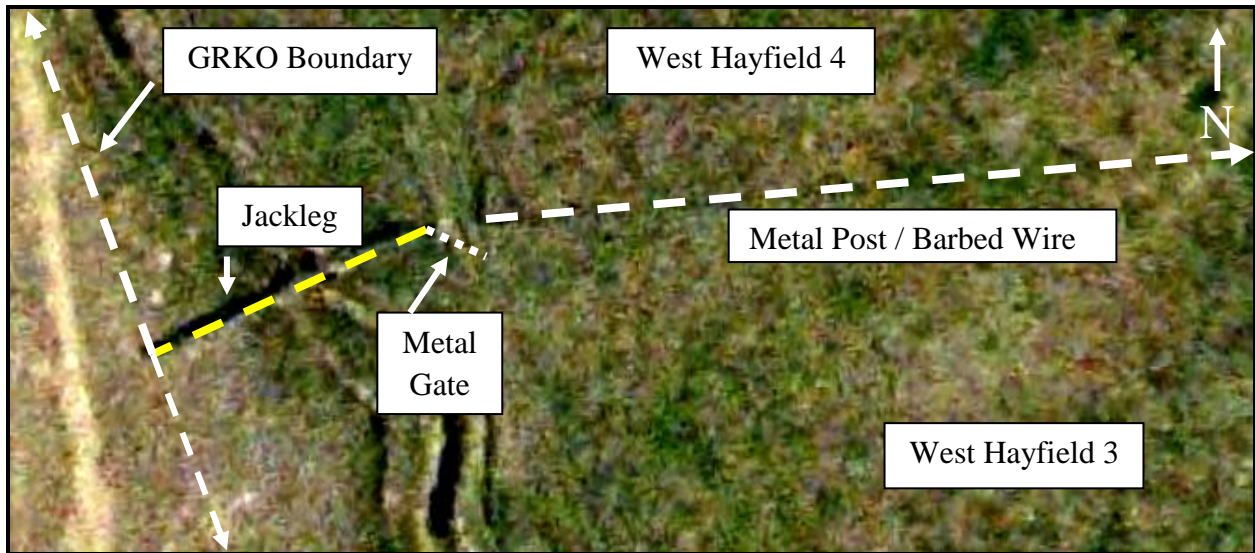
The east boundary fence is metal post and barbed wire and was installed in 1994 ⁽¹¹⁾. The cross fence separating Field 3 from Field 4 is nearly all metal post and barbed wire, as mentioned above; however, there is a short section of jackleg on the west side of the entrance gate to Field 4 (Photo 11). It is not known if this portion was built in 1995 at the time the rest of the cross fence was installed.

Photo 11. Cross fence between Western Hayfields 3 and 4.

and 2 that parallels the Clark Fork River Bridge Road is not as much of a concern because the road splits those two fields anyway. The fence that separates Field 3 from Field 4 should be the last priority because of its distance from the main visitor areas. Also, inadequate irrigation to this field reduces its productivity for hay as compared to the other fields, but provides a useable pasture for cows ⁽¹⁹⁾.

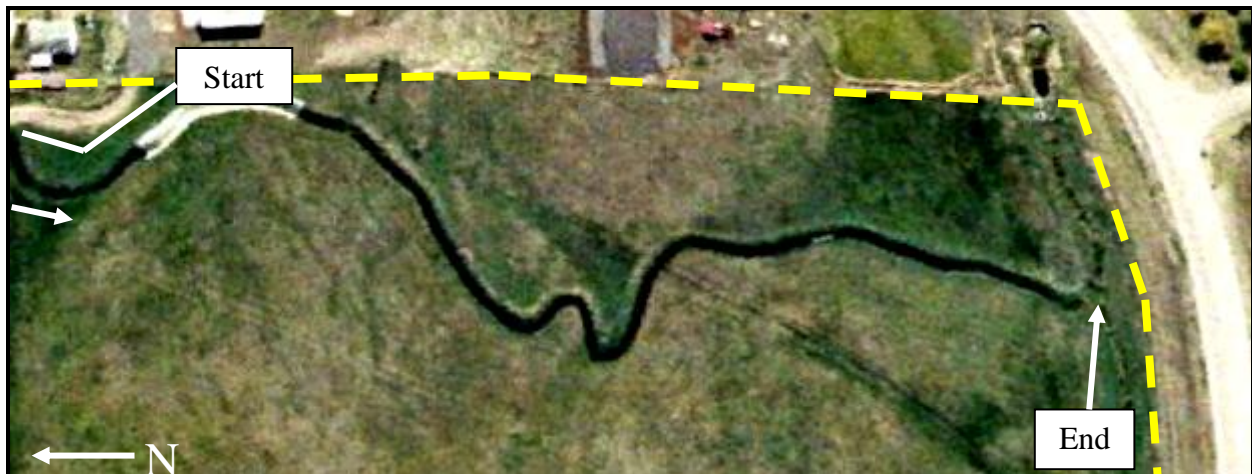
Photo 12. Approximate start and end points of the electric fence that follows the contour of the ditch at the east edge of Lower Taylor Field near GRKO property boundary (yellow lines).

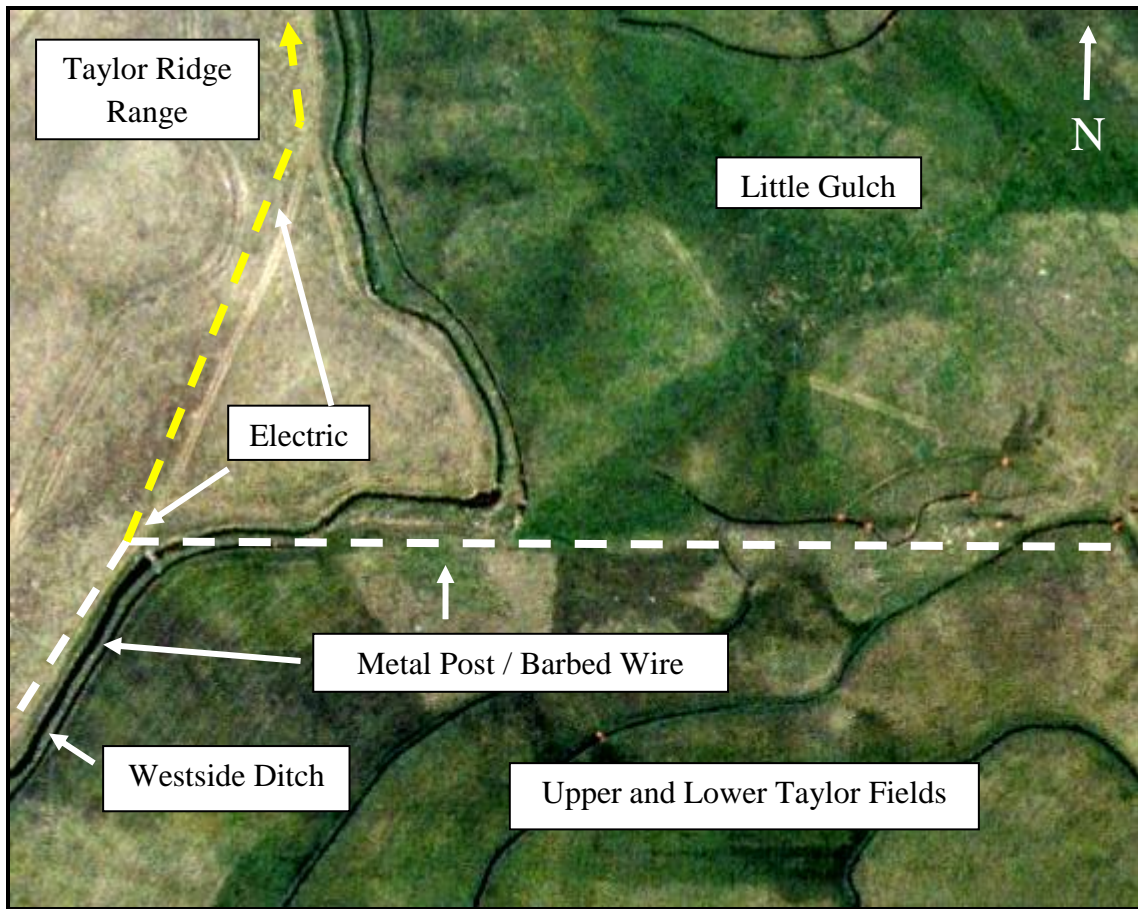
this point an electric fence travels north and marks the east boundary of Taylor Ridge Range (Photo 13). It follows the Upland Pasture Road and meanders to the west to form the northern boundary of the Taylor Ridge Range. This electric fence does not completely enclose the Taylor Ridge Range because just before meeting the main GRKO boundary fence on the west, it turns and travels north. This electric fence was installed by the NPS ca. 2002 ⁽¹¹⁾.

Photo 13. Cross fences (white lines) and electric fence (yellow line) that separate Upper and Lower Taylor Fields, Little Gulch, and Taylor Ridge Range.

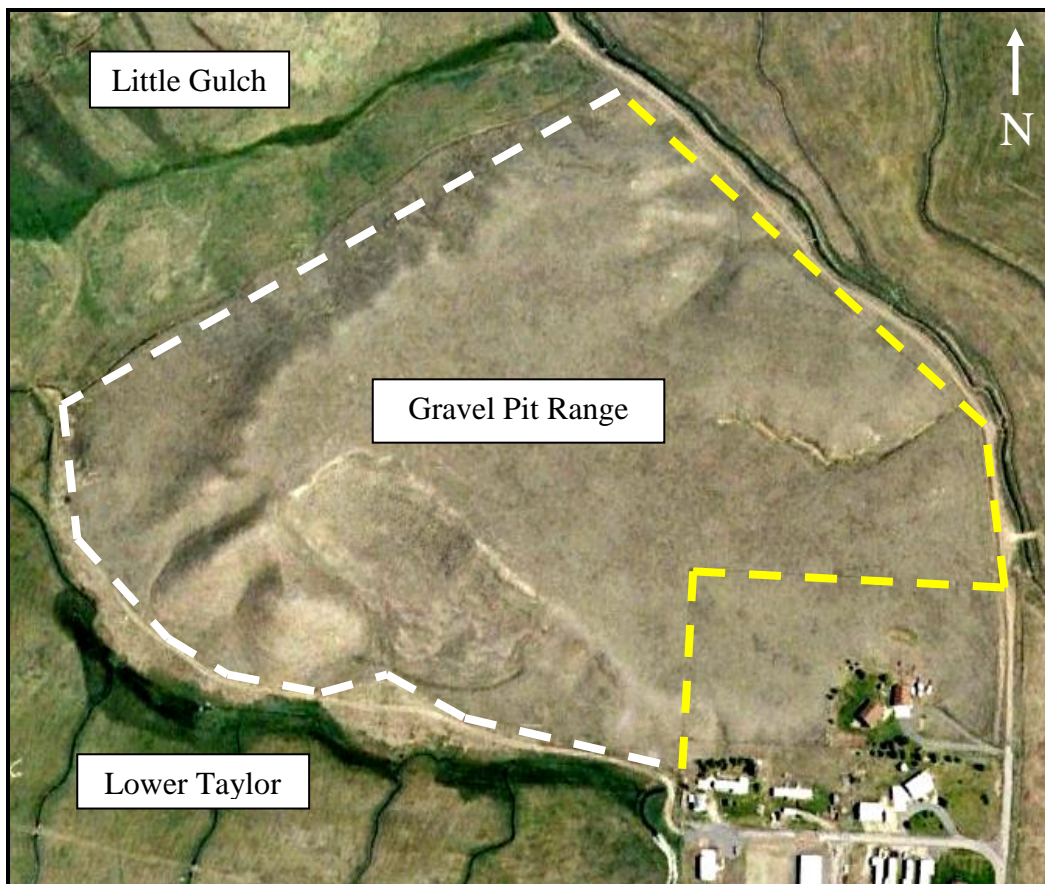
boundary of GRKO property, this fence makes a 90° turn to the west, thereby marking the south boundary of the Gravel Pit Range. This wood post and barbed wire fence again makes a 90° turn to head south and mark the east boundary of the Gravel Pit Range as well GRKO property boundary (Photo 14). This fence was installed ca. 1930s⁽¹¹⁾. The northwest boundary of the Gravel Pit Range is marked by the metal post and barbed wire fence that is the shared fence with the southeast border of Little Gulch. This fence turns to form the southwest border of the Gravel Pit Range, paralleling the Gravel Pit Range Road (Photo 14). It was installed in 1993⁽¹¹⁾.

Photo 14. Metal post (white lines) and wood post (yellow lines) barbed wire fences of the Gravel Pit Range.

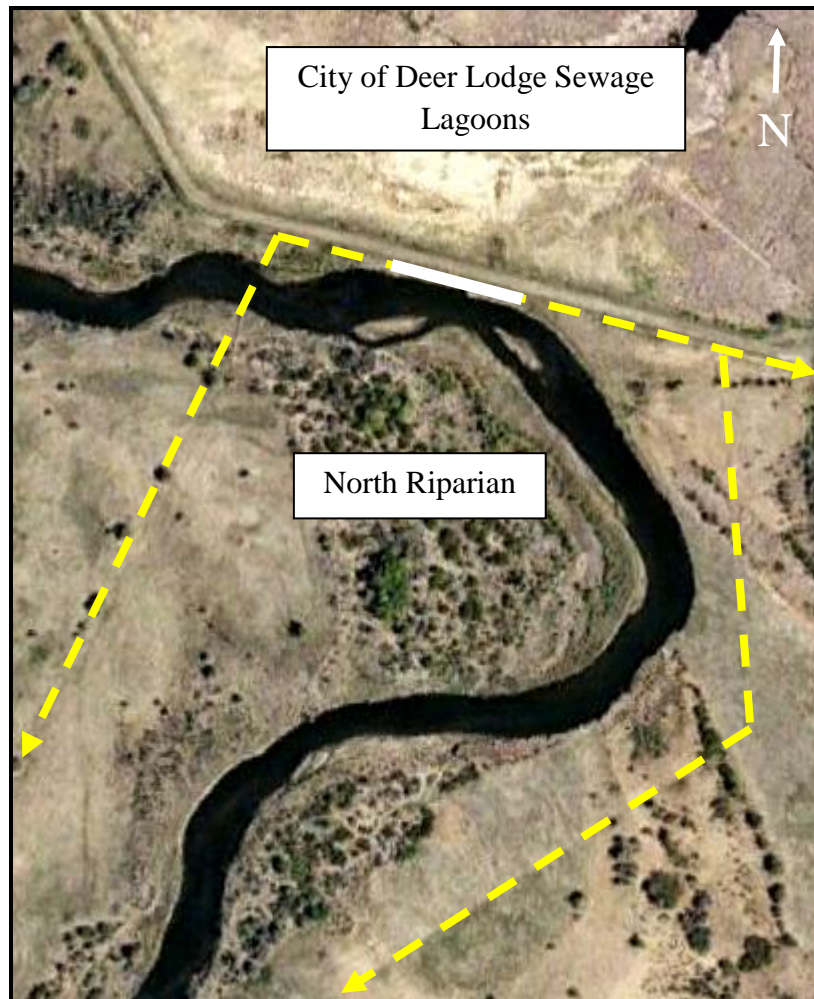
Photo 15. Northern portion of North Riparian area and the damaged section of metal post and barbed wire fence (white line) along the Clark Fork River.

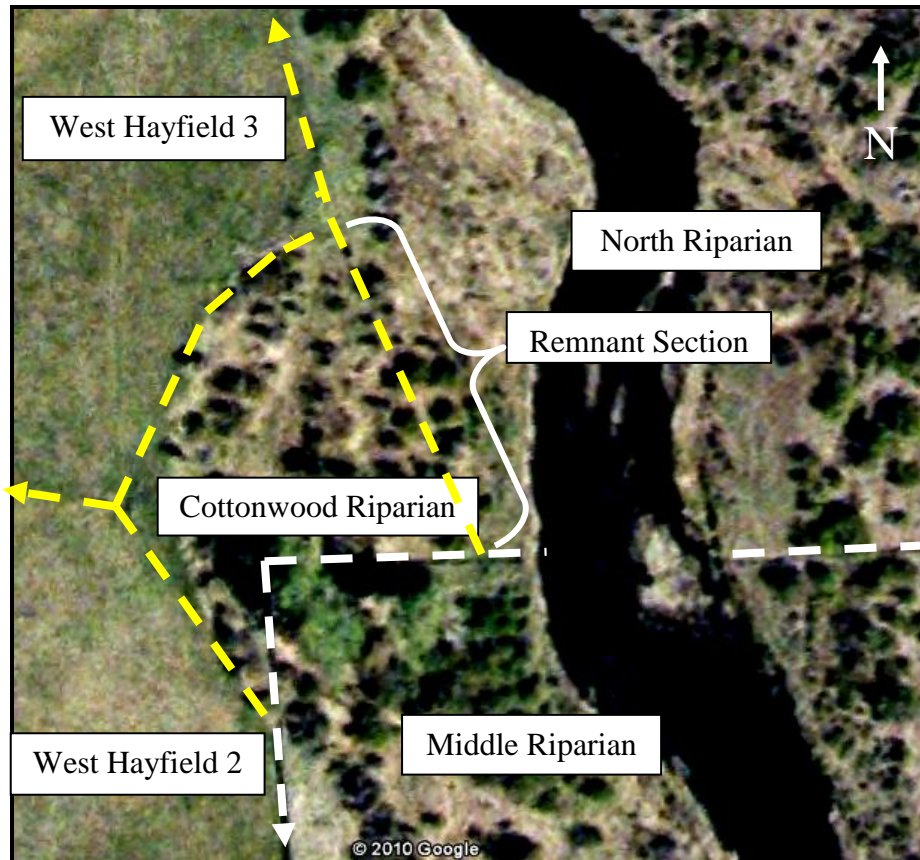
and 3 and the North and Middle Riparian areas. It is enclosed with a combination of fences (Photo 16). The south boundary fence is jackleg and was installed between 1979 and 1983 ^(1e,1f). The southwest and northwest fences are barbed wire and metal posts and represent portions of fencelines of West Hayfields 2 and 3, respectively. The east boundary is an older barbed wire section and is a combination of wood and metal posts. When this fence was originally installed has not been determined, but it may be a remnant section that was not removed when the west boundary (east boundary of the West Hayfield 3) was fenced in 1994. Additionally, the reason for this installation was not obtained through this research. However, because it seems that this short remnant section serves little purpose presently, it could be removed provided appropriate compliance was completed. If it is removed, this area would become part of the North Riparian Area.

Photo 16. Metal and wood post barbed wire (yellow lines) and jackleg (white lines) fences of Cottonwood Riparian area.

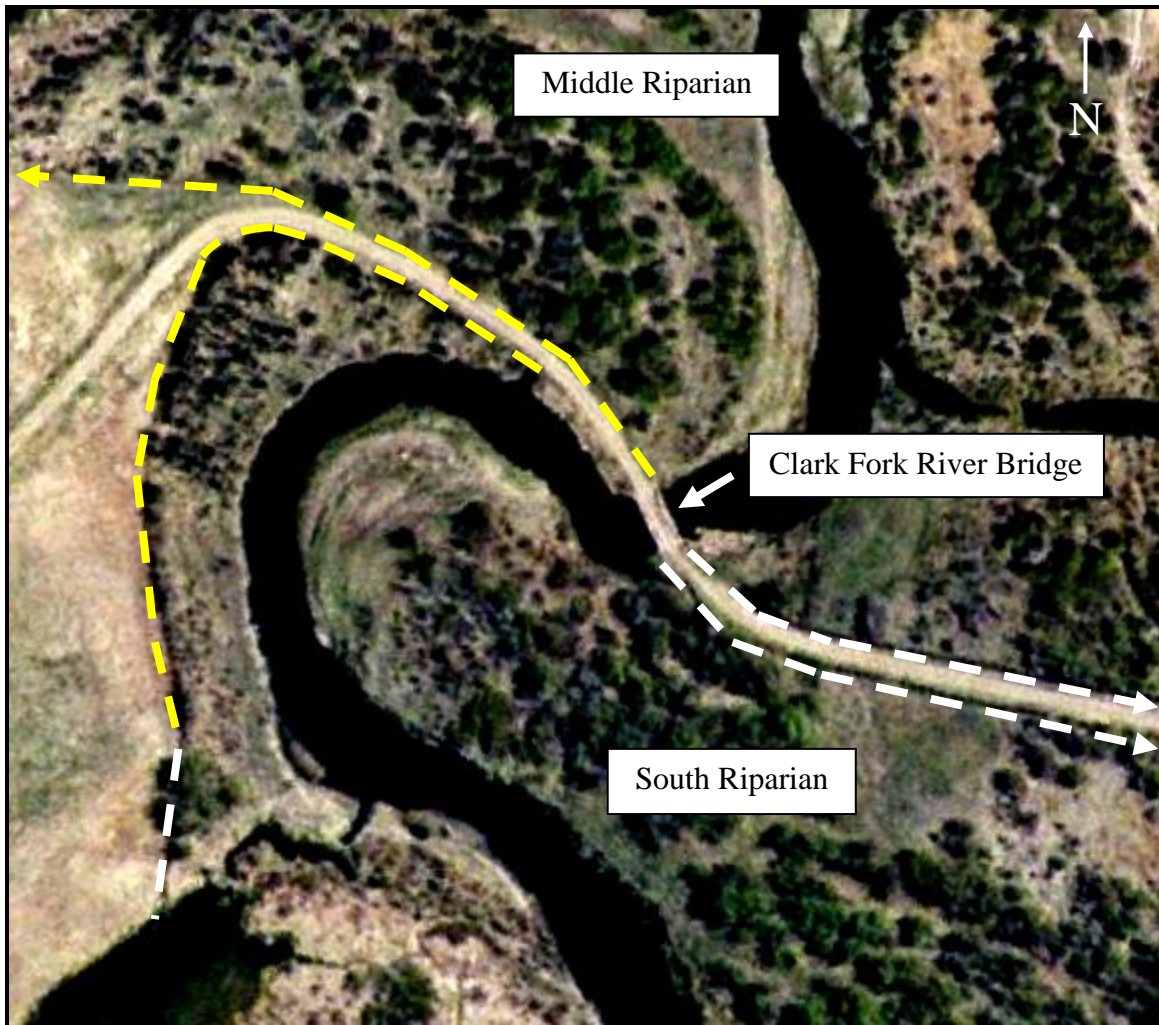
Photo 17. Wood post with woven wire and barbed wire (yellow lines) and jackleg (white lines) fences on the southern boundary of the Middle Riparian area and the north and west boundaries of South Riparian area.

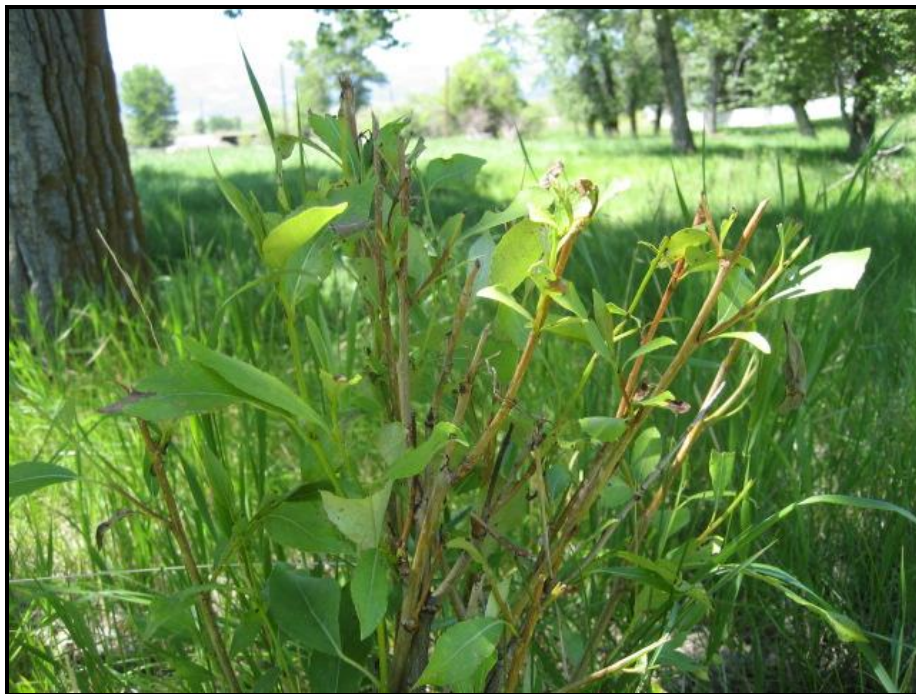
When surveying this area for undesirable ecological impacts, an important characteristic of the black cottonwood (*Populus balsamifera*) and willow (*Salix* spp.) populations in this area was noticed along Johnson Creek, just behind the Warren Residence. It appears that most of the black cottonwoods are rather old, and there are very few middle-aged trees and even fewer young trees present. Because cottonwoods represent an important cultural aspect of the ranch ⁽¹¹⁾, it is important that ecological succession is ensured. However, cottonwoods are dependent on flood disturbance for seed establishment ⁽¹⁷⁾ and this ecosystem process is probably largely subdued, plus cattle grazing appears to be impeding the survival of saplings. To ensure that cottonwood trees persist in this area, and everywhere else around the ranch, it is recommended that what few saplings are present be fenced to exclude grazing by cattle or browsing by wildlife. The map that is associated with this report identifies saplings that have not yet been damaged,

Photo 18. Example of a black cottonwood exhibiting shrub-like growth as a result of grazing or browsing.

and if enclosed with a small fence, will help to facilitate their growth. It is important that if any cottonwood trees are fenced, that they exhibit one main stem only, as this will ensure the desired growth habit of a tree. If the top is removed, then apical dominance is removed, and the growth habit will be shrub-like⁽³⁾ (Photo 18). Similarly, the willow populations in this area, although not particularly old, do not contain many young plants. In fact, no willow saplings were located that could be fenced and therefore, this information is not on the map. If GRKO decides that they want to enclose willows to promote sapling survival it is not important that there is only one main stem, as the natural growth habit of most willows is shrub-like.

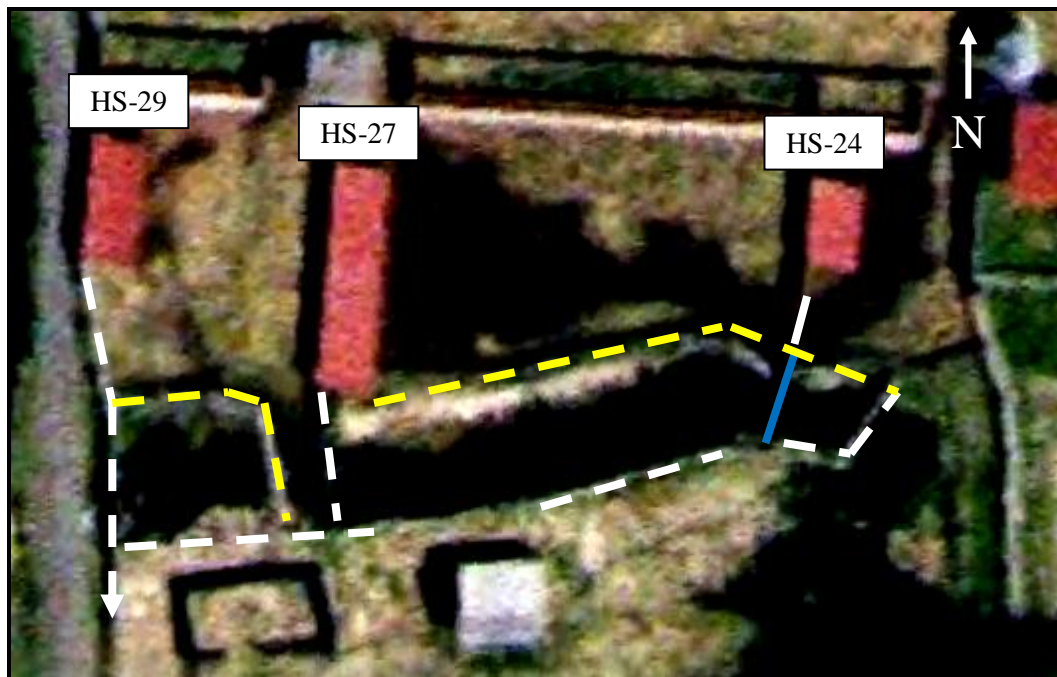
The fences that are present other than the ones from the 1996 addition are historical in type and location ⁽⁴⁾. However, there is one currently missing fence that is present in 1974 Historic American Buildings Survey photos (Photo 19). The reason for removal, as well as the precise date of removal is unknown, although it was sometime after 1987 ⁽¹³⁾.

Photo 19. Fences in the Johnson Creek area east of the Kohrs-Manning Ditch Road: historical, but currently absent (blue line), historical fences that are currently present (white lines), and NPS-installed fences that are currently present (yellow lines).

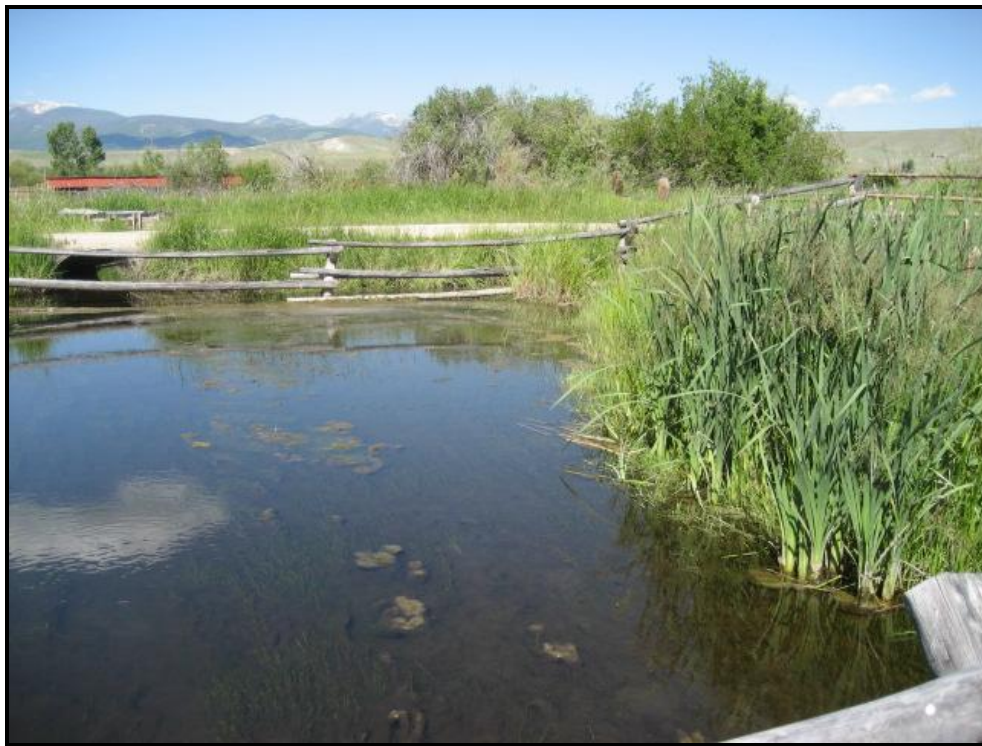
Impacts to hydrologic, stream channel, and vegetation characteristics in this area are noticeable. Specifically, water flow is minimal and the stream channel has widened. This has created stagnant conditions optimal for colonization by cattails and algae. A combination of factors, including livestock use in a small, confined area, short depth to the water table, and slow natural flow-rate are presumably responsible for current conditions.

of the Kohrs-Manning Ditch Road (Photo 20), and without active streambank restoration to direct the water to the culvert, this area may remain in the current condition.

Photo 20. Stagnant water and channel widening of Johnson Creek at the Kohrs-Manning Ditch Road and Stock Shelters HS-24, 27, and 29.

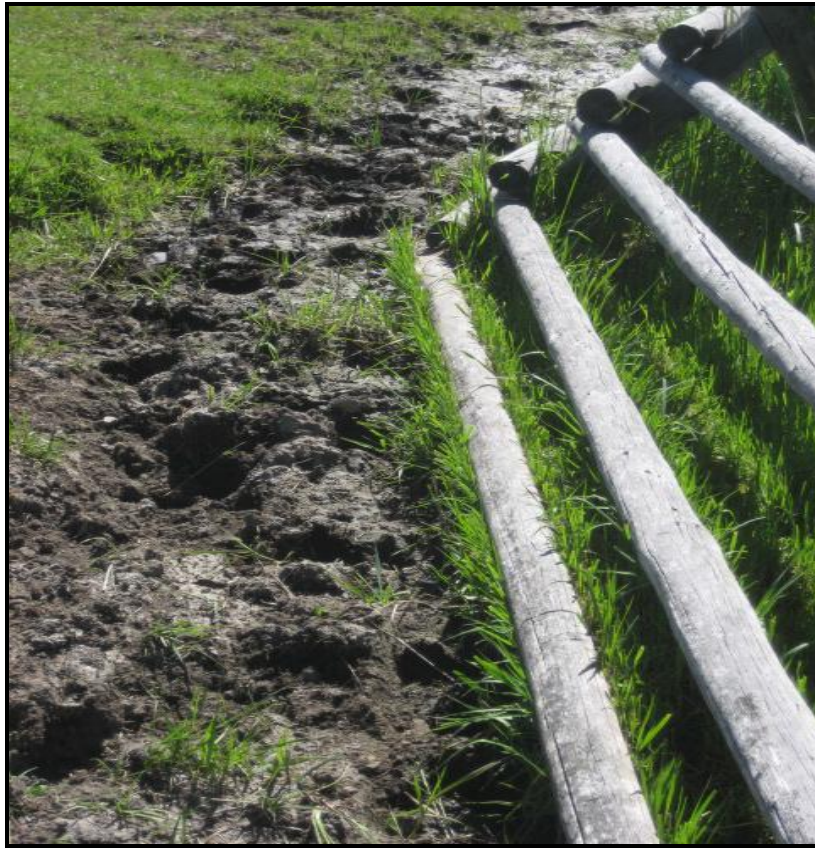
Soil compaction and vegetation loss due to stock use has occurred along the fences that were installed in 1996 on the north bank of the creek (Photo 21). It appears that trampling has exposed and compacted the soil, and because it is close to the stream, has created consistently muddy conditions, thus further impacting hydrologic, streambank, soil, and vegetation characteristics. To help improve this area, it is recommended that two objectives be evaluated. First, active restoration of the north bank of Johnson Creek should be implemented to narrow the channel and to direct water towards the culvert underneath KM Ditch Road. Second, the east-west fences along the north bank of Johnson Creek should be relocated approximately 8 - 10 feet northward, thereby putting them at slightly higher elevation than they are currently. This will

Photo 21. Soil compaction and vegetation loss along the fence on the north bank of Johnson Creek at Stock Shelter HS-29

reduce the probability that future trampling along the fences reaches the water table, and muddy conditions, excessive soil compaction, and loss of vegetation will be reduced.

This would necessitate improvement or replacement of the water trough between HS-24 and HS-27, and installation of a water trough at HS-29. If this option is chosen, the fences that cross Johnson Creek would not be needed; therefore, they should be removed to increase water flow rate.

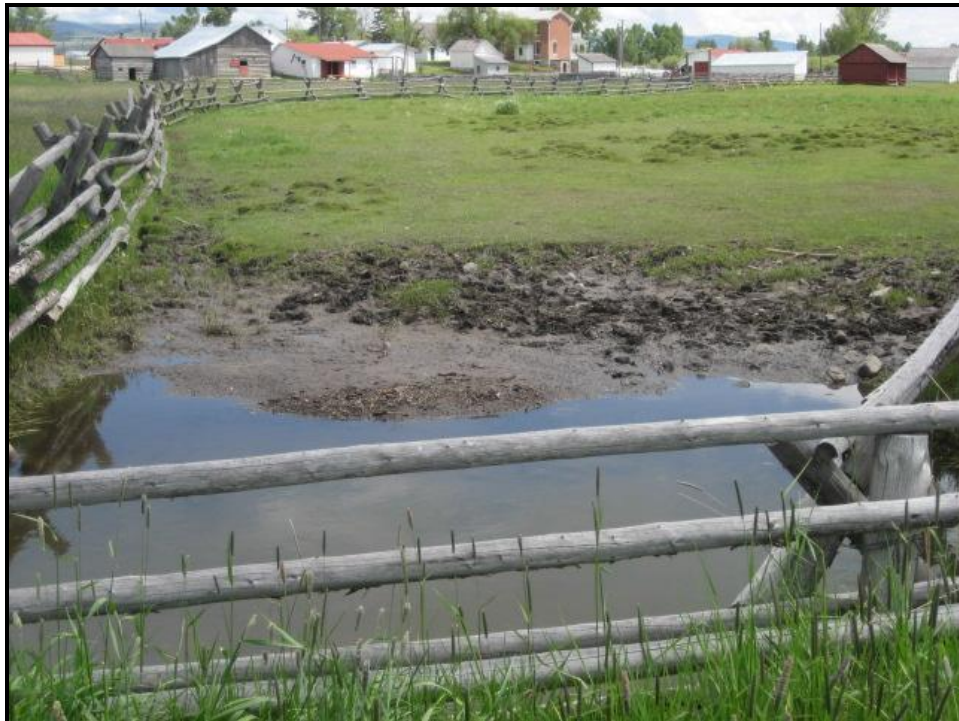
On a section along Kohrs-Manning Ditch, in the northern section of the Horse Pasture, a water gap is present on what is otherwise a completely fenced boundary. It may be beneficial that livestock use is concentrated in one small area to eliminate impacts to the rest of Kohrs-Manning Ditch in the Horse Pasture; however, this area exhibits intensive use (Photo 22). Soil compaction and erosion, as well as vegetation loss are noticeable, and could be reduced or eliminated in this area. Similar to recommendations provided above for the Johnson Creek Stock Shelters, the area would benefit from either fencing off the water gap entirely and installing a water trough, or installing a geo-textile product to reduce further soil compaction and erosion.

Photo 22. Excessive soil compaction and vegetation loss at the Horse Pasture water gap.
