Associated Project Name Complete Determination of National Register of Historic Places Eligibility for Helene Wittmer Property, Hartgrave troperty and the Ruidd Property Temporary Field Number	ECORD TYPE: ✓ First-recording, Full Re-record, Update,	Condition Report, Site Lead
onsultant Project Number DOINPS42501       Agency Project Number(s)	ROPERTY CATEGORY:Prehistoric Site,Historic Site,	_Building,Structure,Object, ✓District,Landscape,Lithic Landscape,TCP
Associated Project Name Complete Determination of National Register of Historic Places Eligibility for Helene Wittmer Property, Hartgrave troperty and the Ruidd Property the Name Hartgrave-Halpin Property Temporary Field Number	. IDENTIFICATION/OWNERSHIP	
Property and the Raidd Property       Temporary Field Number	Consultant Project Number DOINPS42501	Agency Project Number(s)
Agency Site Number Tract: 03-103 Cher Site Number Tract: 03-103 Cher Site Number		al Register of Historic Places Eligibility for Helene Wittmer Property, Hartgrave/H

Other Site Number         andowner (at time of this reporting, specify agency/district, if private give name and address):	ite Name Hartgrave-Halpin Property	Temporary Field Number
andowner (

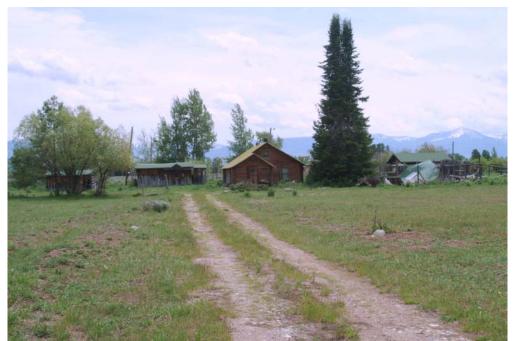
Hartgrave-Halpin Property, view southeast from Moose-Wilson Rd. (Mary Humstone, 2007)

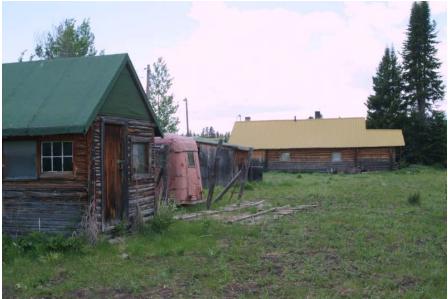
Hartgrave-Halpin Property, view south, showing Bldgs. #1, #2, #4 and #6 (Mary Humstone, 2007)

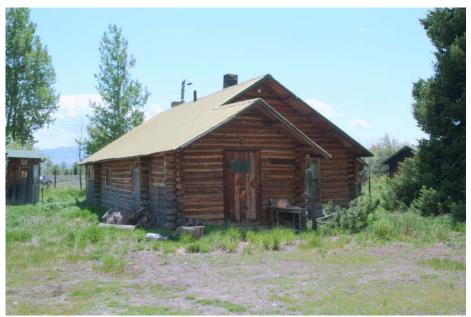
6. Cabin (1950): The Hartgrave Cabin is a one-story, rectangular, front-gabled, log building (48' EW x 24' NS) with a front-gabled, enclosed porch (9' EW x 12' NS) extending across the north half of the façade. The cabin is sited in the middle of and slightly west of the north-south row of outbuildings. The wall logs are round with sawn ends and are saddle-notched at the corners and chinked with quarter-round poles. The logs extend to the peak of the gables. The rear 12 feet of the building is a later addition to the original cabin, and is of frame construction, sheathed in board-and-batten siding. The cabin sits on a poured-concrete foundation. The log-purlin roof is sheathed with standing-seam metal roofing. Two concrete-block chimneys extend from the south slope of the roof, one near the center and one at the east end. The front door is centered in the entrance porch and is constructed of log slabs, with a single, plexiglass light in the upper portion. All windows in the house are wood. There is a 3-by-3 sliding window in the south elevation of the entrance porch. The south bay of the façade features a single 1-over-1, double-hung window with a 2-light storm sash. There is a square opening covered with plastic sheeting in the gable end.

The south elevation has (from west to east) a square, stationary window, a 2-light sliding window and a wood door consisting of 6 lights above a wood panel that has been covered with boards. The rear 12' (addition) of the elevation is sheathed in board-and-batten siding. The east elevation is sheathed

in board-and-batten siding and has two 2-by-2 sliding windows in the first story and a window with 3 vertical lights in the gable end. The north elevation has a 3-light window in the board-and-batten-sided rear addition and two stationary windows in the main log section.

Hartgrave Cabin (Bldg. #6), west and south elevations (Mary Humstone, 2007)

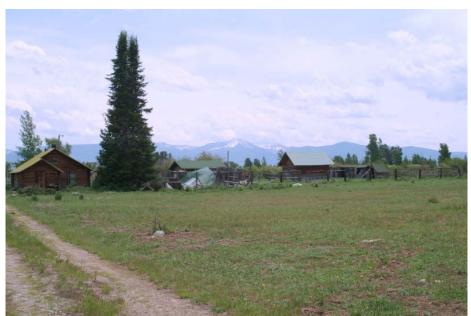
This barn was originally at the Trail Ranch. It was disassembled by Hartgrave and reassembled on his property in the 1950s (*Ted and Doris Hartgrave Homestead* Audiotape). It is in fair condition.

Hartgrave-Halpin Property, view south/southeast, showing Bldgs. #6, #7, #9, #10 and #11 (Mary Humstone, 2007)

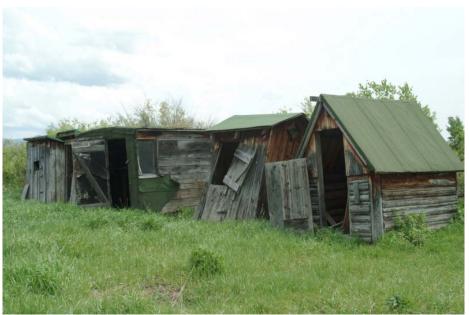
<u>Buildings #11 - 15</u> are very small outbuildings lined up in a row running east-west at the south end of the fenced yard. All the buildings are orientated to the north, and all are in poor condition. Several are leaning heavily. All five buildings appear to have been moved to the property from other ranches in the area, and probably date from the 1940s – 50s.

<u>11. Shed:</u> This 6' by 9' shed is constructed of logs, resting on stones at the corners. The logs are sawn at the ends and nailed to 2- by-4 corner boards. It has a very steeply pitched gable roof, sheathed in green rolled roofing, and vertical wood siding in the gable end. The ridgepole extends past the roof line. The door is broken and hanging to one side.

<u>15. Outhouse</u>: This 4'-by-4' outhouse is constructed of vertical boards, with some interior 2-by-4 framing. It rests on rotted logs laid directly on the ground, and has a wood floor and wood seat with two holes. It has a shed roof sheathed in green rolled roofing, and a vertical-board door with a broken light. It is leaning heavily to the east.

Hartgrave-Halpin Property, view east/southeast, showing Bldgs. #11 - #15 (Mary Humstone, 2007)
