Restoration prioritization and procedures for Drakesbad Meadow, Lassen Volcanic National Park, California

February 2012

DRAKESBAD MEADOW RESTORATION PLAN

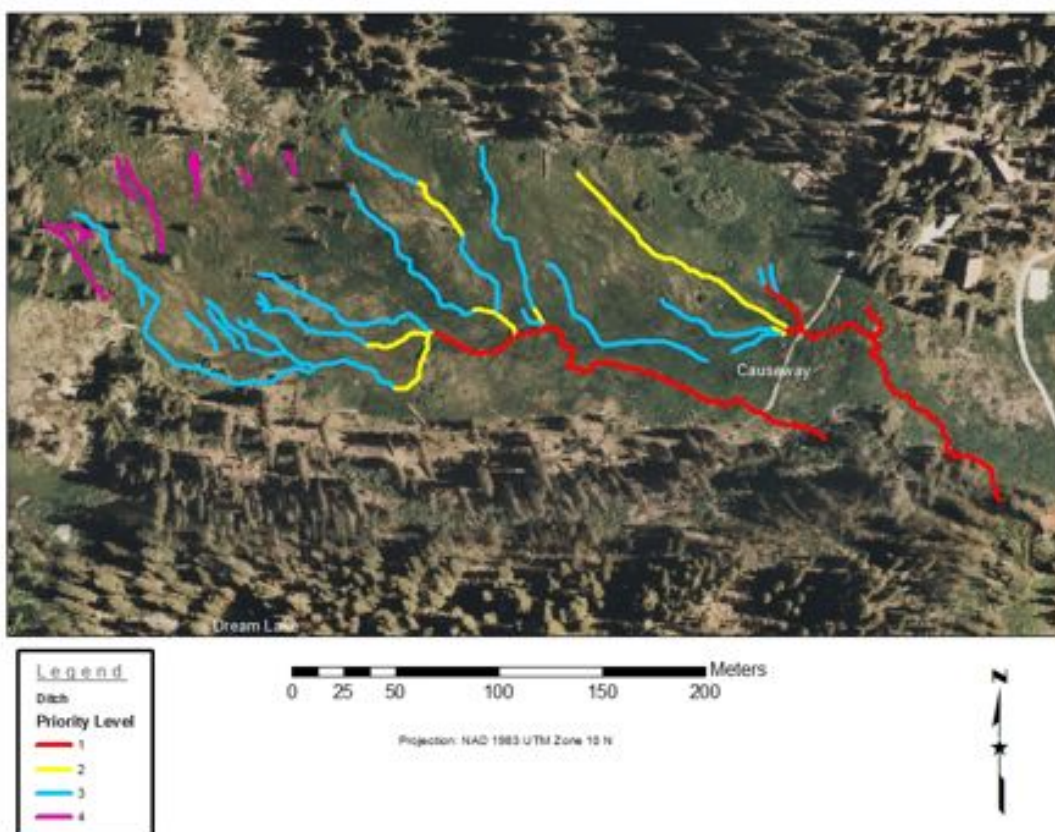
Ditches in Drakesbad Meadow have varying incision depths and vegetation. Ditch types ranged from those whose depth exceeded its width, with no vegetation and perennial running water, to fully vegetated gently sloping depressions that lack surface water. Because all ditches and channels in the meadow may not be restored, we developed a priority systems for ditches (Figure 1).

- Priority 1 ditches are the deepest and most hydrologically impactful features in Drakesbad Meadow. They are incised, usually narrow, and have perennial flowing water. The ditch bottom

is typically unvegetated, and ditch width and depth are often similar. These sites are the highest restoration priority.

- Priority 2 ditches are similar to those identified in Priority 1. However, they have less severe incision and degradation. Most segments are deep and unvegetated and in need of restoration.

- Priority 3 includes gently-sloping depressions that are largely or fully vegetated. We are uncertain if these channels are actively incising. These channels typically are 1 m wide and 15 cm deep, without any distinct breaks in slope. If LAVO desires to fill these channels, we suggest that the vegetation be removed in blocks with hand shovels, sediment added, and the blocks of vegetation reinstalled.

- Priority 4 includes all channels in the northwestern corner of Drakesbad Meadow. These have formed near the break in slope from hillside to flat meadow. We are unsure if these channels should be considered for restoration. None are visibly connected to the main network of ditches (Priority 1 & 2) in the meadow.

Figure 1. Location of priority 1 (red), 2 (yellow), 3 (blue) and 4 (magenta) ditches in Drakesbad Meadow, Lassen Volcanic National Park, CA.

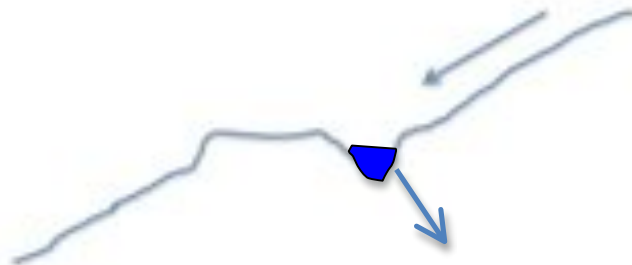
Patterson and Cooper (2007) identified the water tank access road as a significant hydrologic impact to Drakesbad Meadow. The major water source for Drakesbad Meadow is the hillslope springs located above the road. This report cover photo shows the sedge dominated meadow and conifer forest on the far hillslope. A strip of alder extends from Drakesbad Meadow to the spring discharge points. The alder is a key indicator of ground water discharge and an excellent visual indicator of where the spring discharge and flow occurs. The road bisects the alder stands and captures water in its uphill ditch (Figure 2). This water for many decades flowed down the roadside ditch where a couple of culverts routed water under the road. However, in 2004 a series of culverts were placed where the access road crosses the alder stands to allow spring water to flow toward Drakesbad Meadow in locations that have naturally supplied water to the wetland. This has allowed a temporary and partial restoration of the meadow hydrologic regime.

Figure 2. Profile of current water tank road, showing uphill ditch that intercepts sheet flowing water from springs.

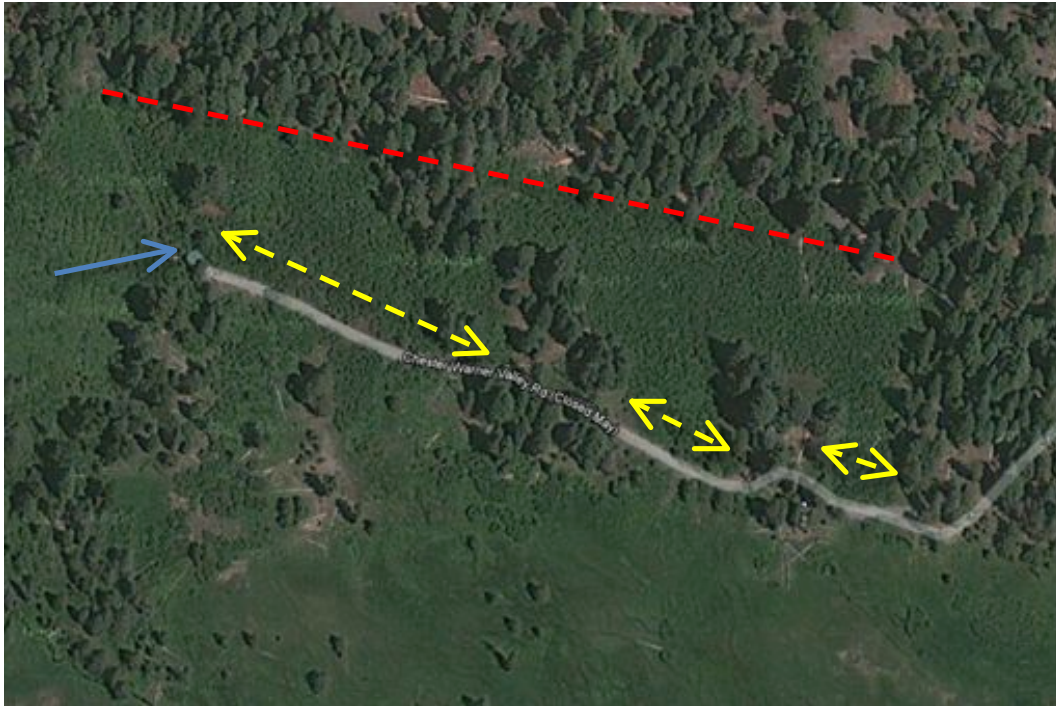
Figure 3. Water tank road and water tank (blue arrow) on hillslope above Drakesbad Meadow. Tall conifers occur on bedrock outcrops that are dry. Between conifer dominated hills are springs that originate at the dashed orange line that is the contact between two volcanic sediment beds. The water flows through alder dominated vegetation, seen as the small dense green clumps. The road crosses three distinct spring flow paths, identified with yellow dashed lines.

The most suitable way to reduce the ongoing hydrologic impacts of the water tank road on the meadow is to construct a road with a water permeable base in the three locations shown in Figure 3. A permeable road is constructed entirely of fill with its base composed of sufficiently sized rock to allow surface water to flow through the road base. Historically, spring water on the hillslope above Drakesbad moved as sheet flow and in numerous small rills to the meadow. Channelizing water behind the road and into culverts resulted in down gradient drying in areas that did not receive water as well as erosion where the concentrated water flows down the hill slope. The three areas identified in Figure 3 could have their road segments rebuilt to reconnect

Drakesbad Meadow with its source water. The current fill should be removed and the uphill and downhill ditches completely filled so that the land surface slopes seamlessly from the intact spring complexes above the road to the hillslope below the road. A geotextile fabric is then laid on the future road location, and rocks 10-40 cm in diameter are laid as the road base (Figure 4). This base should be 40-60 cm thick. A layer of smaller diameter rocks, 5-20 cm in diameter, is then placed on the larger rocks to create a relatively level surface. Another layer of geotextile is then placed on top of the finer rock layer and road surface material is placed on the geotextile and compacted. The road surface should slope gently toward the meadow so that surface runoff from snow and rain will not run down the road surface producing rilling and erosion.
