# **Wetland Restoration Pilot Project at Florissant Fossil Beds National Monument**

David J. Cooper and Jeremy Sueltenfuss  
Department of Forest and Rangeland Stewardship  
Colorado State University, Fort Collins, CO 80523

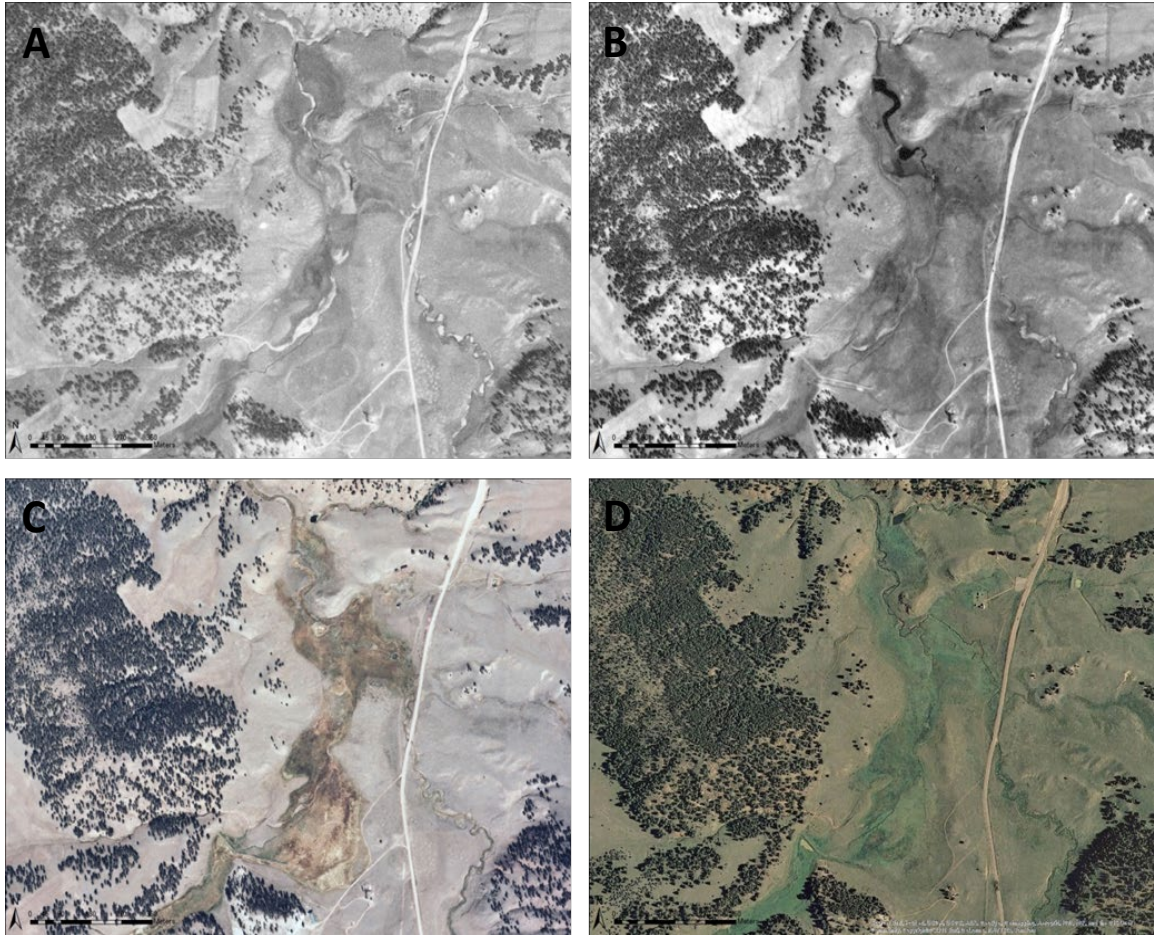
The Hornbeck meadow had already been altered in the earliest image available. Few dams existed on the landscape in 1938, but fence lines and corrals are visible in the image, indicating differences in land management at this early stage (Figure 2). Between 1938 and 1956, many of the dams that exist today were built. The image shows large ponds created by moving the surface of the land into a pile to create both a pool and a dam. By 1975, the dams are still in existence, but many of them no longer hold back any water. In the 20 years of the dams existence, water has eroded channels around each dam. This channelization has continued to the present day image. Channels have become longer than the 1975 image, as well as much deeper and more pronounced. The extent of wetlands in the area is difficult to determine based on image resolution and color, but it is reasonable to assume that wetland acreage declined through the years as some land became ponds, some became dams, and some was drained by the newly formed channels.

Figure 2. Aerial photos of the Hornbeck meadow from (A) 1938 (B) 1956 (C) 1975 and (D) 2010. Most changes to the landscape occurred between 1938 and 1956, when all 5 dams and associated ponds were constructed. Dams do not hold back water in 1975, and channels have formed in the 2010 photo.

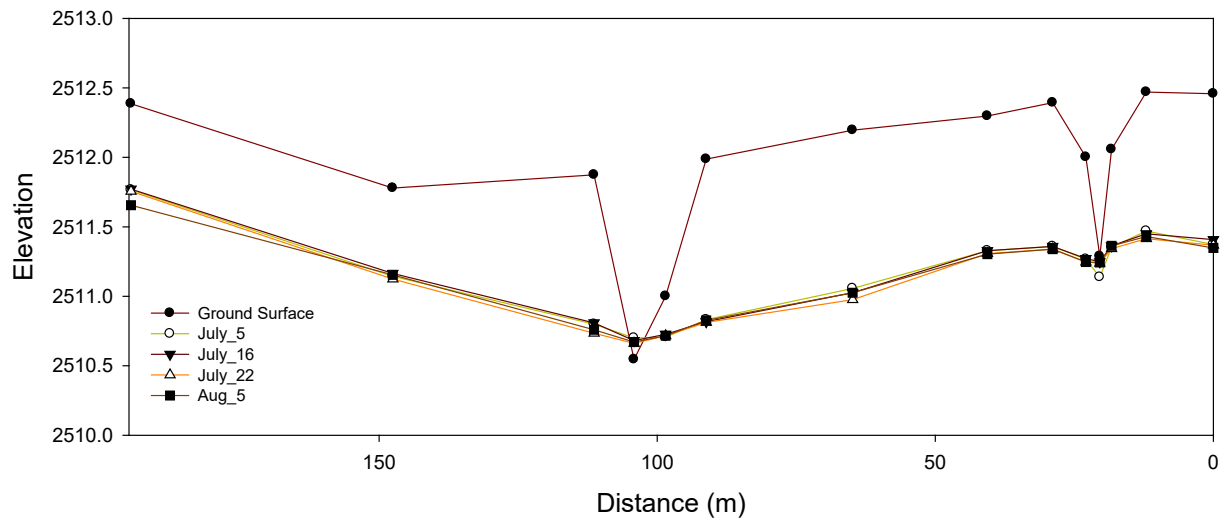
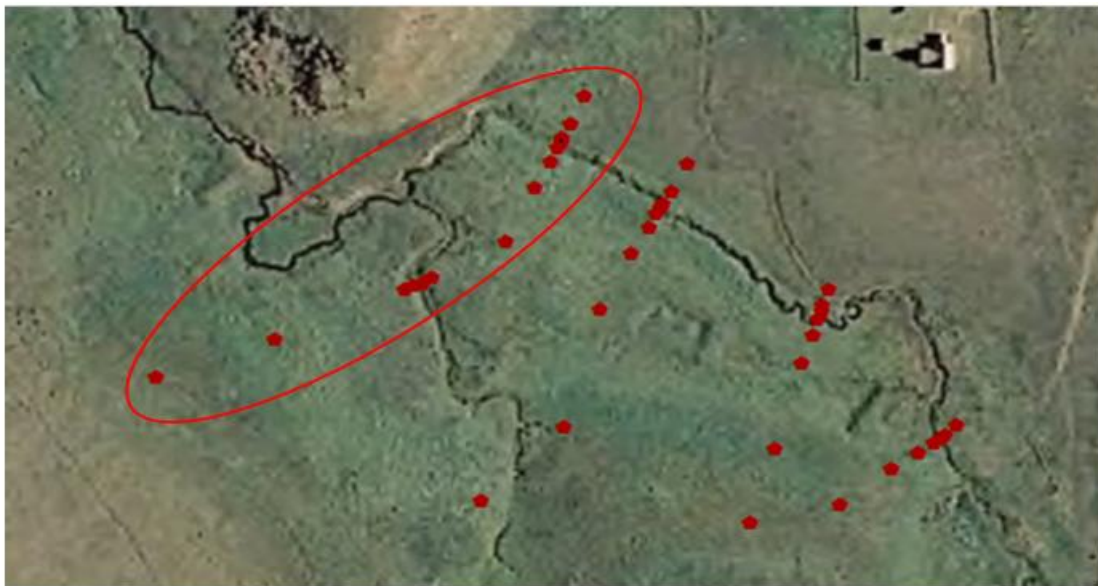
Though 2012 proved to be an anomalously dry year, water table data indicated that both channels within the project area were lowering the water table within the meadow (Figure 3), even though multiple locations were discharging water into the meadow. Monitoring wells near locations of water discharge typically had water table depths less than 0.5 m (Figure 4). Water tables near channels were much deeper than their point of origin. Water tables continually declined as they approached each channel, with a further dip into each channel, indicating that channels are acting as a drain to this meadow.

Figure 3. Top: Land surface and water table elevations within the Hornbeck meadow. Both channels can be seen with lowered water tables near each channel. Bottom: Location of wells shown in top figure.

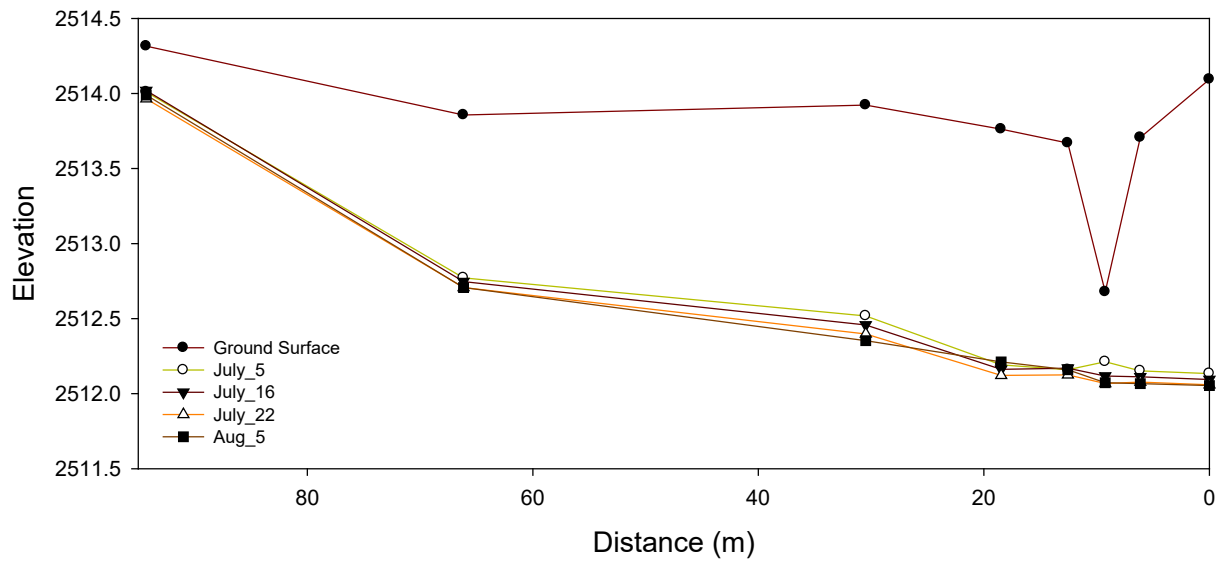
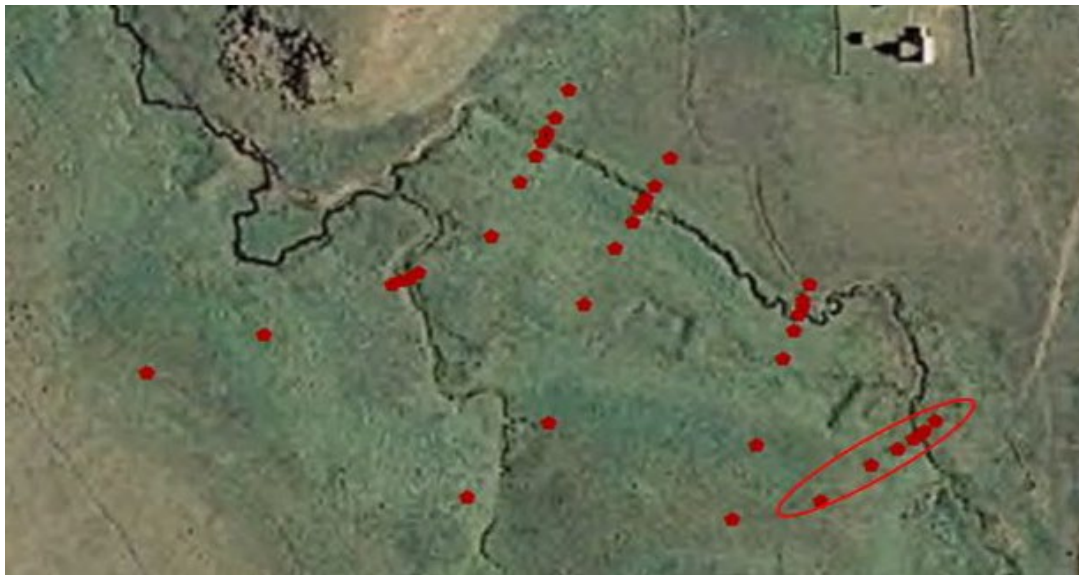
Figure 4. Top: Land surface and water table elevations within the Hornbeck meadow. Ground water discharges into the meadow (from left) and subsequently declines as it approaches the channel. Bottom: Location of wells shown in top figure.

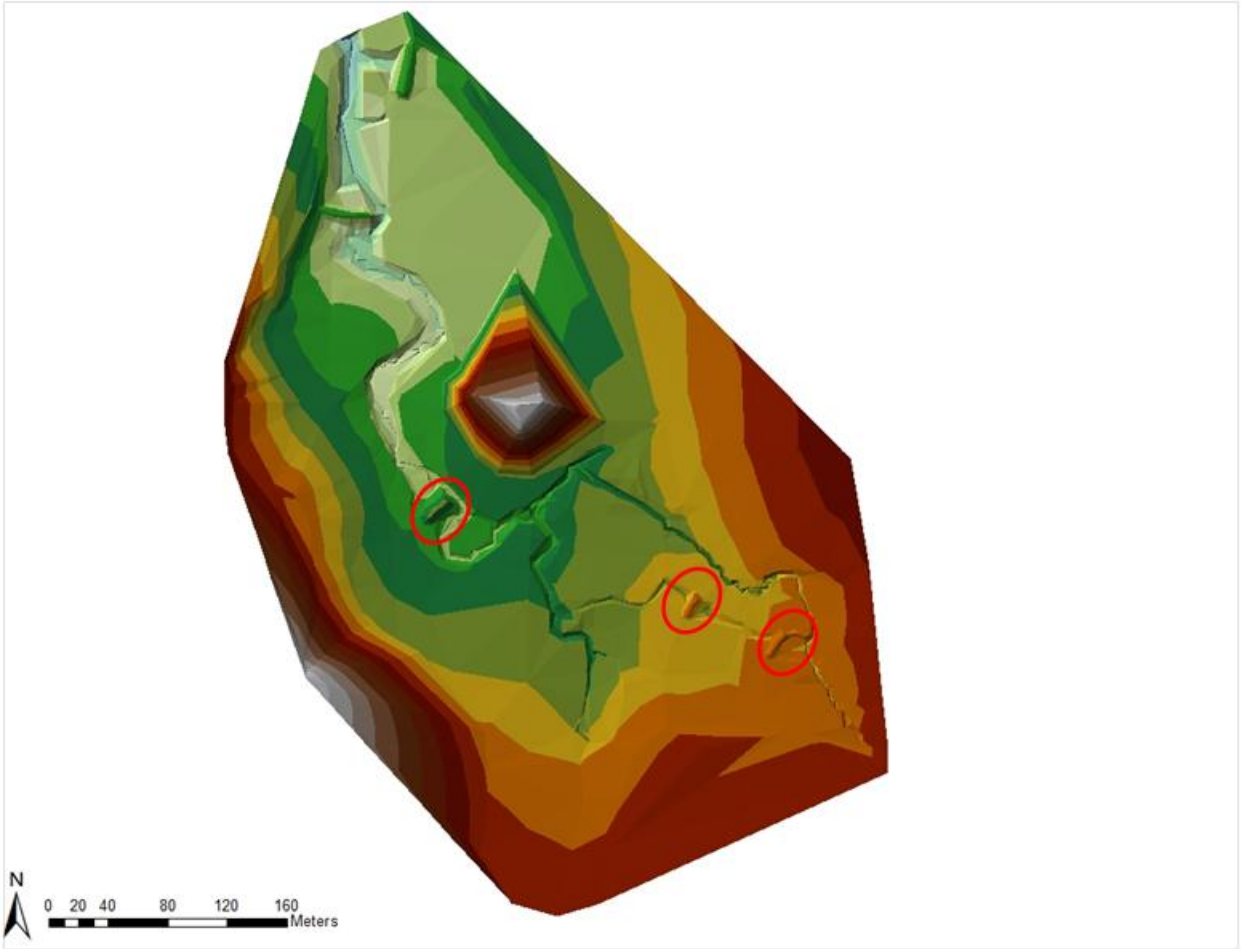
A total of five dams and three channels were part of the surveyed landscape (Figure 6). Three dams with a total volume of 400 m<sup>3</sup> were identified to be removed as part of this pilot restoration project (Figure 7).

Figure 7. TIN from Figure 6 with 3 dams identified for removal circled in red.

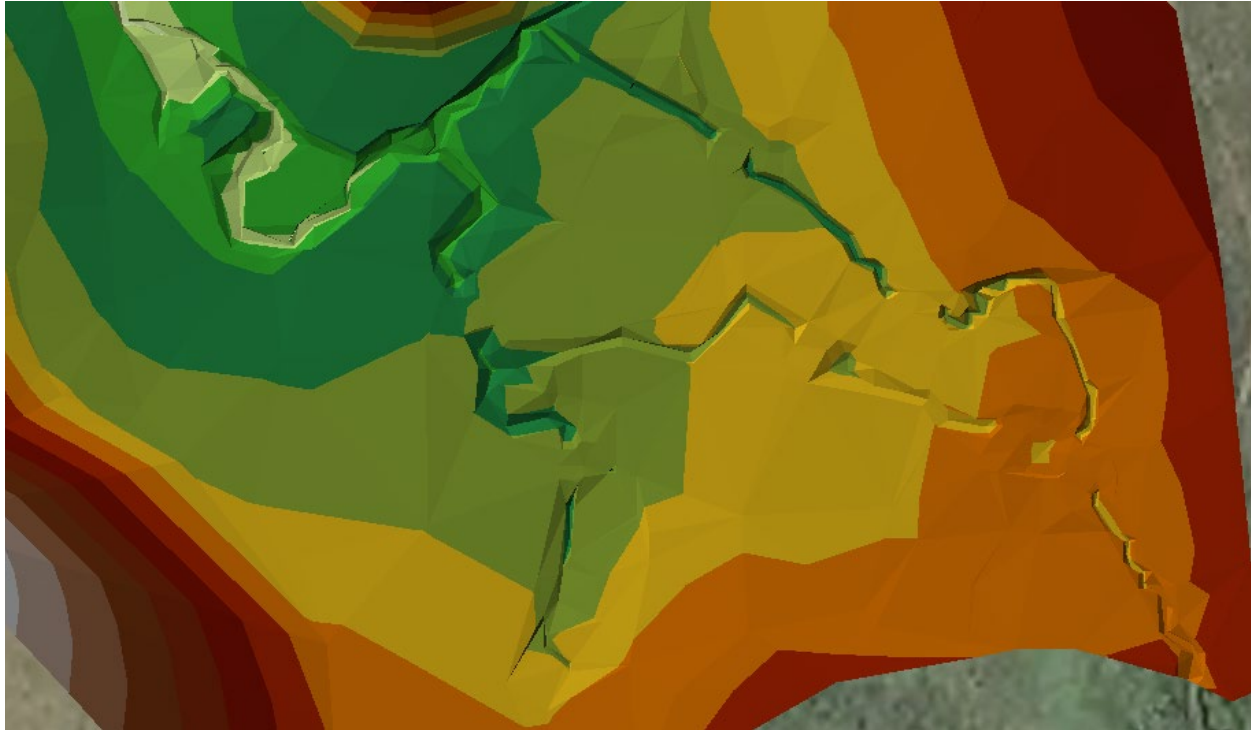
Figure 8. TIN of actual restored landscape with three dams removed and five plugs installed.

Construction took place in October of 2012. All three dams were removed, and the fill was placed into each channel in five previously identified locations (Fig. 8).

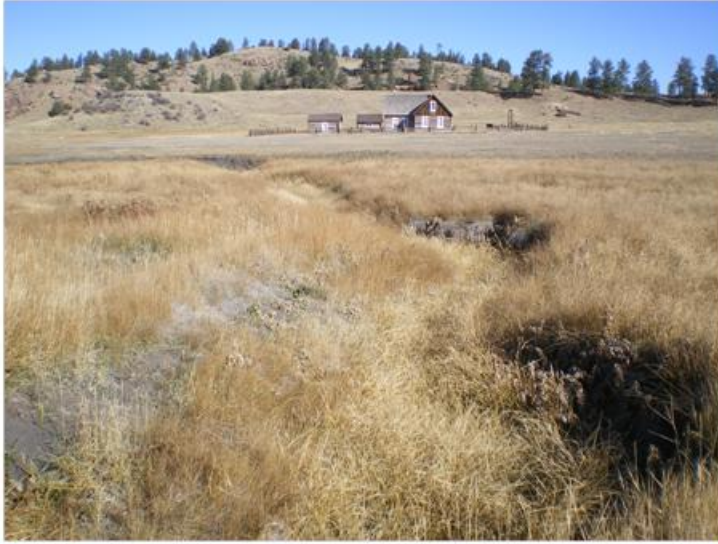
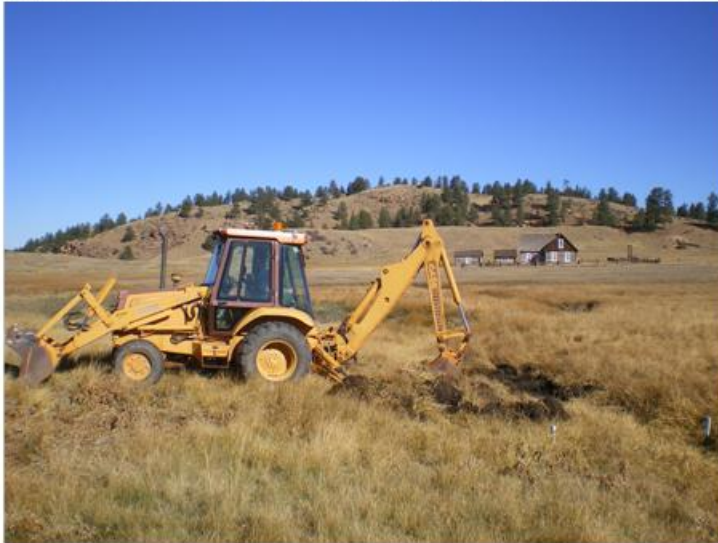
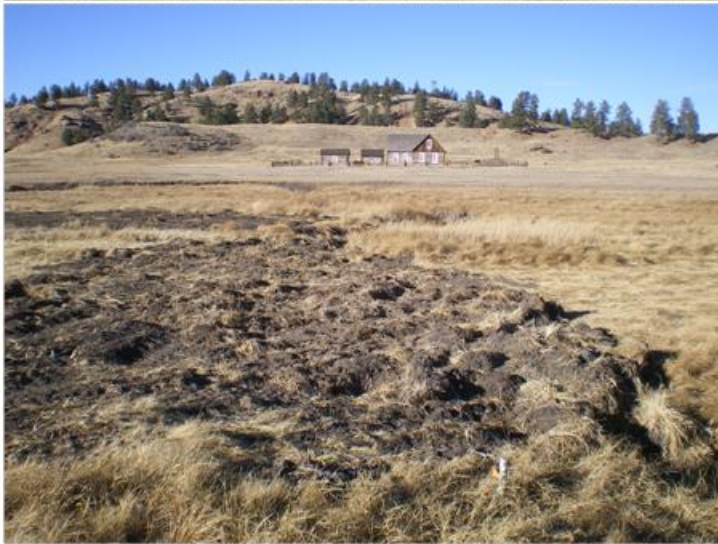
Figure 9. Hornbeck meadow channel before construction (top), during construction (middle) and after construction (bottom). This particular channel did not have any flowing water, making the efficacy of the plug installation unknown at this point.

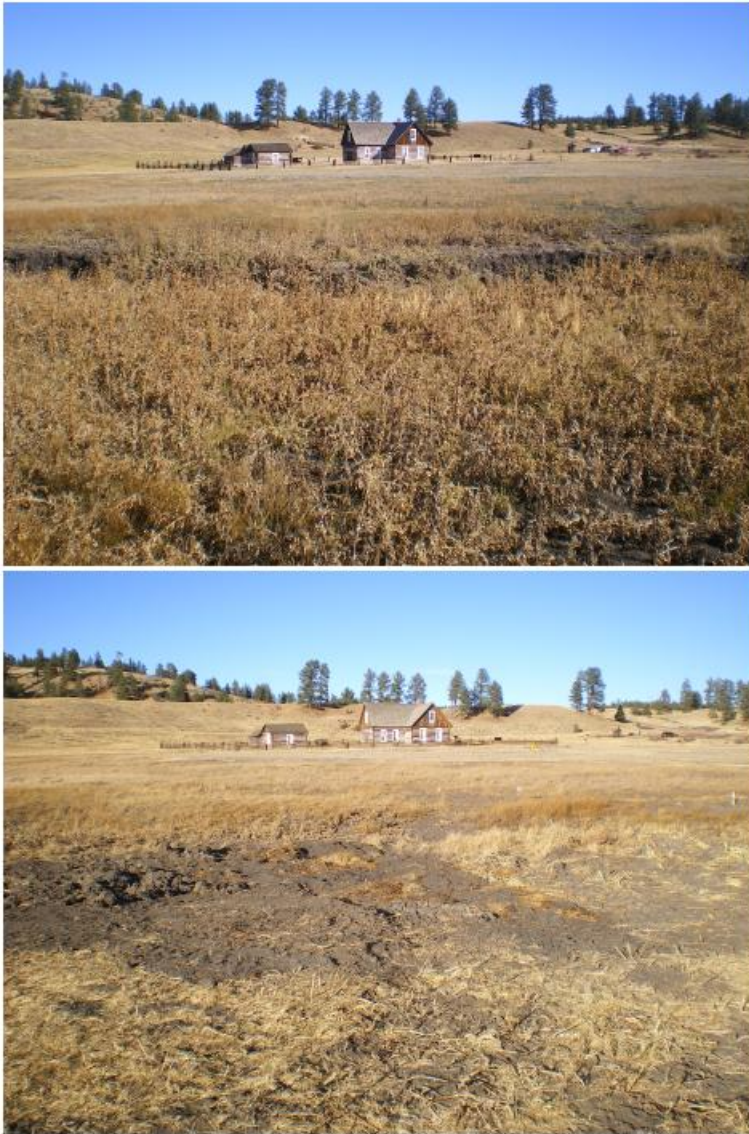
Figure 10. Hornbeck meadow channel before construction (top) and after construction (bottom). This particular channel did not have any flowing water, making the efficacy of the plug installation unknown at this point.

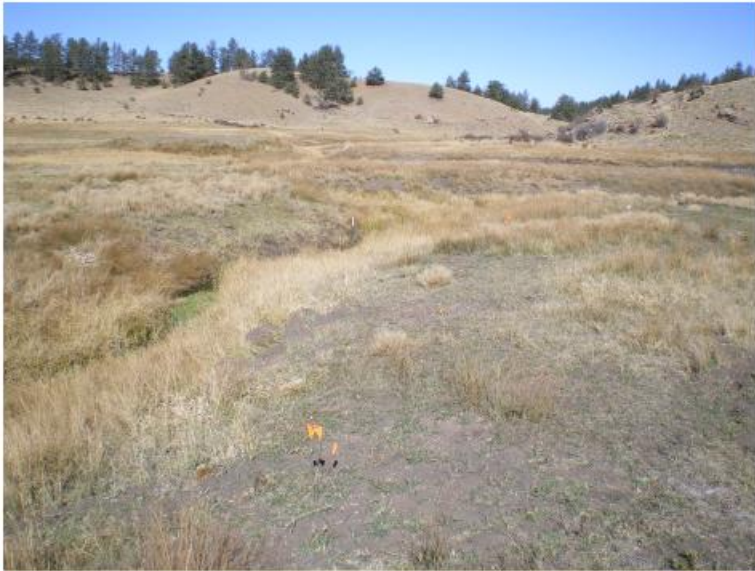
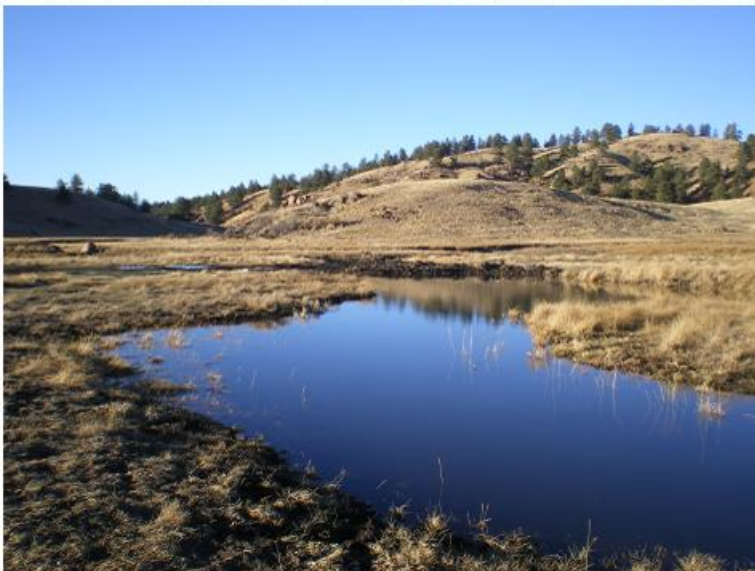
Figure 11. Hornbeck meadow channel before construction (top) and after construction (bottom). Plug installation lead to the backup of water in the channel, which seemed to redistribute the flow into the adjacent meadow.
