Hydrologic Regime, Vegetation, Impact Analysis, and Restoration Concepts for the Rodeo Beach Wetland complex: Golden Gate National Recreation Area, California

David J. Cooper, Ph.D., Evan C. Wolf, M.S.
Department of Forest, Rangeland and Watershed Stewardship
Colorado State University, Fort Collins, CO 80523

September 2008

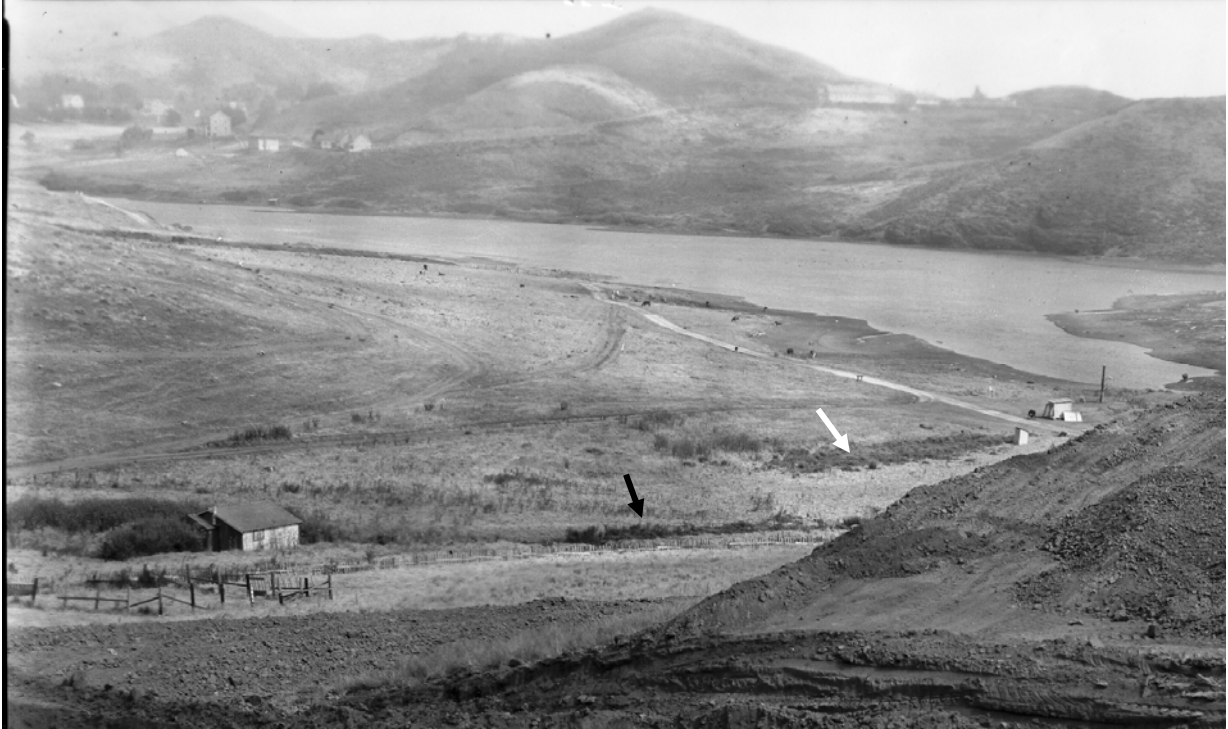
Figure 4. August 31, 1938. Looking southeast to the area down valley (south) of the ranch road (out of frame left). Arrows highlight drainage features visible in Figures 2 and 3. Black arrow shows a ditch below the small building. White arrow points to a natural historic drainage.

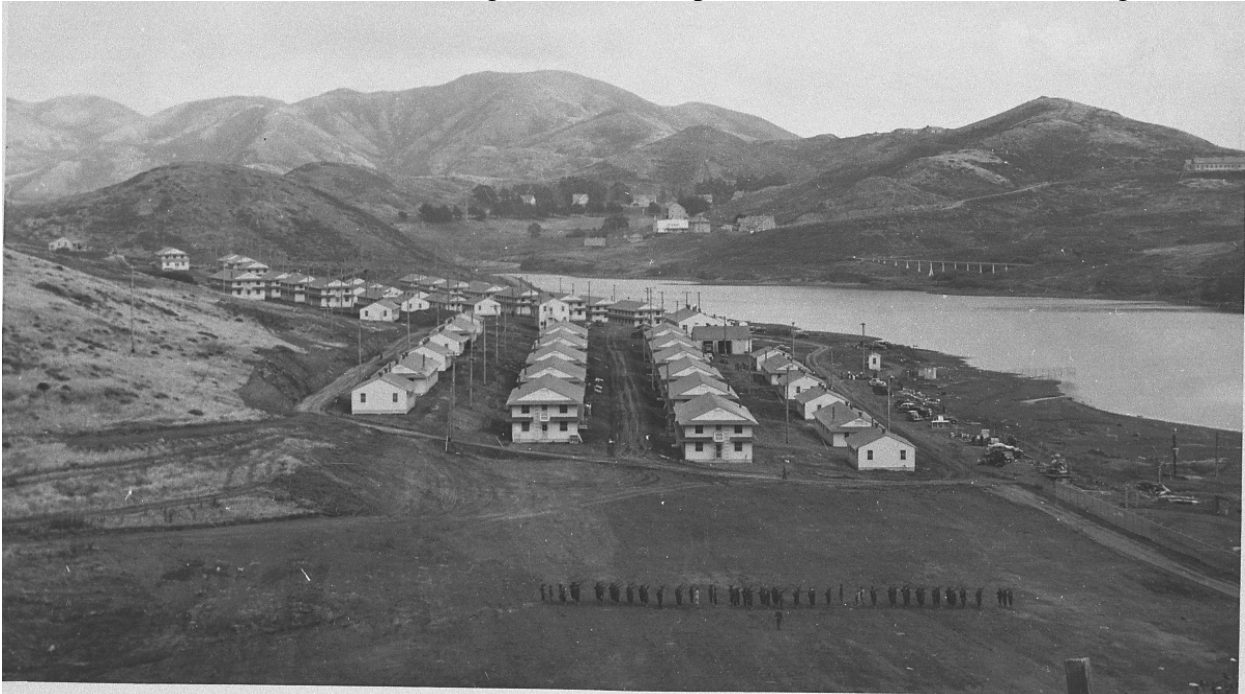
Figure 5. June 24, 1941. Showing entire lower wetland graded for use as a parade ground. No drainage features are apparent and it is likely that at this time the discharge from the headwall culvert (out of frame to the left) was conveyed to the lagoon (at right) in a buried culvert.

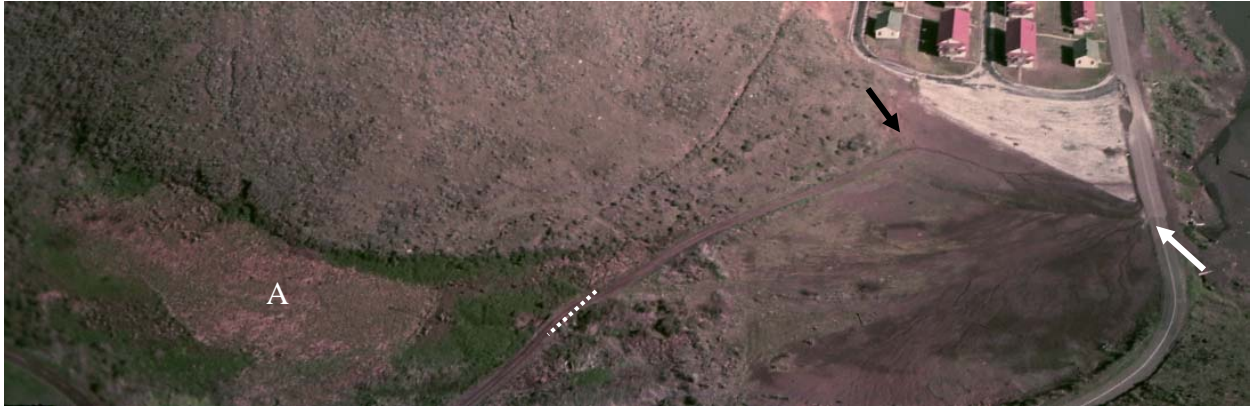
Figure 6. *Ca.* 1980 oblique airphoto. North and upvalley are to the left. Note the transverse road and headwall crossing (white dotted line), and large rectangular zone (A) in what is now perennial wetland that in the photo appears dry and surrounded by green-vegetated, linear-edged features that may be remnant drainage ditches. Note also that the transverse road ends near the black arrow and the drainage pattern below it suggests that a ditch running along the road conveyed water to this point. The larger drainage network, across the bare area that is now the gravel parking lot, drains to a low point marked by the white arrow, roughly in the same location as the natural drainage seen in Figures 3 and 4.

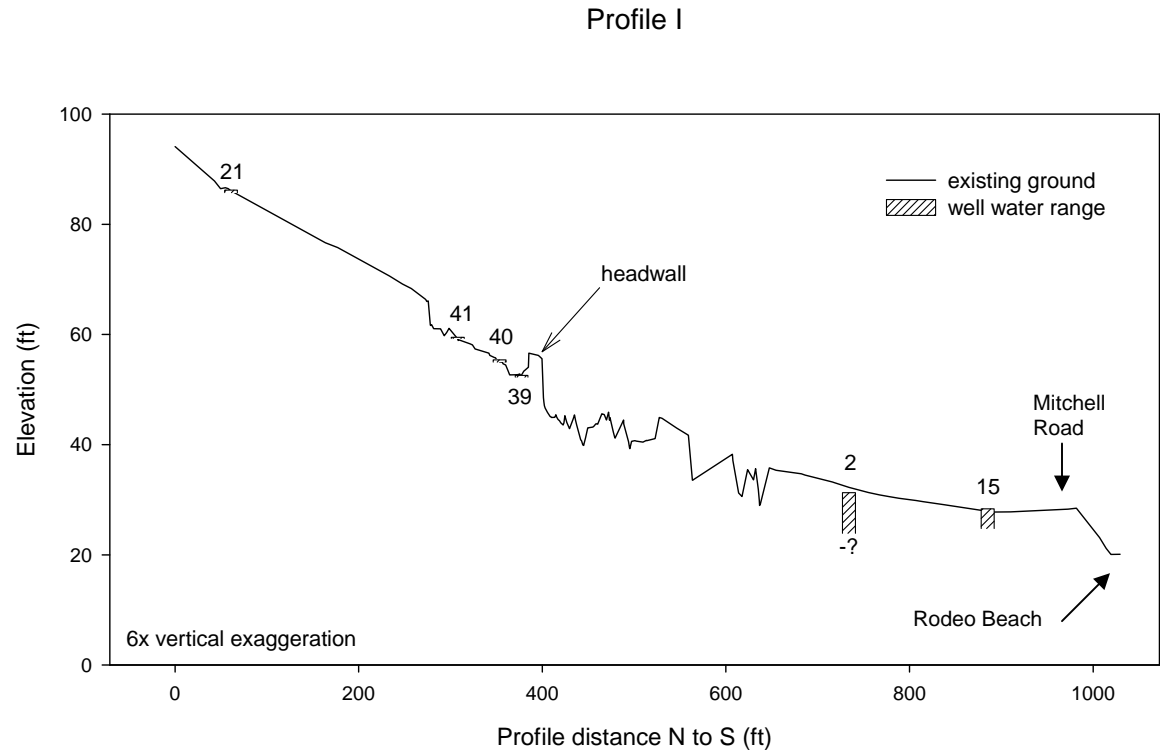
Figure 9. A longitudinal profile (see Figure 7) of Rodeo wetland that shows the relatively smooth and gradual upper wetland slope from well 21 to well 41, the head cutting channels at staff gauges 39 to 41, the headwall below 39 and the large erosion gully below, and the even parking lot with deep low-water water table at wells 2 and 15.

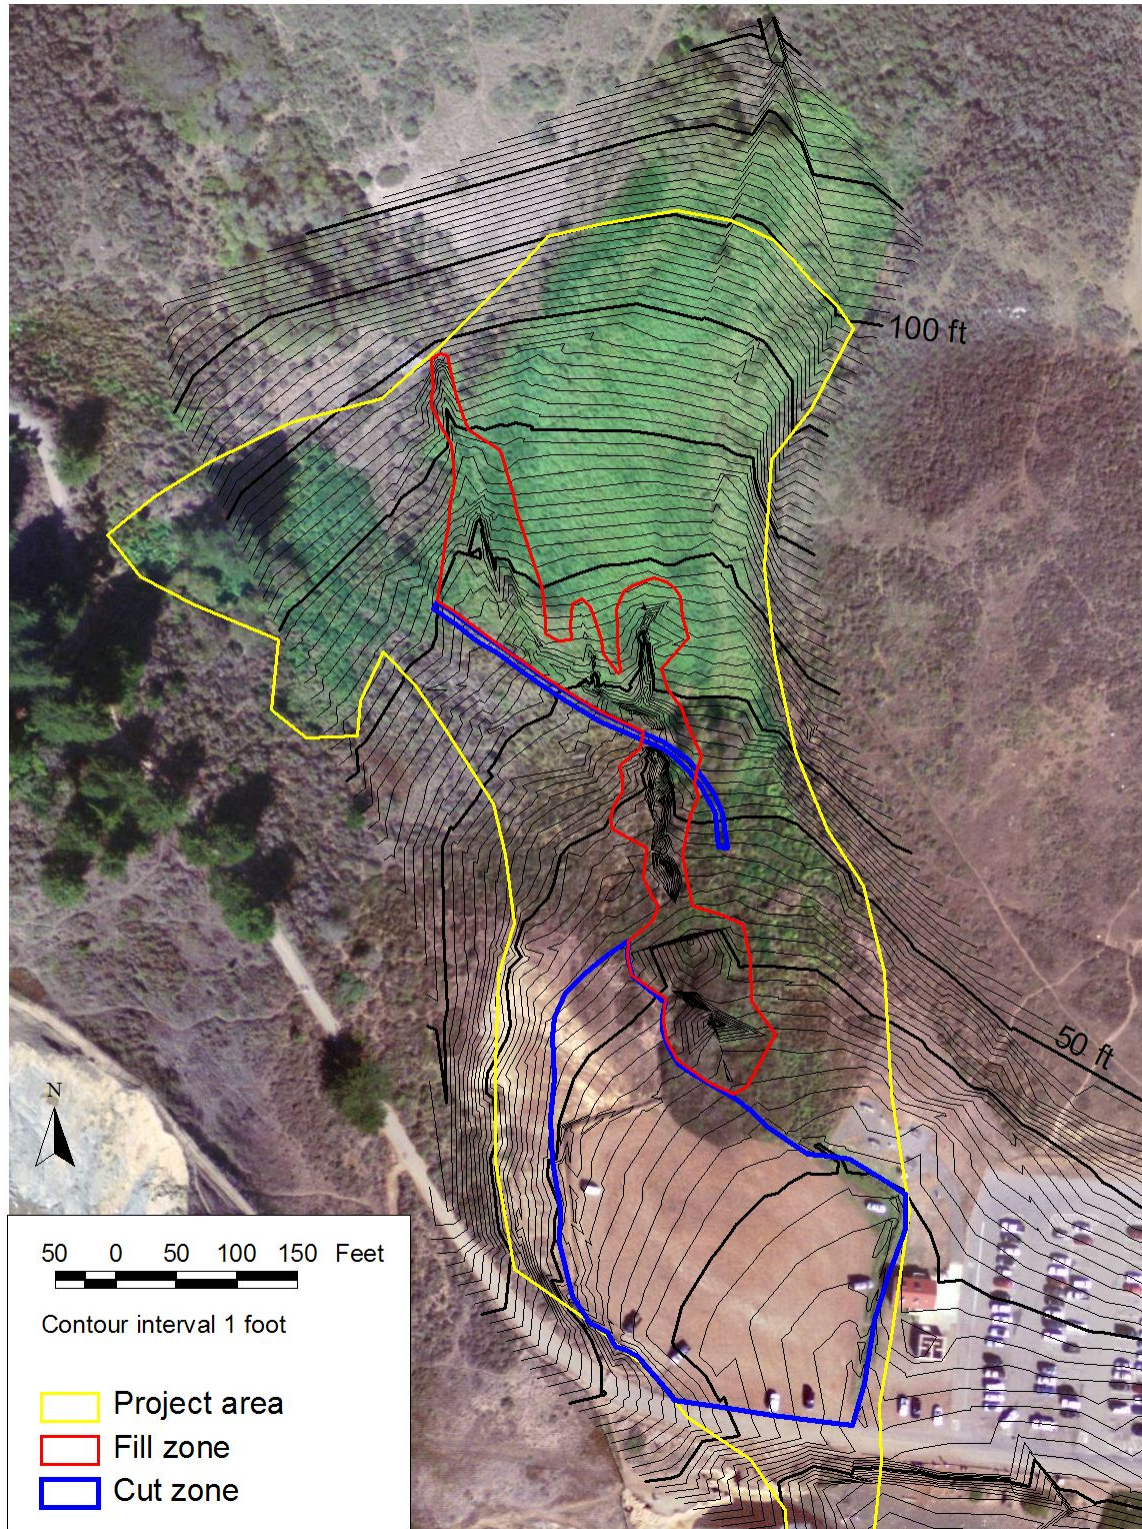
Figure 13. Topographic map showing the existing land surface for Rodeo wetland. The area in red delineates the fill zone where gullies and holes will be filled, and the areas in blue are cut zones where material will be removed.

We recommend that the primary restoration goal be to reestablish the sheet flow hydrologic system extending from the upper wetland above the transverse road down to Mitchell Road. To achieve this hydrologic restoration all channels, gullies, ditches, and other water conduits need to be filled in and the ground surface leveled across the valley (Figure 14). This will allow water to sheet flow down valley saturating the entire valley width and preventing channelization and erosion to occur. The areas to be filled (shown in red) will require 2100 cubic yards of compacted soil material. However, the cutting and regrading of the gravel parking lot and the transverse road will generate 2000-2300 cubic yards of material that can be used to fill the gullies. If additional fill material is required for the gully filling, or if less material than expected is generated on-site, an off-site mitigation project approximately 1 mile from Rodeo wetland will be generating significant suitable fill material. In addition, planting of seedling *Scirpus microcarpus* and other taxa are needed immediately following the grading.

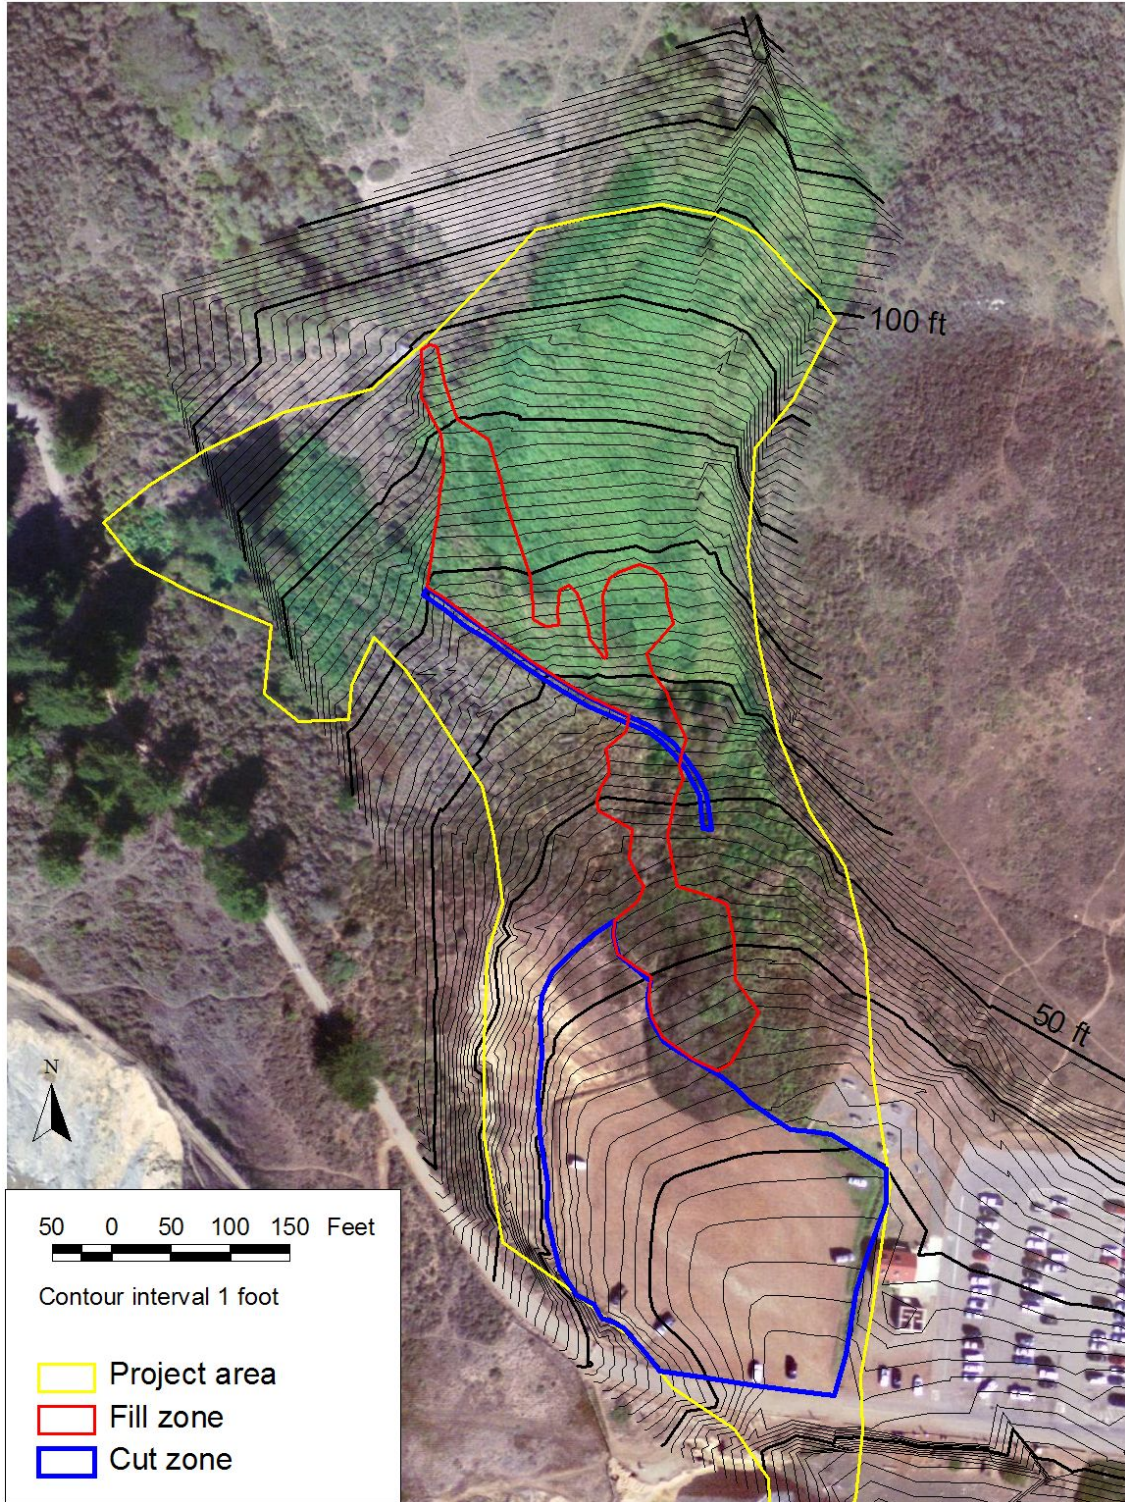
Figure 14. Topographic map showing the proposed post-construction land surface configuration for Rodeo wetland. The area in red delineates the fill zone, the areas in blue are cut zones where material will be removed.
