Restoration of geomorphic structure, hydrologic regime, and vegetation in Upper Halstead Meadow

Evan Wolf, MS and David Cooper, PhD
Department of Forest, Rangeland and Watershed Stewardship
Colorado State University, Fort Collins, CO 80523

February 2011

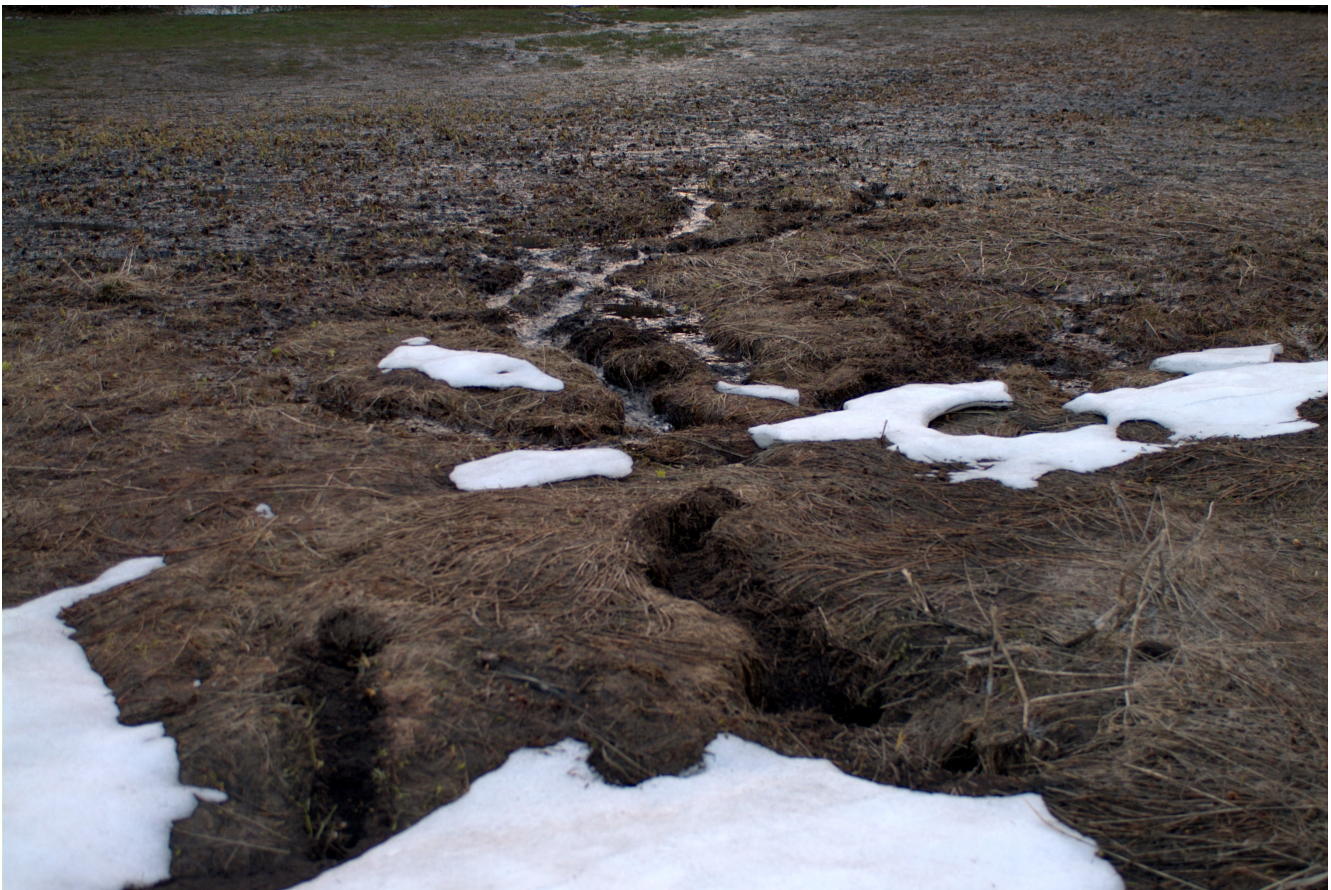
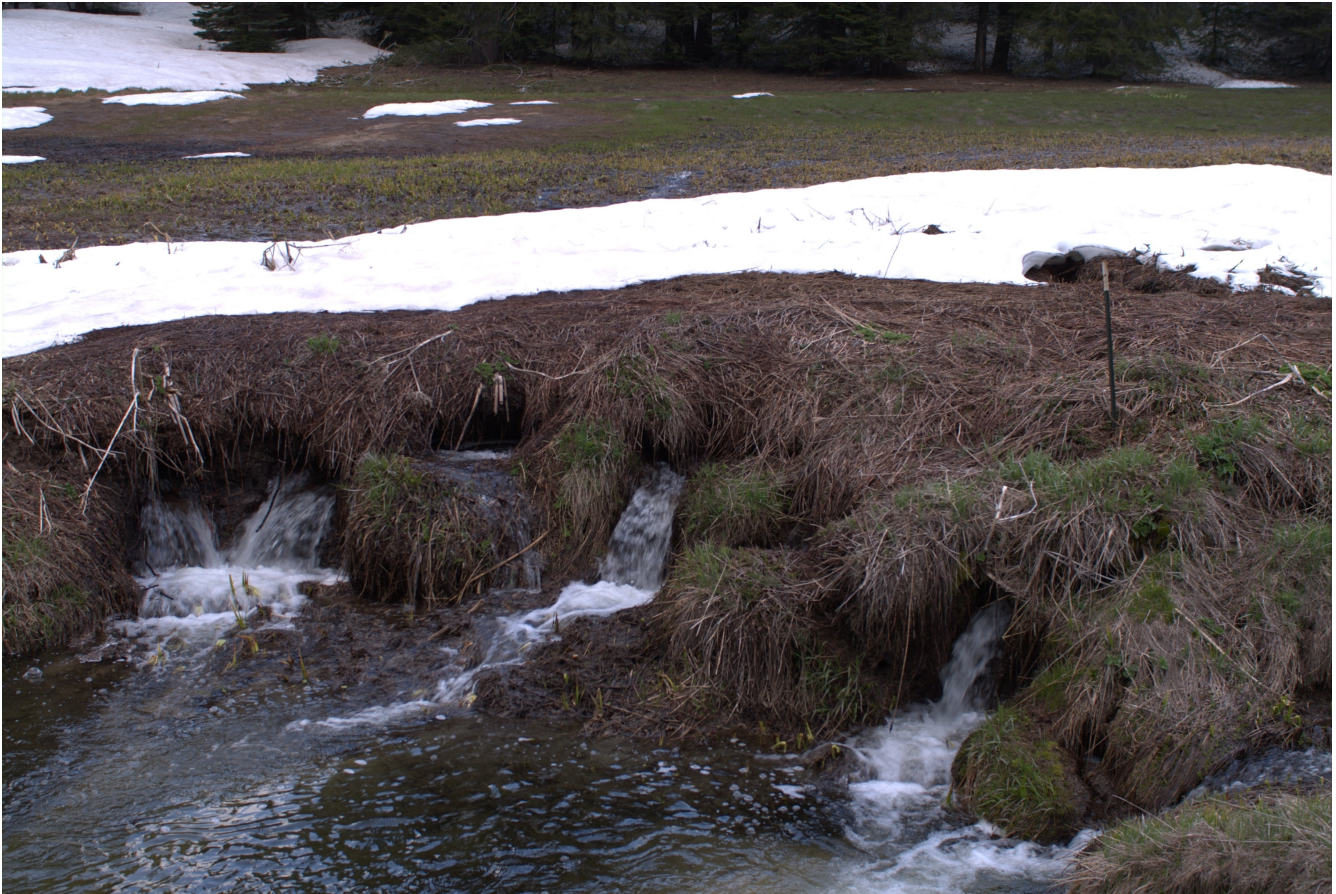
Figure 1. Mountain Beaver burrows in Lower Halstead Meadow. Photos are taken from the degraded Lower Halstead (LH) zone looking west towards the Intact Lower Halstead (ILH) zone. In the top panel, surface sheetflow is visible in the background and the burrows at surface are visible as water flow paths surrounded by drained, dry ground. Burrows seen in the top panel drain by subterranean channels to a water filled basin, lower panel.

The evidence from Cooper and Wolf (2006) indicated that the erosion gully and upland vegetation found in Halstead Meadow were not part of the natural features of meadows in the area. Historical construction efforts and their qualitative descriptions demonstrated that the erosion was severe, ongoing, and could not be effectively prevented or reversed by a small number of check dams. An additional on-site observation that argued against a restoration design involving dams and ponds was that numerous subterranean burrows were acting as pipes, draining intact wetland areas to lower elevation ponds and gullies. A stepped pond design would necessitate leaving some portion of the restored sloped meadow surface higher in elevation than flat-water pond surfaces. Mountain Beaver (*Aplodontia rufa*) seem to exploit this type of landscape and water table gradient for building burrows, causing drainage of the elevated meadow surface (Figure 1).

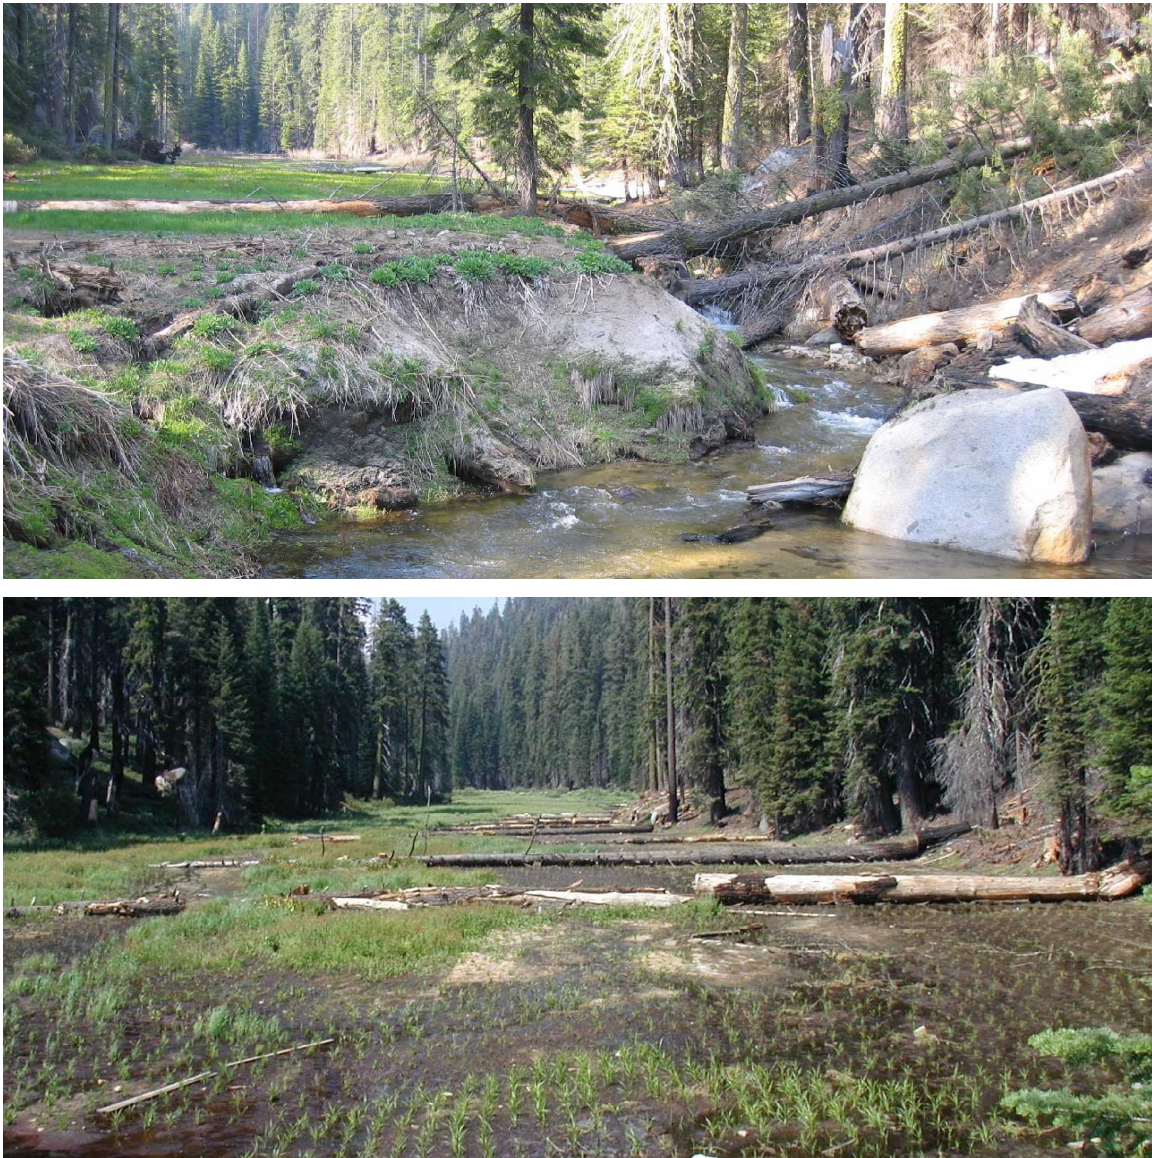
Figure 3. Upstream view of Upper Halstead in 2005 (top) before restoration and 2008 (bottom) after restoration. The planted seedlings are visible in rows in the filled gully at right, while the formerly dry meadow and intact meadow vegetation dominate on the left. Note the dry meadow surface adjacent to the 2005 stream-filled gully, while the entire meadow width is covered in thin sheetflow in the 2008 photo following geomorphic and hydrologic restoration.

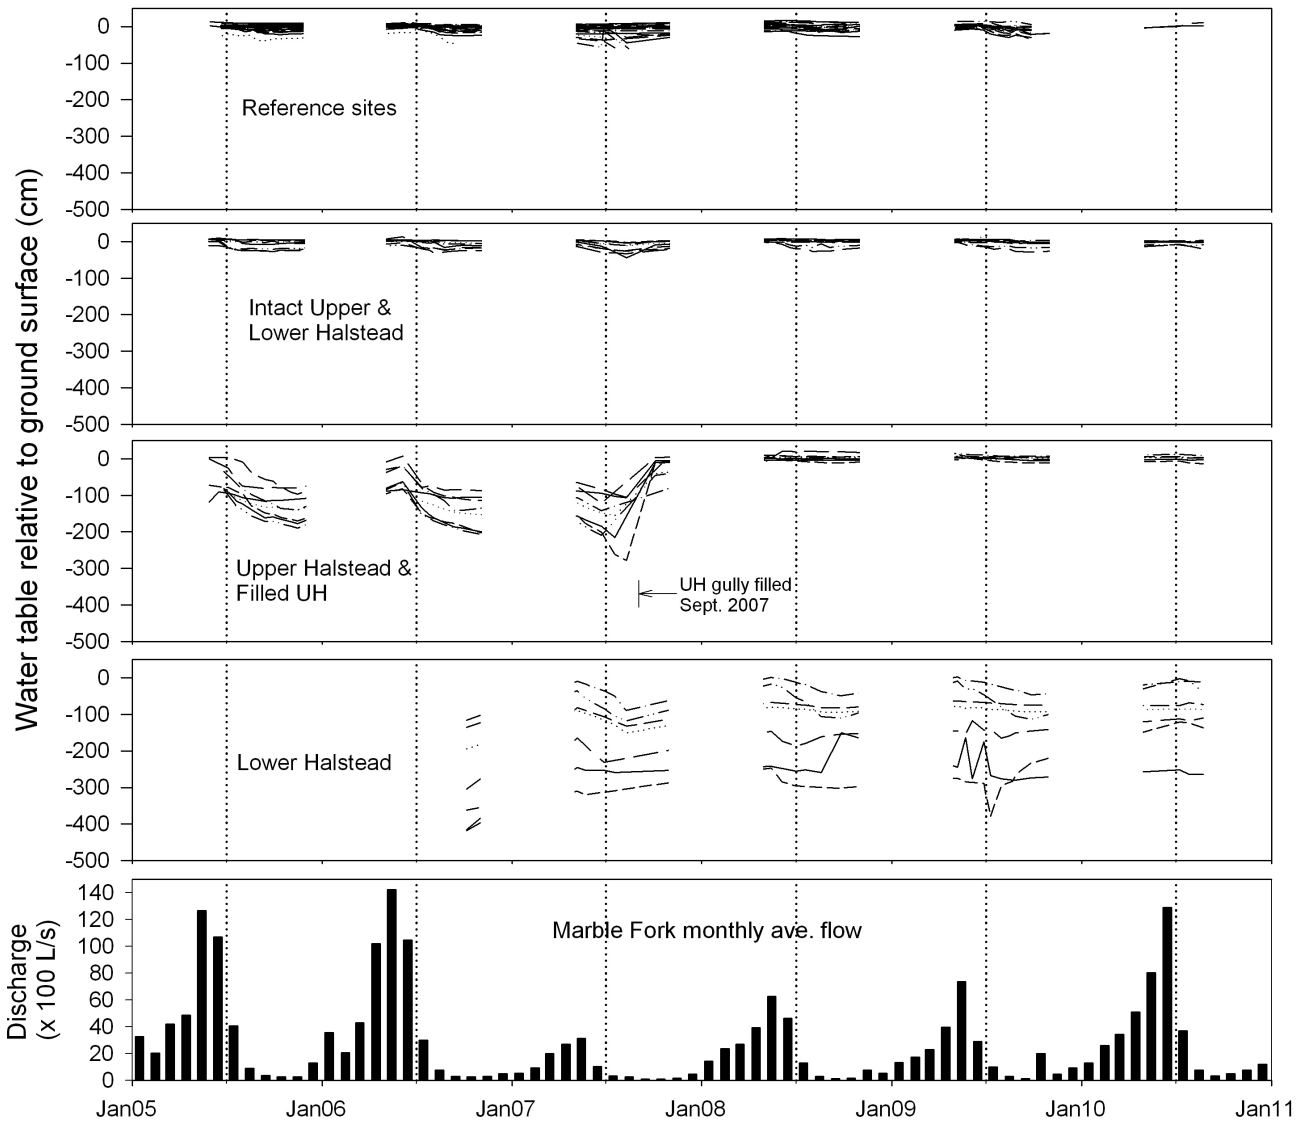
Figure 5. Water table position relative to the ground surface at the reference meadows and sites within Halstead Meadow. Monthly average discharge of the Marble Fork of the Kaweah River is shown as an estimate of relative discharge through Halstead Meadow. Dotted lines are 01 July.

Hydrology: At the five reference meadows and the intact portions of Upper and Lower Halstead (IUH and ILH), the water level remained within 65 cm of the ground surface throughout the growing season during all 6 years of monitoring (Figure 5). This study period included the very wet year of 2006 followed by the very dry year 2007, and water levels in reference sites were only slightly deeper in the summer of 2007. A comparison of water levels in Upper Halstead (UH) wells prior to and following the September 2007 restoration shows a dramatic ground water rise in all wells following restoration (Upper Halstead panel, Figure 5). Prior to restoration the UH water table was only briefly within 50 cm of the soil surface during the period of annual spring snowmelt in May/June, and was a meter or more deep during mid to late summer. Following restoration, the water table in all wells was within 20 cm of the ground surface for the entire growing season. This indicates that all UH sites transitioned from a non-wetland hydrologic regime prior to restoration, to a wetland hydrologic regime after restoration.

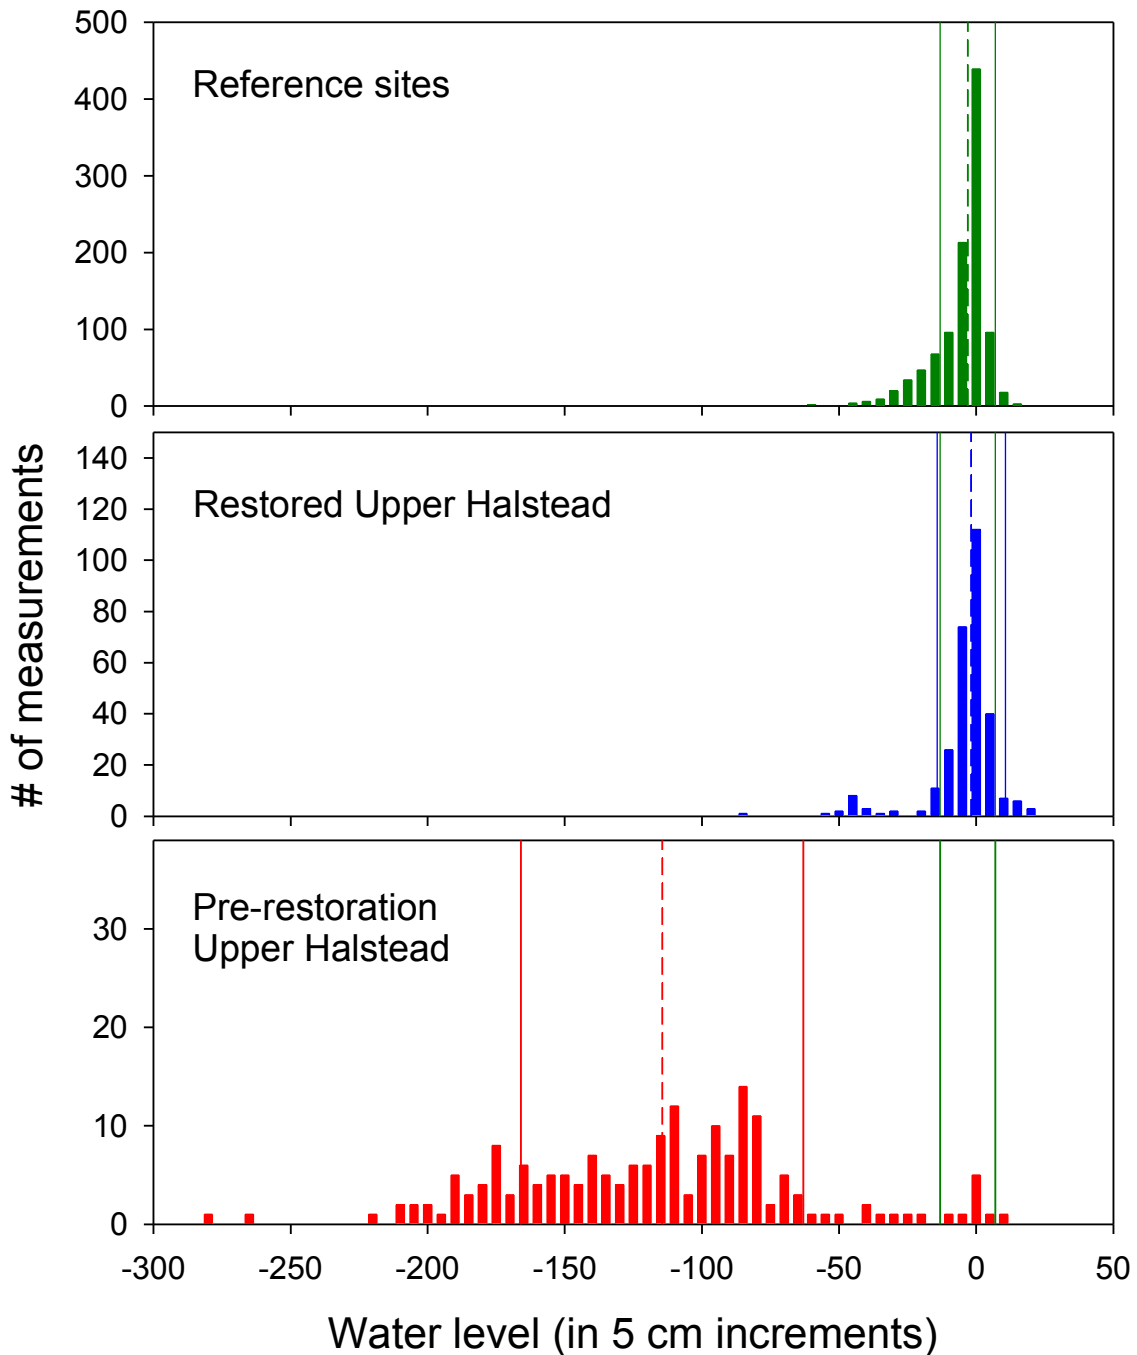
Figure 6. Histograms of the water level readings at the reference sites (green, top), restored Upper Halstead Meadow (zones FUH and UH, blue, middle), and pre-restoration Upper Halstead (zone UH, red, bottom). Average values (dashed vertical lines) ± 1 SD (solid vertical lines) are shown, with the reference range of ± 1 SD overlaid (solid green lines) on the other graphs to illustrate degree of overlap in the data. Note the different scales on the y-axes.

One of the stated hydrologic goals of the restoration (Cooper and Wolf 2006) was to bring the water levels in formerly dry and gullied sections of Upper Halstead (FUH and UH) to within one standard deviation (SD) of the average water level at the reference site and intact portions of Halstead meadow. The average water level of all readings in all years from the reference and intact sites was 3.1 cm below the ground surface, with a standard deviation of 10.1. Therefore the range of water levels within 1 SD of the average reference water level is between 13.2 cm below ground to 7.0 cm above ground. For normally distributed data, 68.2% of the observations fall within 1 SD of the mean. Shapiro-Wilks tests for normality indicated that none of the three data sets, reference sites ($n = 1058$, $W = 0.803$, $p \ll 0.0001$), restored Upper Halstead ($n = 299$, $W = 0.7312$, $p \ll 0.0001$), or pre-restoration Upper Halstead ($n = 186$, $W = 0.9825$, $p = 0.02$) were normally distributed. Both the reference and the restored Upper Halstead data sets are significantly skewed to the left, while the pre-restoration Upper Halstead data display significant kurtosis, with a broad, short peak (Figure 6).

Because none of the water level data sets are normally distributed, the proportion of the data falling within one standard deviation of the mean departs from the predicted 68.2%. In the reference sites well data, 13.4% of the readings are deeper than -13.2 cm (mean - 1 SD), and 6.2% are higher than 7.0 cm (mean + 1 SD), for a total of 19.6% of the readings falling further than 1 SD from the mean, or 81.4% of data within 1 SD of the mean. Basic transformations (e.g. log, square root, power) failed to normalize any of the data sets, and the non-normality and unbalanced design (unequal number of measurements for the different data sets) precluded conducting an analysis of variance (ANOVA). However, it is clear from a visual examination of the graphed data, that the restored Upper Halstead data follows a very similar distribution to the reference site data, whereas the pre-restoration Upper Halstead does not. 83.2% of restored Upper Halstead well readings fall within +/- 1 SD of the reference well average, exceeding the 81.4% of the reference data, indicating an even tighter clustering of the restored data near the ground surface zero value. On the other hand, only 3.7% of the pre-restoration

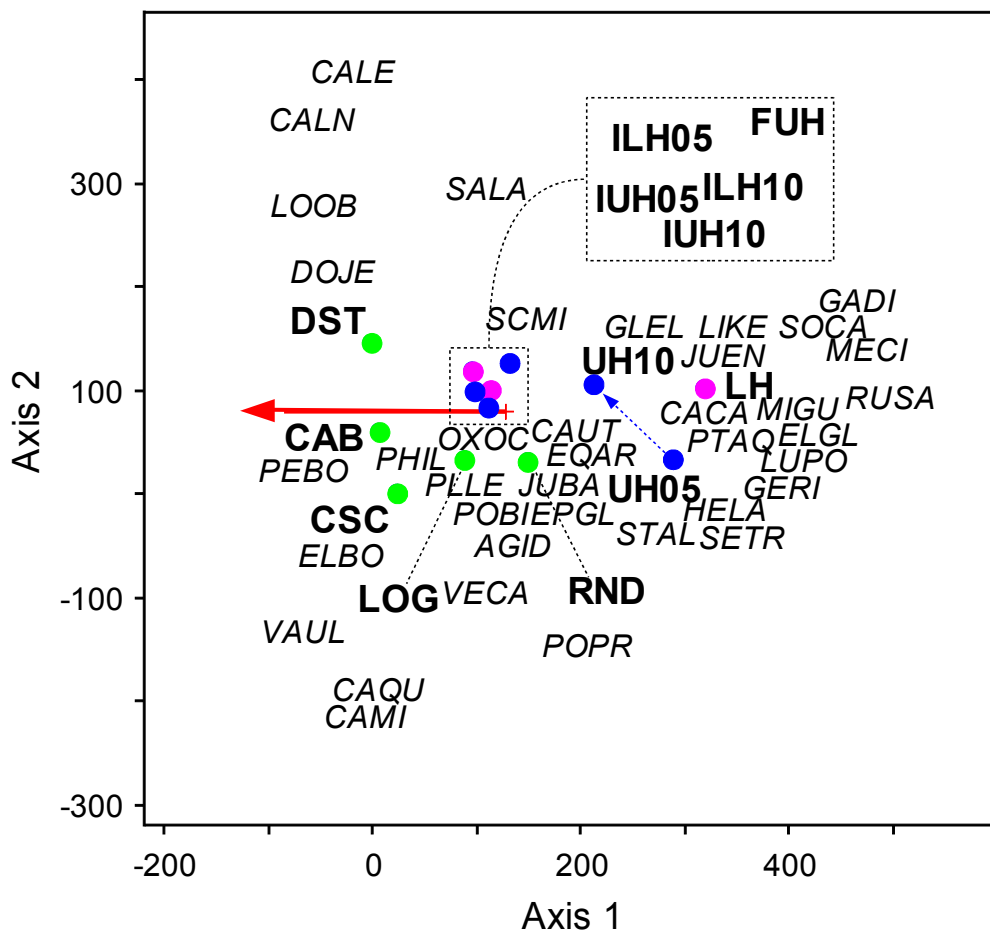
Figure 7. DCA biplot ordination of site vegetation data and species centroids. Green dots are reference sites, blue dots are sites in Upper Halstead Meadow, and purple dots are sites in Lower Halstead Meadow. Four letter italic codes are species centroids. See Appendix 1 for a complete list of species and site codes. The red vectors indicate the direction of increasing average and low water level correlated with the vegetation data. The blue vector shows the vegetation change at the Upper Halstead site from 2005 to 2011.

The red vectors in Figure 7 represent hydrologic variables overlaid on the ordination. These vectors show how the hydrologic variables are correlated with the vegetation data that structures the axes, spacing of sites, and species centroids. The two red vectors show the average and minimum water levels measured at the sites. The direction of each vector (pointing left) indicates increasing values, with decreasing values in the opposite direction. The vectors are nearly parallel with axis 1, indicating a strong correlation with the primary changes in vegetation that this axis represents. The R^2 values for a Pearson and Kendall Correlation test with the ordination axes are as follows: for axis 1; average water level 0.658, minimum water level 0.611. A third hydrologic variable, the peak water level was not significantly correlated with any axis. No variable tested had an R^2 greater than 0.2 for axis 2. This indicates that slightly more than 60% of the vegetation variation along axis 1 can be explained by either of the two hydrologic variables, average water level or minimum water level, with peak flow having no explanatory power. The remaining ~40% of variation is unexplained by this analysis.

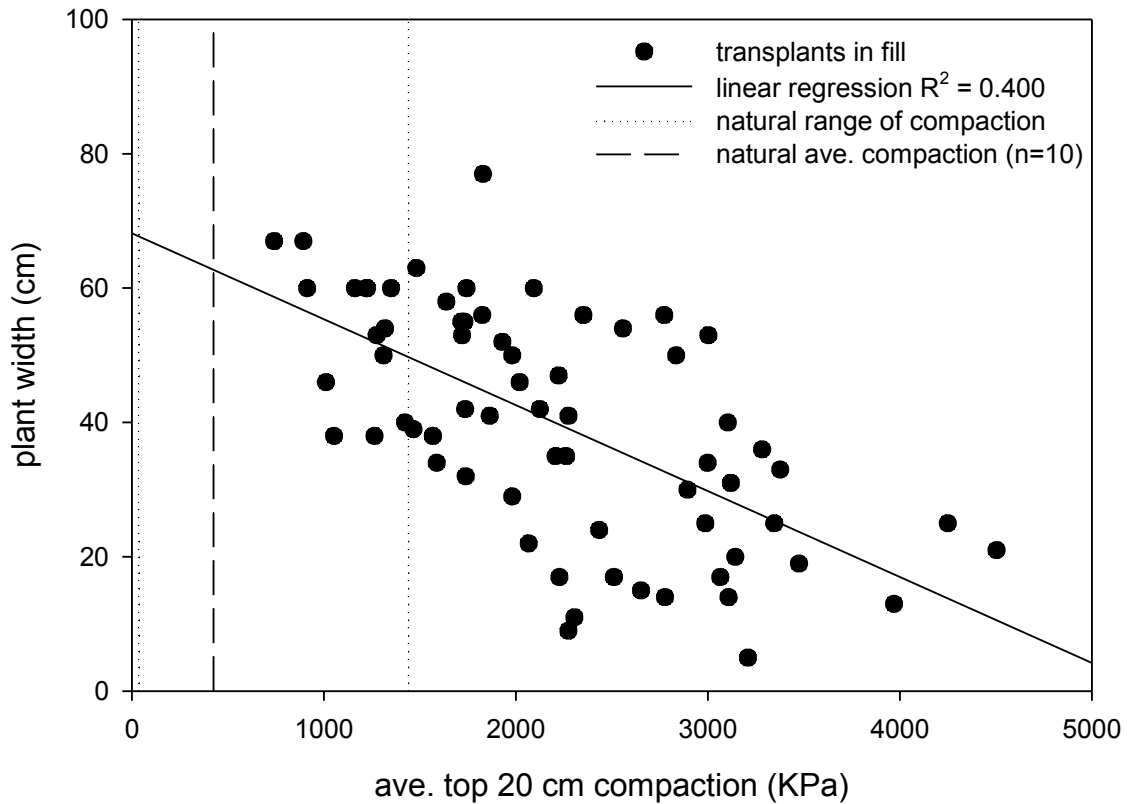
Figure 9. *The relationship between the width of Scirpus microcarpus seedlings after 14 months of growth and surface soil compaction. Linear regression is shown as a solid line, see text for equation. All transplants experienced compaction that was higher than the average in reference sites and most were in soil more compact than the most compact natural soils, as indicated by the dashed and dotted lines, respectively.*

Unexpected findings, compaction: The growth of the 2008 *Scirpus microcarpus* plantings over a 14 month period was significantly affected by the level of soil compaction in FUH. A significant linear trend in the data indicates a negative relationship between plant width and soil compaction in the upper 20 cm of soil as described by the equation $y = -0.0128x + 68.136$ ($p < 0.0001$) where y is plant width in cm and x is soil strength in KPa (Figure 9). The correlation coefficient (R^2) for this linear trend is 0.400, indicating that 40% of the variance in plant-width data is explained by changes in surface soil compaction. Other potential effects on plant width include initial size of the transplant, amount of shade, soil and water nutrient levels, and water speed, temperature, and depth. The levels of compaction in the adjacent Intact Upper Halstead site were used as a measure of natural conditions. All compaction measurements in the FUH zone exceeded the natural average compaction (424 KPa) and most readings were higher than the highest natural compaction reading (1429 KPa). The seedlings were planted 45.7 cm (18 inches) apart in June of 2008 and the width and compaction readings were taken in September 2009. Using the above equation, for plants to grow to a width of 45.7 cm and meet their nearest neighbor after 14 months of growth, soil with a compaction of 1750 KPa or less is required. Plants growing in soil with a compaction >1750 KPa are not predicted to grow sufficiently in 14

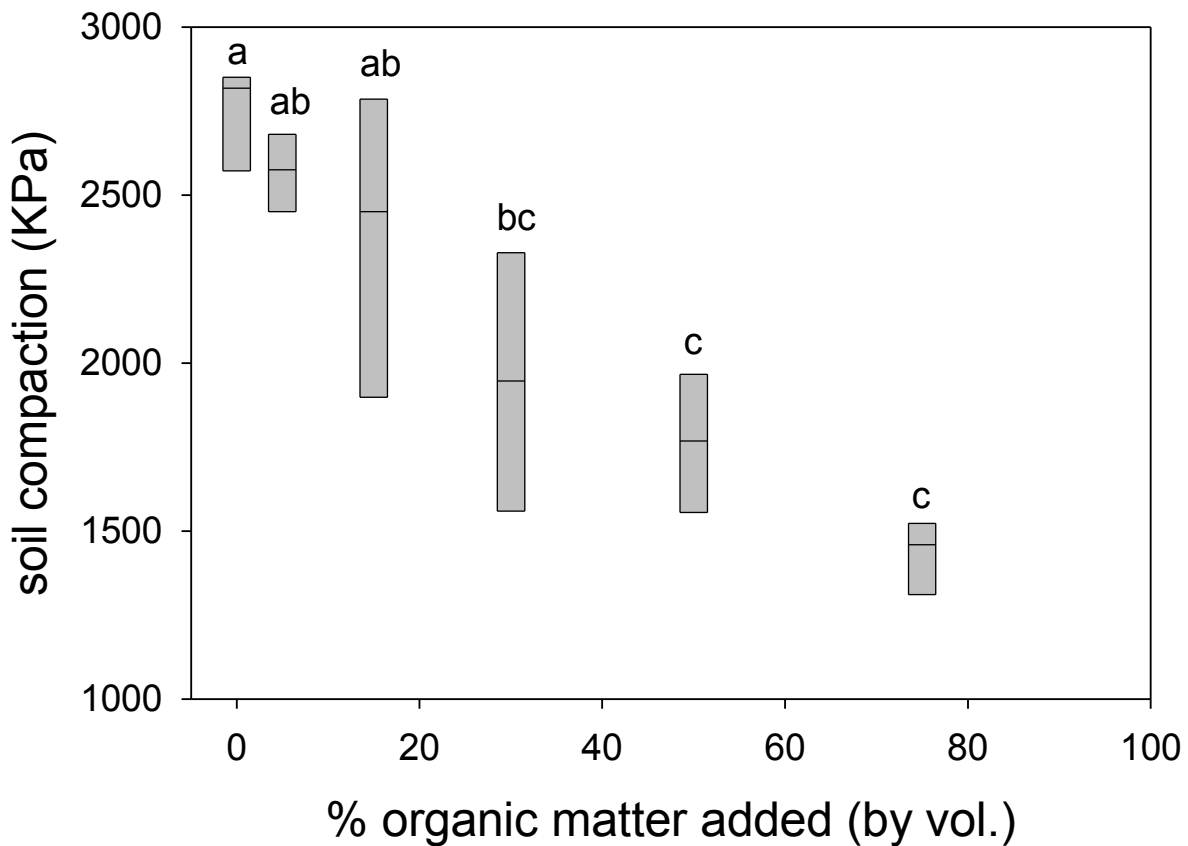
Figure 10. Boxplot showing the different levels of compaction in soils with different proportions of wood chips added. Boxes sharing the same letter are not significantly different from each other, as tested by an ANOVA.

months to intersect the adjacent planted seedlings. Using data from a companion study not described in this document, the 30% wood chip fill used to repair the 2009 storm damage should result in significantly lower compaction levels than fill with no wood chips (Figure 10). This means that the 2010 transplants growing in the wood chip fill should spread faster than the 2008 plantings.

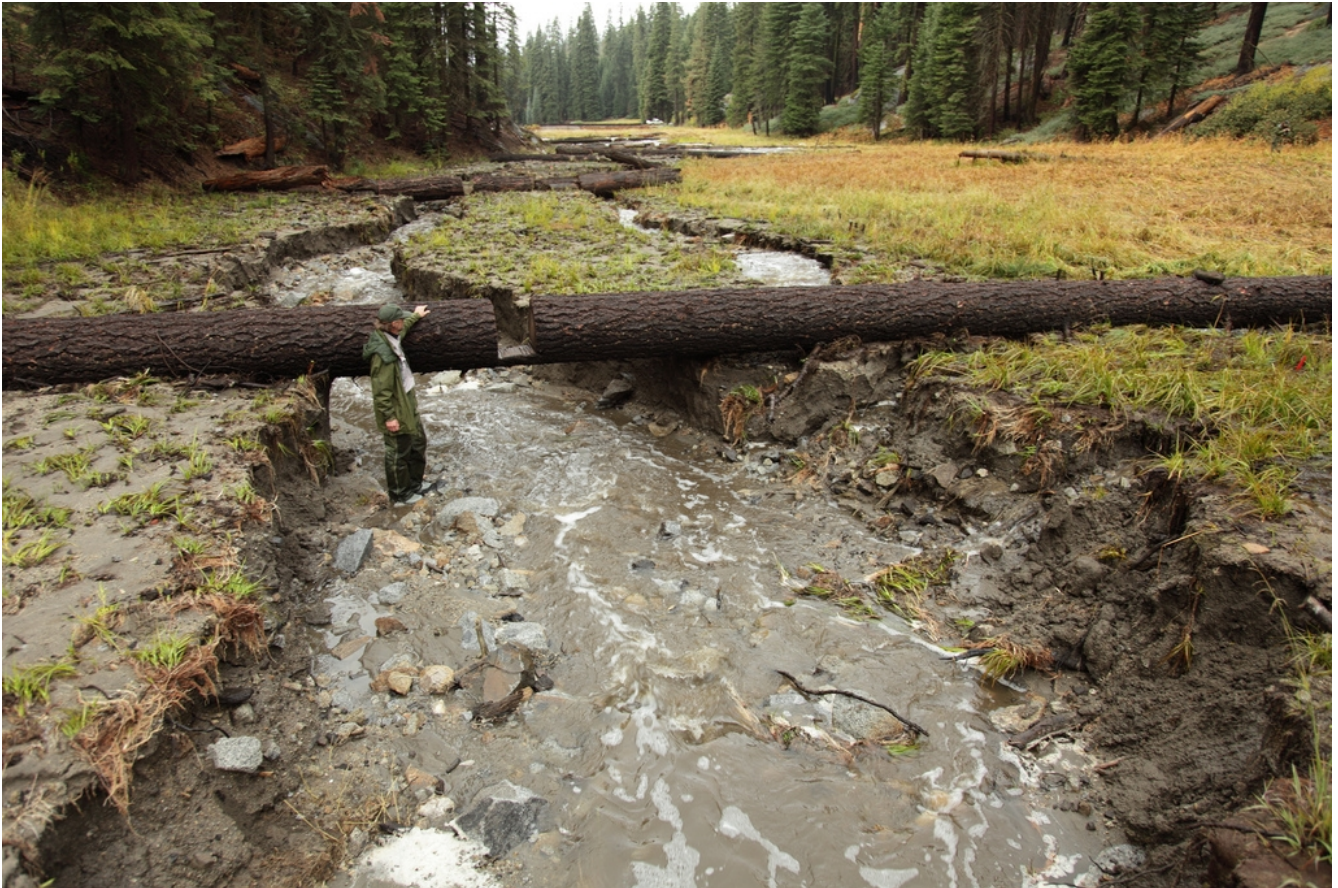
Figure 11. Downstream view of the erosion damage caused by the October 14th, 2009 storm. Rich Thiel of the NPS stands at a long, on-contour log with a notch cut out directly over the eroded gully. Note the long roots and rhizomes dangling from planted *Scirpus* on the left bank, in the foreground.

Project damage and repair: On October 14th 2009 a large storm dropped over 20 cm of rain in a 24 hour period and eroded approximately 10% of the sediment from the FUH zone and washed away or deposited sediment on top of almost a third of the seedlings planted in 2008. It was determined that, in the absence of dense vegetation, the long on-contour logs may have exacerbated the erosion by impounding storm water that then cascaded over the top, channeled over a low point, or undercut the logs, concentrating and energizing surface flow. In addition, the shear stress rating of the original erosion control blanket was likely exceeded by the storm flow (Herrera 2010). A repair of the erosion was made in November 2009, the new gully was refilled, and all contour logs were broken up and scattered where practicable.

erosion control blanket. During peak flow events of the previous two growing seasons, 2008 and summer 2009, the logs had acted as dams holding back small amounts of water. This ponded water created a head gradient across the log, often resulting in undercutting of the logs and small erosion rills forming. These small erosion events were manageable by hand crews and notches were made in logs (see next to Richard Thiel in Figure 11) to drain ponding where it was observed. However, all of these efforts were tailored to low and moderate flows, and we failed to consider the performance of the logs during high flow events. It is likely that the severe erosion that occurred in October 2009 initiated at a notched or undercut log where a large proportion of all down-valley flow was forced to concentrate by the long log. In retrospect, the smaller erosion events that initiated at logs were harbingers of the larger failure that required heavy equipment to repair. Following the erosion damage, an engineering firm was hired to conduct a risk analysis, and it was determined that not only were the logs likely culprits, but that the shear stress rating of the original erosion blanket was exceeded during the October 2009 storm. As a result of the hydrologic analysis in the risk assessment, design criteria for the Upper Halstead repair and the Lower Halstead project were modified to provide erosion protection against the 10-year flow event occurring before planted vegetation had established a resistant sod, after approximately 5 years. This more stringent erosion protection plan called for heavier erosion blanket, no ponding of water, and more numerous, smaller roughness elements such as coir wattles and shorter log segments, as opposed to relatively few long logs.
