Analysis of Meadow Hydrology, Vegetation, and Soils and Suggestions for Restoration of upper Halstead Meadow, Sequoia National Park, California

Report Prepared for: Sequoia National Park

February 2006

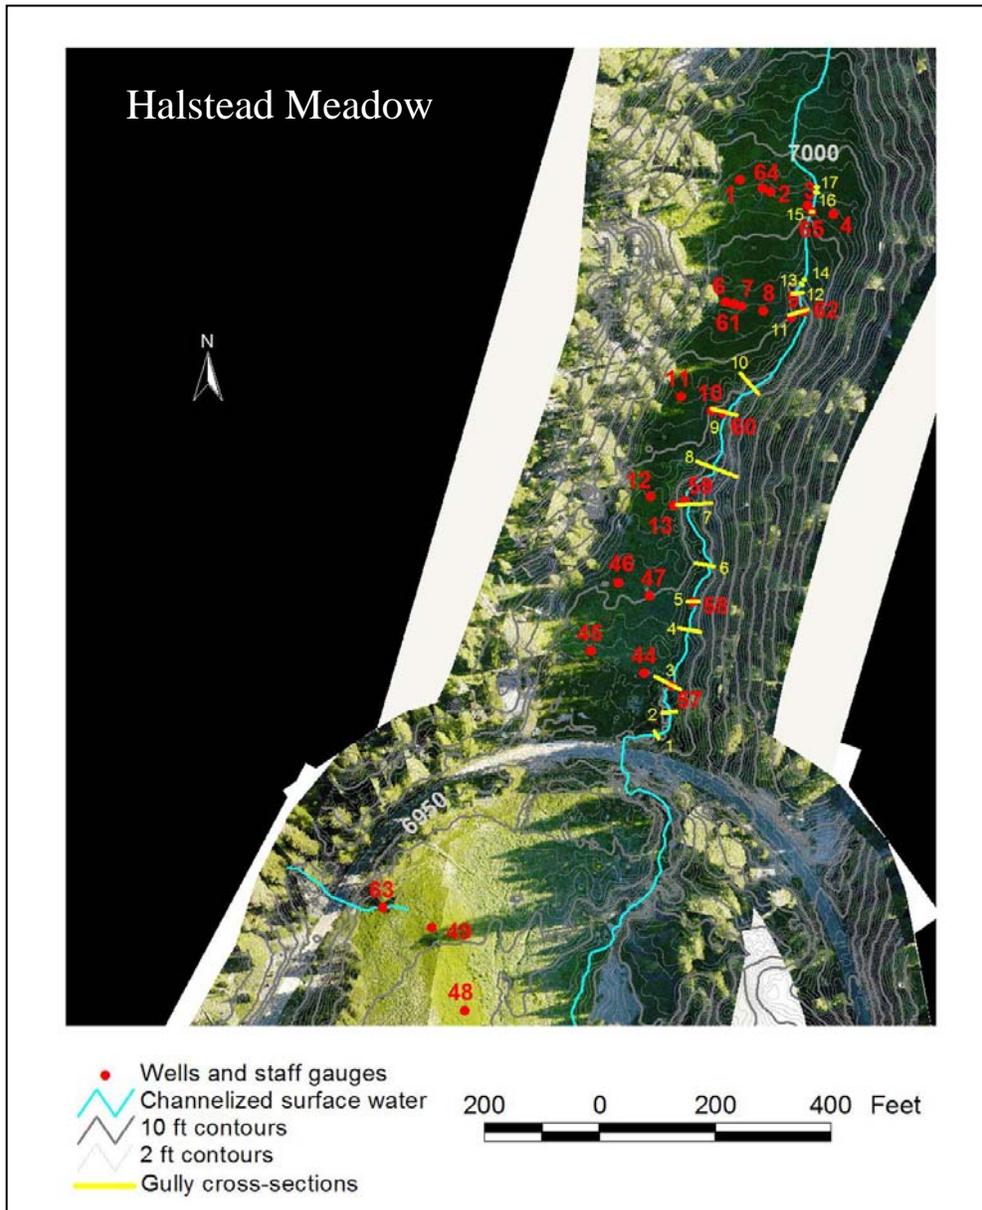
Figure 2. Topographic map of Halstead Meadow, with Lidar image topography. Red numbers are monitoring wells, yellow lines indicate gully cross sections. The gully restoration will fill the area of cross sections from section 1 upstream to section 17.

In Halstead Meadow wells were installed in three locations: the upper portion of the meadow above the highway that is intact and unaffected by the gully, the area of the upper meadow that is affected by the gully, and the northern portion of the meadow below the highway.

Topography for Halstead (Figure 2), Dorst (Figure 3), Crescent (Figure 4), Log (Figure 5), Round (Figure 6), and Cabin (Figure 7) Meadows indicates that contour lines cross the meadow almost perpendicular to the water flow direction. This maintains sheet flow through all of the meadows. In addition, streams are generally absent.

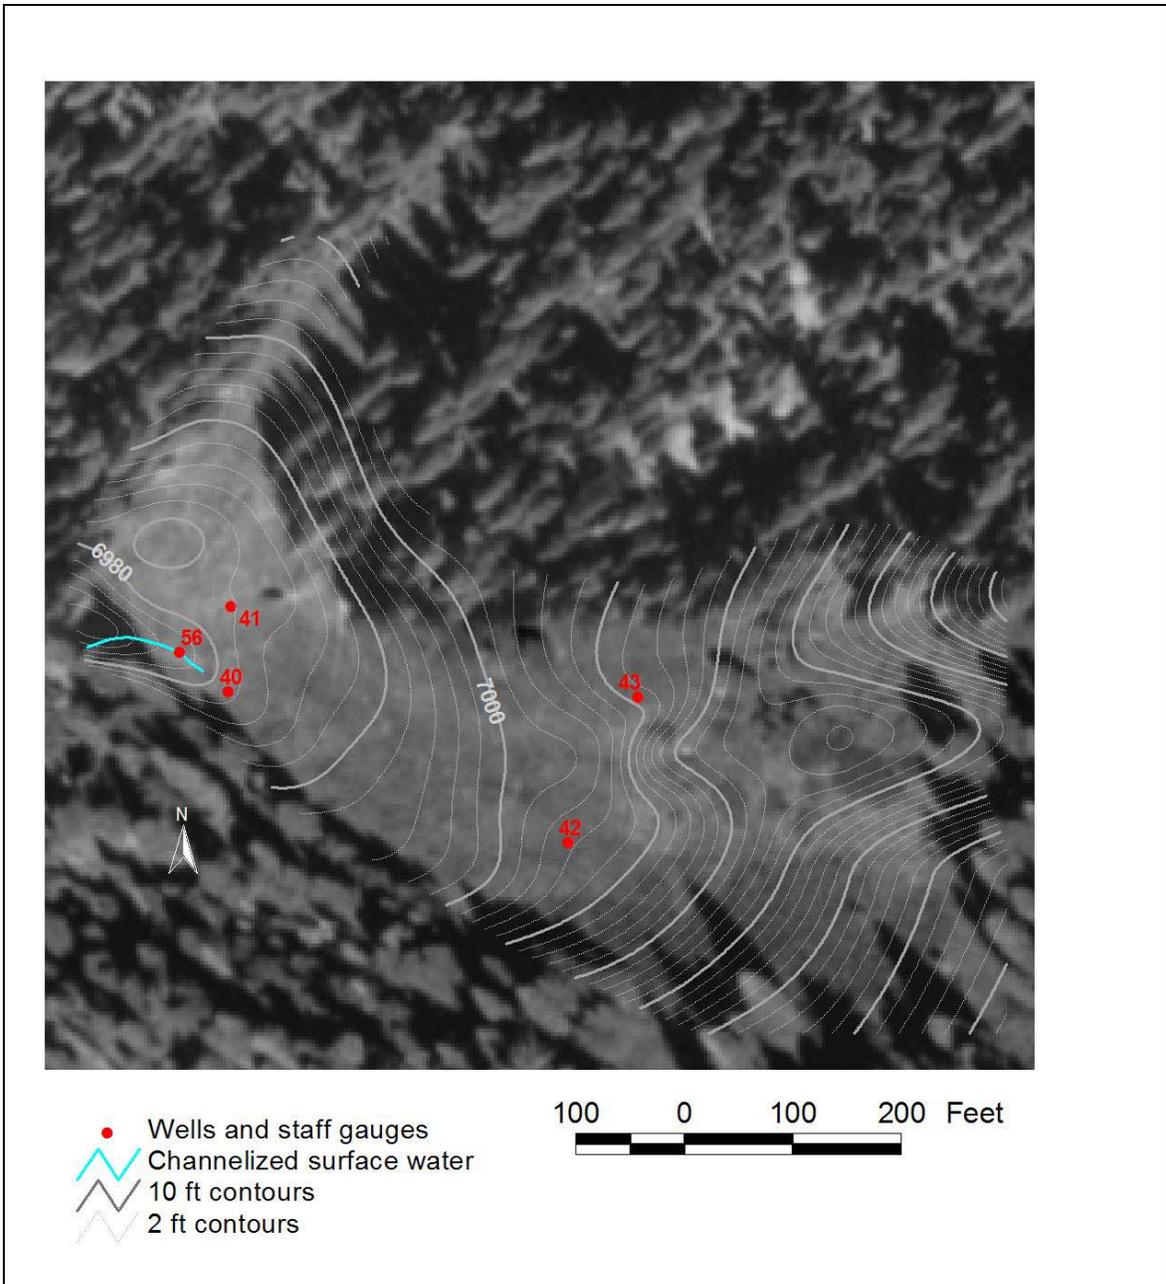
Figure 3. Dorst Meadow, showing elevation contours, and wells in red.

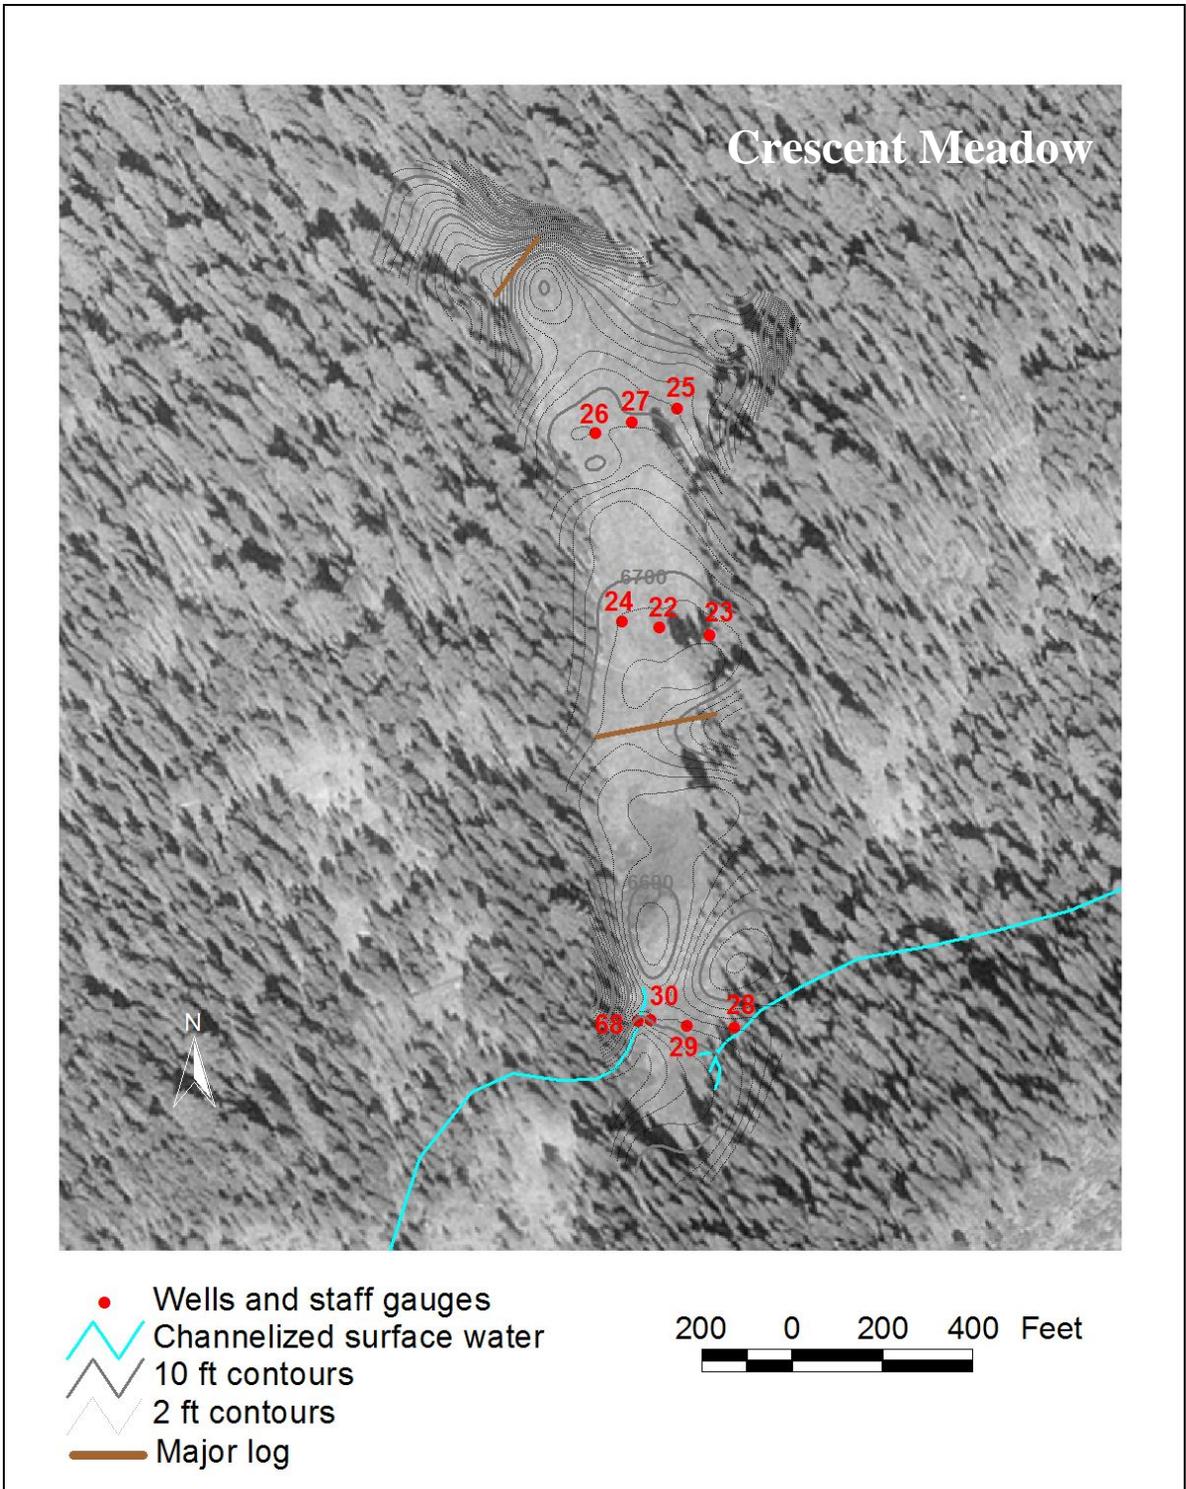
Figure 4. Topographic map of Crescent Meadow. Contour lines are 2-foot intervals. Wells are identified in red.

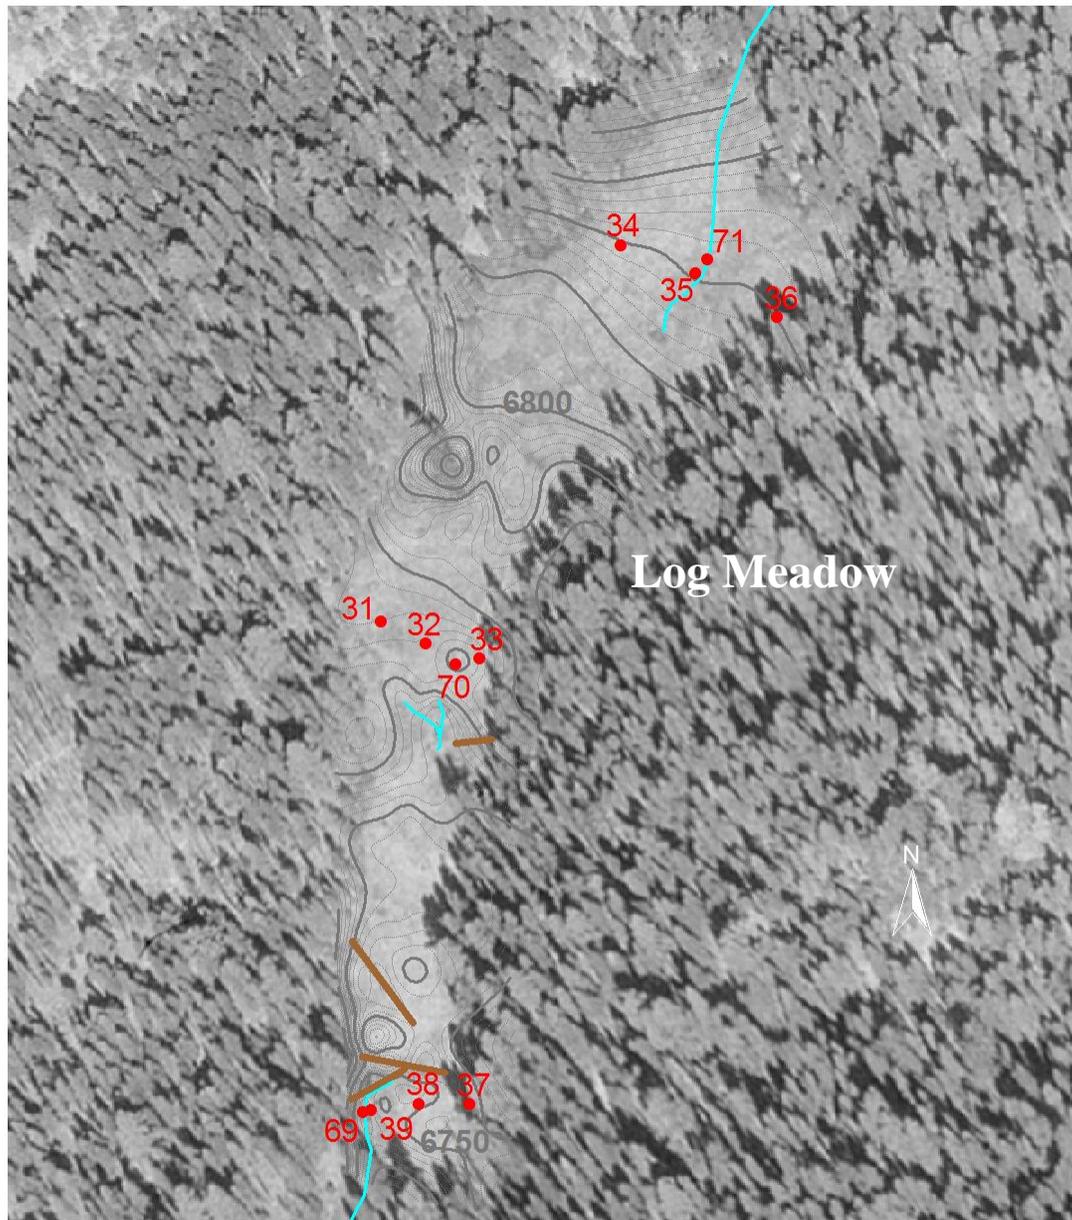
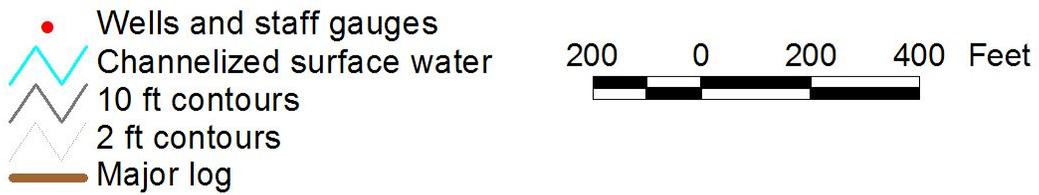
Figure 5. Topographic map Log Meadow. Contour lines are 2-foot intervals. Wells are identified in red.

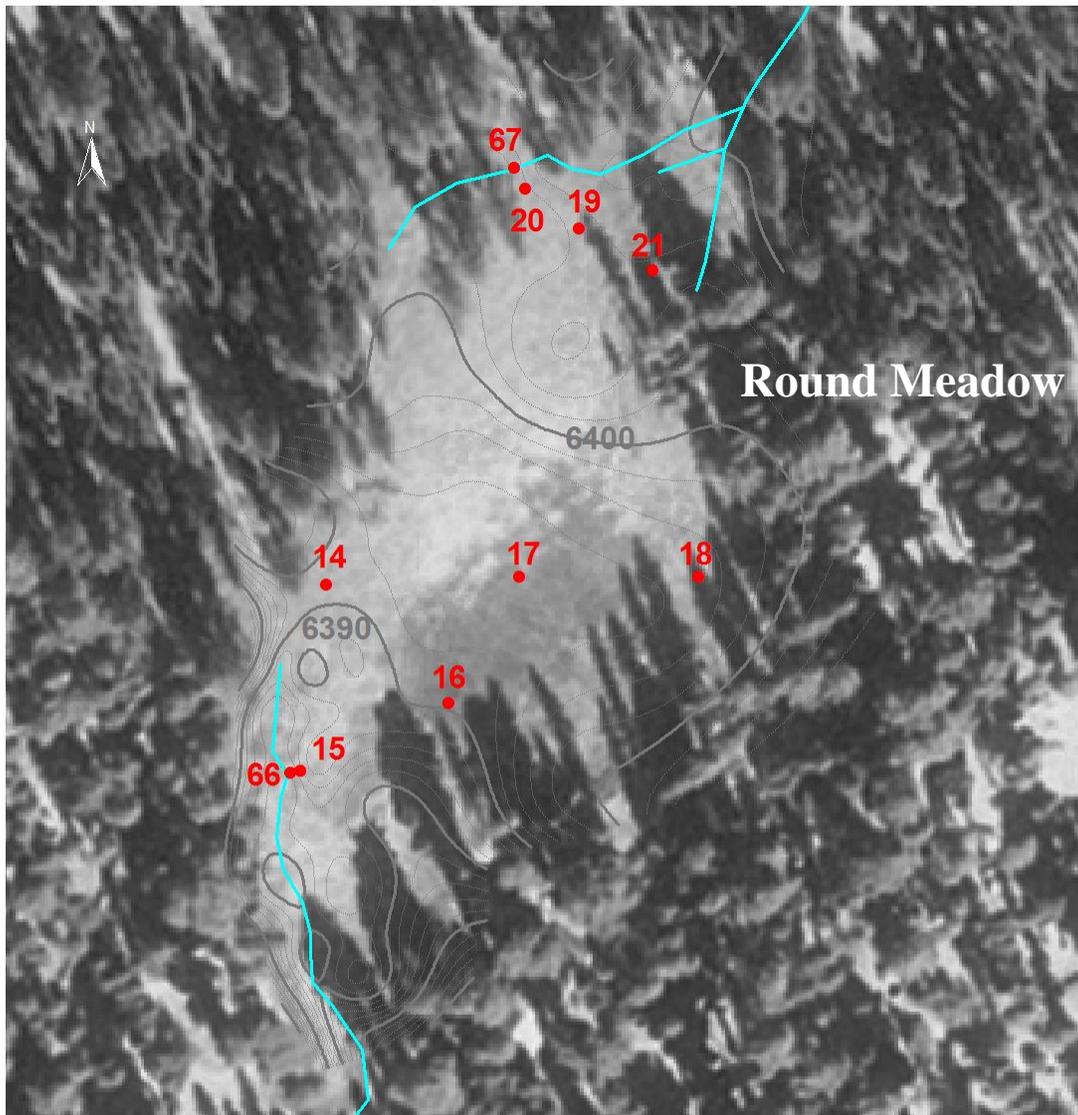
Figure 6. Topographic map of Round Meadow. Contour lines are 2-foot intervals. Wells are identified in red.

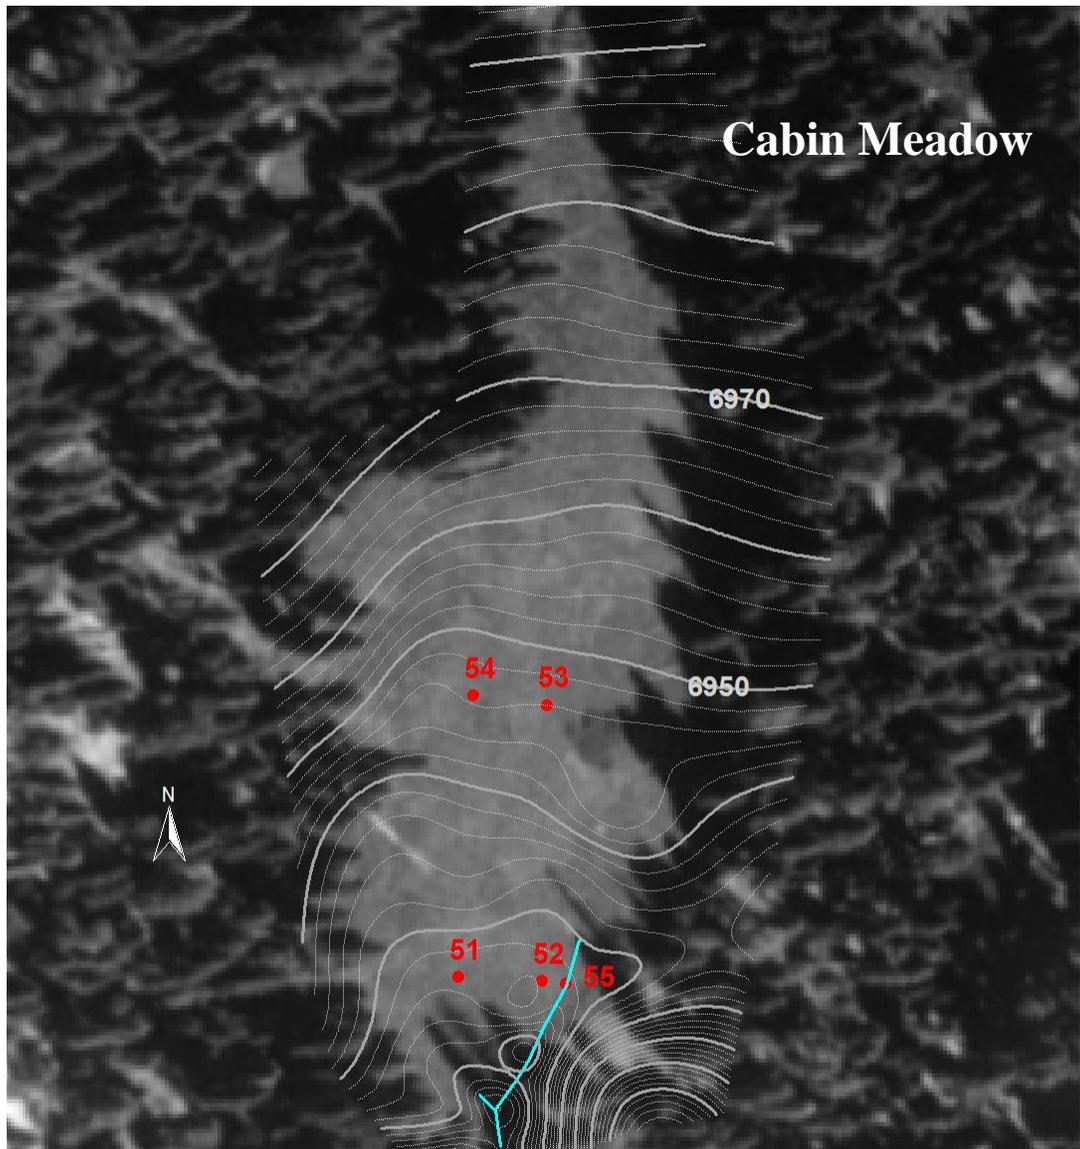
- Wells and staff gauges
- Channelized surface water
- 10 ft contours
- 2 ft contours

Figure 7. Topographic map of Cabin Meadow. Contour lines are 2-foot intervals. Wells are identified in red.

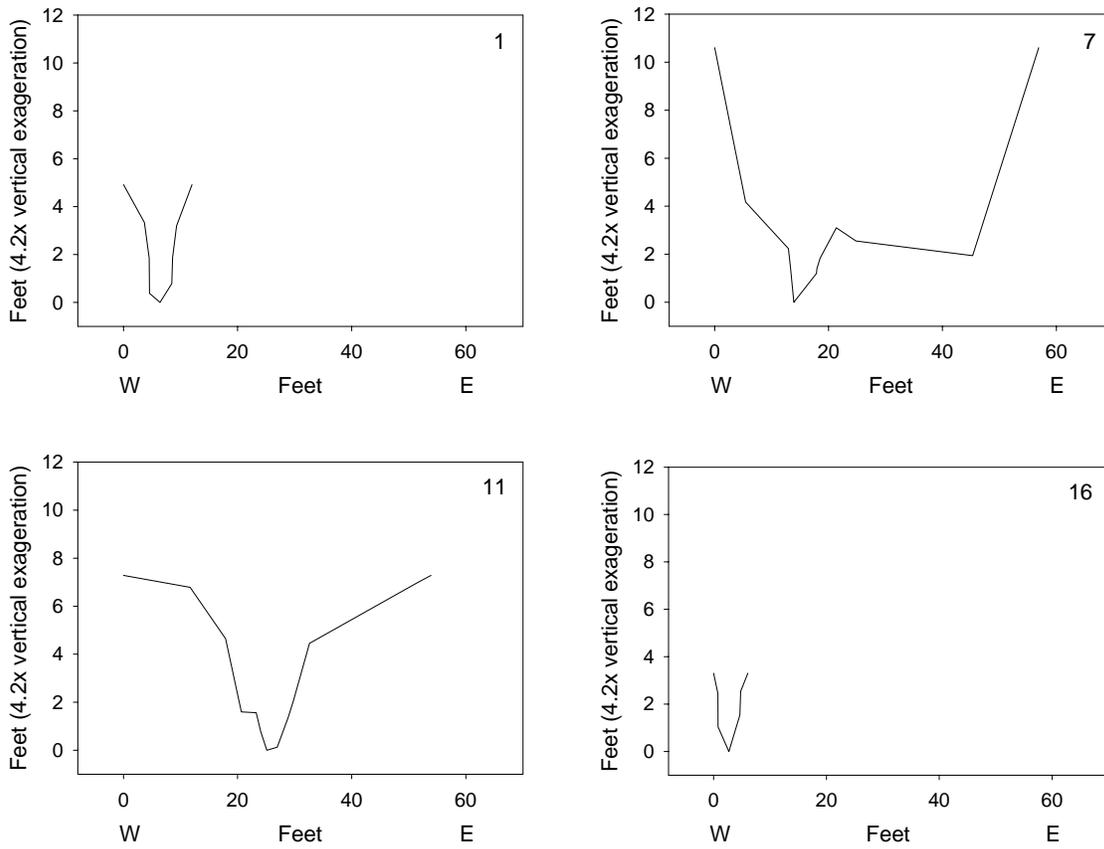
Figure 8. Surveyed cross-sections 1, 7, 11, and 16 of the gully at Halstead Meadow. Cross sections are identified on Figure 2.

Four cross-sections of the gully in upper Halstead Meadow are shown in Figure 8 and indicate the depth of incision.

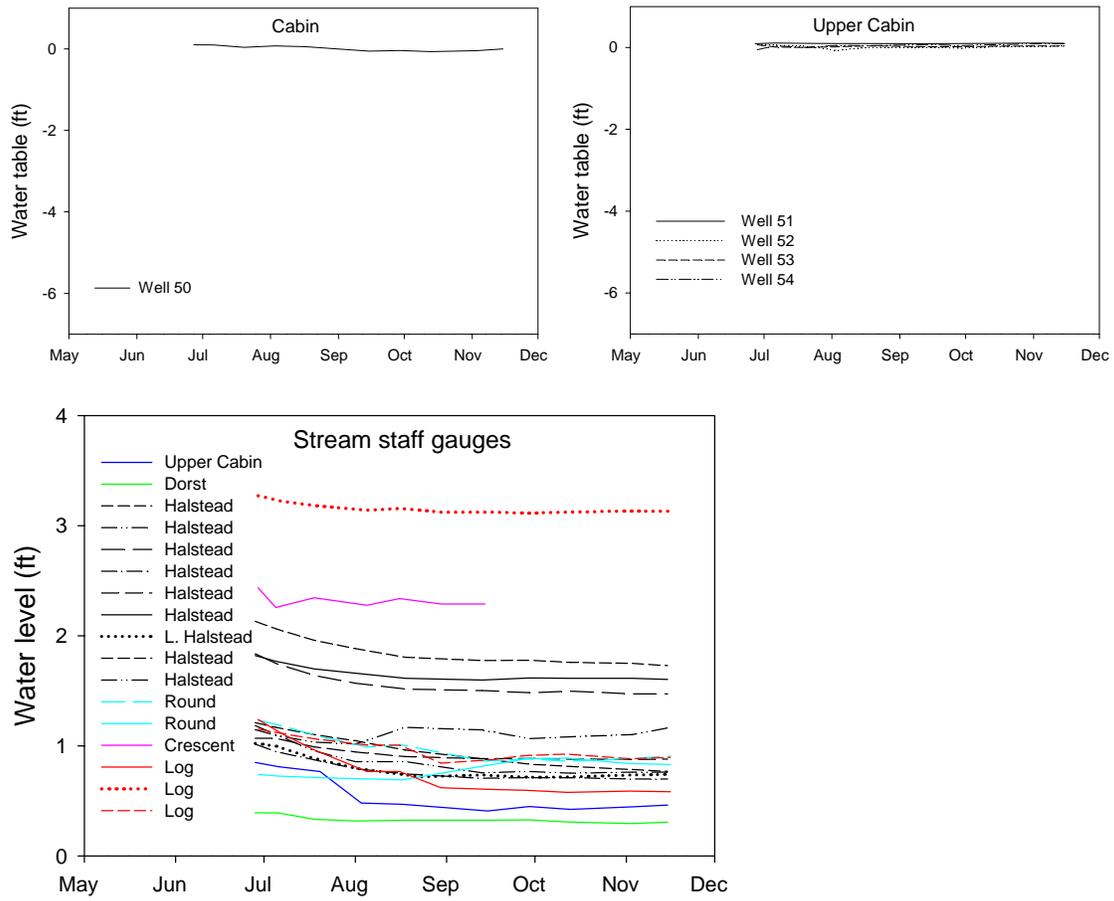
Figure 9. Water table depths for ground water monitoring wells in Upper and lower Cabin Meadow, and stream stage for all surface flows in all meadows during 2005.

Water year 2005 included a very large snowpack, a late melt out, and abundant surface and ground water. Under these conditions water table depths in monitoring wells within upper Halstead, lower Halstead, Round, Crescent, Log, Dorst, and upper and lower Cabin were close to the soil surface, with few exceptions (Figures 9, 10). Wells 15 at Round Meadow and 39 in Log Meadow had deeper water tables and are located near head cuts within these meadows. Well 34 in Log Meadow had a very deep summer water table due to its location on a raised lobe on the meadow margin. Water tables for wells in the gullied portion of upper Halstead Meadow, wells 9, 10, 12, 13, 44-47, all dropped to more than 20 inches below the soil surface, and several to more than 60 inches below the soil surface during 2005. Based upon analysis of intact meadows, and the intact portions of Halstead Meadow, it appears that ground water levels throughout Halstead Meadow should be within 8 inches of the soil surface for most of the growing season.

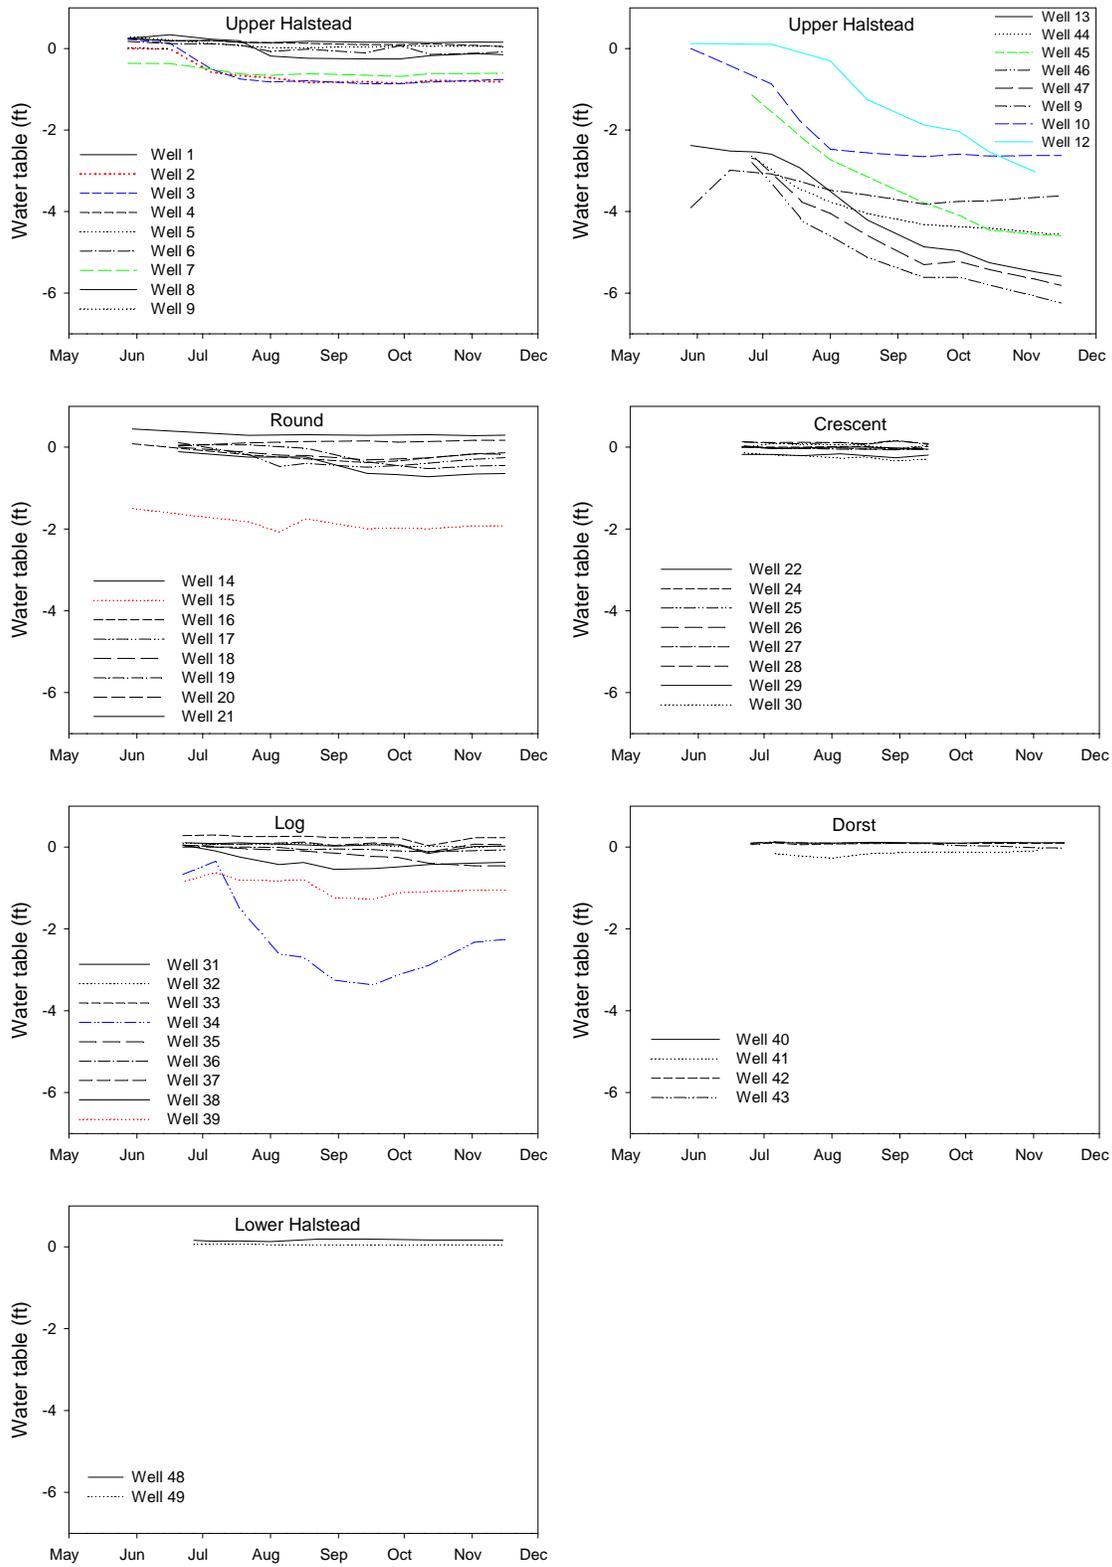
Figure 10. Water table depths for ground water monitoring wells in Halstead, Round Crescent, Log and Dorst Meadows during 2005.

A number of wells are located in peat soils. These are wells 1, 5 and 6 in upper Halstead, 18 in Round, 36-38 in Log, 40-42 in Dorst, 48 in lower Halstead, and 54 in Cabin Meadows. Water table depths of the wells in peat soils were not different than most of the wells in mineral soils in the study meadows during 2005, with several notable exceptions as reported above. The similarity of the water levels in peat soils as compared to mineral soils indicates that at least on high snowpack years most meadow areas have a similarly high water table for the entire summer. However, in summers that follow winters with average to low snowpack, it would be expected that water tables would remain near the soil surface only in the sites with peat soils, and in other meadow locations the water table would be deeper.

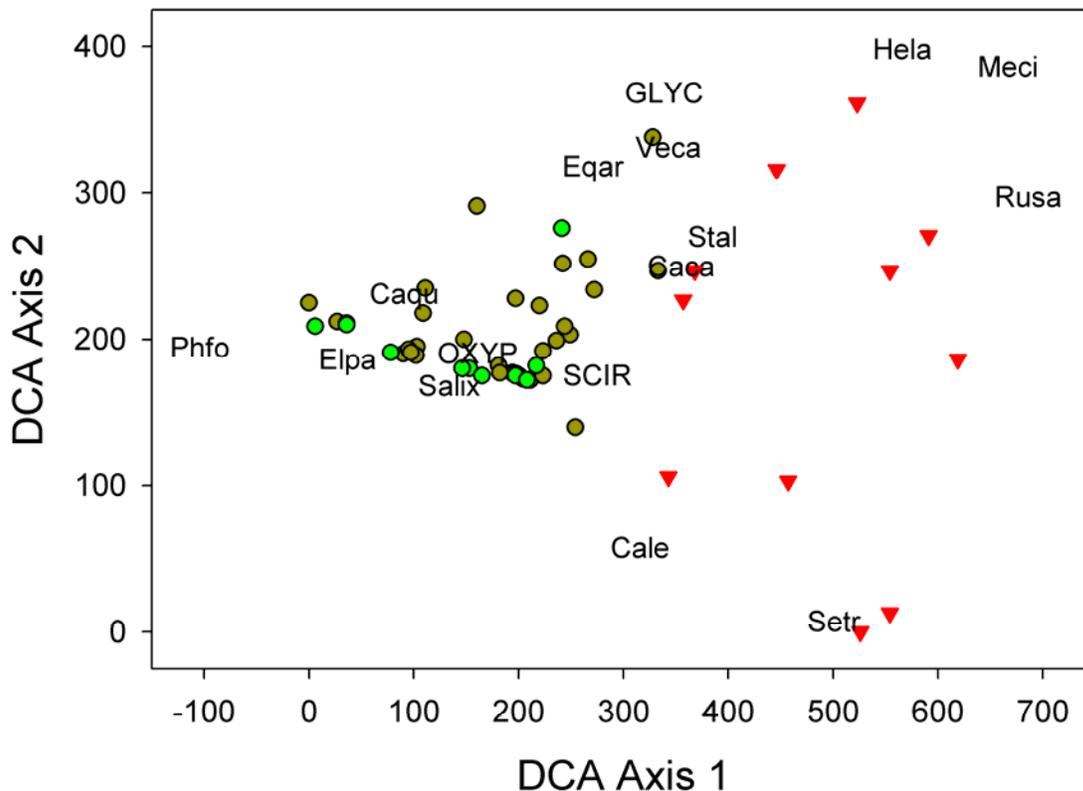
Figure 11. Detrended correspondence analysis (DCA) ordination of meadow vegetation. Brown circles are plots with perennially high water tables and mineral soils, green circles are plots with perennially high water tables and organic soils, red triangles are plots with deep water tables and mineral soils. The centroids of key plant species are shown. Plants in CAPS, SCIR = *Scirpus microcarpus*, GLYC = *Glyceria elata* and OXYP = *Oxypolis occidentalis* are dominants in many meadows. Other species are Phfo = *Philonotis fontana*, Elpa = *Eleocharis pauciflora*, Caqu = *Camassia quamash*, Salix = *Salix* spp., Ecar = *Equisetum arvense*, Veca = *Veratrum californicum*, Caca = *Calamagrostis canadensis*, Stal = *Stachys albens*, Cale = *Carex lemmonii*, Setr = *Senecio triangularis*, Hela = *Heracleum lanatum*, Meci = *Mertensia ciliata*, Rusa = *Rumex salicifolius* var. *denticulatus*.

The DCA analysis of vegetation data (Figure 7) indicates that most wet meadow plots are on the left side of the ordination space, have similar vegetation, and are dominated by *Oxypolis occidentalis*, *Scirpus microcarpus*, *Glyceria elata* and *Eleocharis pauciflora*. On the right side of the ordination space are plots located where gullying has dried the soils. These plots, mostly located in Halstead Meadow just above the highway, are dominated by *Heracleum lanatum*, *Mertensia ciliata*, *Rumex salicifolius* var. *denticulatus* and *Senecio triangularis*. Plots from the very upper portion of Halstead and the northern portion of Halstead below the highway, both of which have high water tables throughout the summer, are plotted on the left side of the ordination space. Plots with peat soils are identified with green symbols. Those with mineral soils and high water tables are brown and those with mineral soils and deep water tables by red triangles.

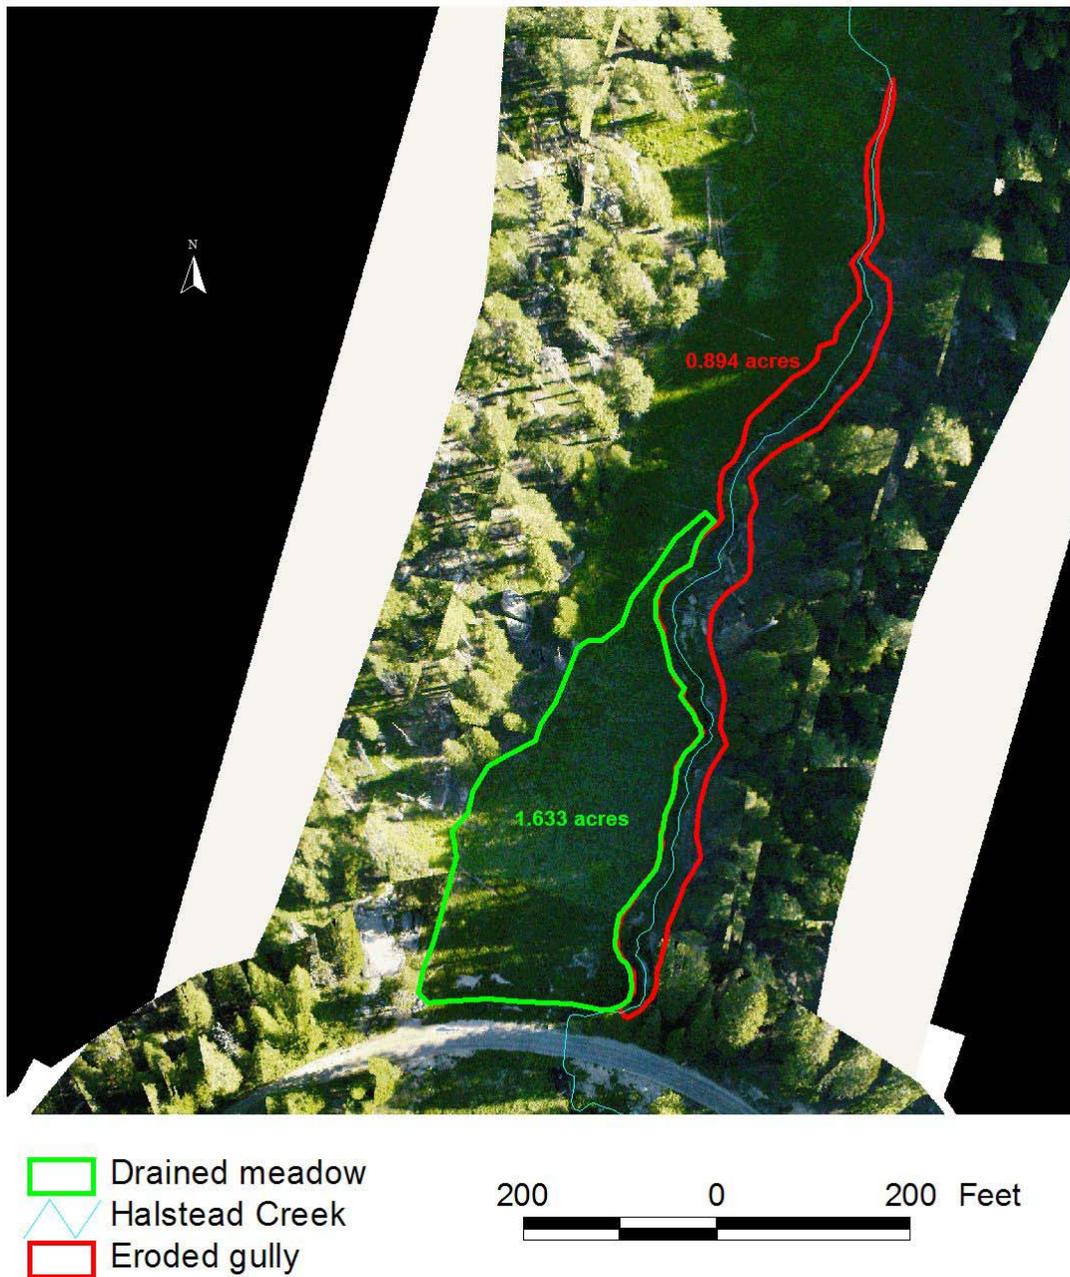
Figure 12. Air photograph of the upper Halstead Meadow restoration site. The area in red, 0.894 acres, is the gully proposed for filling. The area in green, 1.633 acres, has been drained by the gully, and has lost its natural vegetation, and is now dominated by *Heracleum lanatum*, *Mertensia ciliata* and other native, but exotic species to this portion of the meadow. This area should be planted with *Scirpus microcarpus*, *Oxypolis occidentalis*, and *Glyceria elata*.

To restore the sheet flow hydrologic system in Halstead we recommend filling the entire gully with layers of mineral sediment, including rock, and creating a flat meadow surface, as occurs in all of the reference meadows perpendicular to the flow direction. A temporary road could be constructed from the Generals Highway into the meadow, and along the channel. Truck loads of material can be dumped into the channel once the stream flow is diverted out of the channel. A small bulldozer can spread and compact the sediments. The channel should be filled to a level that allows for some settling. Areas of the meadow that have been eroded may also require additional minor filling or grading to reestablish the lateral continuity across the meadow.
