RIPARIAN BASELINE DATA COLLECTION PRIOR TO OPENING THE PECOS RIVER TO FISHING ACCESS IN PECOS NATIONAL HISTORICAL PARK

Final Report

Edward Gage and David Cooper
Department of Forest, Rangeland and
Watershed Stewardship
Colorado State University
Fort Collins, CO

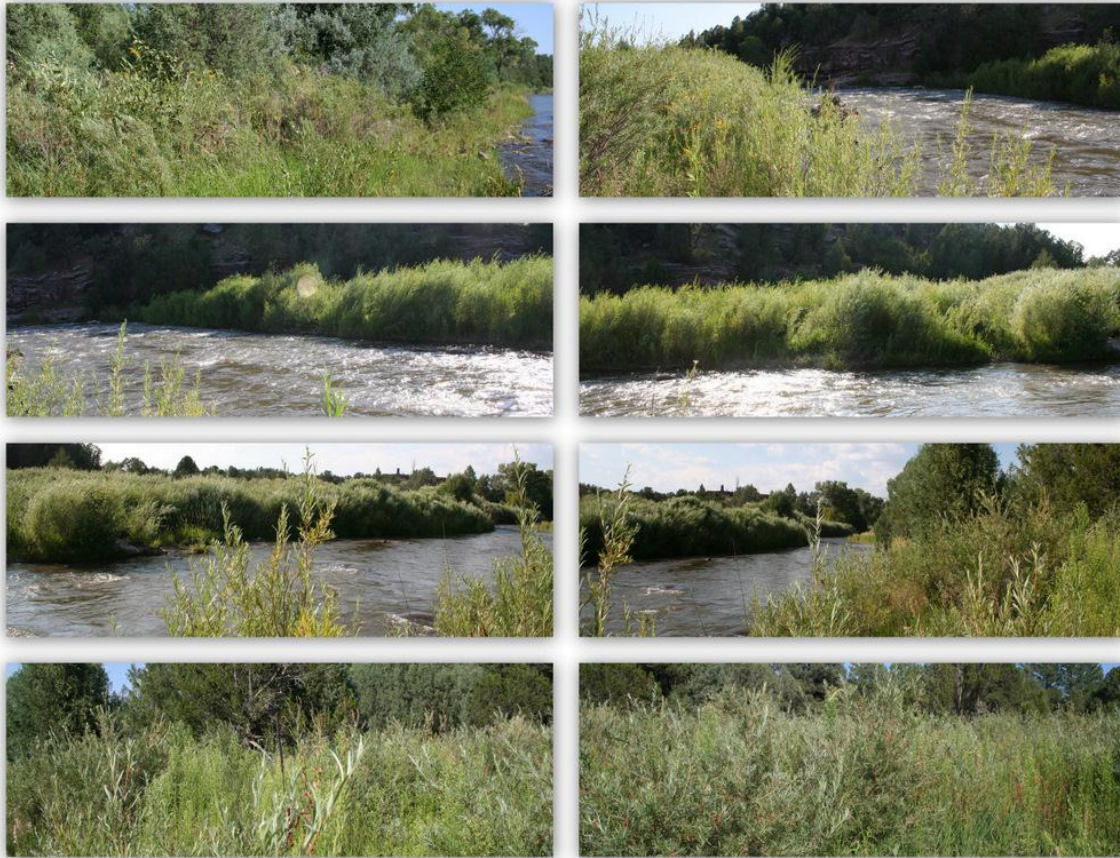
Figure 6. Example of a series of photopoints taken along a sample reach. All photos have been geotagged and included on a CD as a supplement to the report.

Over 500 photographs were taken along sampled reaches (Figure 6). The utility of photos for monitoring is variable. Many reaches, for example those dominated by dense stands of *Salix exigua*, were difficult to effectively photograph.
