Appendix 3. Final Grand Ditch Report (2009-2010 task agreement). Rocky Mountain National Park, CO. Covey Potter and Dr. David Cooper.

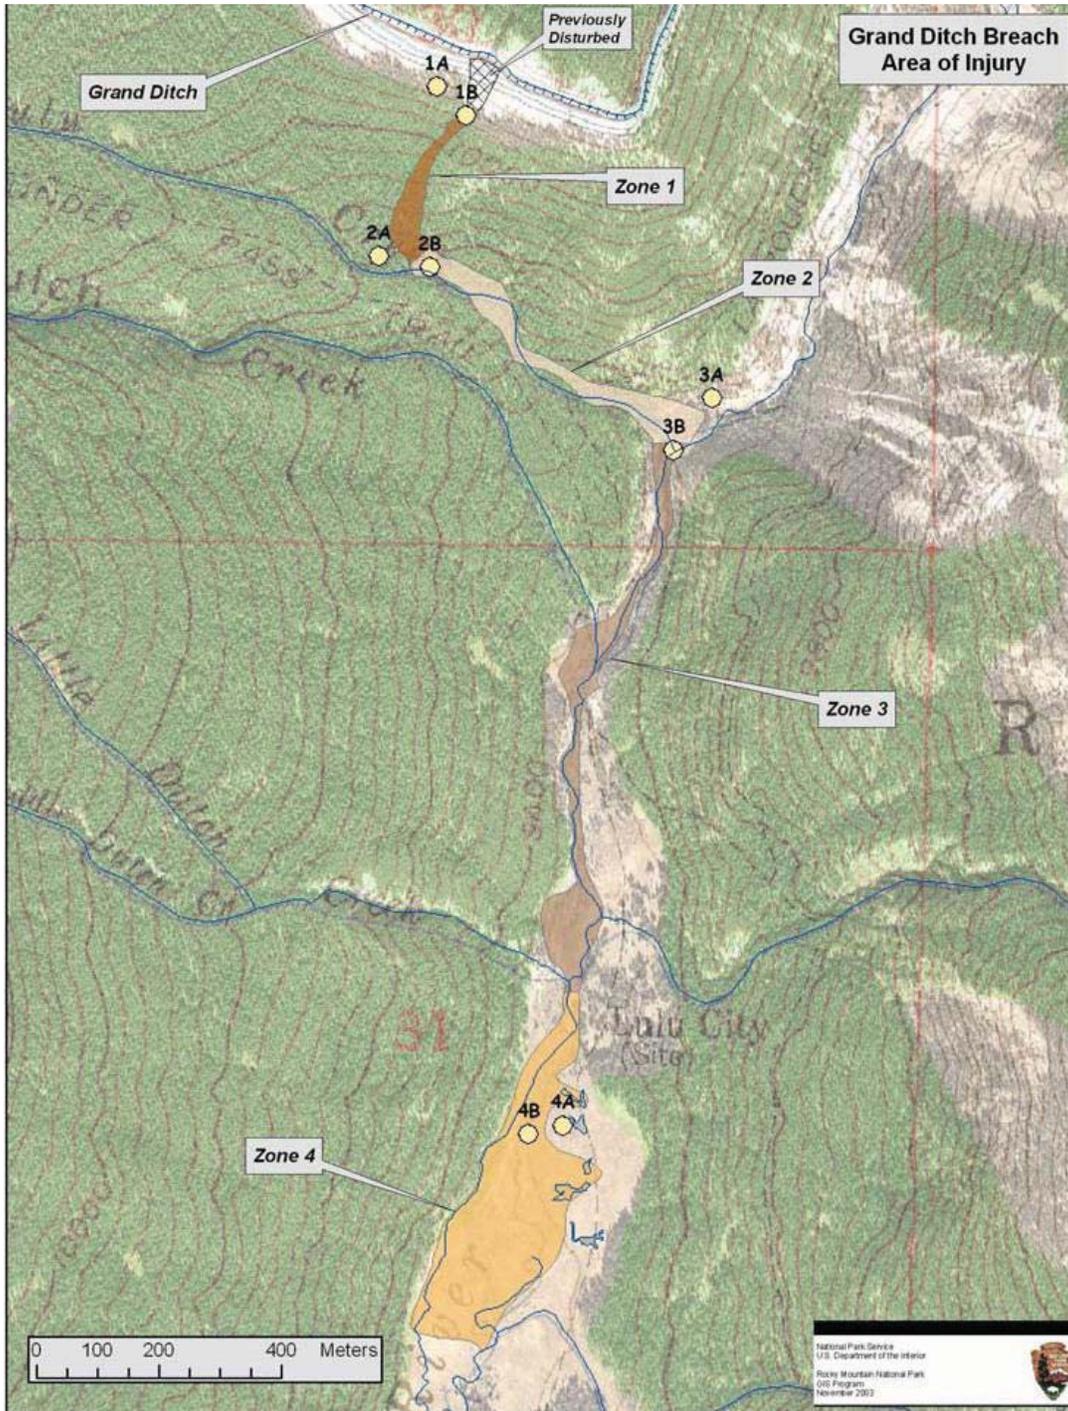
Figure 1: Areas of injury from the 2003 Grand Ditch Breach. Figure shows zones of impact. From Cooper Expert Report 2008.

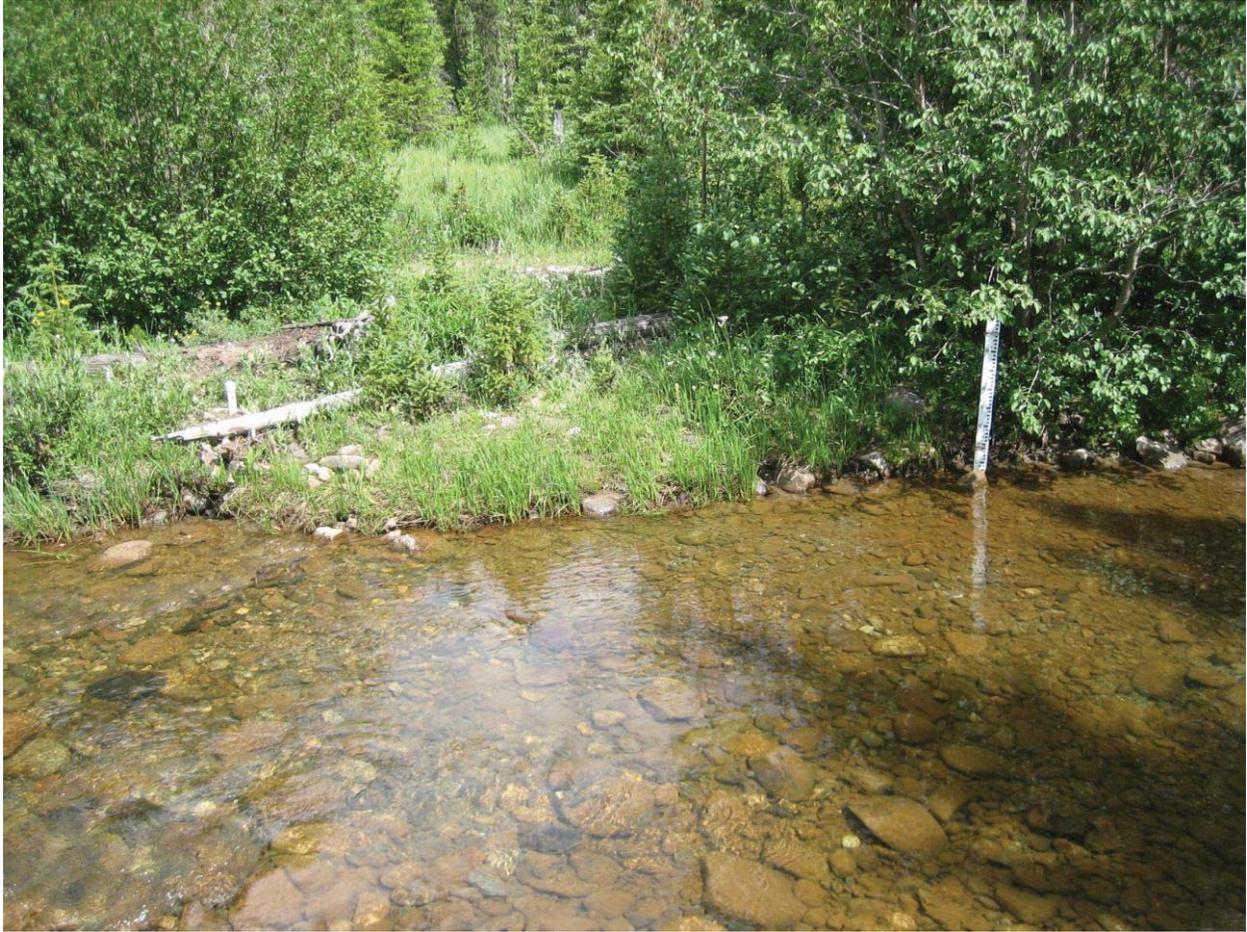
Figure 2: Photo of Shipler Park onsite reference site. Demonstrating groundwater well and staff gage placement for water table monitoring.

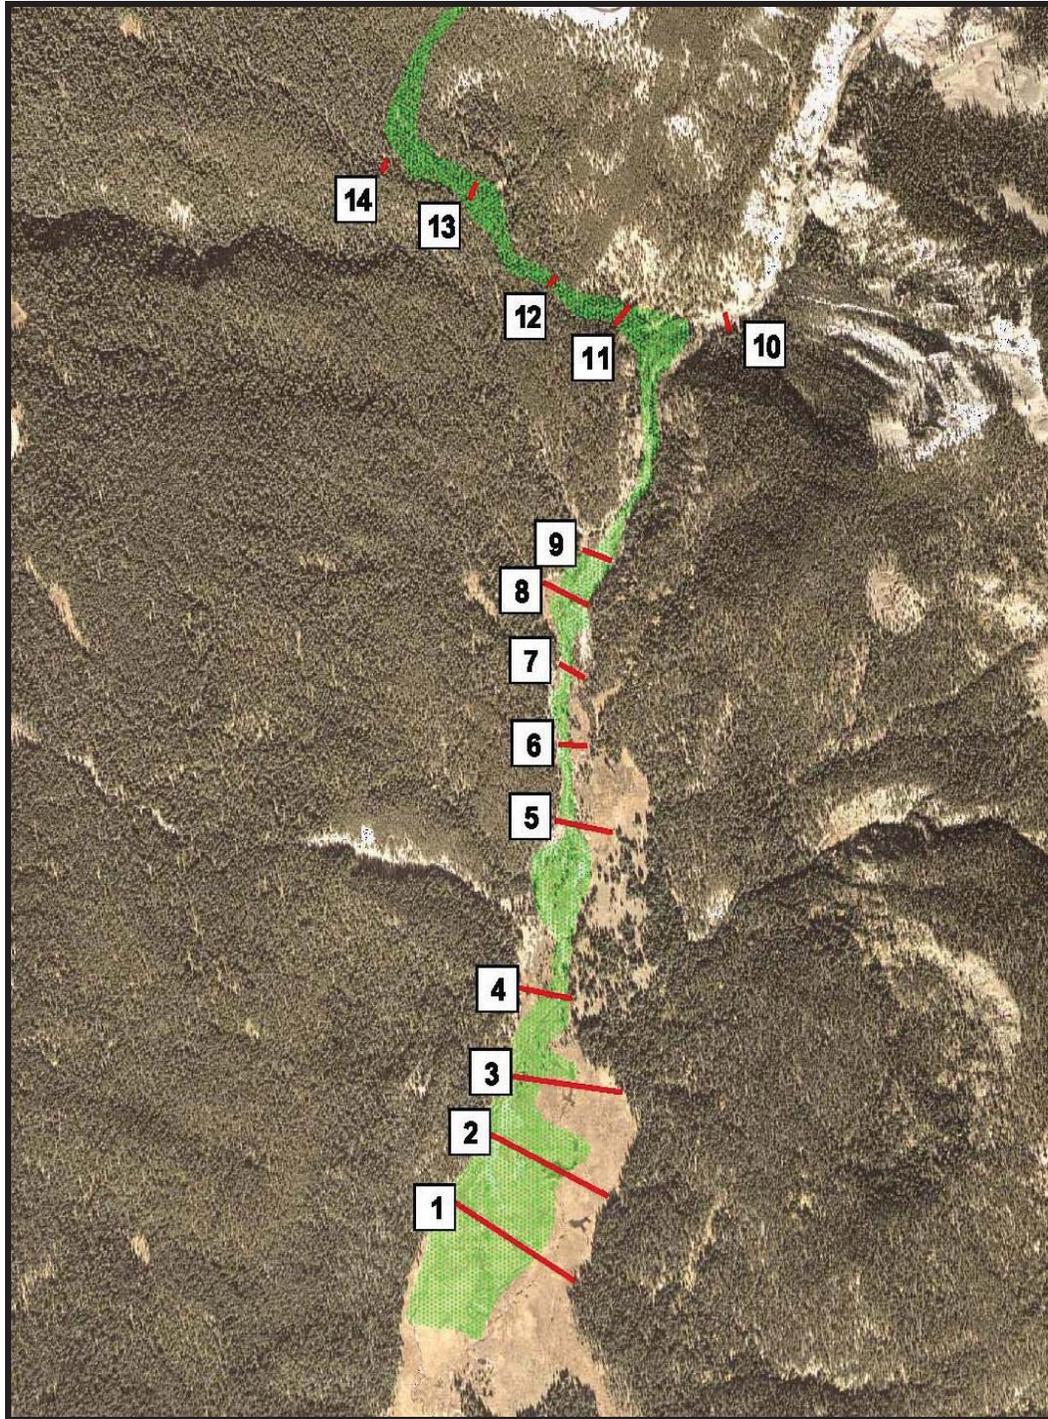
Figure 3. Groundwater monitoring well transects along the affected reaches of Lulu Creek and the Colorado River. Rocky Mountain National Park, CO. Installed 2003 and 2004 (Gage 2005).

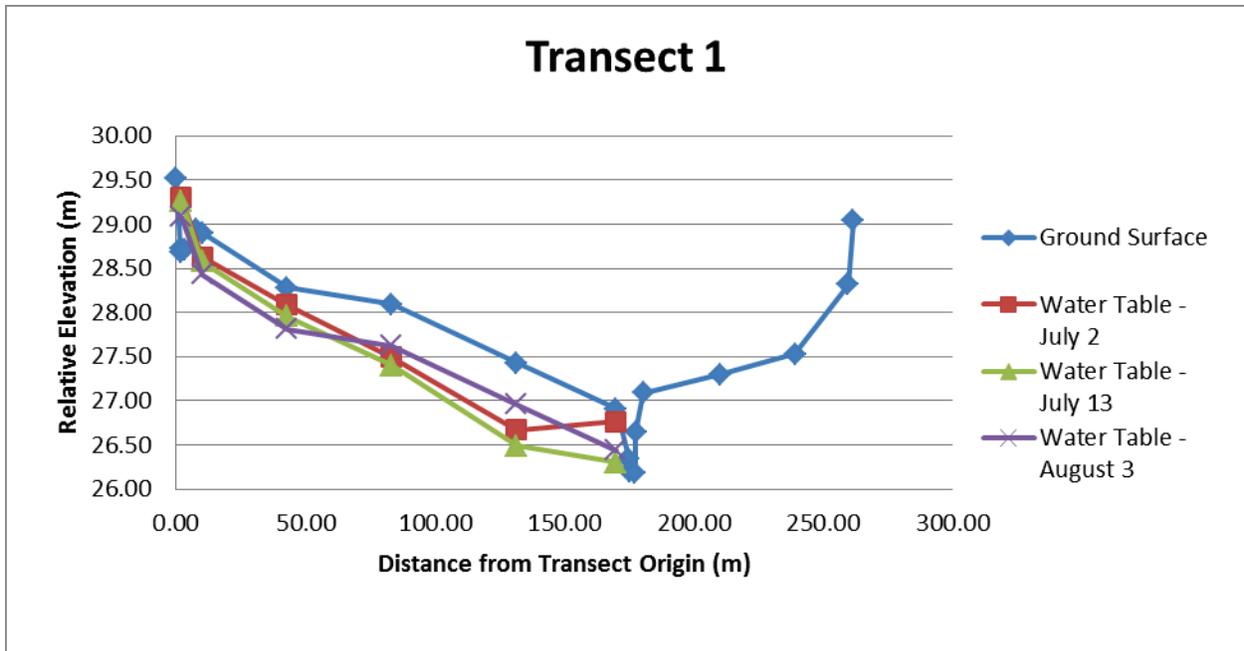
Figure 4. 2-dimensional cross section of transect 1 shown in Figure 1. This cross section describes a somewhat stable ground surface combined with monthly variations in 2009 depth to groundwater collected from the groundwater monitoring wells.

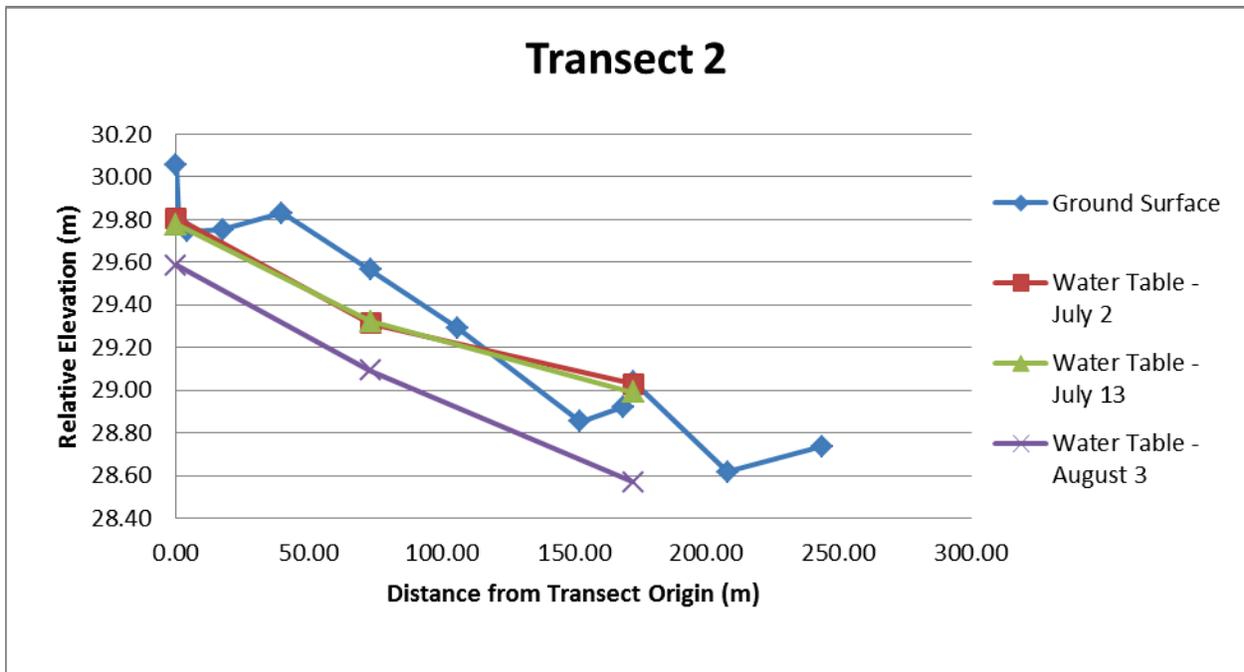
Figure 5. 2-dimensional cross section of transect 2 shown in Figure 1. This cross section describes a somewhat stable ground surface combined with monthly variations in 2009 depth to groundwater collected from the groundwater monitoring wells.

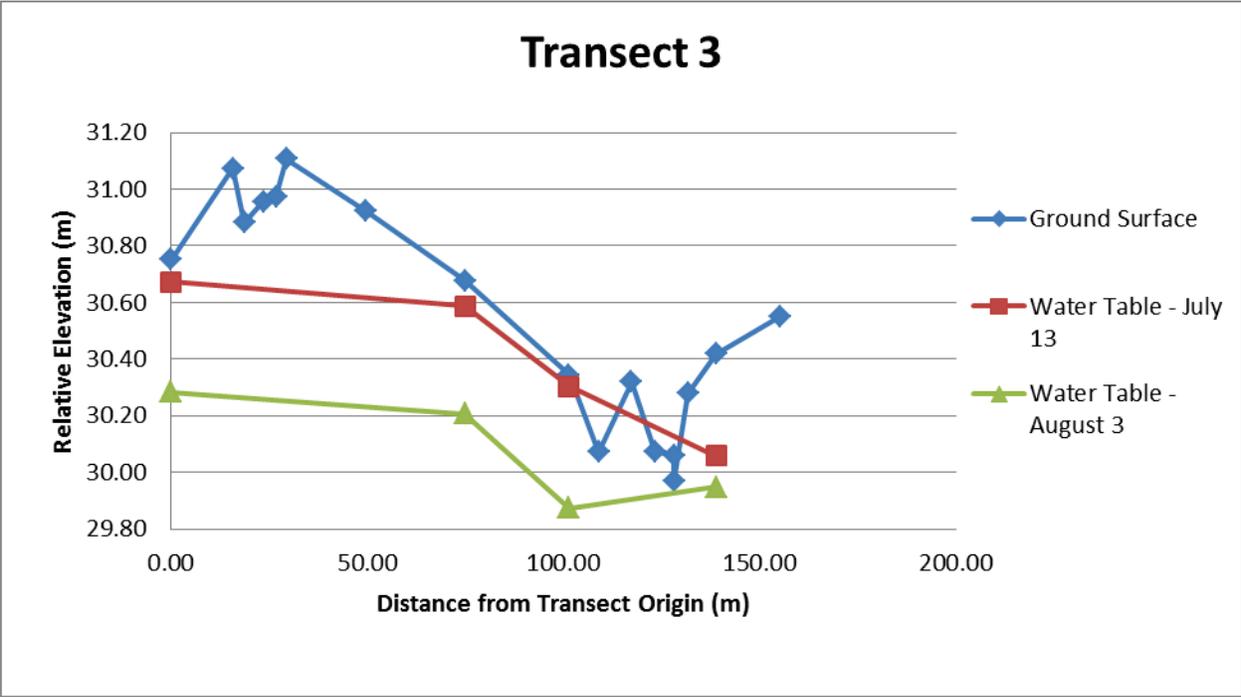
Figure 6. 2-dimensional cross section of transect 3 shown in Figure 1. This cross section describes a somewhat stable ground surface combined with monthly variations in 2009 depth to groundwater collected from the groundwater monitoring wells.

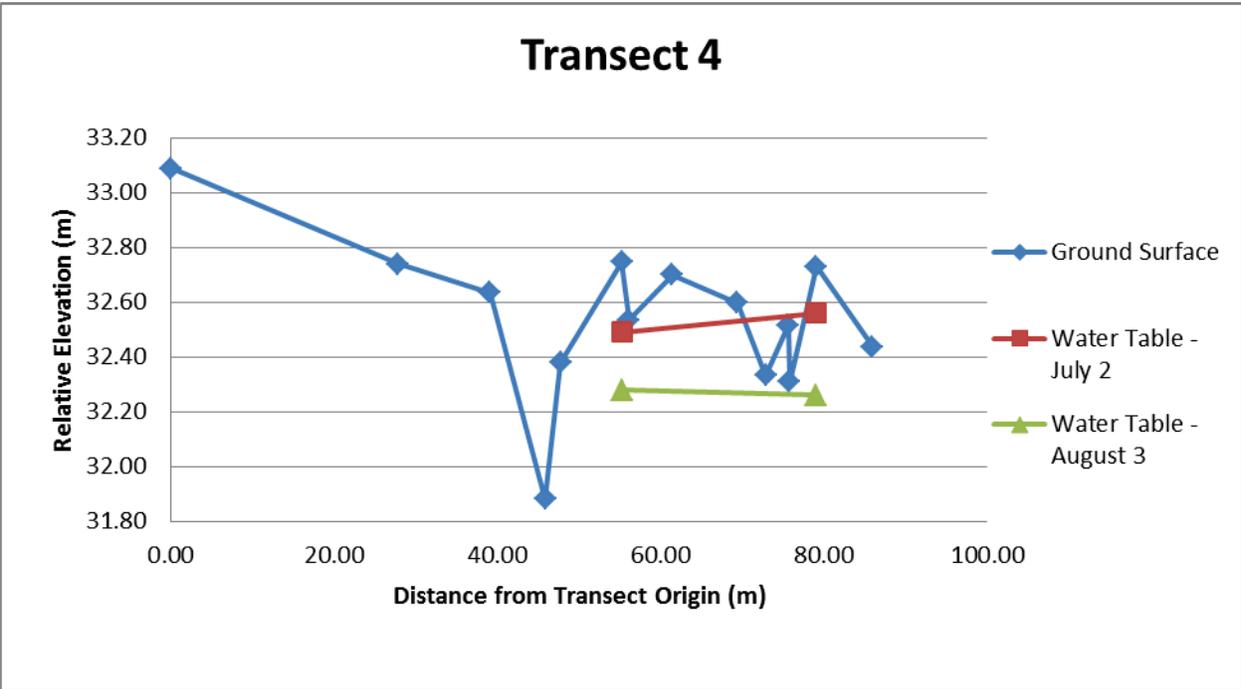
Figure 7. 2-dimensional cross section of transect 4 shown in Figure 1. This cross section describes a somewhat stable ground surface combined with monthly variations in 2009 depth to groundwater collected from the groundwater monitoring wells.

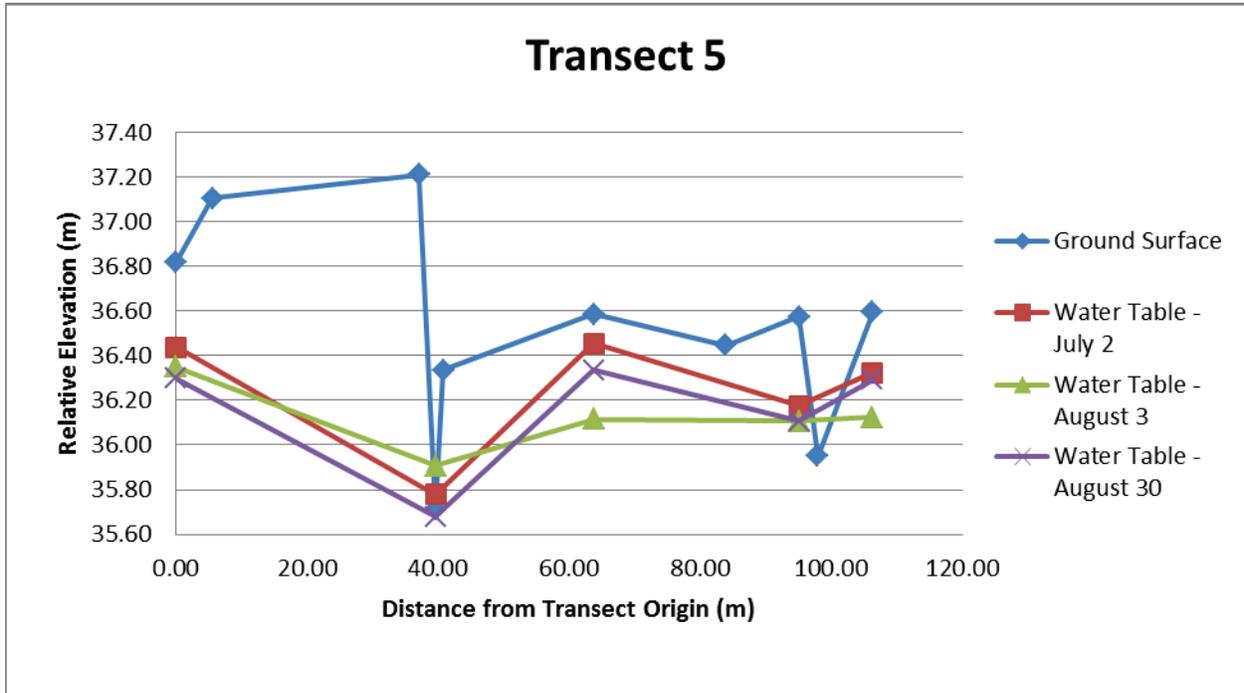
Figure 8. 2-dimensional cross section of transect 5 shown in Figure 1. This cross section describes a somewhat stable ground surface combined with monthly variations in 2009 depth to groundwater collected from the groundwater monitoring wells.

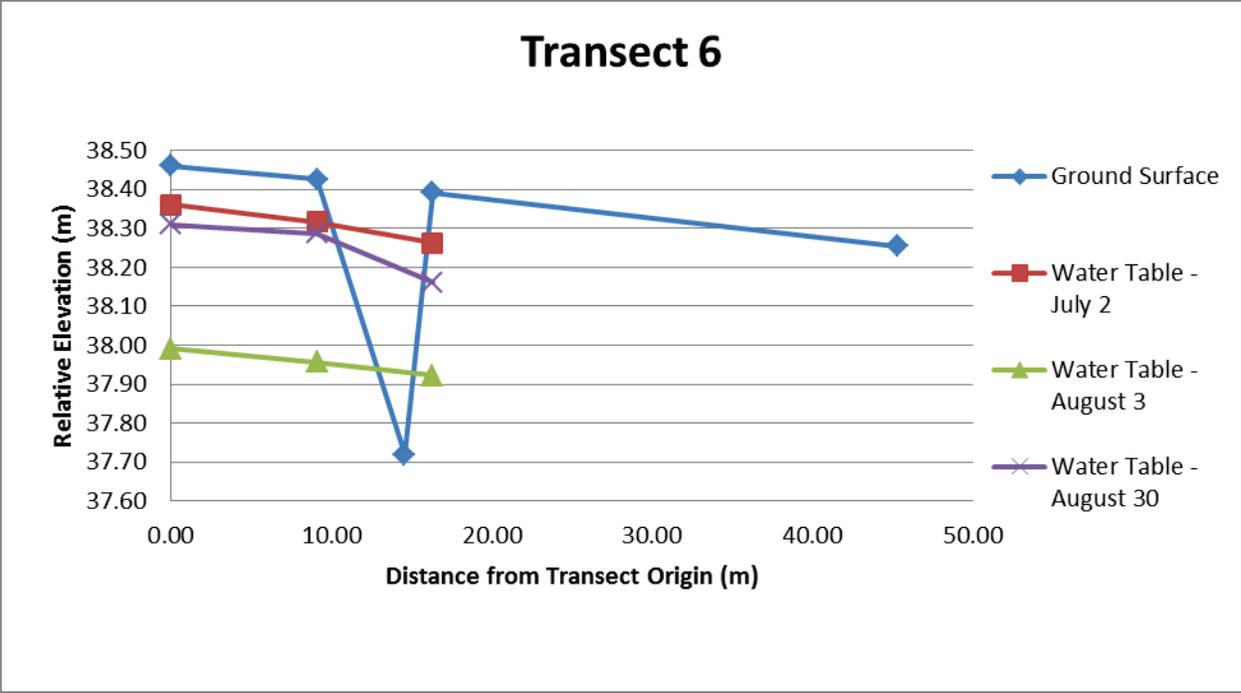
Figure 9. 2-dimensional cross section of transect 6 shown in Figure 1. This cross section describes a somewhat stable ground surface combined with monthly variations in 2009 depth to groundwater collected from the groundwater monitoring wells.

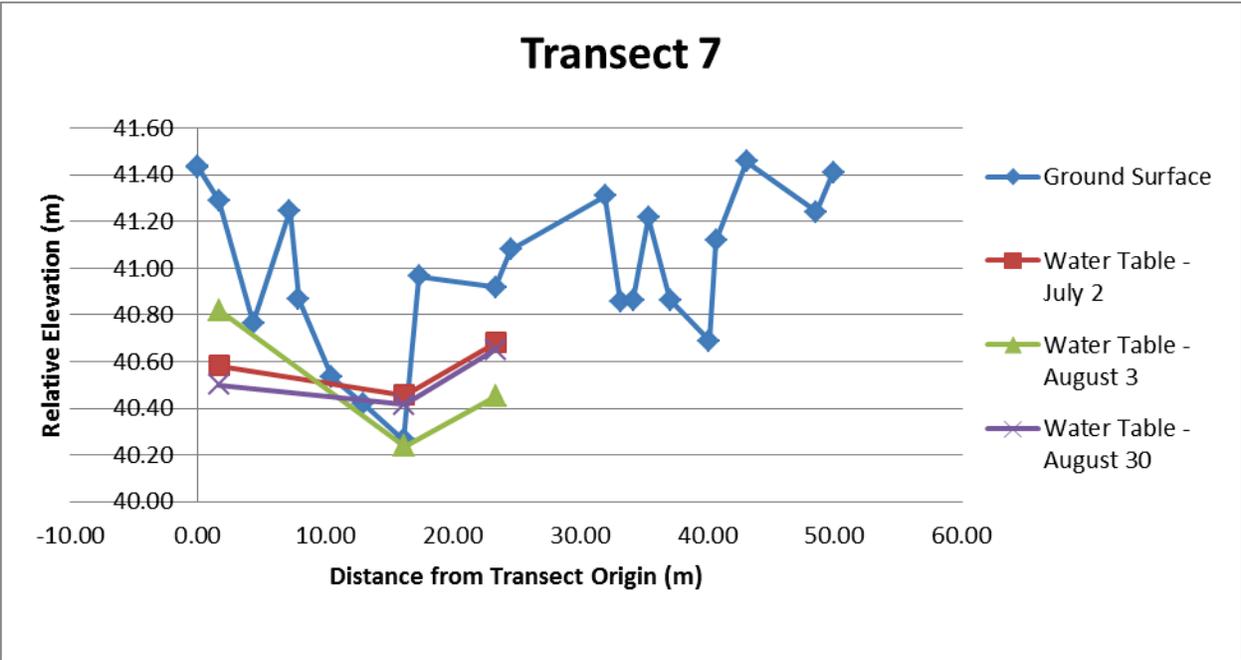
Figure 10. 2-dimensional cross section of transect 7 shown in Figure 1. This cross section describes a somewhat stable ground surface combined with monthly variations in 2009 depth to groundwater collected from the groundwater monitoring wells.

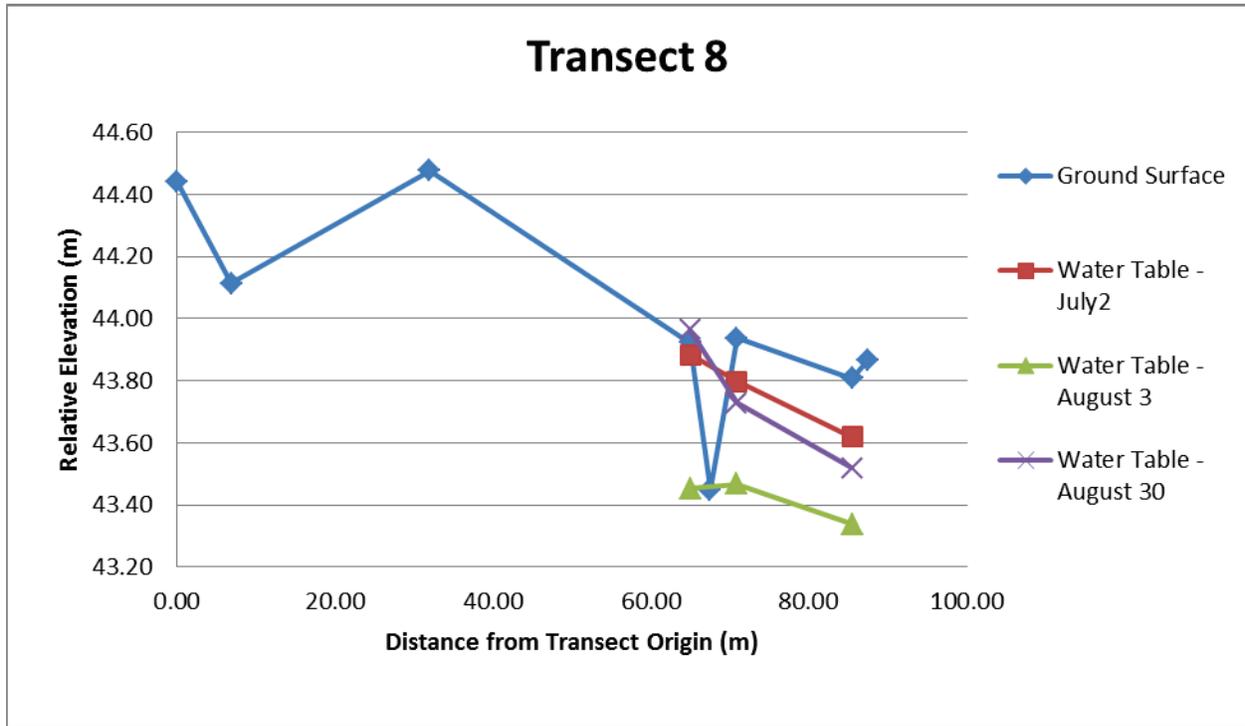
Figure 11. 2-dimensional cross section of transect 8 shown in Figure 1. This cross section describes a somewhat stable ground surface combined with monthly variations in 2009 depth to groundwater collected from the groundwater monitoring wells.

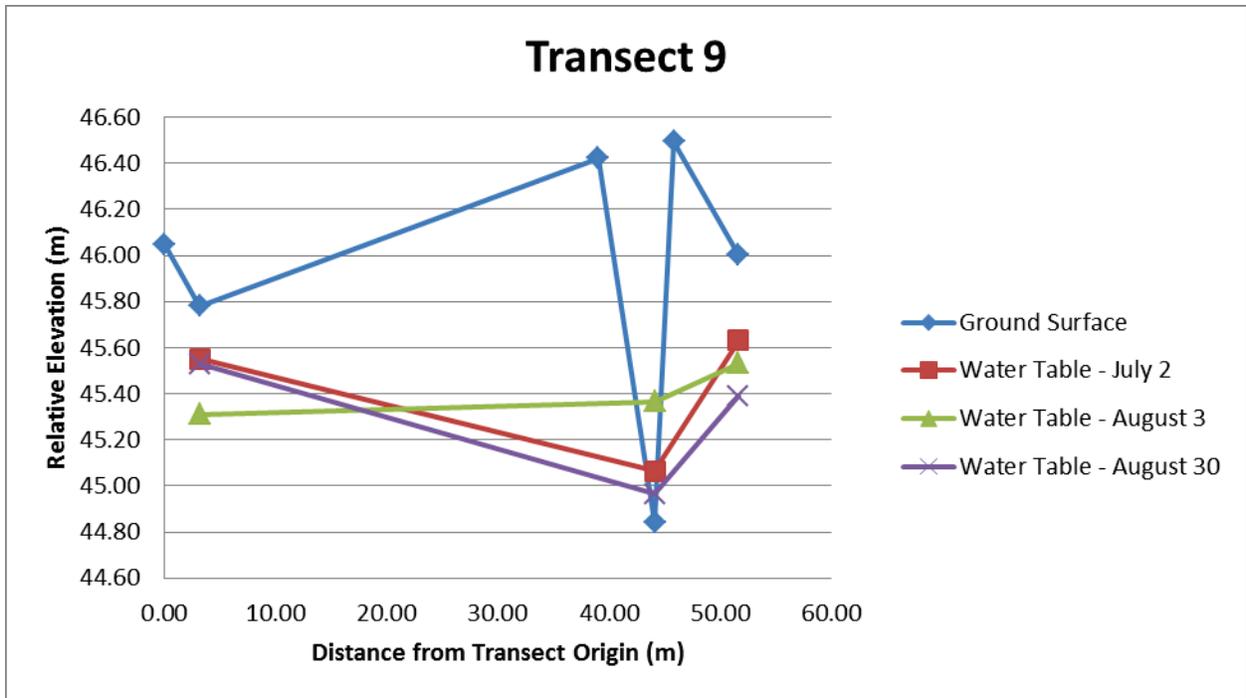
Figure 12. 2-dimensional cross section of transect 9 shown in Figure 1. This cross section describes a somewhat stable ground surface combined with monthly variations in 2009 depth to groundwater collected from the groundwater monitoring wells.

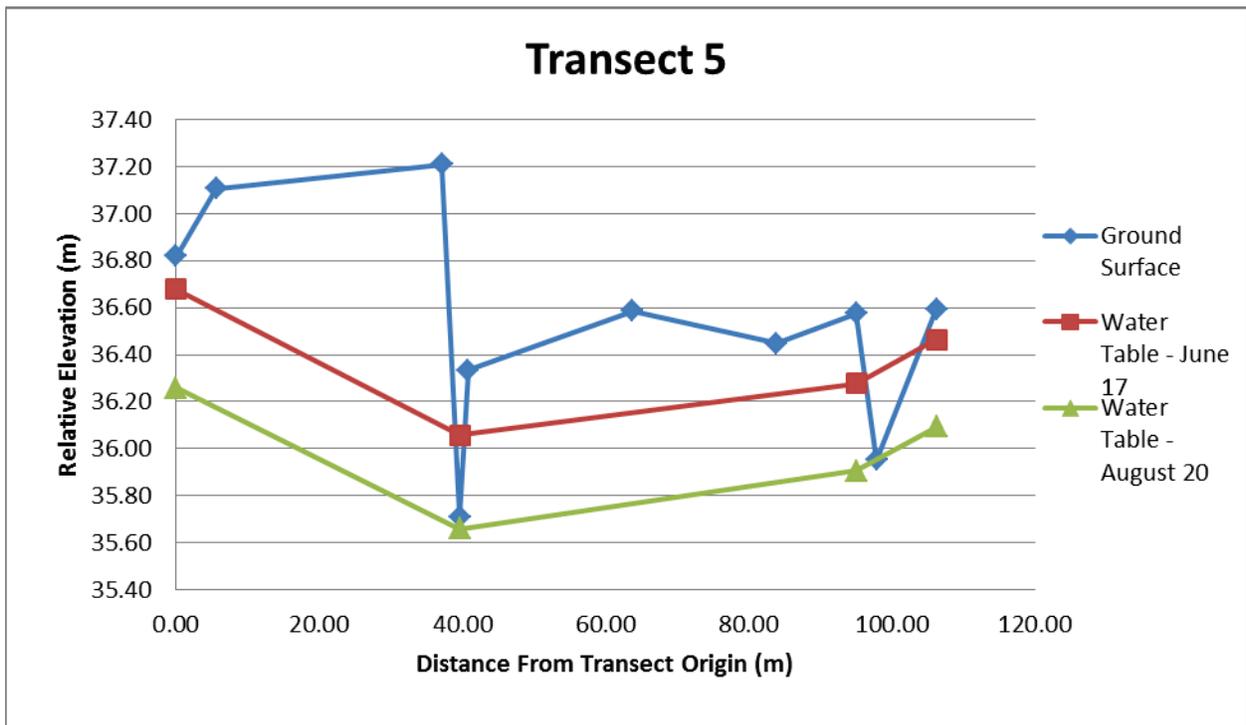
Figure 13. 2-dimensional cross section of transect 5 shown in Figure 1. This cross section describes a somewhat stable ground surface combined with monthly variations in 2010 depth to groundwater collected from the groundwater monitoring wells.

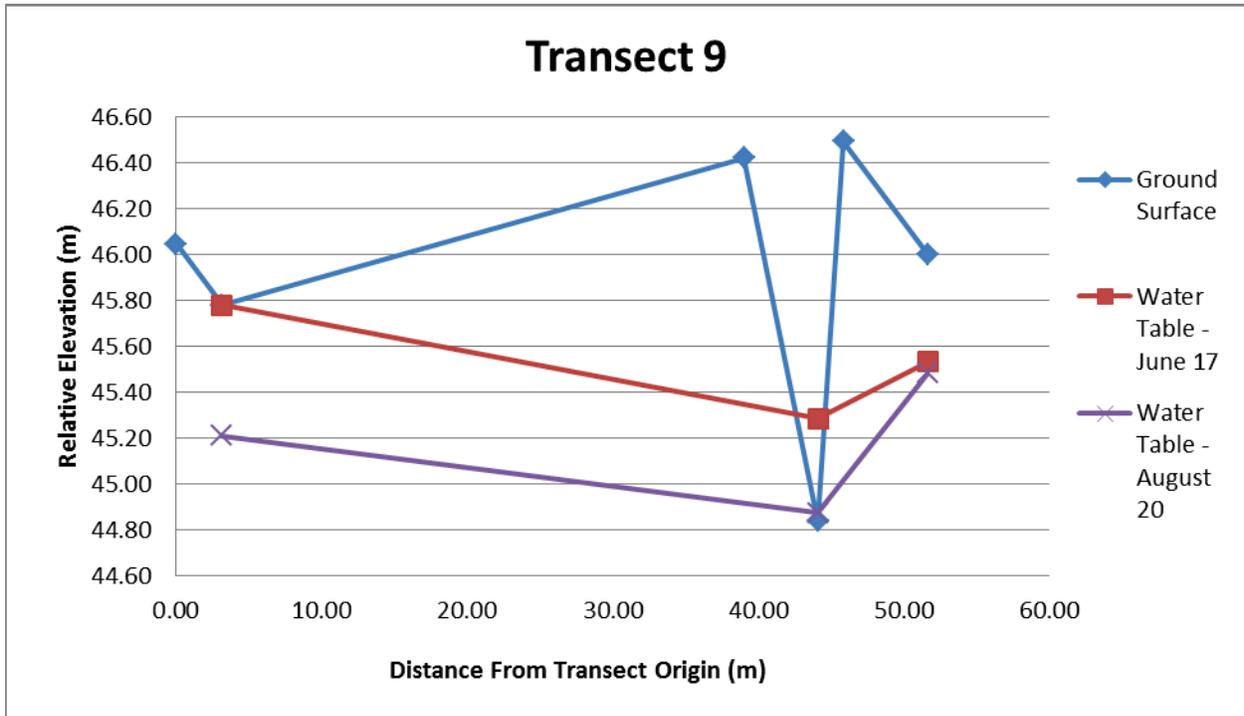
Figure 14. 2-dimensional cross section of transect 9 shown in Figure 1. This cross section describes a somewhat stable ground surface combined with monthly variations in 2010 depth to groundwater collected from the groundwater monitoring wells.

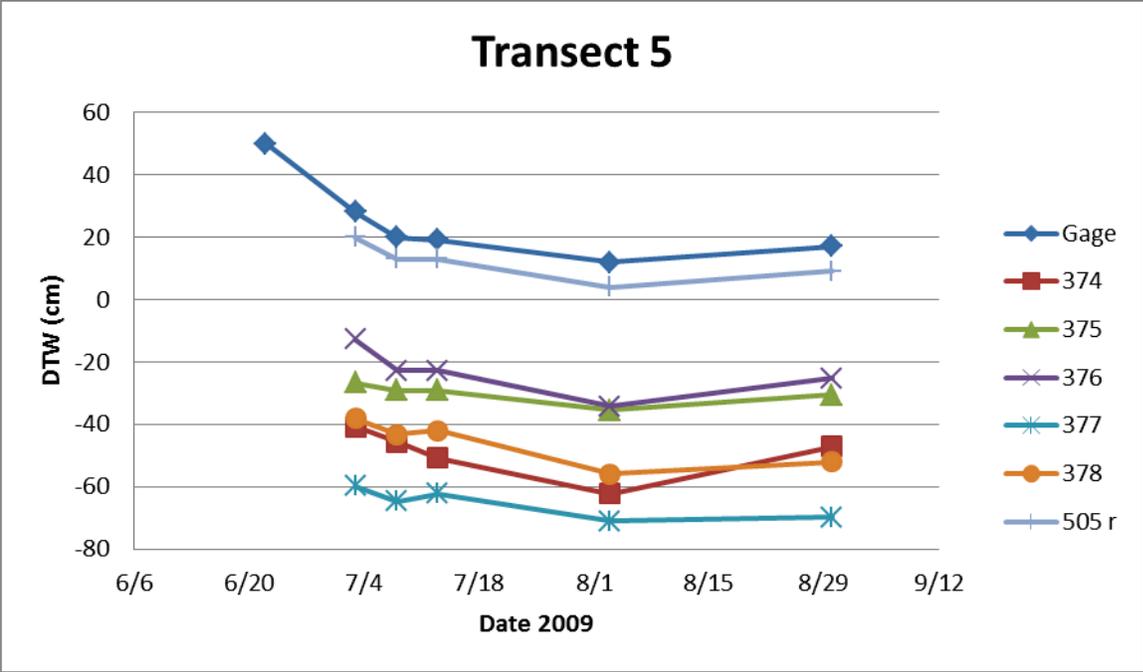
Figures 23. Depth to water table hydrographs for the 2009 season in Zone 3 along transect 5. This hydrograph describes a steadily lowering water table as the season progresses until an interestingly uniform increase in water table at the end of August. This increase is likely due to increased precipitation from the summer monsoon and late season ditch releases.

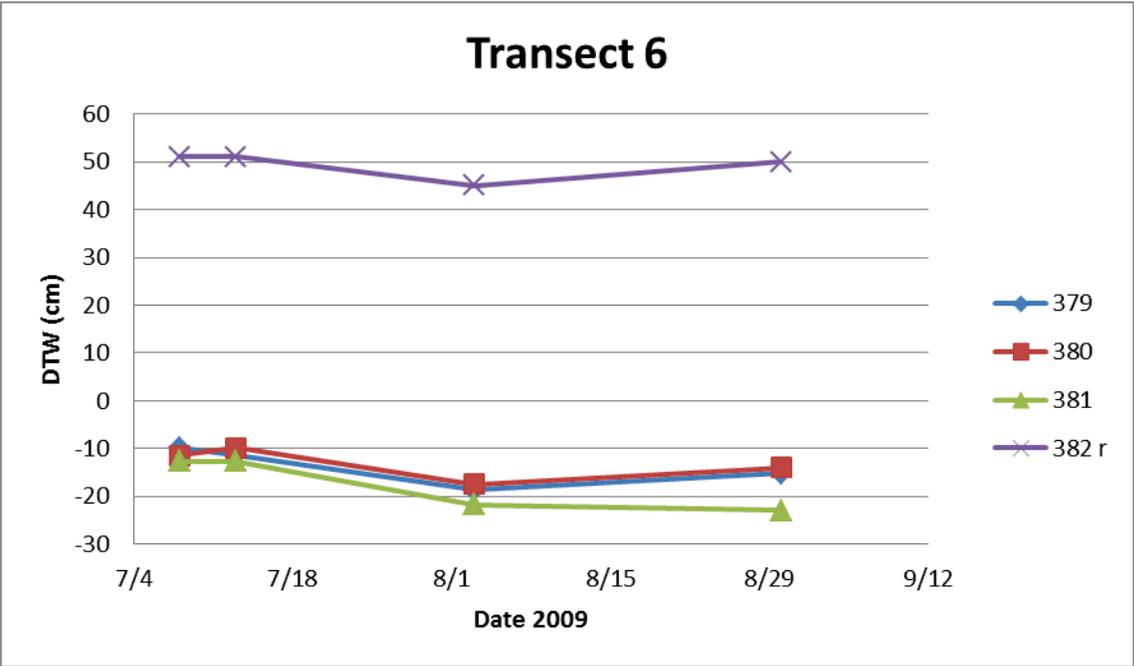
Figures 24. Depth to water table hydrographs for the 2009 season in Zone 3 along transect 6. This hydrograph describes a steadily lowering water table as the season progresses until an interestingly uniform increase in water table at the end of August. This increase is likely due to increased precipitation from the summer monsoon and late season ditch releases.

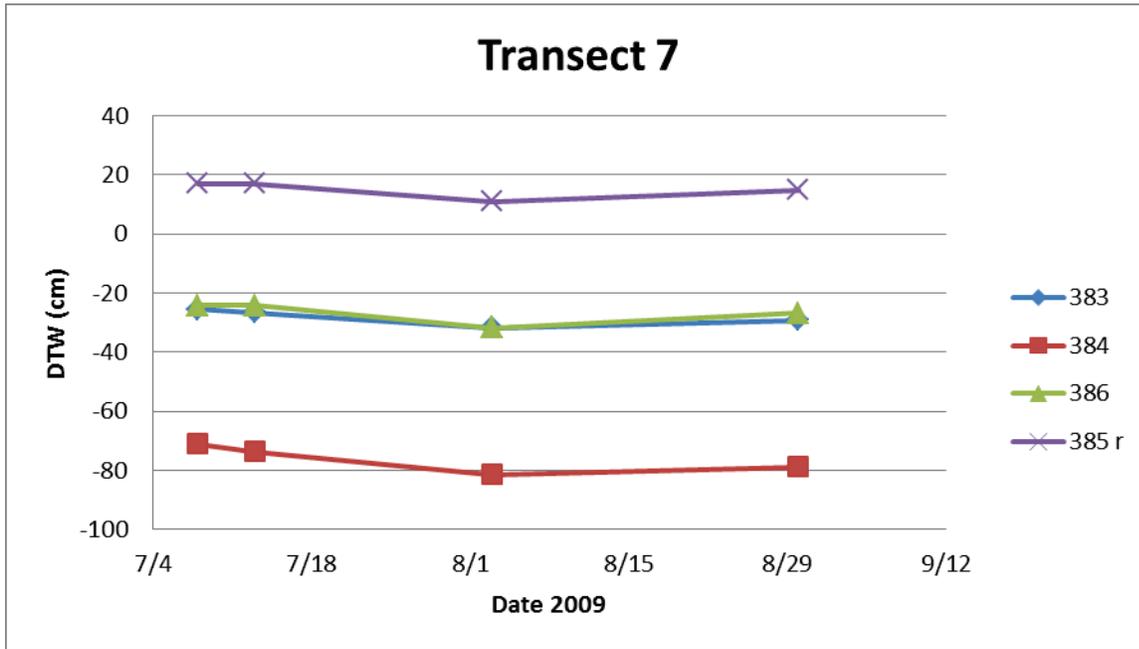
Figures 25. Depth to water table hydrographs for the 2009 season in Zone 3 along transect 7. This hydrograph describes a steadily lowering water table as the season progresses until an interestingly uniform increase in water table at the end of August. This increase is likely due to increased precipitation from the summer monsoon and late season ditch releases.

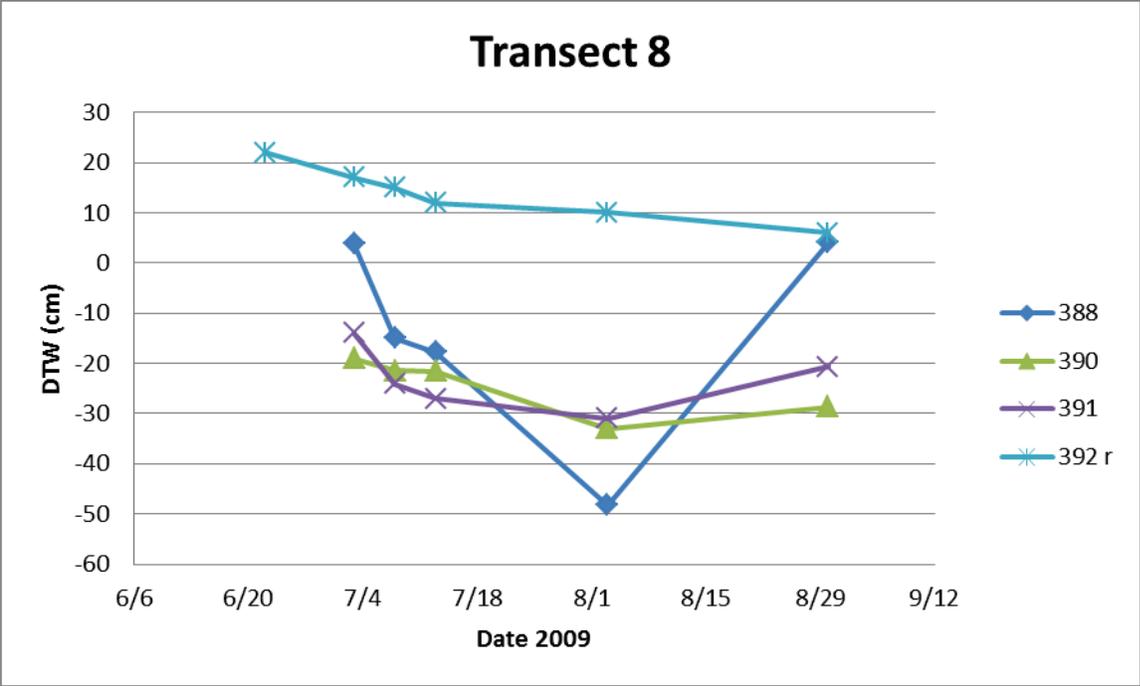
Figures 26. Depth to water table hydrographs for the 2009 season in Zone 3 along transect 8. This hydrograph describes a steadily lowering water table as the season progresses until an interestingly uniform increase in water table at the end of August. This increase is likely due to increased precipitation from the summer monsoon and late season ditch releases.

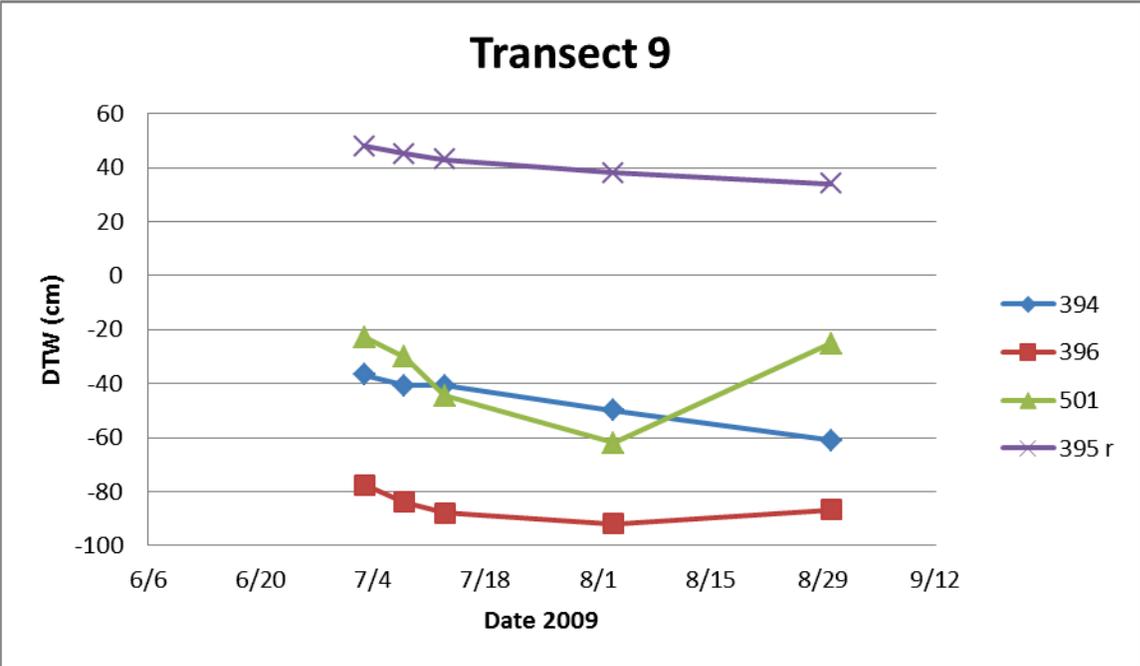
Figures 27. Depth to water table hydrographs for the 2009 season in Zone 3 along transect 9. This hydrograph describes a steadily lowering water table as the season progresses until an interestingly uniform increase in water table at the end of August. This increase is likely due to increased precipitation from the summer monsoon and late season ditch releases.

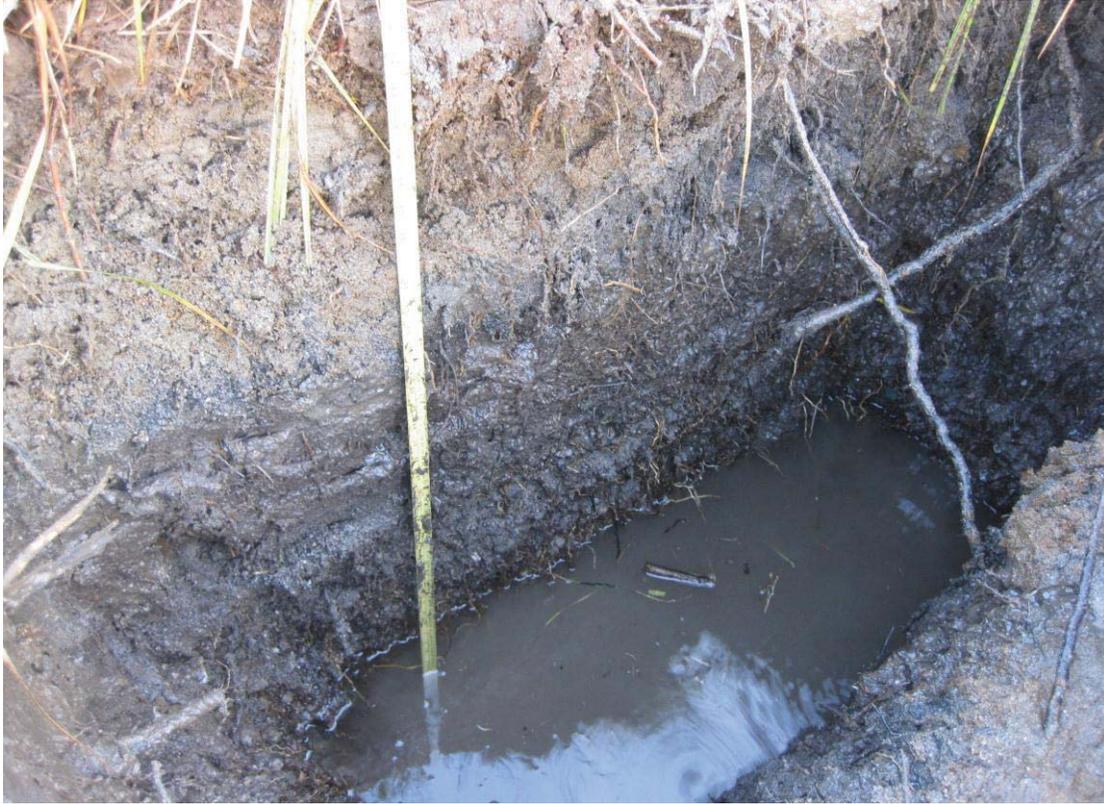
Figure 31: Stratigraphic interpretations of the sediment pits revealed multiple debris events with variable particle size and buried vegetation layers.

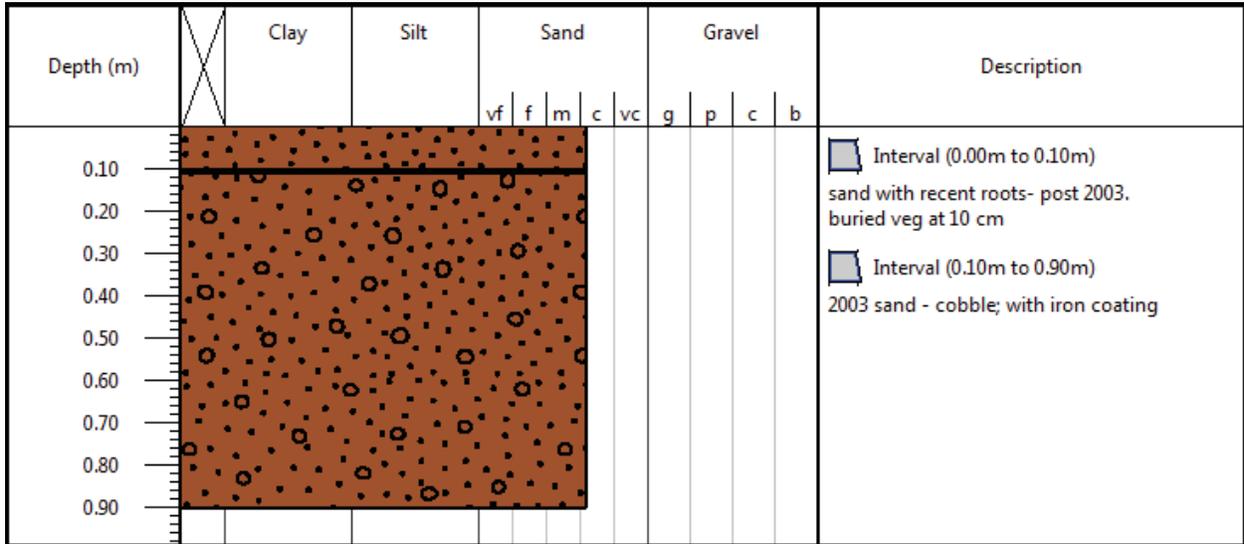
Pit 2

Figure 33: Stratigraphic sediment profile cross section. Representing thickness and texture of sediments and buried materials. Collected September 2009 using a Bobcat Excavator in Lulu City Wetland.

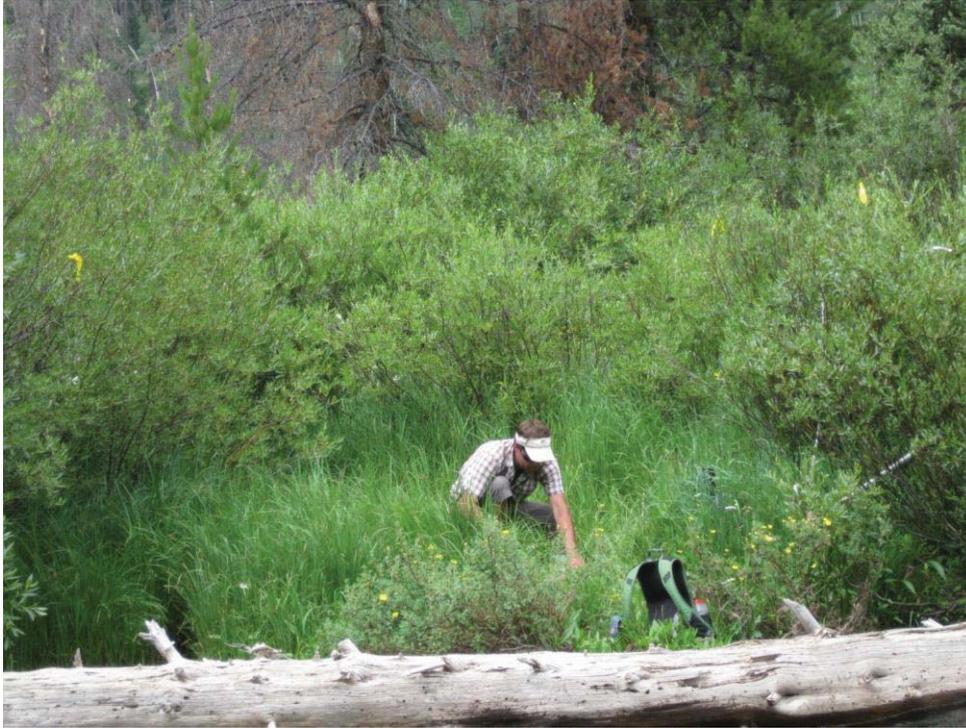
Figure 84: Offsite reference site survey of Soil texture, DTW, and riparian vegetation community structure. Note the variability of community type at each of these plots due to gradient, stream size, and other environmental factors.

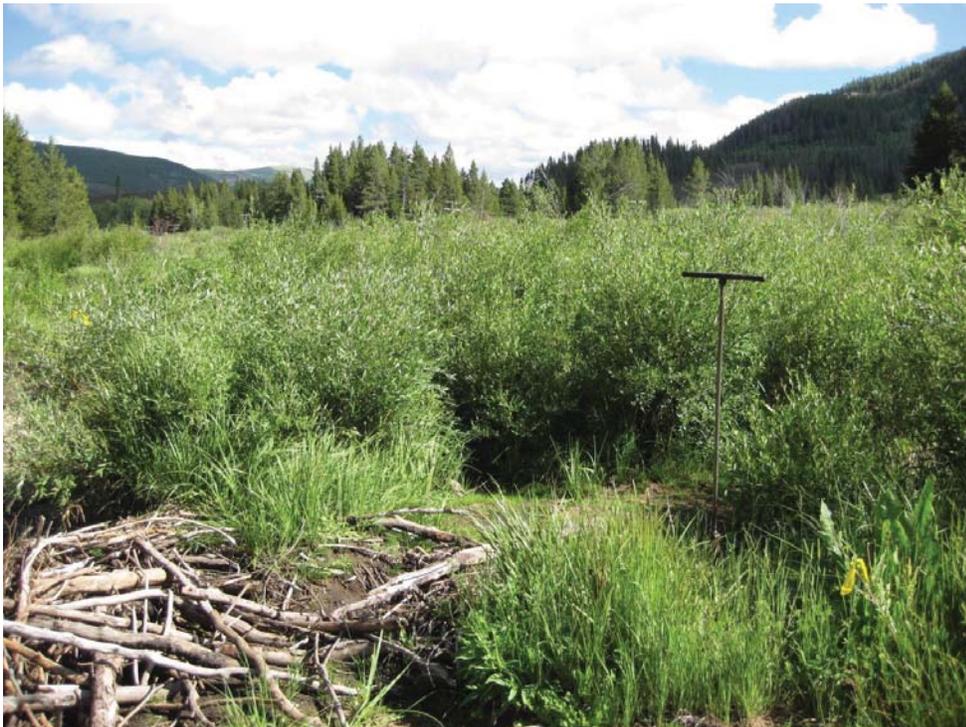
Figure 85: Offsite reference site survey of Soil texture, DTW, and riparian vegetation community structure. Note the variability of community type at each of these plots due to gradient, stream size, and other environmental factors.

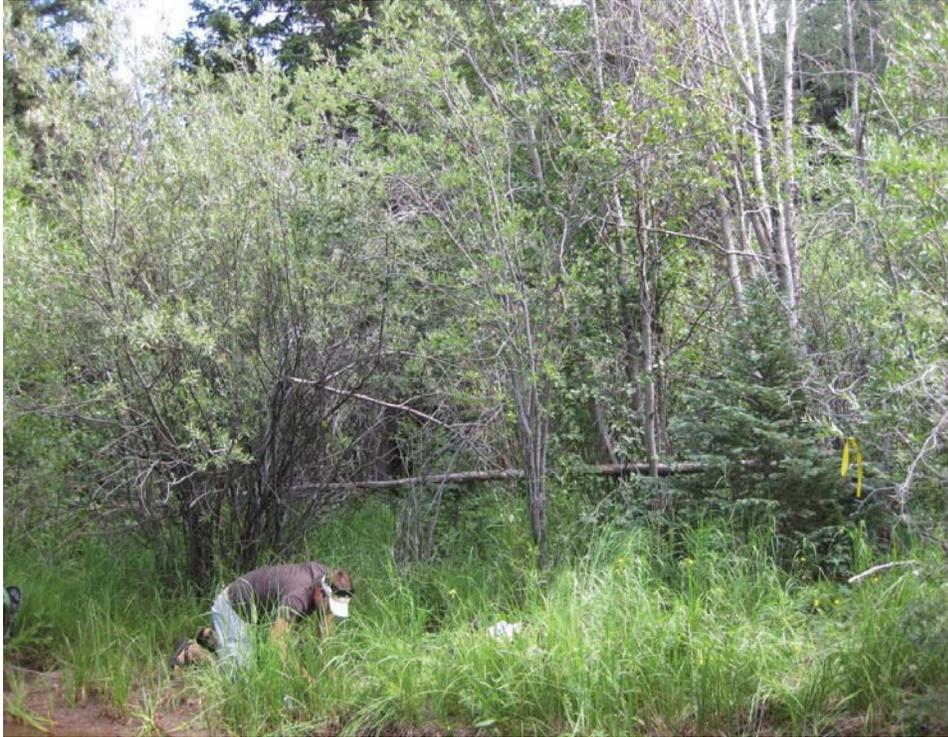
Figure 86: Offsite reference site survey of Soil texture, DTW, and riparian vegetation community structure. Note the variability of community type at each of these plots due to gradient, stream size, and other environmental factors.
