Jurisdictional Wetland Delineation along Sand Creek, Great Sand Dunes National Park, Colorado

David J. Cooper, Ph.D.
Department of Forest, Rangeland and Watershed Stewardship
Colorado State University, Fort Collins, CO 80523

January 2010

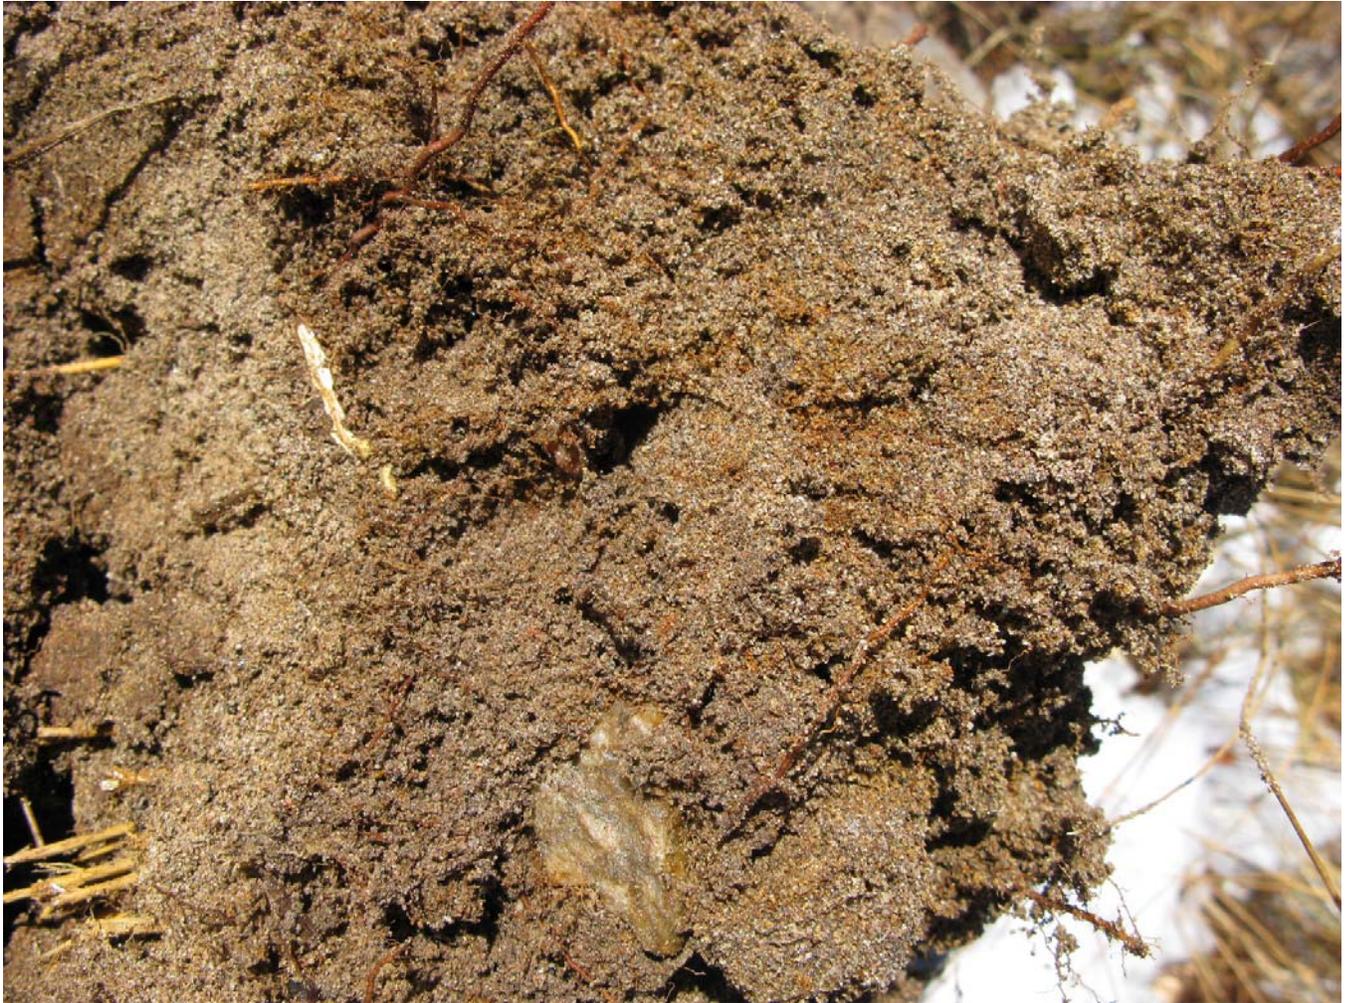
Figure 3. Soil in *Juncus arcticus* stand with well developed mottles in sandy low chroma matrix.

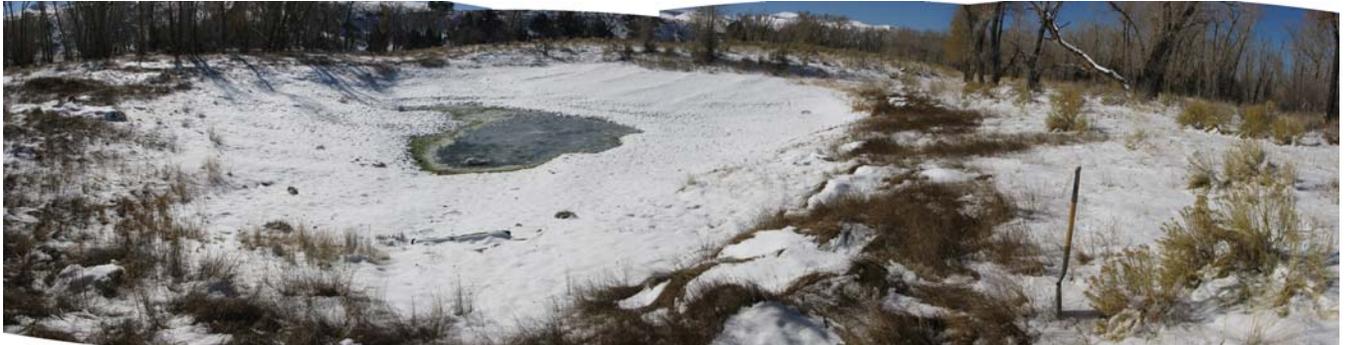
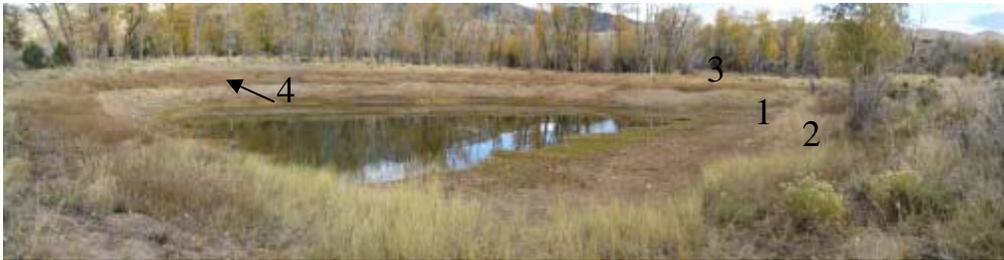
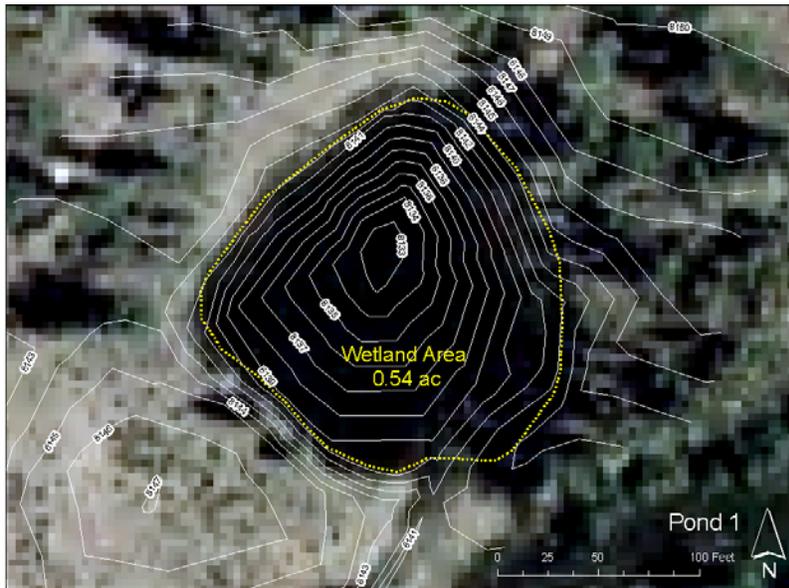
Pit 1: This pit supports 0.54 acres of jurisdictional wetland. It was created by pushing material to the west to form the pit. The main wetland community is dominated by *Juncus arcticus* and the wetland upland boundary was sharp.

Early winter and summer photos of Pit 1, and jurisdictional wetland map with contours. Numbers on middle photo identify the location of sample plots 1, 2, 3, and 4 (see data sheets).

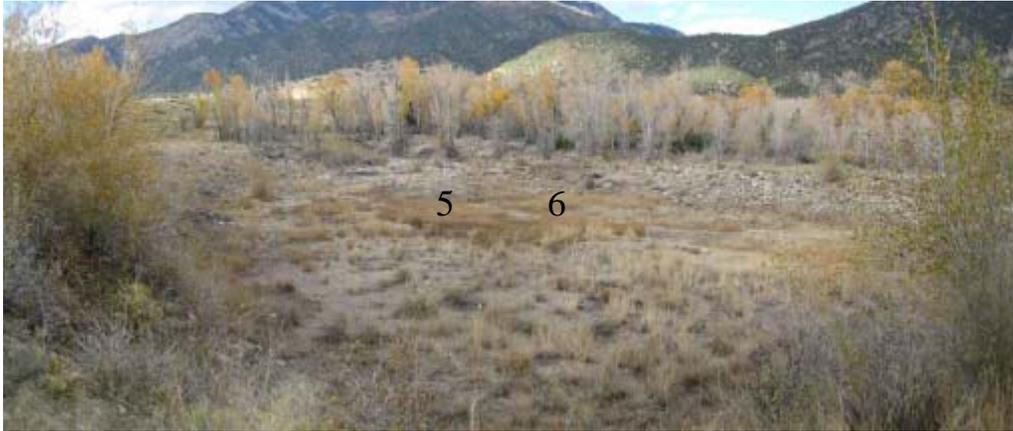
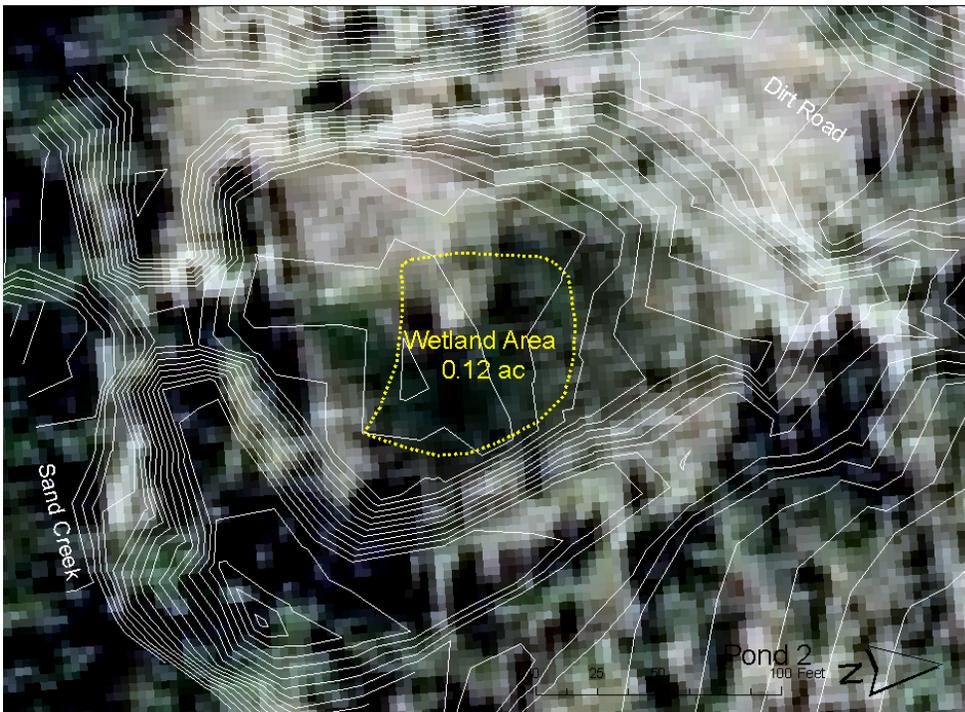
Pit 2: This pit has a disturbed area of approximately 0.9 acre, and a jurisdictional wetland area of 0.12 acre. The large dike on the South side of this pond apparently breached and the pond holds little water. A small wetland area exists in the pit bottom. The wetland here is dominated by *Carex lanuginosa* (OBL), and *Juncus arcticus*.

Summer photo showing the locations of sample plots 5 and 6, and jurisdictional delineation map of Pit 2.

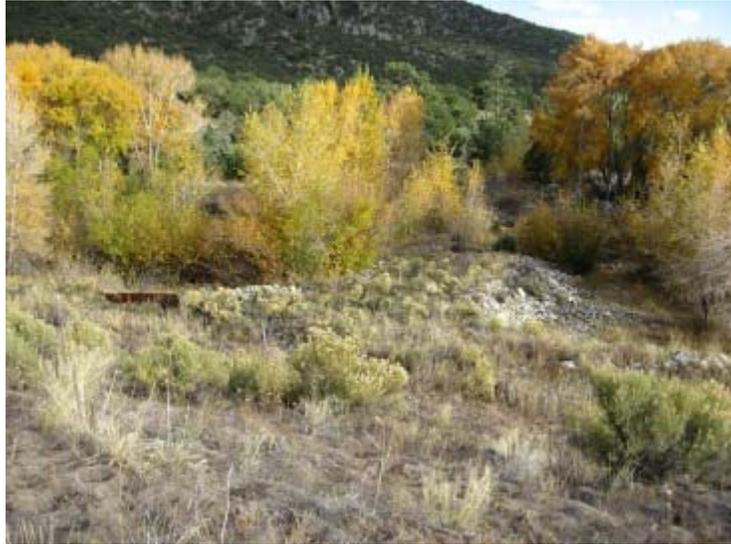
Pit 3: Pit 3, shown below, is a small depression that did not contain jurisdictional wetlands.

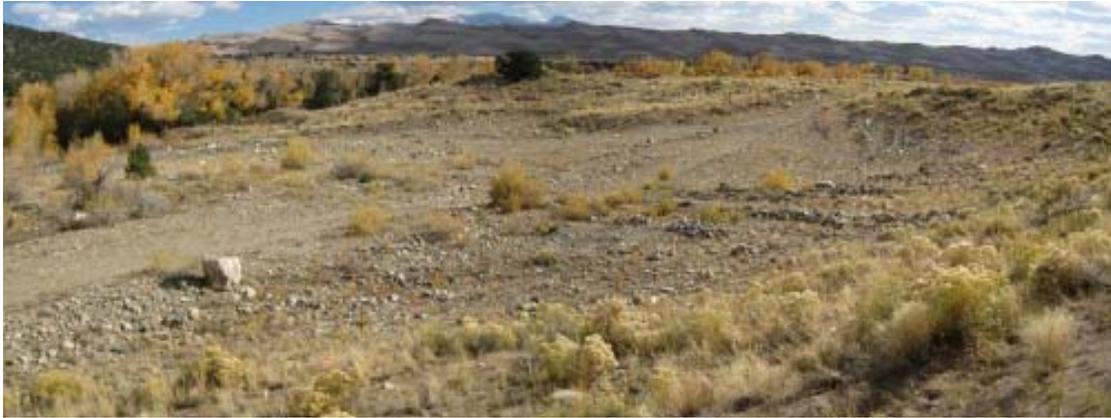
Pit 4: This pit, shown below, is a large disturbed area that does not support any jurisdictional wetland, is covered by bare gravel and apparently has a deep water table.

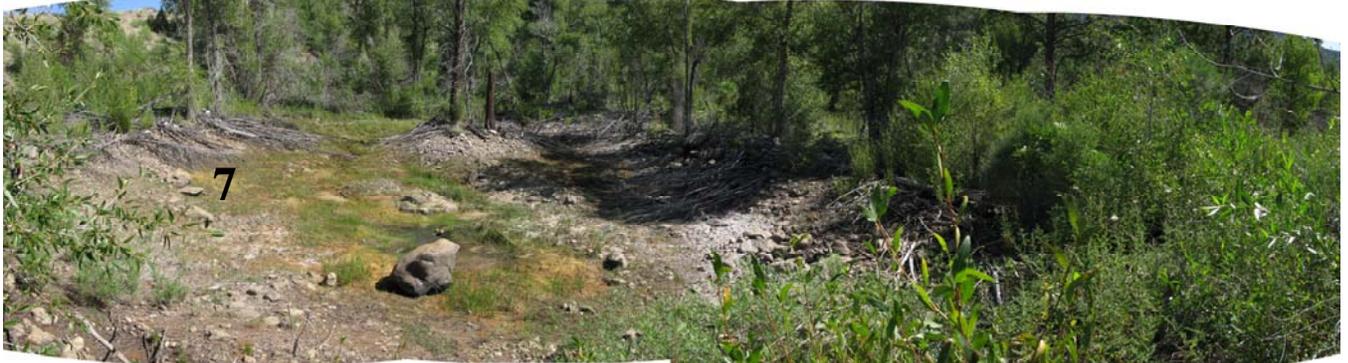
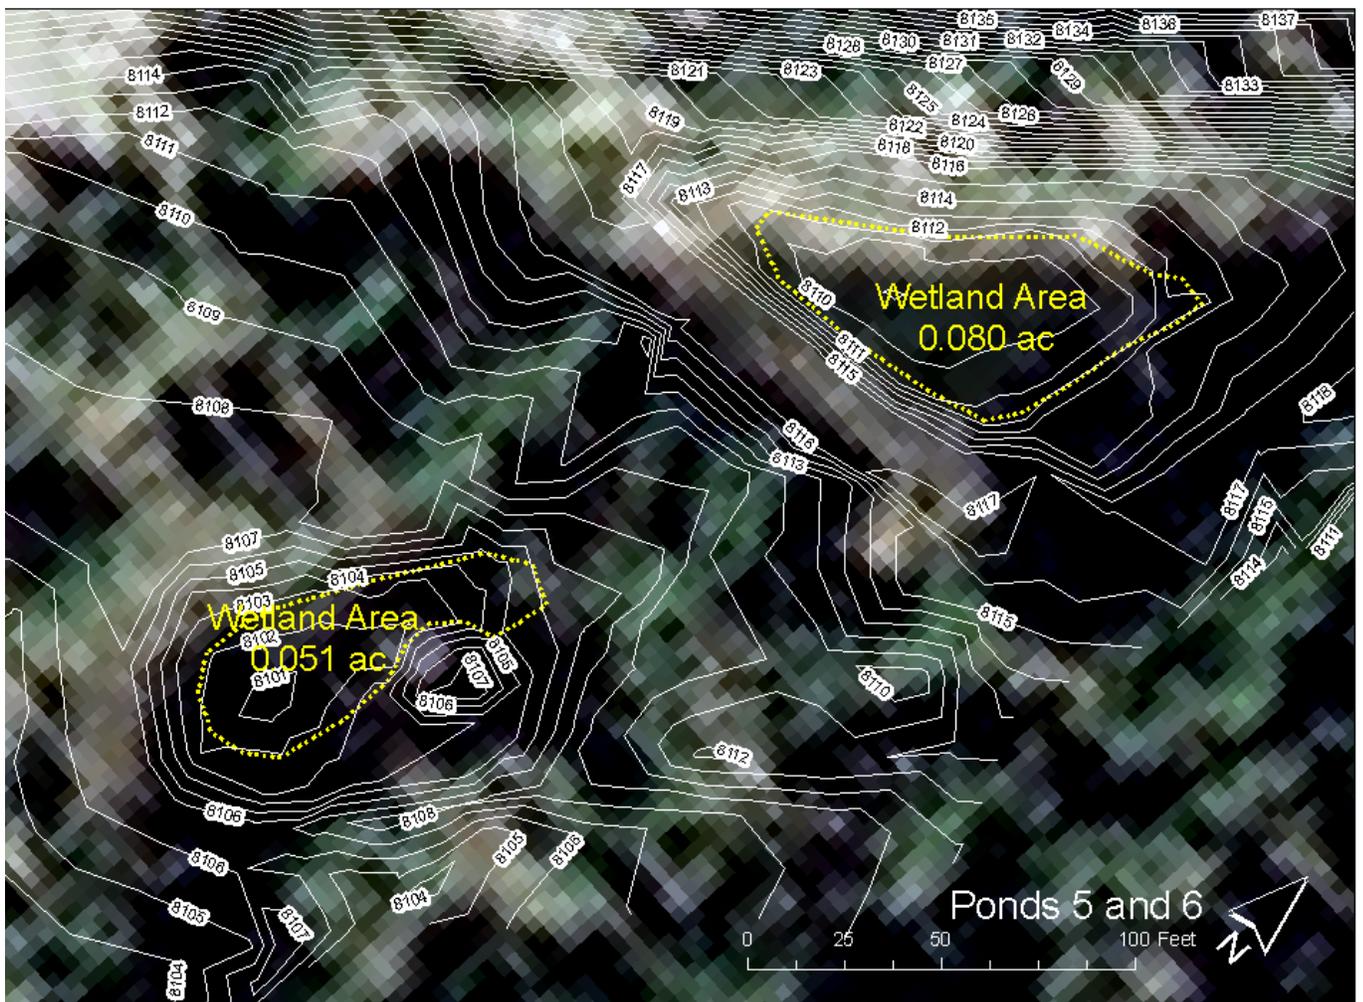
Pit 5: Pit 5 is a small pond area, with 0.051 acre of jurisdictional wetland. The area is poorly vegetated, but supports spike rush (*Eleocharis macrostachya*) and other obligate wetland plants.

Summer photo of Pit 5 showing the location of sample plot 7, and jurisdictional and topographic map of Ponds/Pits 5 & 6.

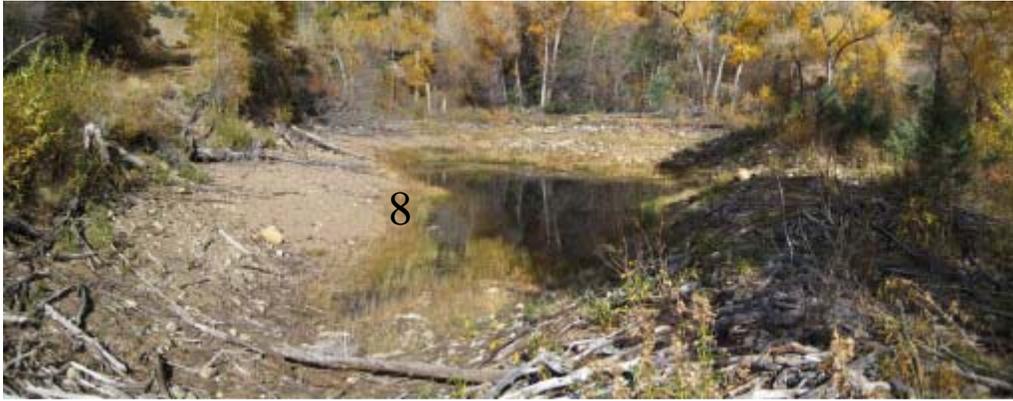
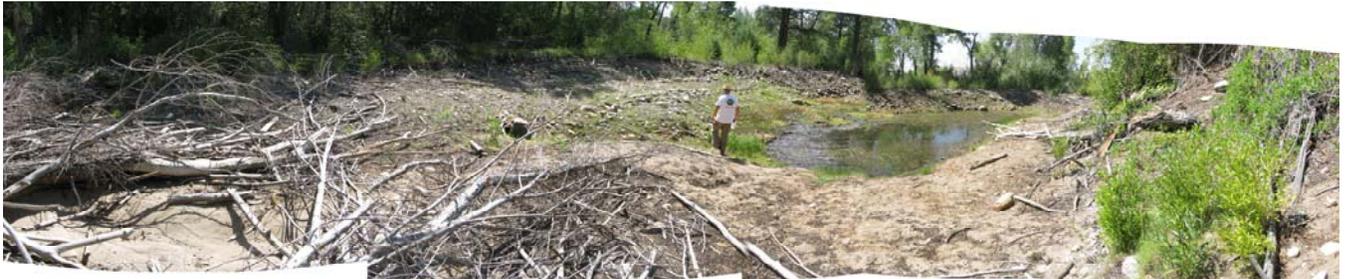
Pit 6: This pit supports 0.080 acre of jurisdictional wetlands at the bottom of the pit. The upper portions of the pit are dry most of the time and support bare gravel and no perennial plants.

Summer photos of Pit 6 showing small perennial pool with emergent vegetation, and dry gravel slopes within the pit boundary. Top photo shows the location for sample plot 8.

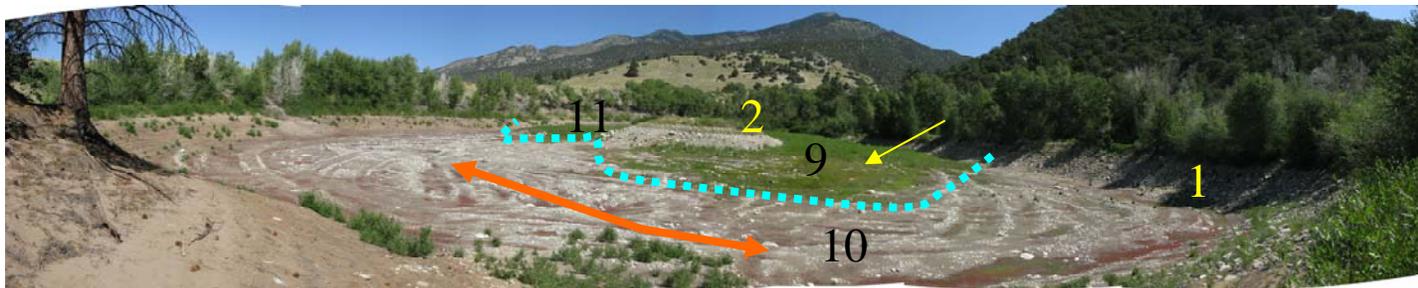
Pit 7: This is by far the largest basin in the study area and has the tallest dikes and levees. This pit was scraped from a terrace of Sand Creek and sediment piled up as dikes on the south and west. The south side material forms a levee against the Sand Creek channel (shown as the cottonwood lined surface at 1), and the western dike, shown in the bottom right corner of the photograph, is essentially a dam 20 feet tall. Water is diverted from Sand Creek (2 on both the photo and the map) flows into the basin from its eastern side and recharges the ground water table as it moves west around the island in the pond center. The area wetted by surface water is jurisdictional wetland, covering 0.91 acre. However, most of the basin is bare gravel dominated by an annual buckwheat (*Polygonum aviculare* UPL) which is an upland plant species and shows up as patches of reddish brown plants on the photo below.

Plant species that have established in the wetland portion of Pit 7 include narrow leaf cottonwood (*Populus angustifolia*), bulrush, and other OBL and FACW plant species. At the time of my data collection, the water table in the wetland (yellow arrow) was within 10 inches of the soil surface, while in the upland area (orange arrow) the water table was much deeper than 16 inches. It appears that the surface diversion from Sand Creek is not functional, and the only water reaching the pit at present is from ground water seepage from Sand Creek under the levee and into the basin.

Looking west across Pit 7. Yellow #1 is the levee, yellow #2 the river inflow channel (now defunct), and the blue line indicates that approximate wetland-upland boundary. Yellow arrow indicates the wetland area, orange arrow indicates the upland area. Reddish patches in upland are *Polygonum aviculare* (UPL). Black numbers 9 (wetland), 10 (upland), 11 (wetland) are the locations of those sample plots.

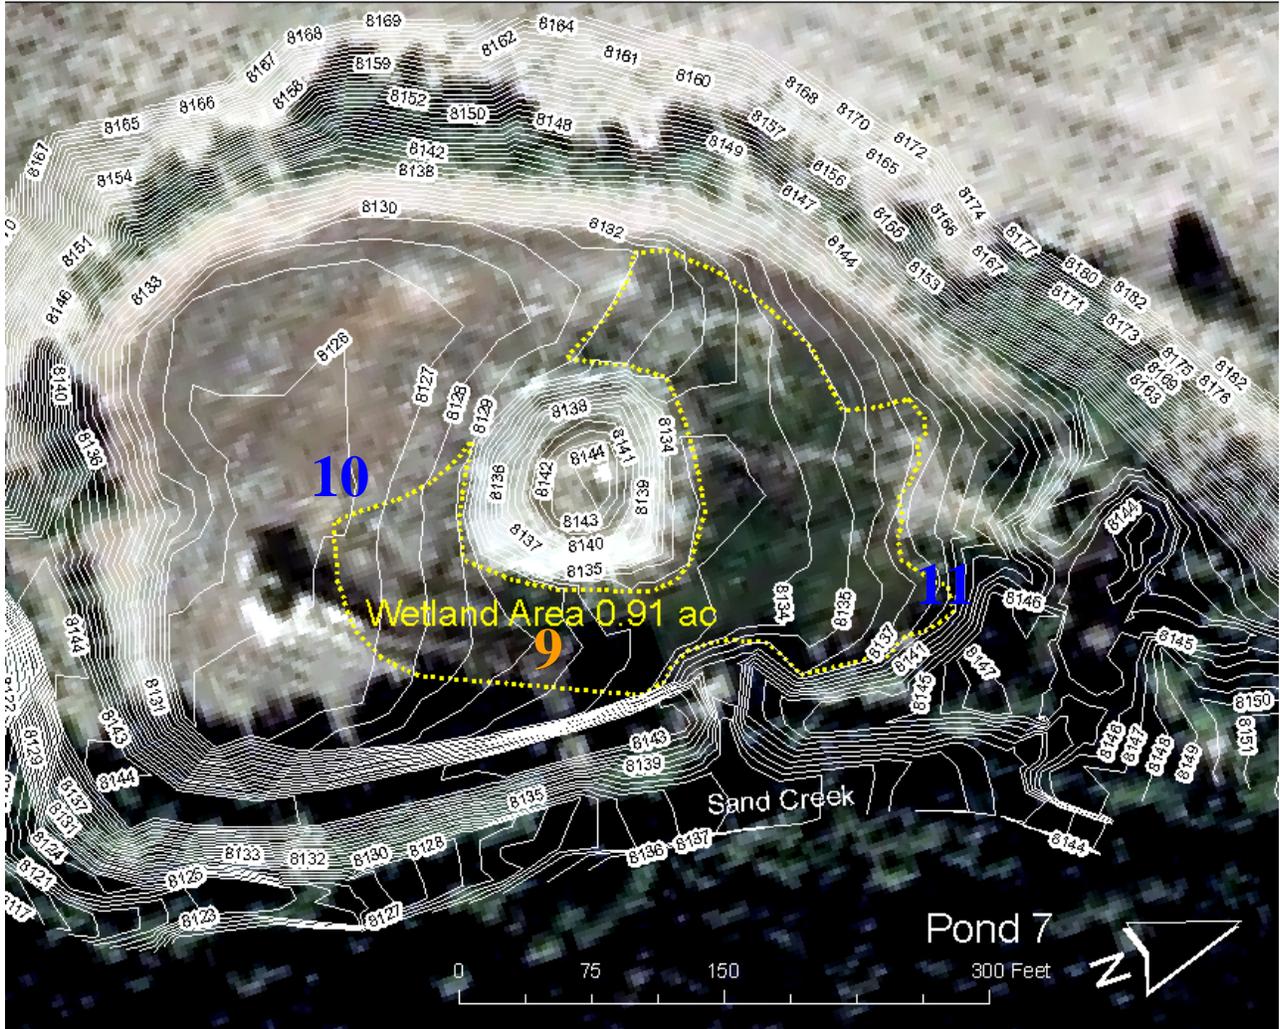
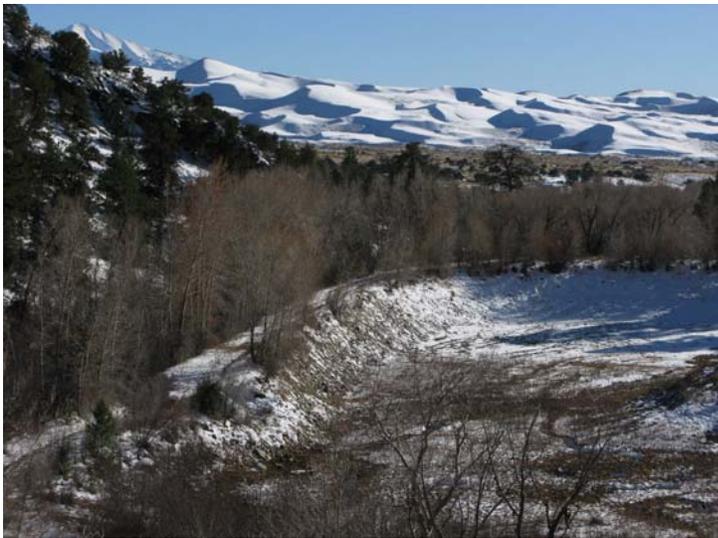
Topographic and jurisdictional wetland map of Pit 7 showing location of plots 9, 10, 11. Lower photo shows levee on south side of Pit 7 showing its artificial contours, height and shape.

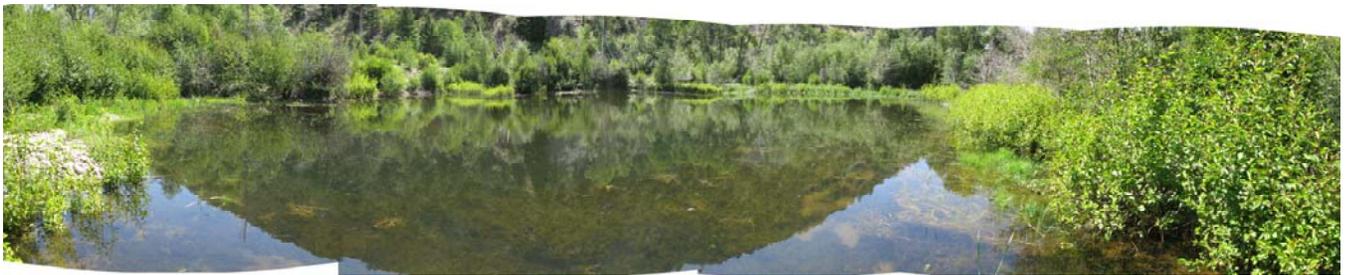
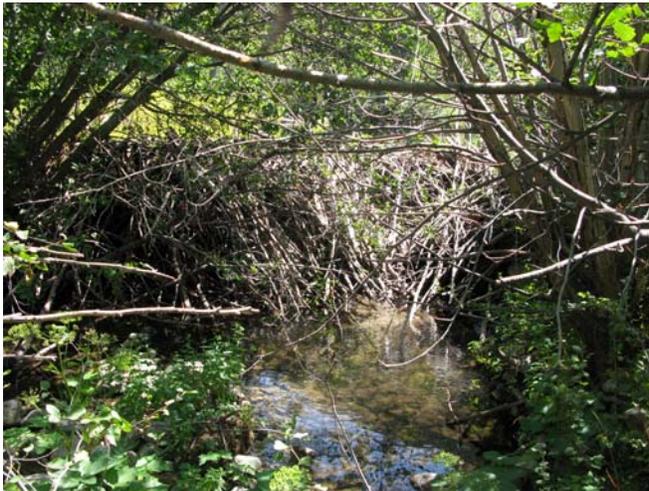
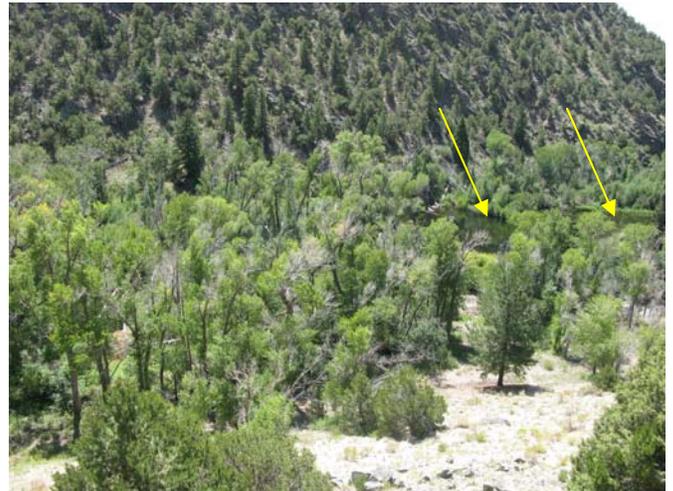
Pits 8, 9, 10. These three excavated basins are separated by dikes of pushed gravel material. The pits hold water to near their tops because they are occupied by beavers which have build dams and are actively managing and maintaining the high water levels (see top and bottom left photo below). Each pit was excavated into the Sand Creek floodplain, among mature narrow leaf cottonwood forests (bottom right photo – arrows point to pits). Pit 8 contains 0.33 acre of wetland, mostly open water, with few submerged aquatic plants, and a fringe of cattail (*Typha latifolia*), willows (*Salix exigua*), and alder (*Alnus incana*). Plots were not analyzed in pits 8, 9, and 10 because all wetland sites were inundated, and all uplands were above the apparently static water level, with very sharp boundary between inundated and upland sites. Delineation was based upon the long-term position of the water level.

Pits 9 and 10 contain 0.61 and 0.56 acre each respectively of jurisdictional water, most of which is shallow open water less than 6 feet in depth. These ponds also support a well developed fringe of emergent wetland vegetation, but have little submerged aquatic vegetation. Photo on bottom right shows ponds 9 and 10 located within mature cottonwood forest. Beavers and their dams help maintain the water levels in these ponds.

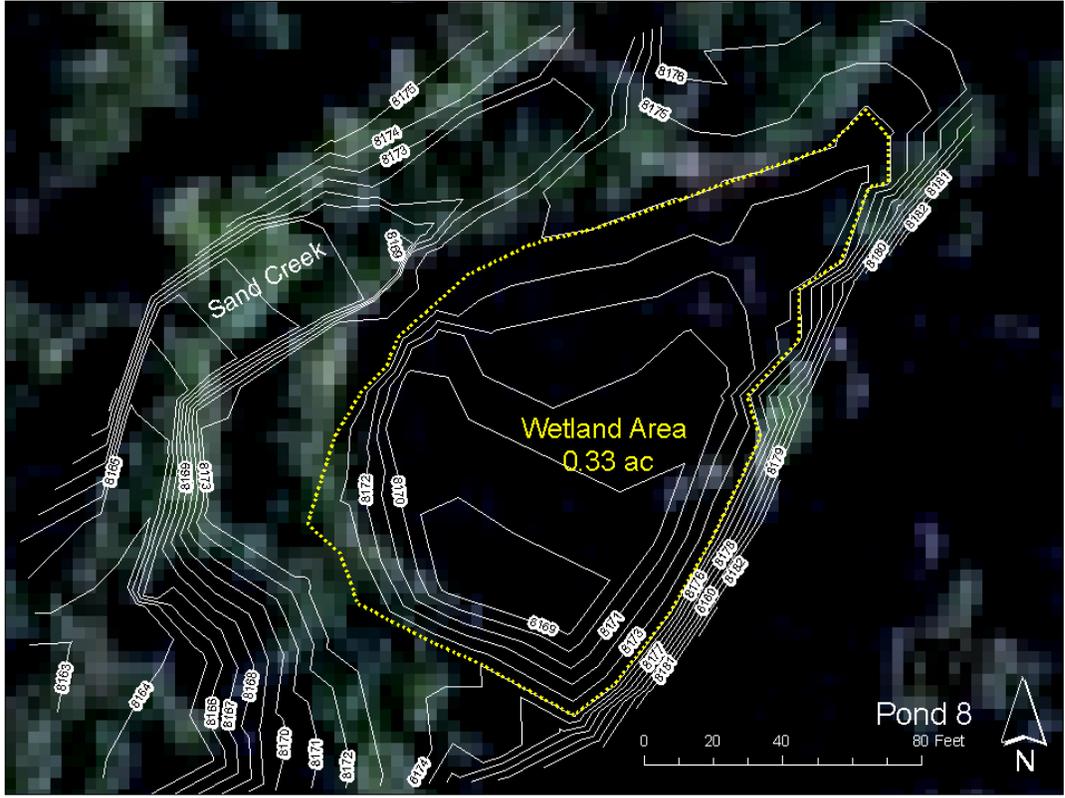
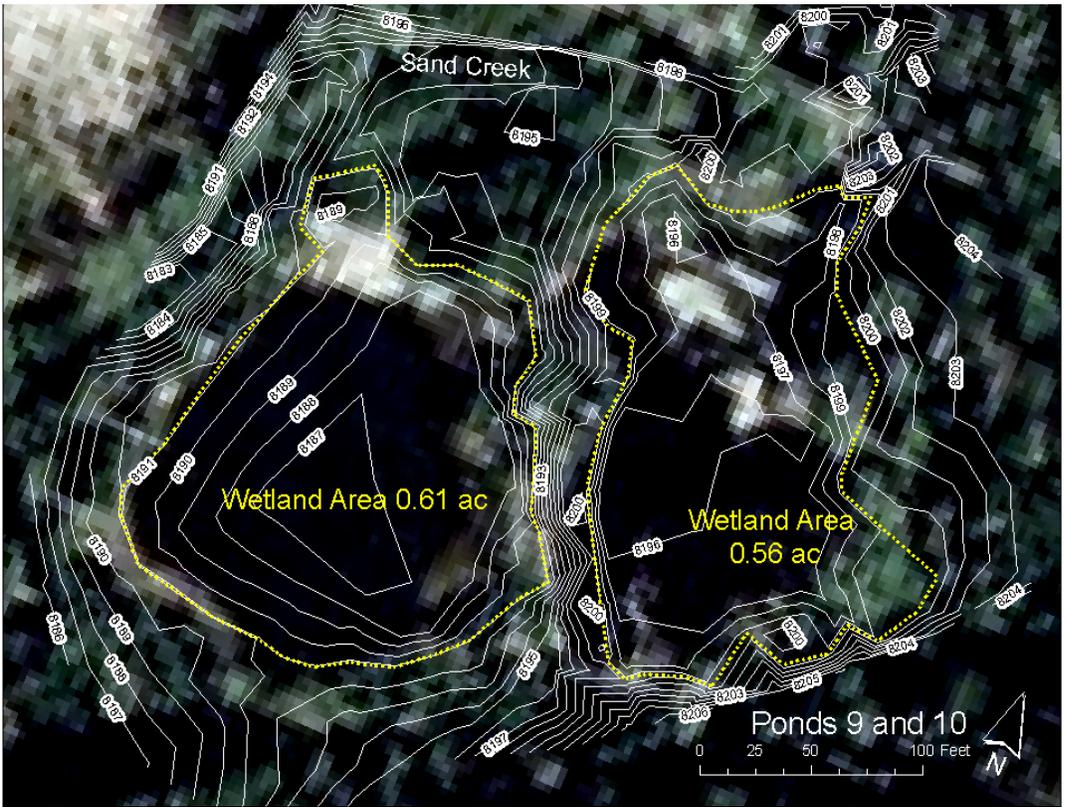
Topographic and jurisdictional wetland maps of ponds 8, 9 and 10.

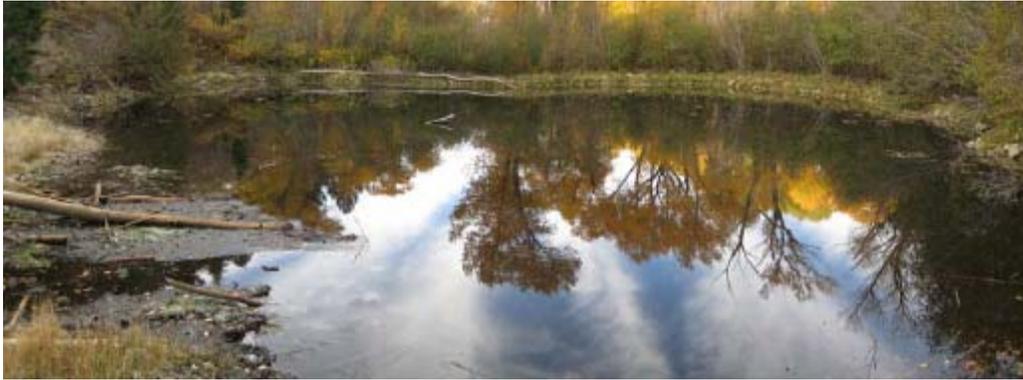
Pit 8, above, has little wetland vegetation.

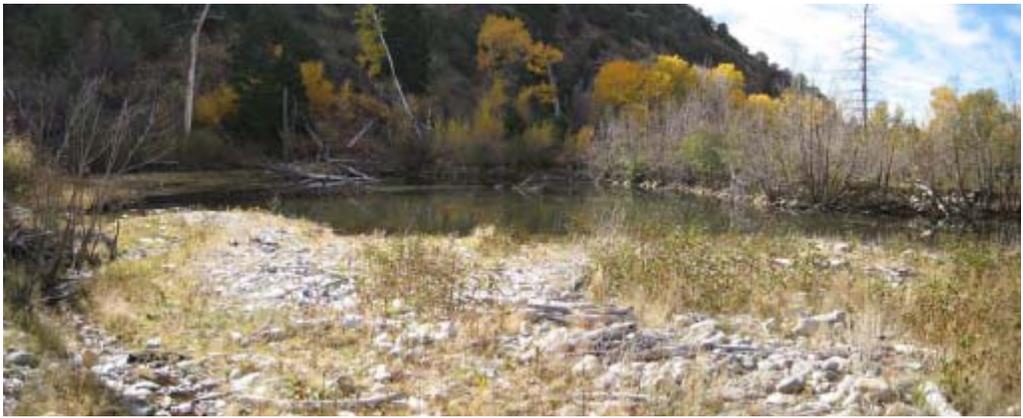
Pit 10, above, with dike in foreground, and limited wetland vegetation.

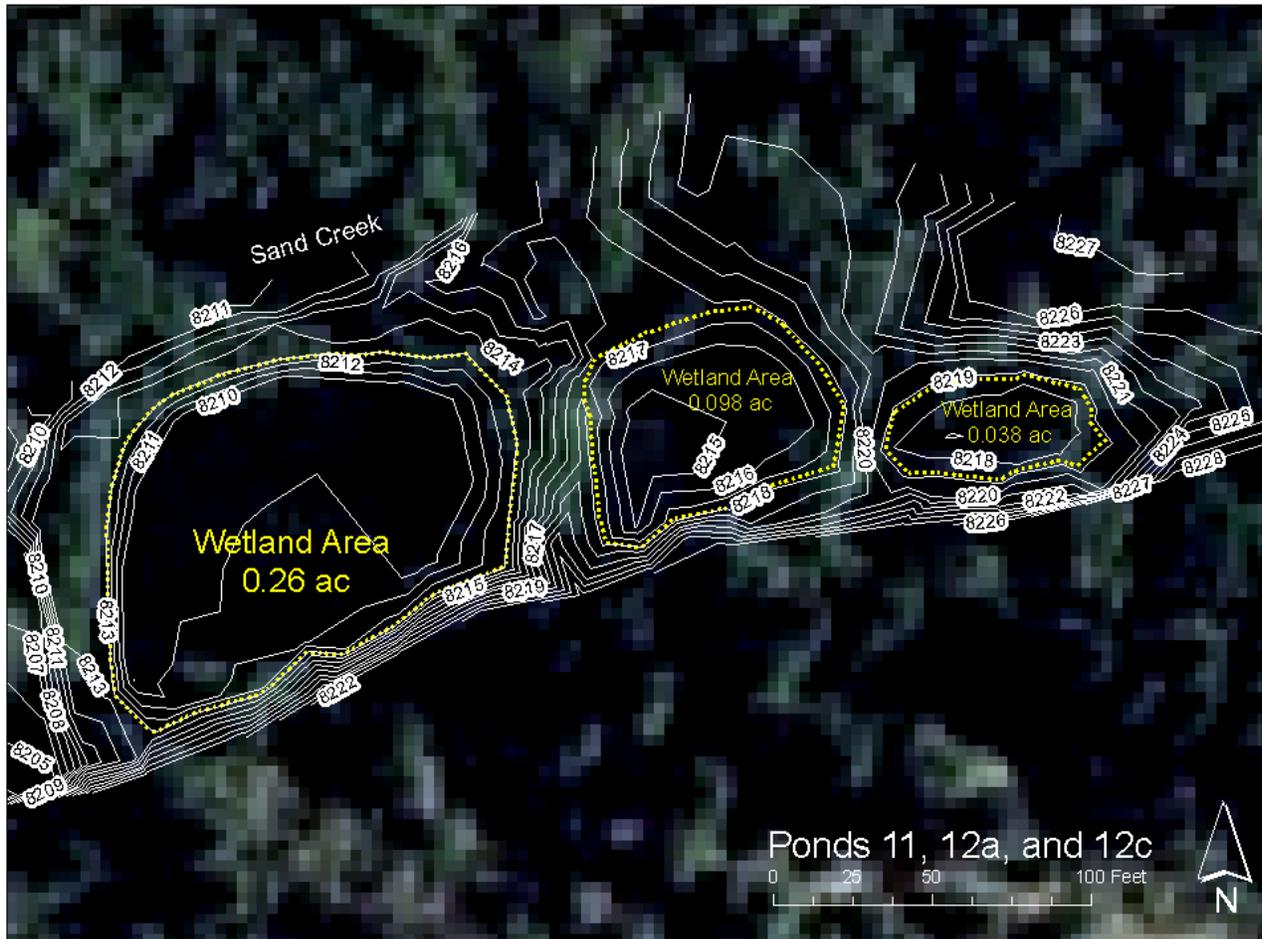
Pits 11 and 12: These pits are small, and occur on the south side of Sand Creek in a hard to reach portion of the study area. Pit 11 contains 0.26 acre of open water with fringing emergent vegetation, and pit 12 (broken into two sections by a low dike) supports 0.098 and 0.038 acre of open water and fringing vegetation for a total pit 12 wetland area of 0.136 acre. These pits are very hard to reach, and may not be restored due to the impact restoration would have on vegetation and soils in the area. No plots were analyzed at these sites because wetlands were located within the inundated pond boundary, and the line between wetland and upland was sharp and could be identified as the water surface.

Topographic and jurisdictional wetland map of pits 11, 12a and 12c.

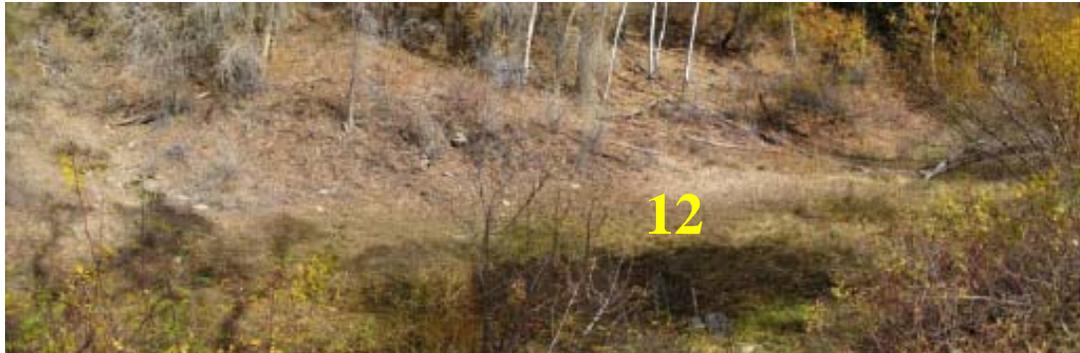
Pit 13. Pit 13 is a shallow depression and has a dysfunctional channel on its eastern side that once connected it with Sand Creek. The pit bottom is populated by *Carex lanuginosa*, and OBL wetland plant, and the soils were hydric with prominent gleying, low chroma color (10YR 3/1, and abundant and well developed oxidized root channels in the top 8 inches, and a water table at 6 inch depth. A total of 0.099 acre of jurisdictional wetland occurs in this pit.

Summer photo of pit 13 showing well developed wetland vegetation in pond bottom, and location of sample plot 12.

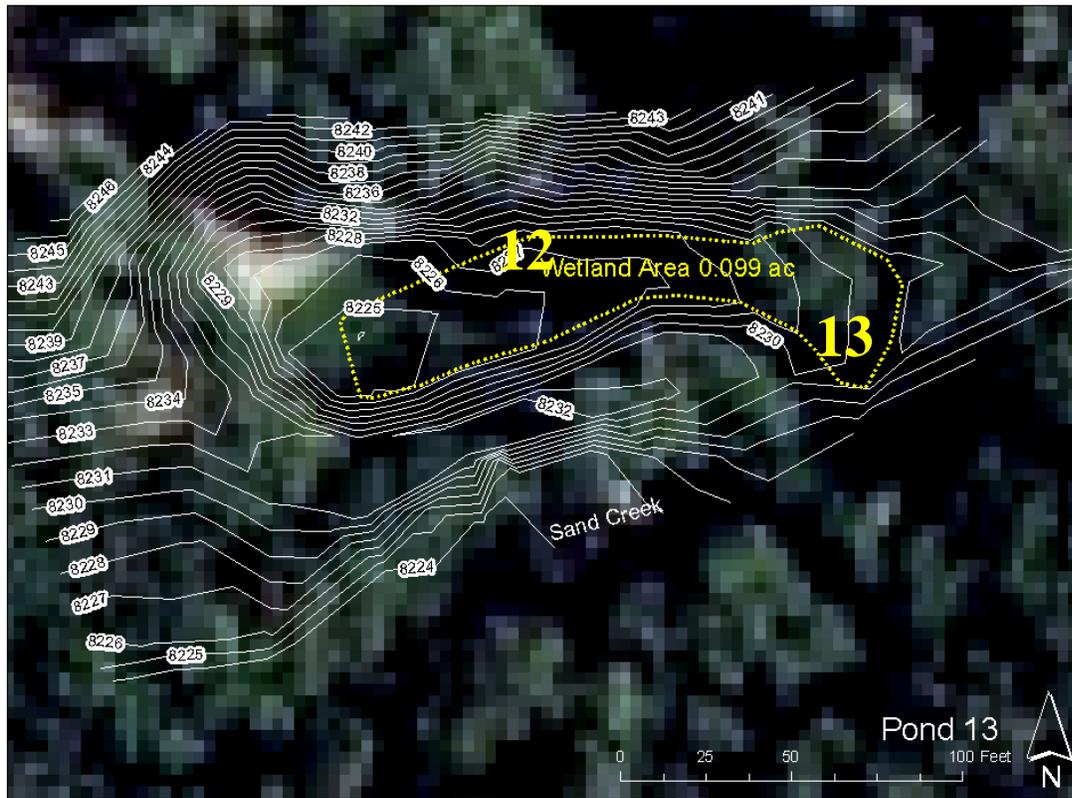
Topographic and jurisdictional wetland map of Pit 13 showing location of sample plots 12 and 13.
