***Final Report***  
**Channel Restoration Planning for Lulu Creek and Colorado River  
in Rocky Mountain National Park**

Sara L. Rathburn, Dept. of Geosciences, Colorado State University  
February 24, 2011

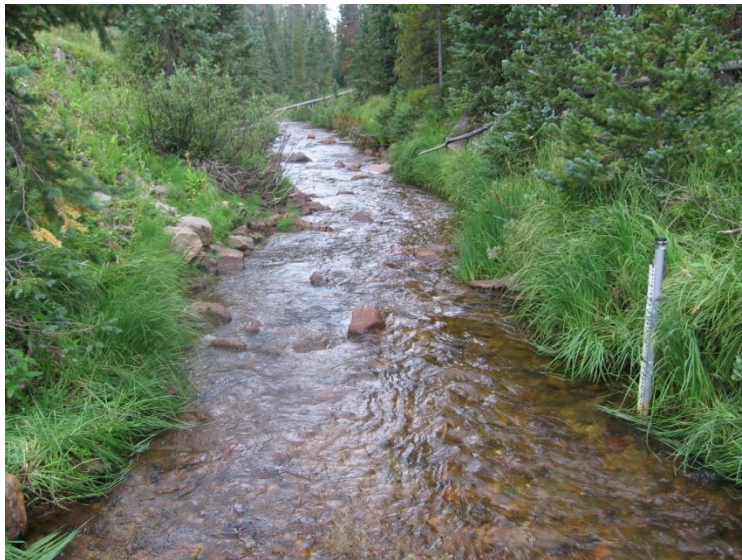
Figure 2. Lower Sentinel site (LS, Figure 1) on the Colorado River downstream from the Lulu City wetland. The gauging station was installed in collaboration with the I&M program. View is downstream.

Two sentinel sites were established in collaboration with the Rocky Mountain Network I&M Program during the summer 2010 field season. Water quality data were collected over one month at each site, and pressure transducer measurements were collected over the same time period. A survey of the Lower Sentinel cross section was completed, as was a longitudinal profile of the Colorado River up and downstream of the cross section. All data will be shared with the various groups working collaboratively at the Lower Sentinel and Little Yellowstone sites.

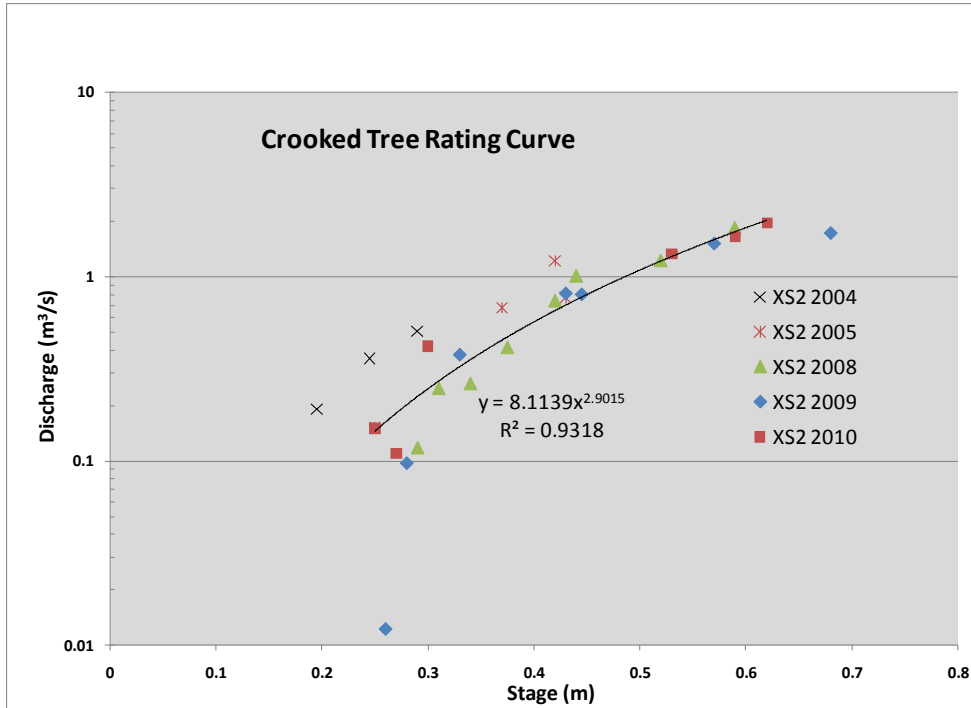
Figure 3. Rating curve for Crooked Tree on the Colorado River showing the regression equation fit to the 2010 data.

Rating curves were developed for all four sampling cross sections, two of which are shown in Figure 3 and 4. A shift in the rating curve at Crooked Tree is evident between the years of 2004 and 2005, and again in 2008, with smaller shifts in 2009 and 2010. A shift in the rating curve, as seen in stage-discharge data from Crooked Tree, suggests a change in channel capacity, and may be caused by aggradation of the channel bed. Aggradation has been observed and measured in the field at Crooked Tree beginning in 2008, with maximum aggradation of 23 cm occurring at the gauge on 9/24/10 (Figure 5). This loss of channel capacity is typical of disturbed systems that receive a steady supply of sediment, and underscores the importance of tracking sediment transport and its influence on channel capacity to convey flow.

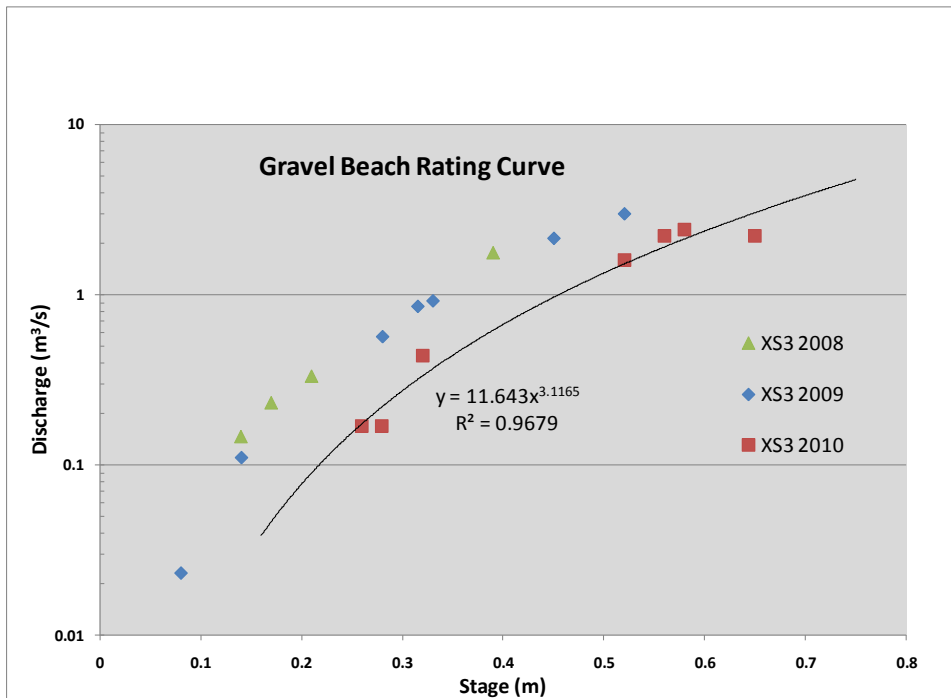
Figure 4. Rating curve for Gravel Beach representing three years of reliable flow data and the regression data equation fit to the 2010 data. There is a shift in the rating curve possibly due to downstream control from deposition and backwater conditions.

The rating curve for Gravel Beach (Figure 4) includes the third year of reliable data, and also shows a pronounced shift in the rating curve from 2008-2009 to 2010. Another cause of loss of channel capacity, and hence a shift in the rating curve, may be due to a downstream control such as aggradation causing backwater effects. At the Gravel Beach cross section, extensive erosion of up to 20 cm scoured out a deep pool during peak flow because of a width-spanning log that became lodged against the gauge (Figure 6). Immediately downstream from the scour hole a large bar was deposited, causing a backwater condition at the gauge.

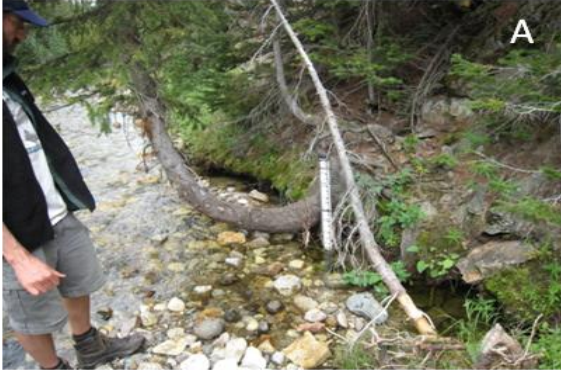
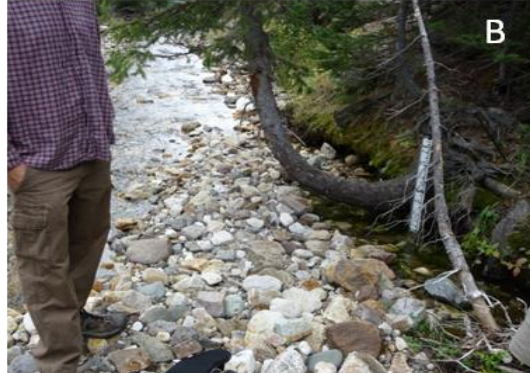
Figure 5. Repeat photographs from Crooked Tree Cross Section on 8/31/08 (A), and 9/18/09 (B) and 8/28/10 (C) showing growth of coarse bar beneath tree near right bank. View is downstream. Aggradation around the gauge in 2010 reached a maximum of 23 cm on 9/24/10, with boulders wedged against the staff plate.

In a comparison of changes in the  $D_{50}$  of bed material grain size at the Crooked Tree and Gravel Beach sample transects (Figure 11) it is evident that bed coarsening occurred at Gravel Beach (to coarse gravel), with little change at Crooked Tree in 2010 (still very coarse gravel). Bed material at Gravel Beach is now comprised of similar sizes to what was originally measured in 2005. Observations, measurements, and repeat photographs support both the increased bedload transport and coarsening of the bed material (Figures 6 and 9).

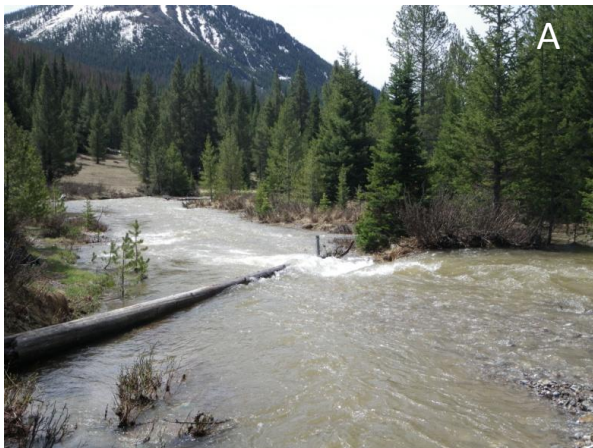
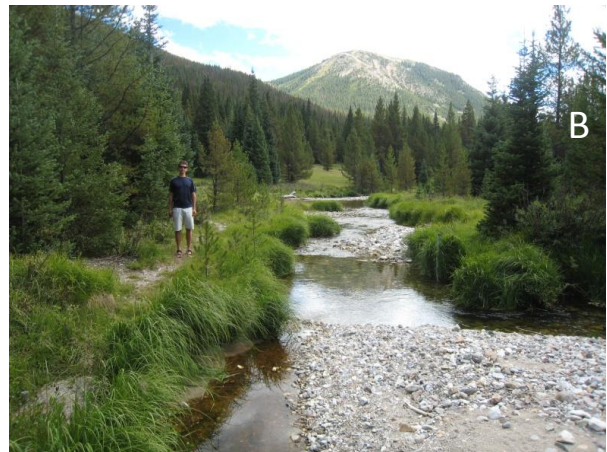
Figure 6. Repeat photographs from Gravel Beach Cross Section on 6/7/10 (A), and 8/29/10 (B) showing formation of a scour hole during high flow due to a log abutting the staff plate. Erosion beneath the gauge reached a maximum of 20 cm on 9/24/10. View is downstream.

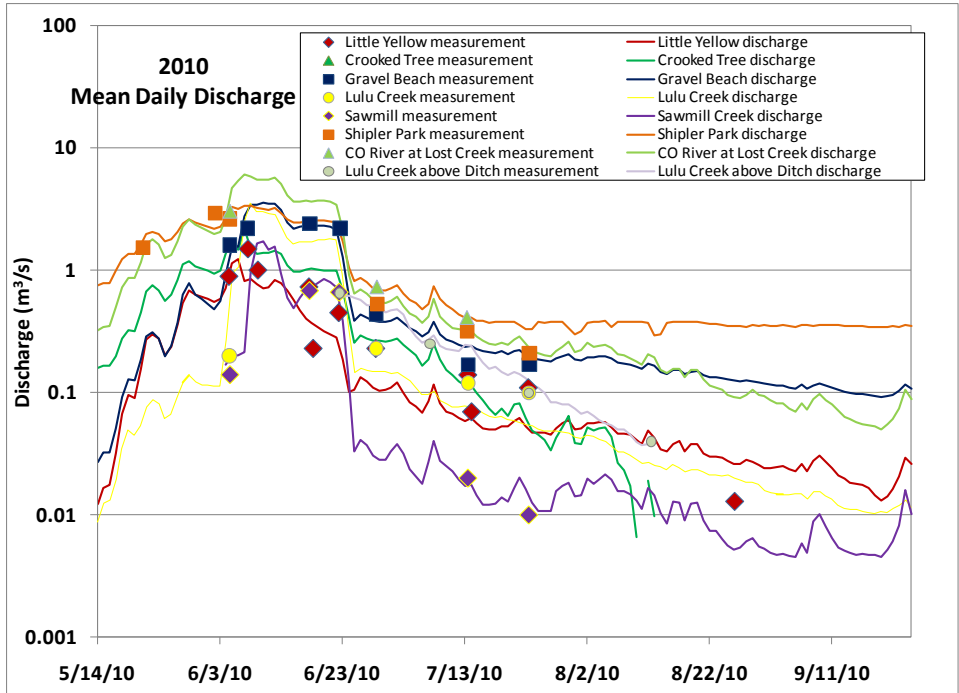
Figure 7. Hydrograph showing mean daily flow at sample cross sections. Peak flow of 6.0 m<sup>3</sup>/s occurred at Lost Creek on 6/8/10. Locations of gauges shown in Figure 1.

Mean daily discharge at all sites is shown in Figure 7. The point measurements of cross sectional averages of flow measured in the field (symbols in Figure 7) correspond well with continuous measurements attained by the Leveloggers. The snowmelt hydrograph peaked on 6/8/10, and discharge remained high for approximately one week, before dropping abruptly on 6/24/10 due to regulation of the Ditch. Our field measurements on 6/7/10 are a minimum estimate of peak discharge because only a portion of the channel was wadeable at the highest velocities. From the pressure transducers at our sample cross sections, peak flow was measured at 3.55 m<sup>3</sup>/s (125 ft<sup>3</sup>/s) at Gravel Beach. Due to erosion beneath the gauge at Gravel Beach during peak flow (Figure 6), all subsequent pressure transducer recordings were minimum estimates of stage because of the unmeasured depth of water below the pressure transducer. The pressure transducer at Gravel Beach will be readjusted during field season 2011 to ensure accurate stage measurements are collected.

An extremely rapid rise in the hydrograph on Lulu Creek on 6/8/10 (Figure 7) caused extensive erosion including undercutting of the banks, and mobilization of large quantities of unconsolidated sediment from the Lulu Creek fan. The rapid rise of the hydrograph also destabilized banks through undercutting on Sawmill Creek, a reference reach that was unaffected by the 2003 event.

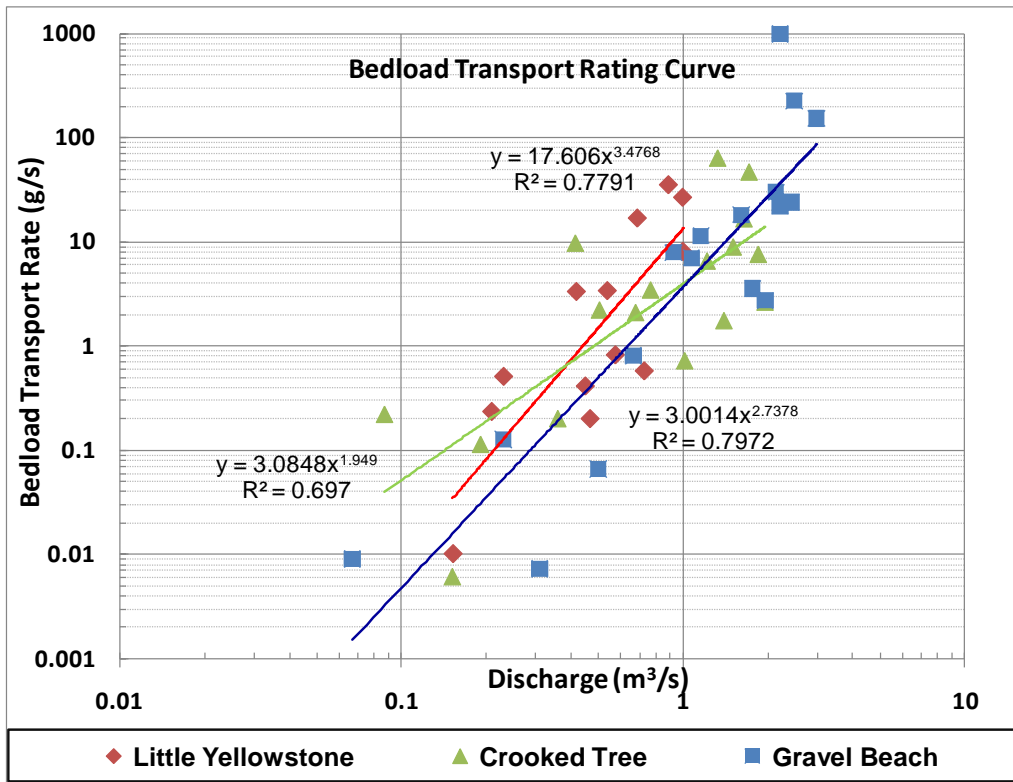
Figure 9. Bedload transport versus water discharge for three sampling cross sections during 2004, 2005, 2008, 2009, and 2010. Bedload transport is not measured along Lulu Creek because of turbulent flow.

Bedload transport of sand and larger-sized material is equally well correlated with discharge ( $R^2$  of 0.69-0.79) as is suspended load, especially at the Gravel Beach cross section (Figure 9). In summer 2010, bedload transport was the dominant mechanism of sediment movement measured at the sample cross sections. On 6/7/10, bedload concentrations were an order of magnitude higher than during any previous field season, with a maximum load of 1000 g/s (compared to the next largest load of 140 g/s passing through Gravel Beach during 2008). As the most downstream sample cross section, bedload transport at Gravel Beach indicates substantial amounts of sand and coarser grain sizes are being transported downstream toward the Lulu City wetland. The  $D_{50}$ , or median grain size of bedload in transport on 6/7/10 was 1.2 mm in size (very coarse sand). Because of the vast supply of sediment upstream along Lulu Creek and stored in the Lulu Creek fan, the sediment transport potential is extremely high throughout the study site, and does not follow expected rules of supply-limited transport common along mountain rivers (Wohl, 2000). The low threshold for sediment mobility translates into high bedload transport rates given sufficient discharge.

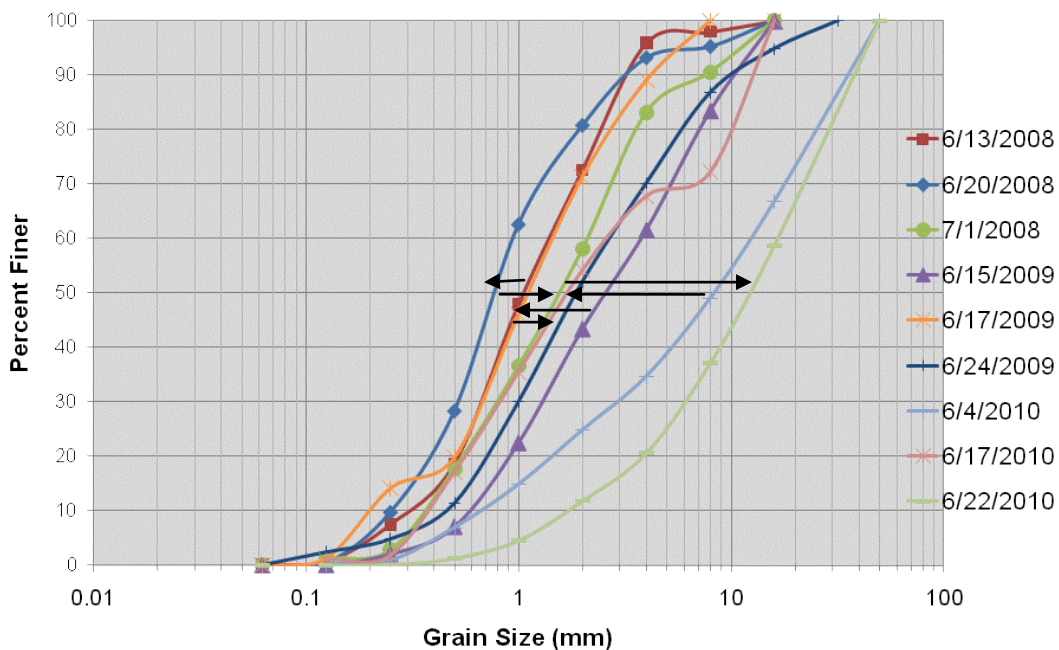
### Crooked Tree Bedload Grain Size Distribution

Figure 10. Cumulative frequency plot of bedload sediment in transport at the Crooked Tree cross section over the 2008 and 2009 field seasons. Black arrows show a pattern of fining of the bedload at the onset of snow melt, with a coarsening during or after peak flow.

Results of the sieve analysis of bedload transported through the Crooked Tree cross section (Figure 10) indicate that sediment moving along the bed during summer 2010 ranged in median grain size ( $D_{50}$ ) from very coarse sand to medium gravel (1.5-11 mm). Using the three years of data available at Crooked Tree (2008, 2009, 2010), a pattern of the grain size changes over snowmelt is observed. The grain sizes in transport as bedload fines during the first onset of snowmelt, when stored sediment is mobilized from the bed, compared to later in the hydrograph, when the  $D_{50}$  coarsens.

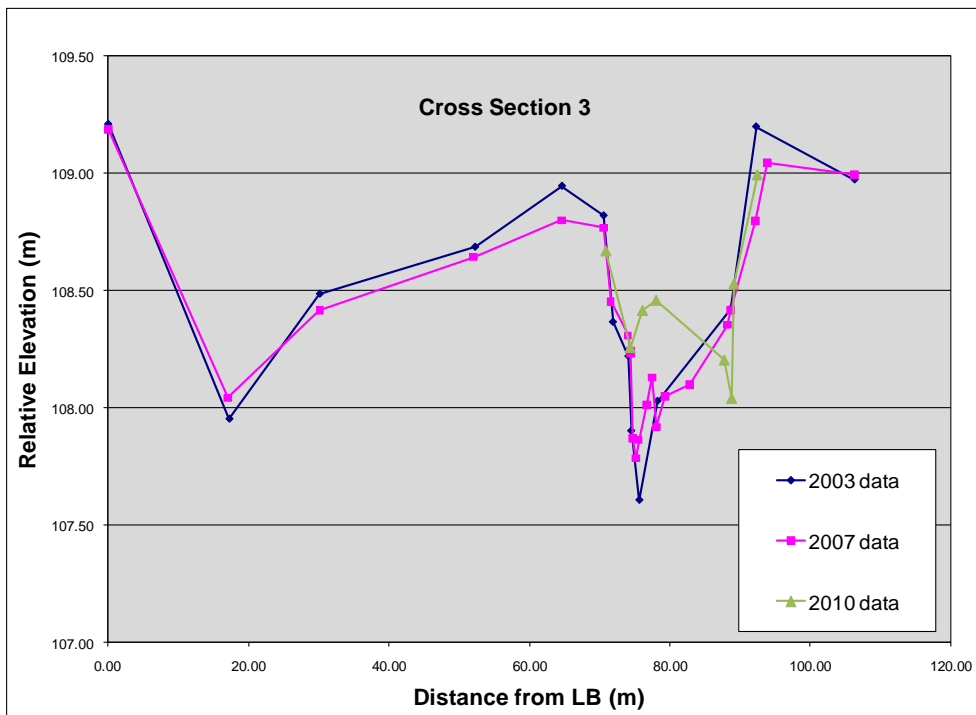
Figure 12. Relative elevation versus distance from left bank, Cross Section 3 (immediately upstream from Gravel Beach). Aggradation of 35 cm occurred in the thalweg between 2007 and 2010 due to downstream transport of sediment of a mid-channel bar. Bar is shown in Figure 6A, right bottom.

Six cross sections from the original 2003 survey were resurveyed in late August-early September 2010. The resurveys corroborate other sources of data documenting the extensive changes in channel morphology that occurred in 2010. At Cross Section 3 for example, immediately upstream from Gravel Beach, downstream migration of the mid-channel bar towards the Gravel Beach gauge is evident (Figure 12), and underscores the highly dynamic nature of the system with the potential for abundant coarse sediment transport during overbank flows. Aggradation of 35 cm occurred between 2007 and 2010 at Cross Section 3.
