# **Restoration Concepts and Approaches for Lulu Creek, Colorado River, and the Lulu City Wetland Impacted by the May 2003 Breach of Grand Ditch, Rocky Mountain National Park, Colorado (DRAFT 9/8/14)**

By Sara Rathburn<sup>1</sup> and David J. Cooper<sup>2</sup>  
With technical assistance from David Dust<sup>1</sup> and Jeremy Sueltenfuss<sup>3</sup>

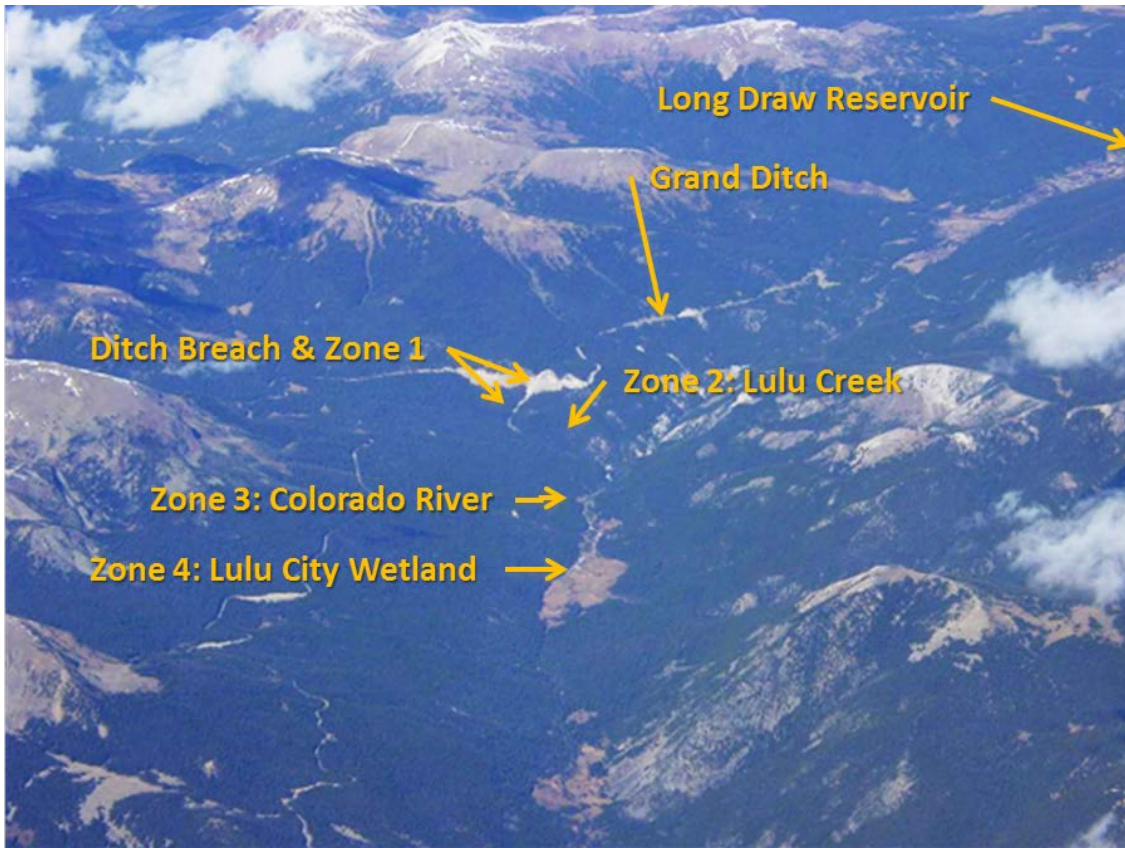
Figure 2. Oblique aerial view looking north up the Colorado River Valley. The Grand Ditch is the tan horizontal line to the middle right of the image and extends to where the Ditch meets Cache la Poudre Pass. The 2003 Ditch breach is located at the arrow that bisects the Ditch, with Zone 1 on the hillslope below. Additional arrows identify Zones 2 (Lulu Creek), 3 (Colorado River), and 4 (Lulu City wetland). Long Draw Reservoir is just off the image at upper right.

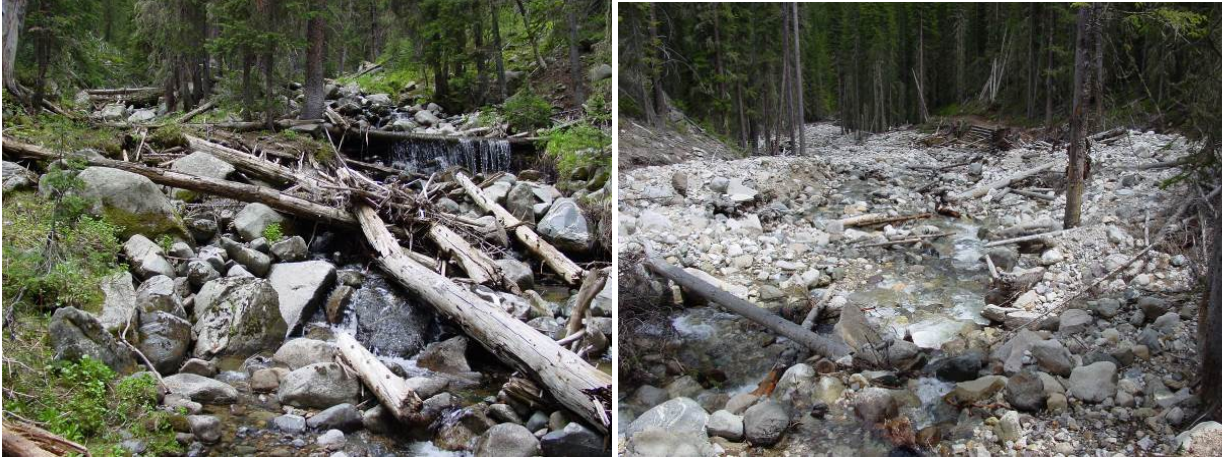
Figure 4. Lulu Creek upstream from the confluence with the Grand Ditch debris flow scar (left) photographed in 2007, and Lulu Creek downstream from the debris flow confluence the same year (right; view downstream). The types and extent of in-stream wood introduced into the reference reach and because of the 2003 debris flow are shown.

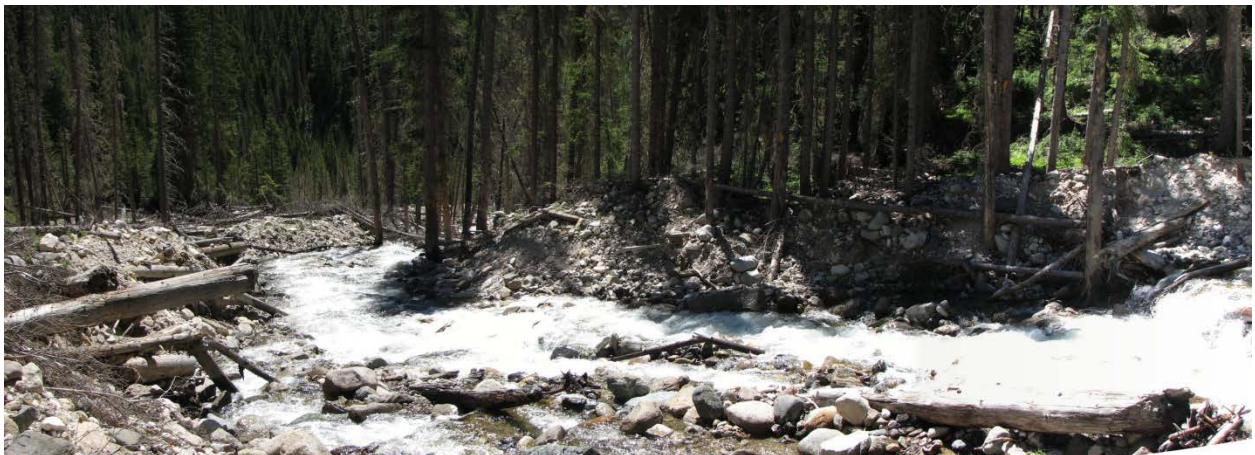
Figure 5. Downstream view of Lulu Creek showing current channel conditions with unstable banks and levees, and in channel and overbank wood.

absence of pre-2003 debris flow data. Ongoing field measurements of bed geometry on Lulu Creek indicate that dynamic bed adjustments are occurring, especially after the high flows of 2011 and 2014, such that a cascade bed configuration is now more dominant within Zone 2. Where large in-channel clasts and wood are setting step location, the step-pool geometry is consistent with reference conditions. As such, minimal bed reconfiguration is recommended for Zone 2 to allow for natural processes to occur. Restoration efforts should instead be directed at the abundant, unstable fine sediment in banks and debris flow levees of Lulu Creek and the fan that get transported episodically downstream to the Colorado River and Lulu City wetland, and the extensive in-channel and overbank wood introduced during and since the 2003 event. Simultaneous wood and sediment mitigation is necessary in Zone 2, given the abundance of wood deposited in the debris flow sediment along the length of Lulu Creek (Figure 4). At present, safety is a major concern during restoration of Zone 2 with the high, unstable banks and debris flow levees, tangle of wood protruding from banks and strewn on top of the fan surface and numerous large standing dead trees (Figure 5).

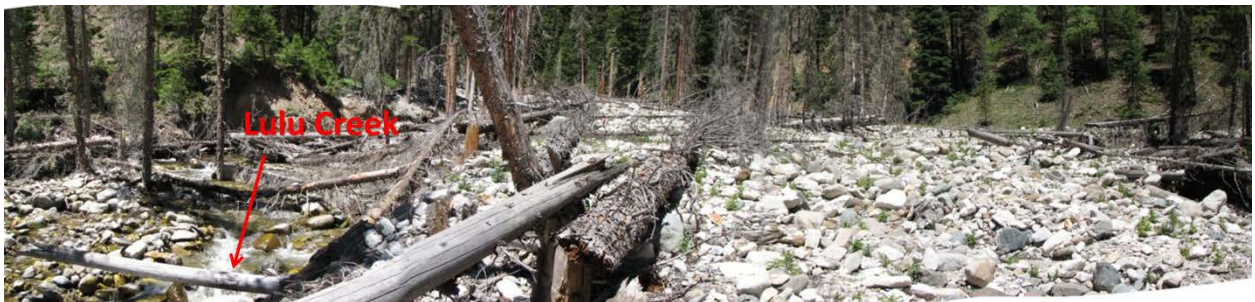
Figure 6. Upstream view of Lulu Creek showing the existing condition of the left overbank area.

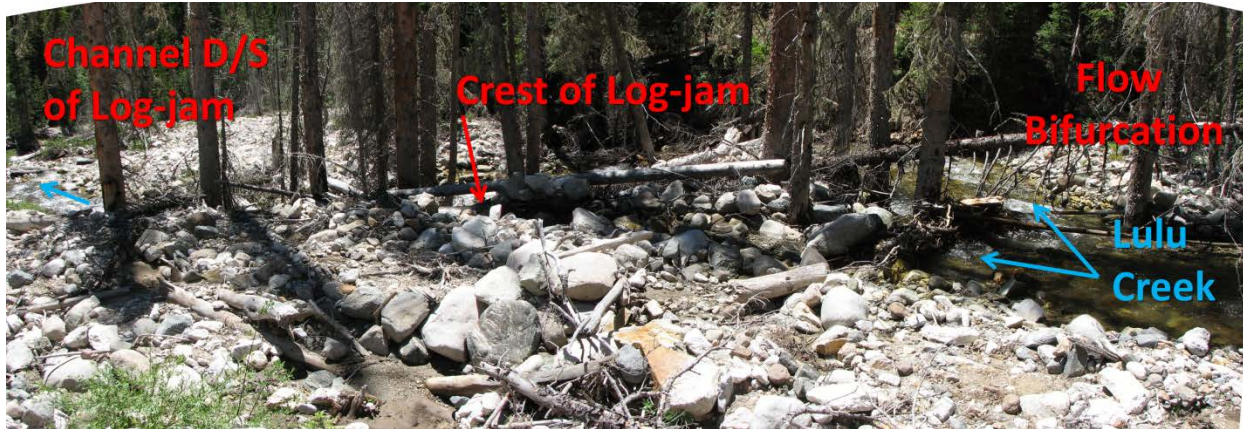
Figure 7. View downstream on Lulu Creek showing log jam, flow bifurcation, and sediment deposition at approximately Station 55.

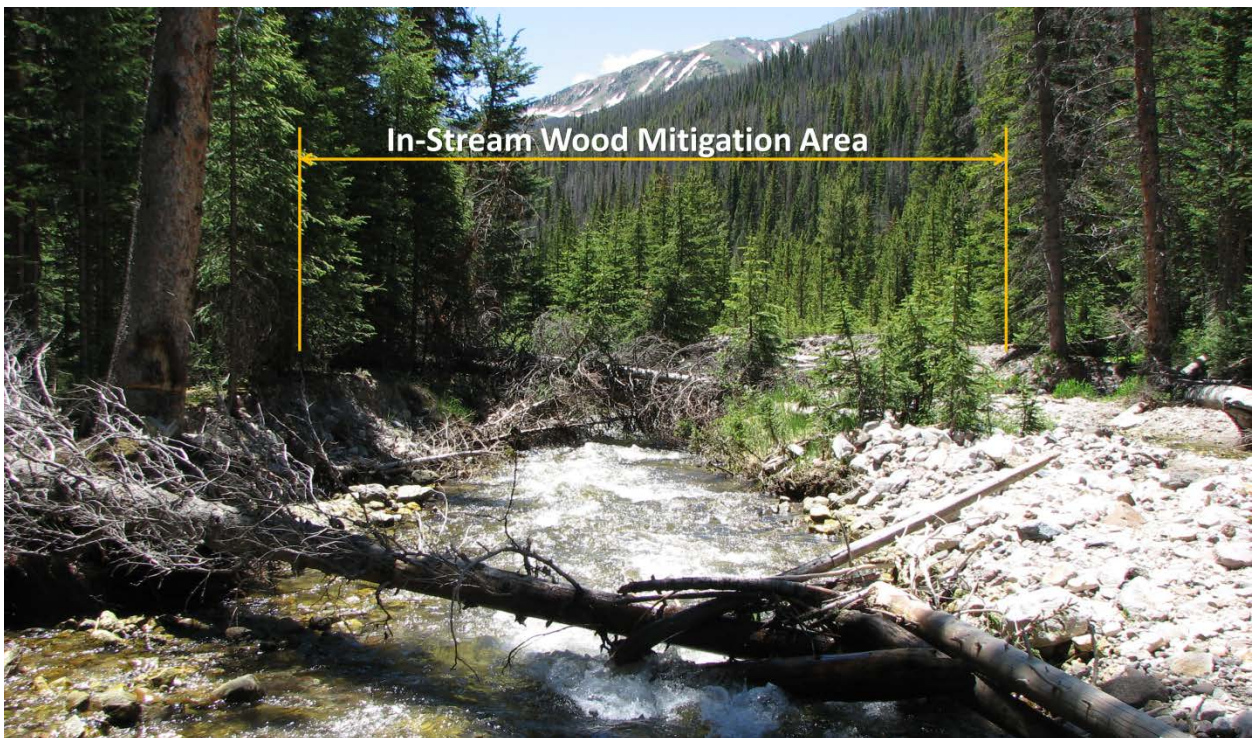
Figure 9. View downstream of in-stream wood mitigation area along the Colorado River, Zone 3. Corresponds to purple polygon in Figure 19.

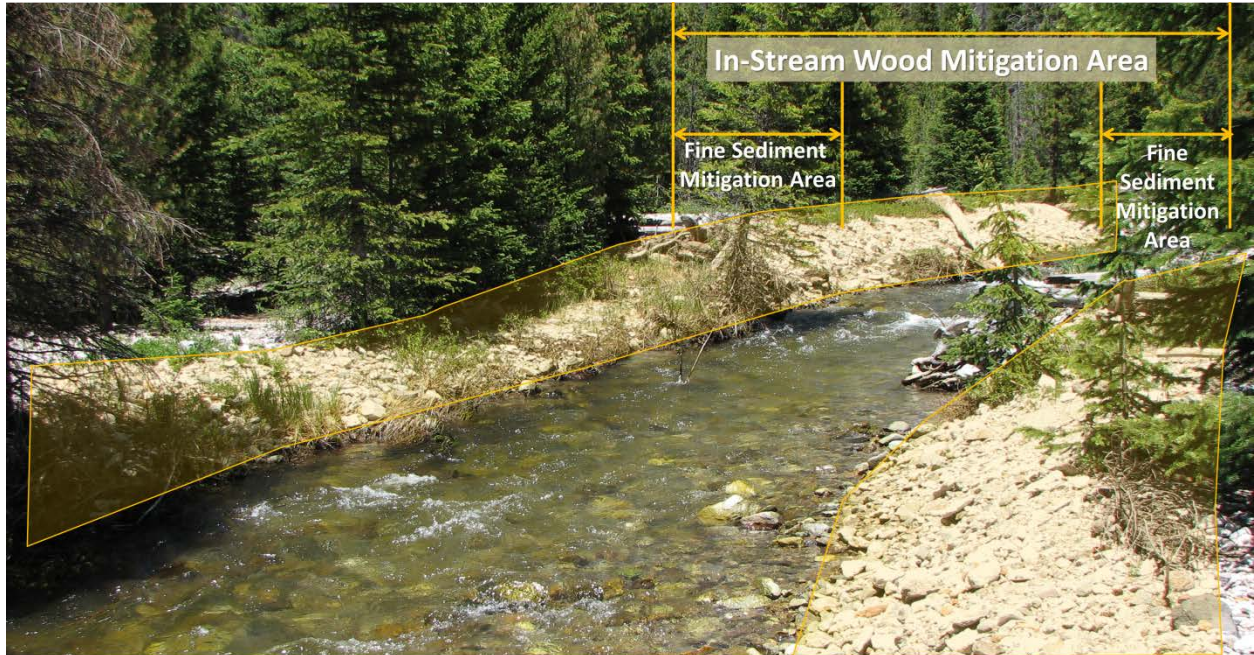
Figure 10. View upstream of fine sediment mitigation along the Colorado River Zone 3. Corresponds to green polygon in Figure 19.

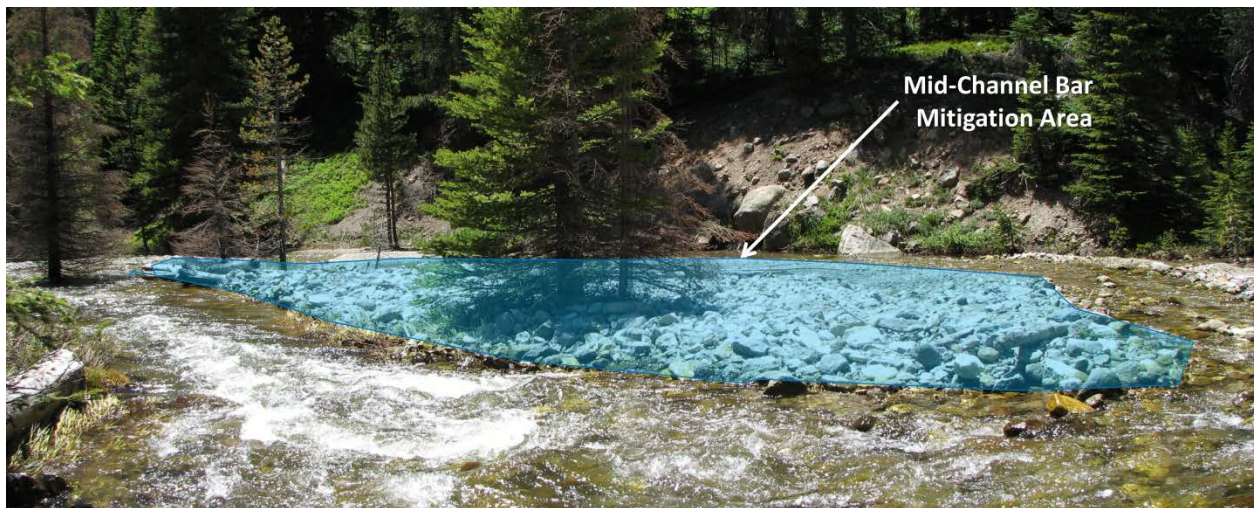
Figure 11. View across and downstream of the Colorado River, Zone 3 showing mid-channel bar sediment mitigation. Corresponds to yellow polygon in Figure 19.

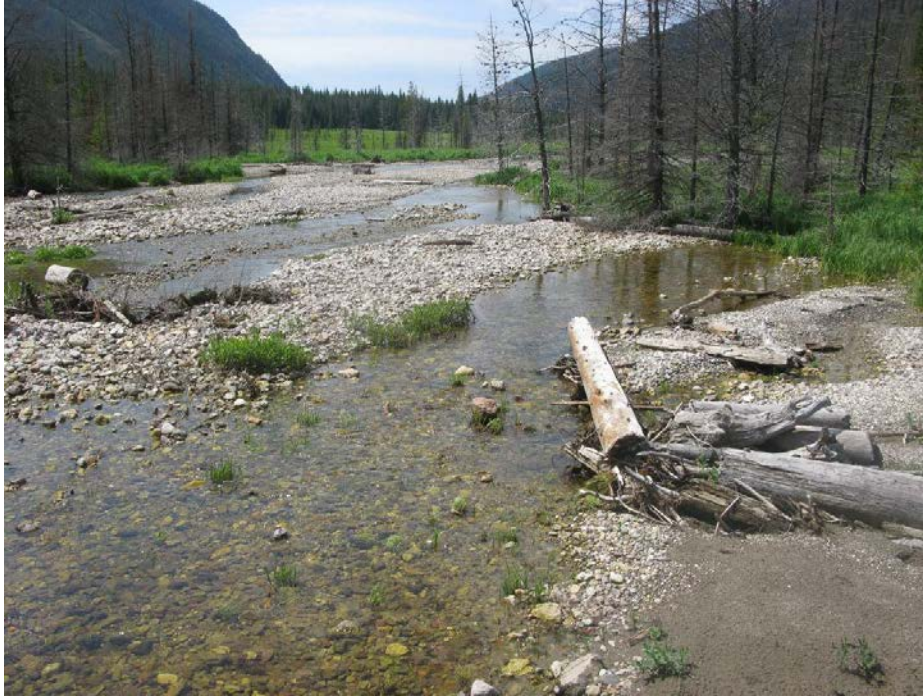
Figure 15. Looking south at the lowest part of the Colorado River just before it enters the Lulu City wetland. A large alluvial fan of sediment has been deposited here causing the channel to braid and the flow to separate into multiple channels.

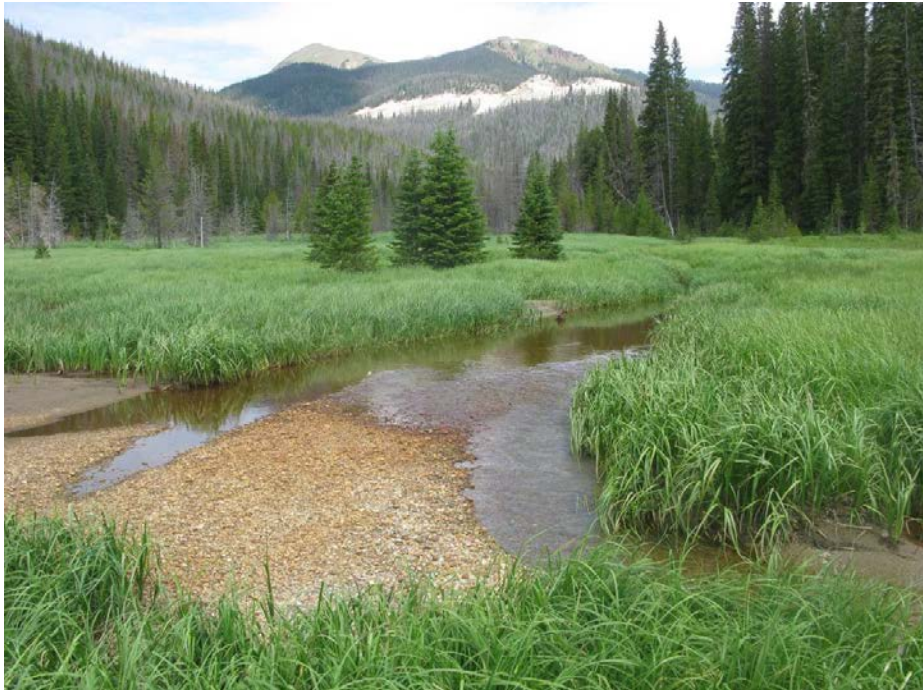
Figure 16. Historic Colorado River channel in the upper portion of the Lulu City wetland, looking north. Sedge dominated vegetation now dominate the entire wetland. Conifer trees in the meadow have drowned from the perennial soil saturation.

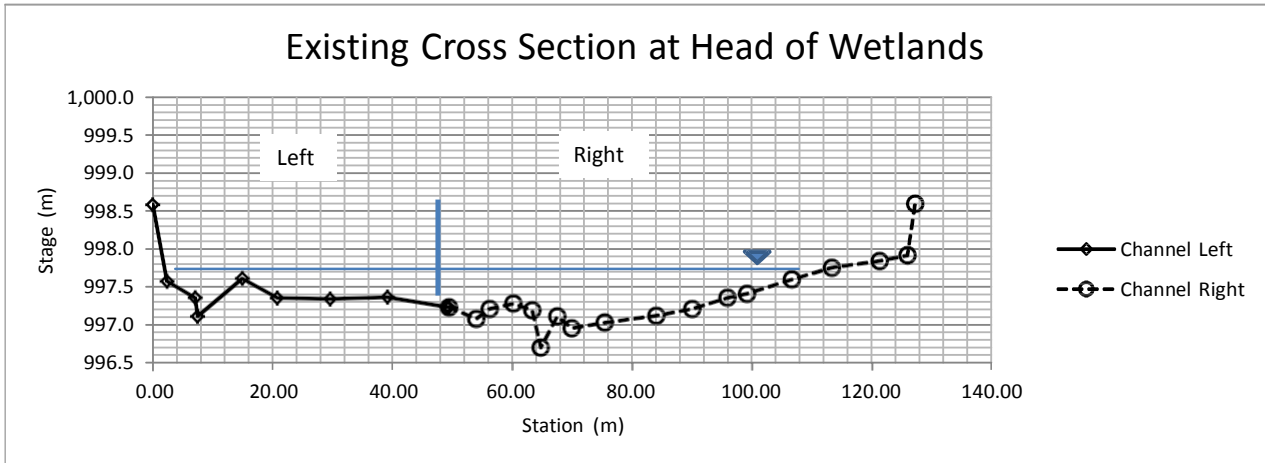
## Split Flow Analyses at Head of Wetlands

Based on detailed topographic data collected in August 2014, a split flow analysis was performed to assess the hydraulic effectiveness of the lateral and mid-channel bar sediment mitigation at the head of the Lulu City wetland reflected in Typical Sections 3 and 4 (Appendix A). The objective of the mitigation effort is to redirect the Colorado River flow away from the 2003 sediment deposit on the west side of the wetland and back to the historic channel in the center left of the wetland (Figure 20), by removing a lateral bar that has formed on the Colorado River at the head of the wetland (see Typical Section 3). Uniform flow computations were performed to assess the percentage of the total flow in the river splitting from the main channel and flowing to the southeast past the lateral bar location for both existing and proposed conditions. As summarized in Table A1 (Appendix A), the results of the split flow analyses indicate that under existing conditions approximately 20% of the total flow in the river splits to the southeast past the lateral bar and back into the historic channel during a moderately high flow. However, the proposed lateral bar sediment mitigation would result in approximately 70% of the total flow in the river splitting to the southeast and entering the historic channel under the same conditions. Furthermore, the hydraulic analyses indicate that flow velocities for the flow reentering the historic channel are sufficient to maintain channel form. Therefore, the flow split analyses suggests that the lateral bar sediment mitigation should be effective in redirecting the flow in the Colorado River into the historic channel and away from the 2003 sediment deposits in the wetland.

A split flow analysis was performed to assess the hydraulic effectiveness of the lateral and mid-channel bar sediment mitigation at the head of the Lulu City wetland reflected in Typical Sections 3 and 4 (Appendix A). The objective of the mitigation effort is to redirect the Colorado River flow away from the 2003 sediment deposit on the west side of the wetland and back to the historic channel in the center left of the wetland (Figure 20), by removing a lateral bar that has formed on the Colorado River at the head of the wetland (see Typical Section 3). The approach attempts to minimize the amount of sediment removed from this area. Complete details of this approach are in Appendix A. A different approach is proposed in the following section, Lulu City Wetland, and is based on the removal of all recently deposited sediment.

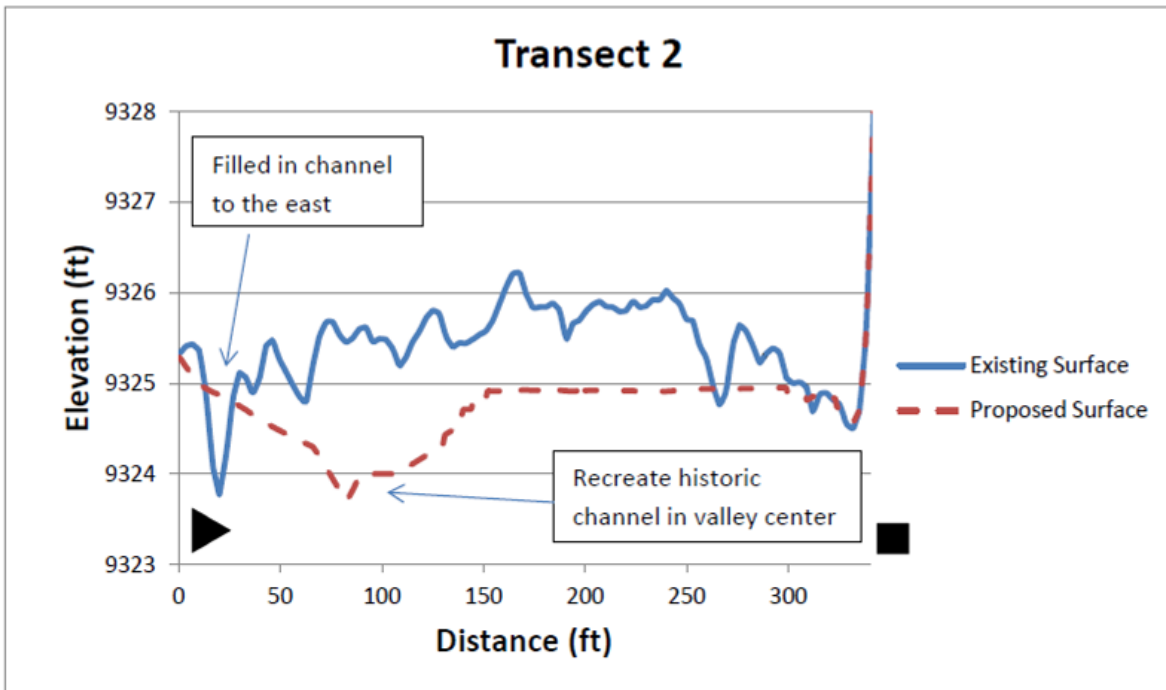
Figure B5. Existing and proposed topography for transects 1 and 2 depicted in Figure B6. Horizontal axis is distance from right bank looking upstream.

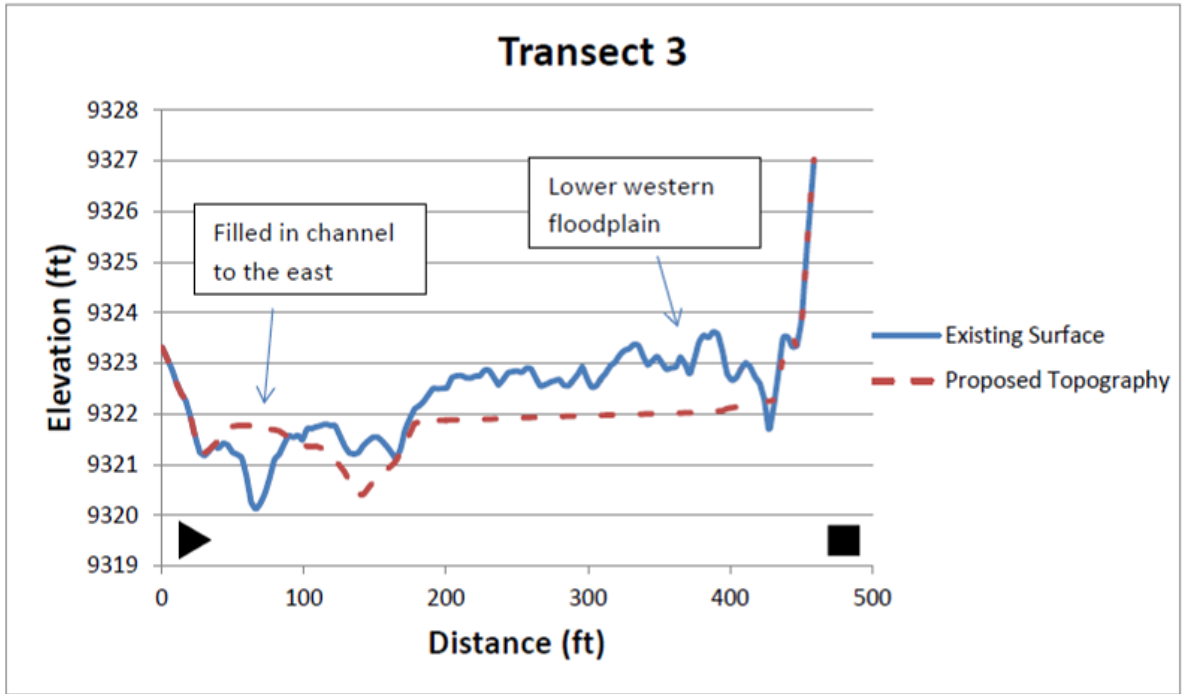
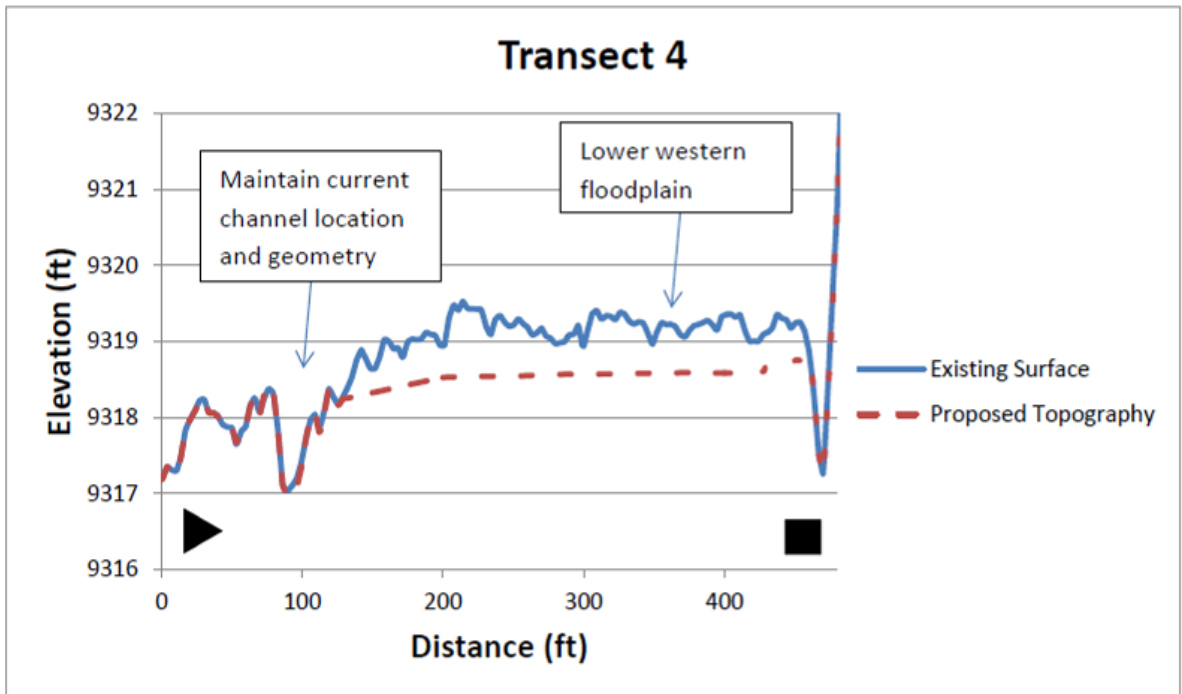
Figure B6. Existing and proposed topography for transects 3 and 4 depicted in Figure B6. Horizontal axis is distance from right bank looking upstream..

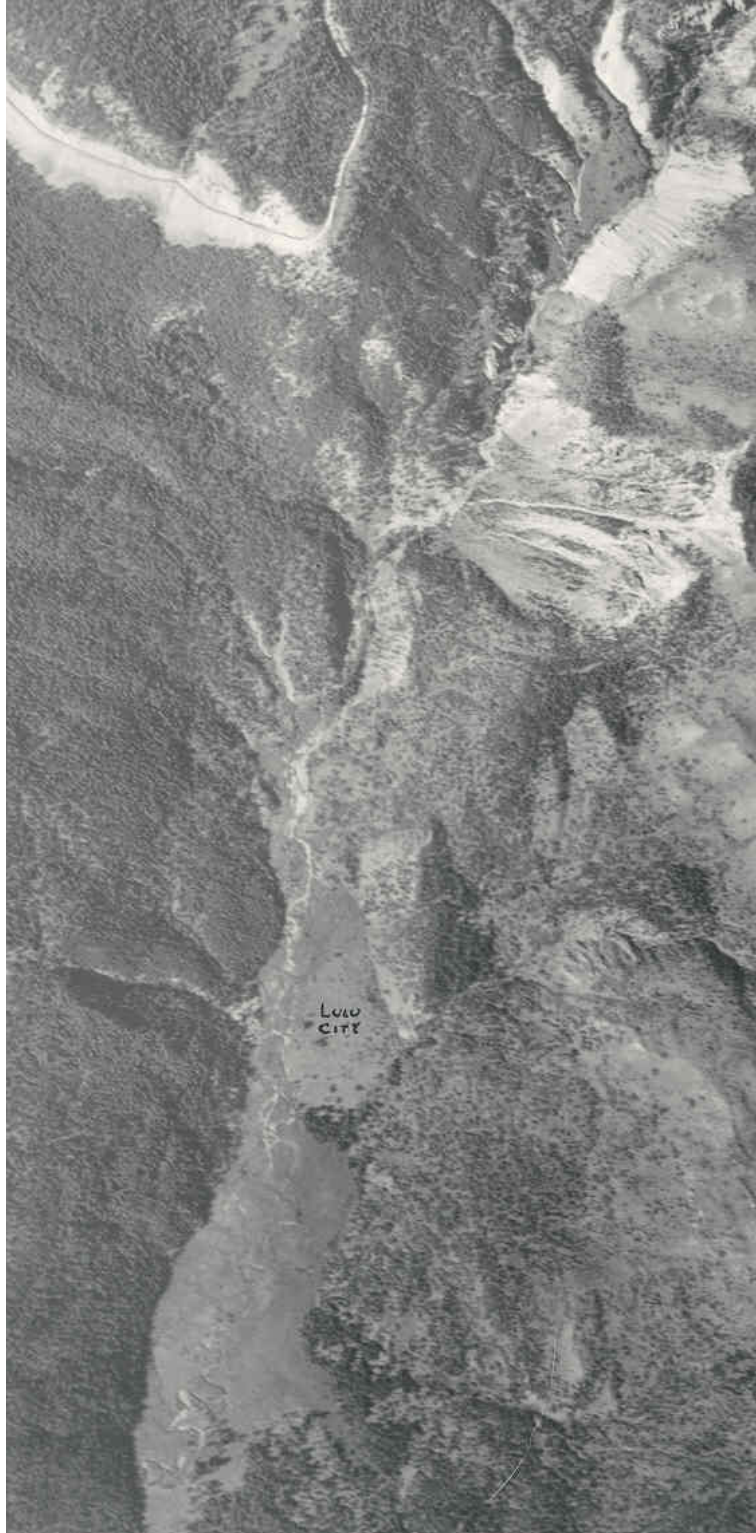
Figure B7. August 1937 air photograph of the Lulu City area. The location of the historic Lulu City town site is inked onto the photograph. The Colorado River flows north to south, top to bottom. Its meandering channel can be seen.

The proposed channel orientation uses the channel location from the August 1937 photo and ties in to the restoration designs of the Colorado River outlined above and shown in Figure 20. Earthwork would remove ~8,500 yd<sup>3</sup> from the Lulu City wetland as shown in Appendix B, with the option of removing more debris should funding permit to the maximum allowable sediment removal as described in the FEIS.
