# Wetland delineation for Cahoon Meadow, Sequoia and Kings Canyon National Park

Prepared for:

Sequoia and Kings Canyon National Parks

November 2015

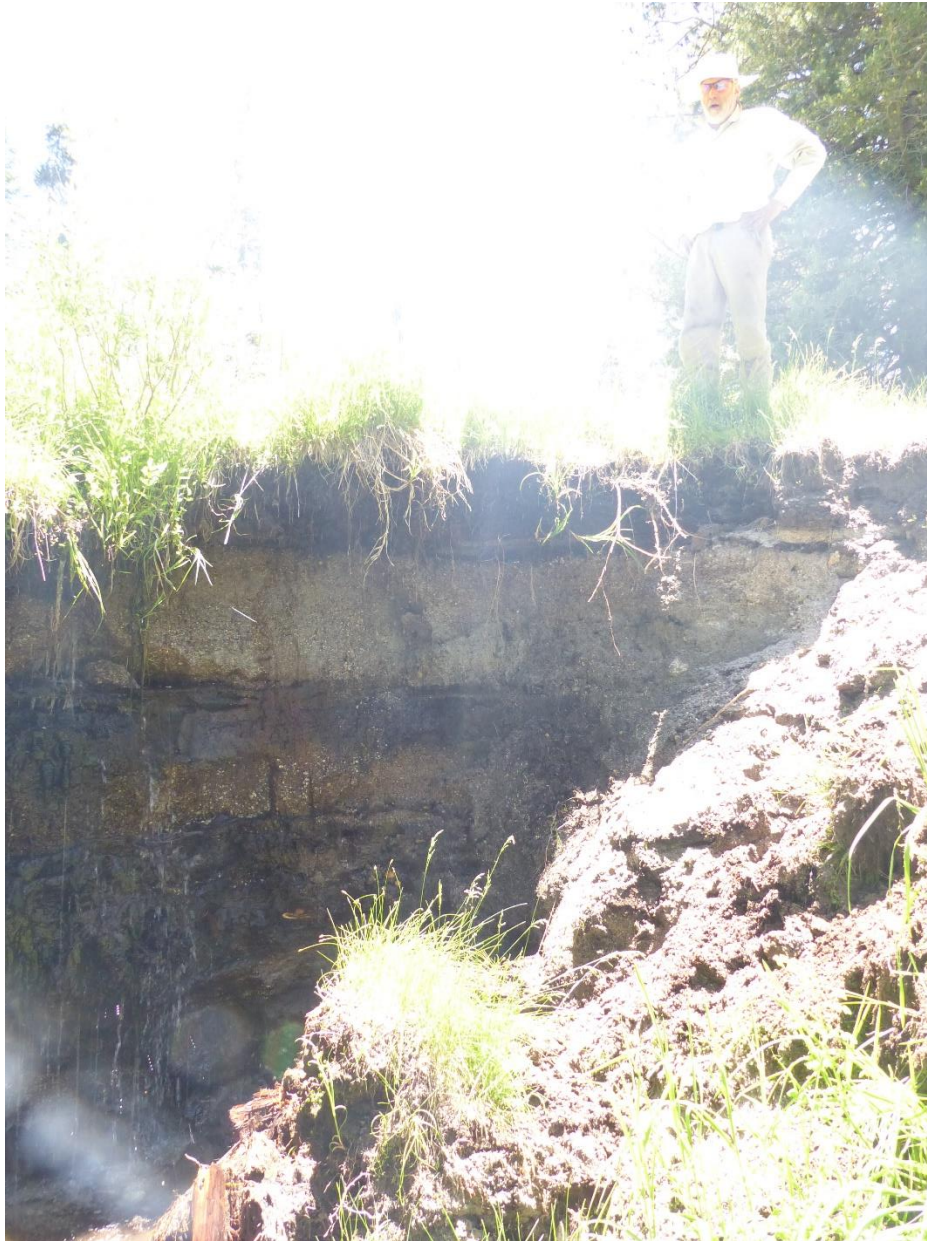
*Figure 1. Vertical gully headcut exposure showing alternating 1-2 foot thick layers of dark peat (at surface) and lighter coarse sand. Note 6-foot tall second author in upper right for scale, slumped soil and vegetation on right, wetland vegetation growing on the meadow surface, and water drops free-falling from the saturated surface at lower left.*

The 15+ foot high cut banks created by the gully display the meadow stratigraphy down to bedrock in several locations. At seven cutbank exposures and 25 augured holes in the meadow, each soil layer encountered was described for color, texture, and composition. Typical exposures at cutbanks had 1-2 feet of desiccated peat at the surface, underlain by alternating layers, 0.3-2 feet thick, of coarse sand and peat. Figure 1 shows a cut bank exposure displaying the layers of peat, darker and more prominent, between loose sand layers. A 6-foot-tall person is visible on the right, for scale. These layered sediments indicate that Cahoon Meadow was formed over thousands of years in relatively stable, saturated wetland conditions (peat layers

The soil at Cahoon Meadow is composed of two distinct types of layers that are interbedded, generally in 1-2 foot intervals. Across much of the meadow, including most of the saturated upstream wetland above the erosion gully, the surface layer of soil is peat. Underlying the approximately 1-foot thick peat layer is a 1-2 foot thick sandy gravel layer. The alternation of peat and sand/gravel layers continues 8-10 feet down, as far as the strata are exposed on the sides of the erosion gully (see Figure 1). The sand/gravel layers are generally poorly sorted homogenous units that we interpret as rapidly laid-down storm or snow melt high-flow deposits. The peat layers clearly reflect long periods of perennial groundwater saturation and accumulation of wetland plant organic matter. The substrates at Cahoon Meadow plots were classified as wetland soils if at least 16 of the upper 32 inches of soil was peat, following the USACOE definition for histisols (hydric soil indicator A1).
