National Register of Historic Places Registration Form

Historic name: Oak Creek Historic District
Other names/site number: _____
Name of related multiple property listing: Multiple Resources for Zion National Park
(Enter "N/A" if property is not part of a multiple property listing)

The 1987 nomination only listed the district's eligible buildings. This amendment addresses an additional eighty-four historic resources, fifty-five contributing and twenty-nine non-contributing. These features include water features, circulation networks, designed outdoor spaces, vegetation related to land use, and other landscape elements that mirror the "Rustic" style of their associated buildings. The district's period of significance under Criterion C for "NPS Rustic/Naturalistic Design" is 1932-1942. Furthermore, under Criterion A, this amendment adds the context of the Civilian Conservation Corps (CCC) for its work constructing the buildings and

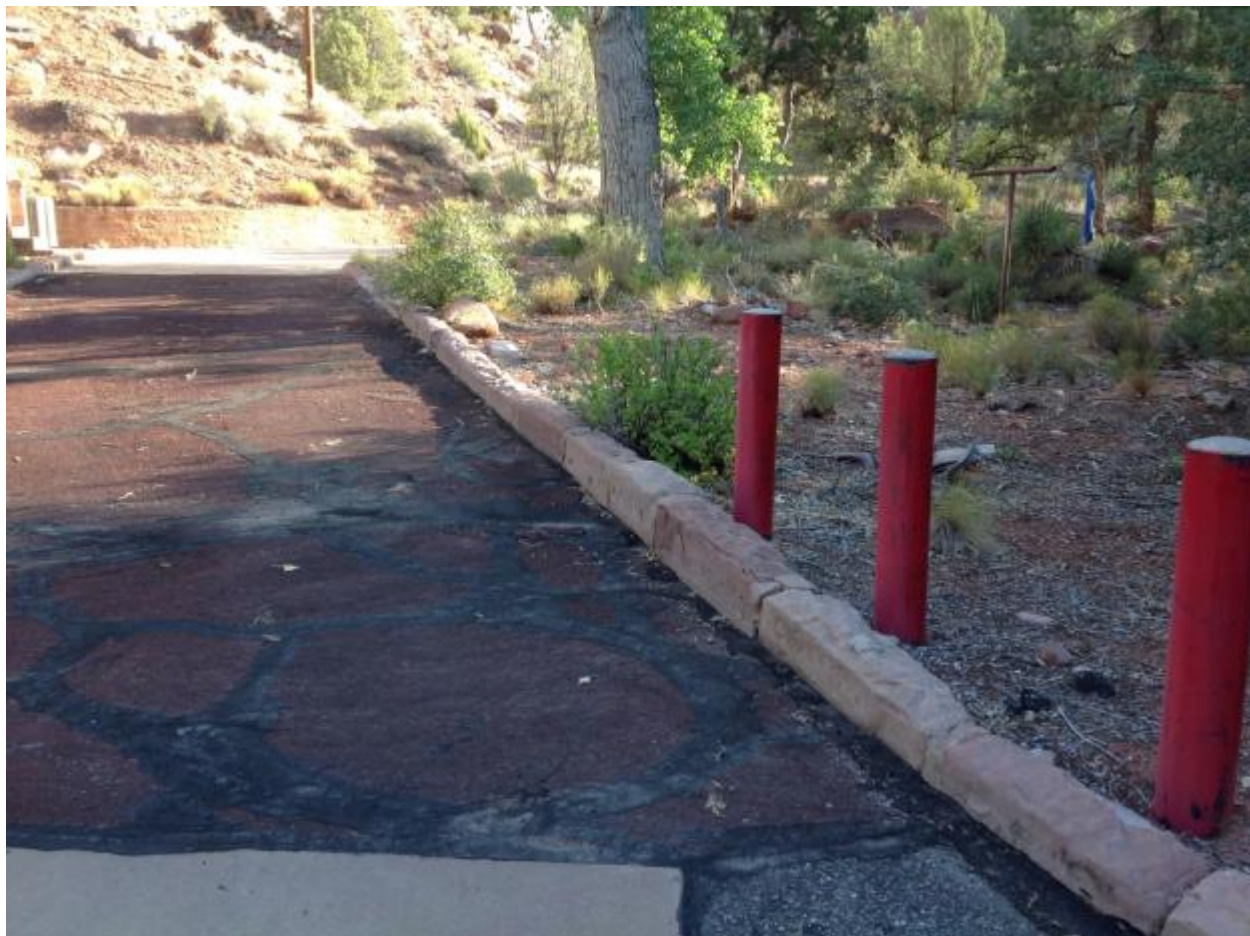
Name of Property: Oak Creek Historic District
City or Vicinity: Springdale
County: Washington
State: Utah
Photographer: Russell Cash
Date Photographed: 8/1/2014
Description: Curb near Ranger Dormitory (HS-0005).
Feature Number: FEA-001a
View Aspect: East
1 of 84

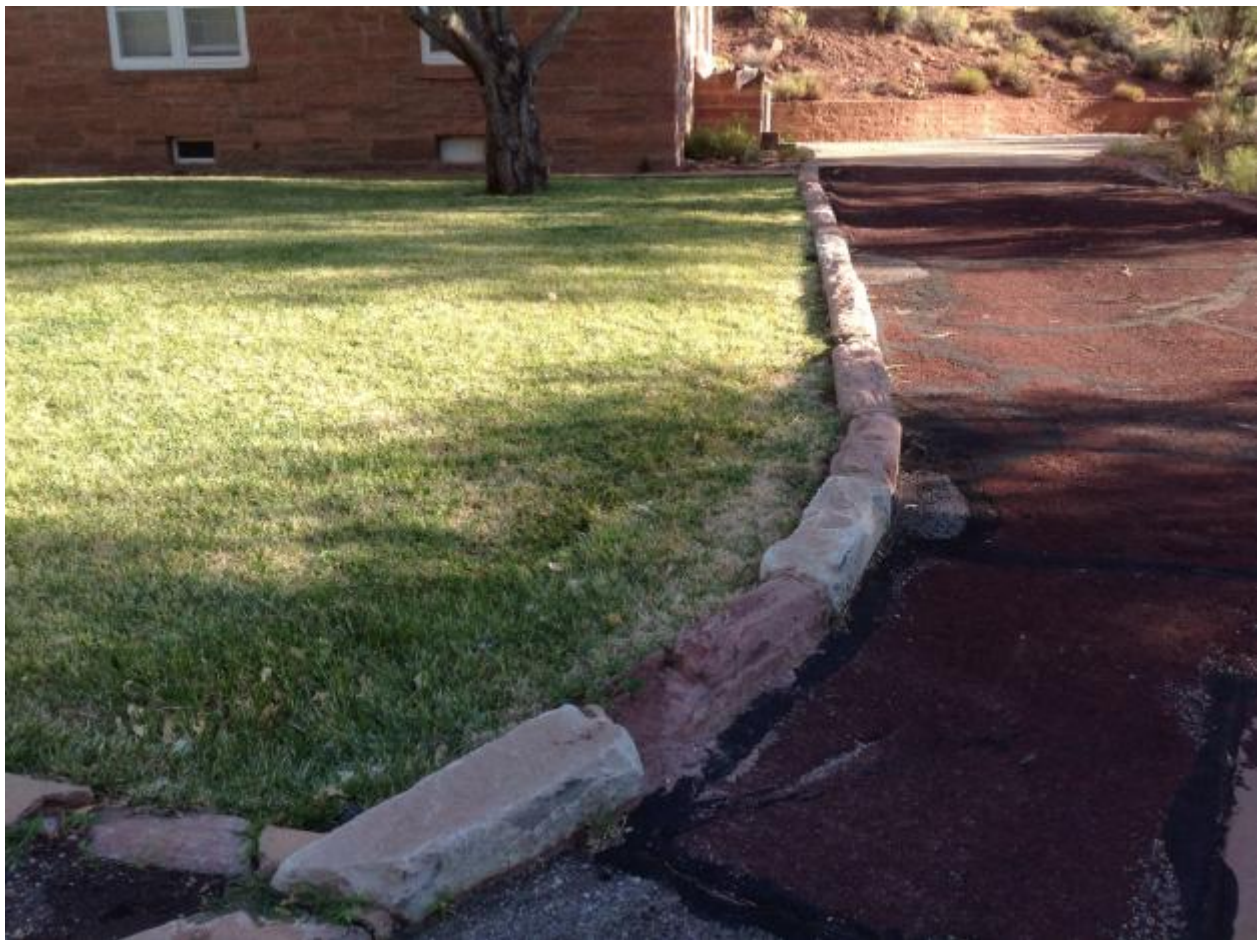
Name of Property: Oak Creek Historic District
City or Vicinity: Springdale
County: Washington
State: Utah
Photographer: Russell Cash
Date Photographed: 8/1/2014
Description: Curb near Ranger Dormitory (HS-0005)
Feature Number: FEA-001b
View Aspect: North
2 of 84

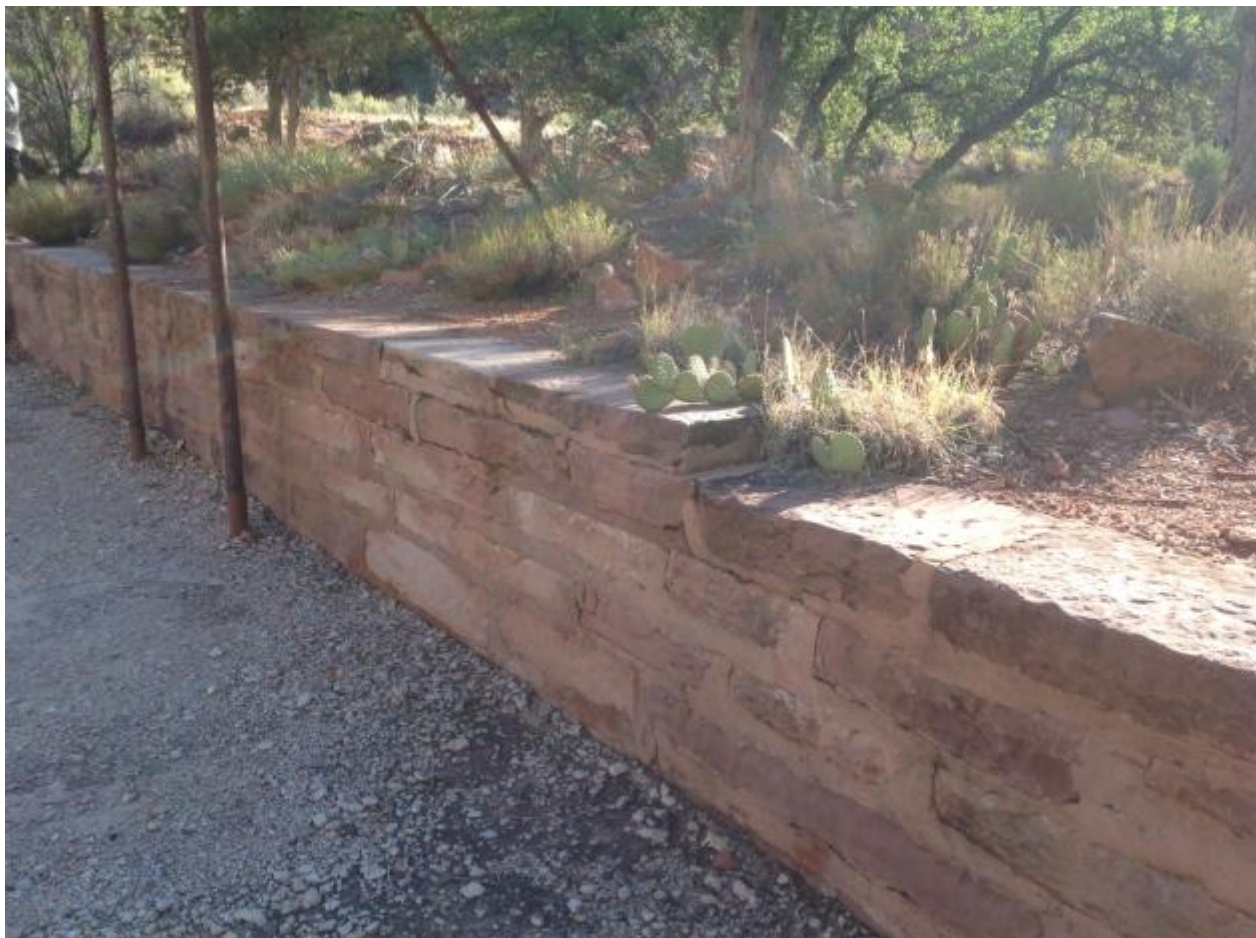
Name of Property: Oak Creek Historic District
City or Vicinity: Springdale
County: Washington
State: Utah
Photographer: Russell Cash
Date Photographed: 8/1/2014
Description: Retaining Wall at Ranger Dormitory (HS-0005)
Feature Number: FEA-002
View Aspect: North-Northeast
3 of 84

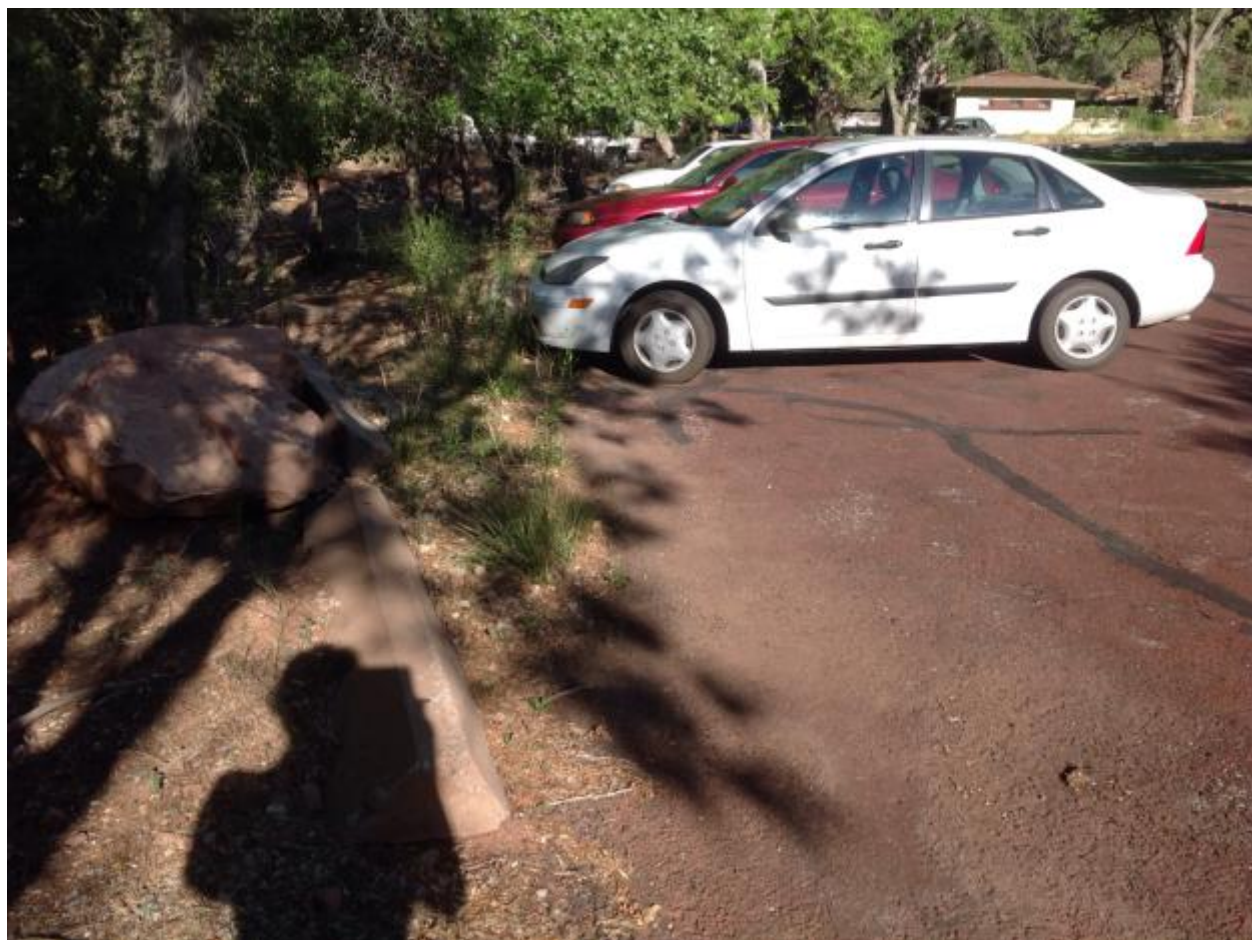
Name of Property: Oak Creek Historic District
City or Vicinity: Springdale
County: Washington
State: Utah
Photographer: Russell Cash
Date Photographed: 8/1/2014
Description: Parking Lot south of Ranger Dormitory (HS-0005)
Feature Number: FEA-003a
View Aspect: West
4 of 84

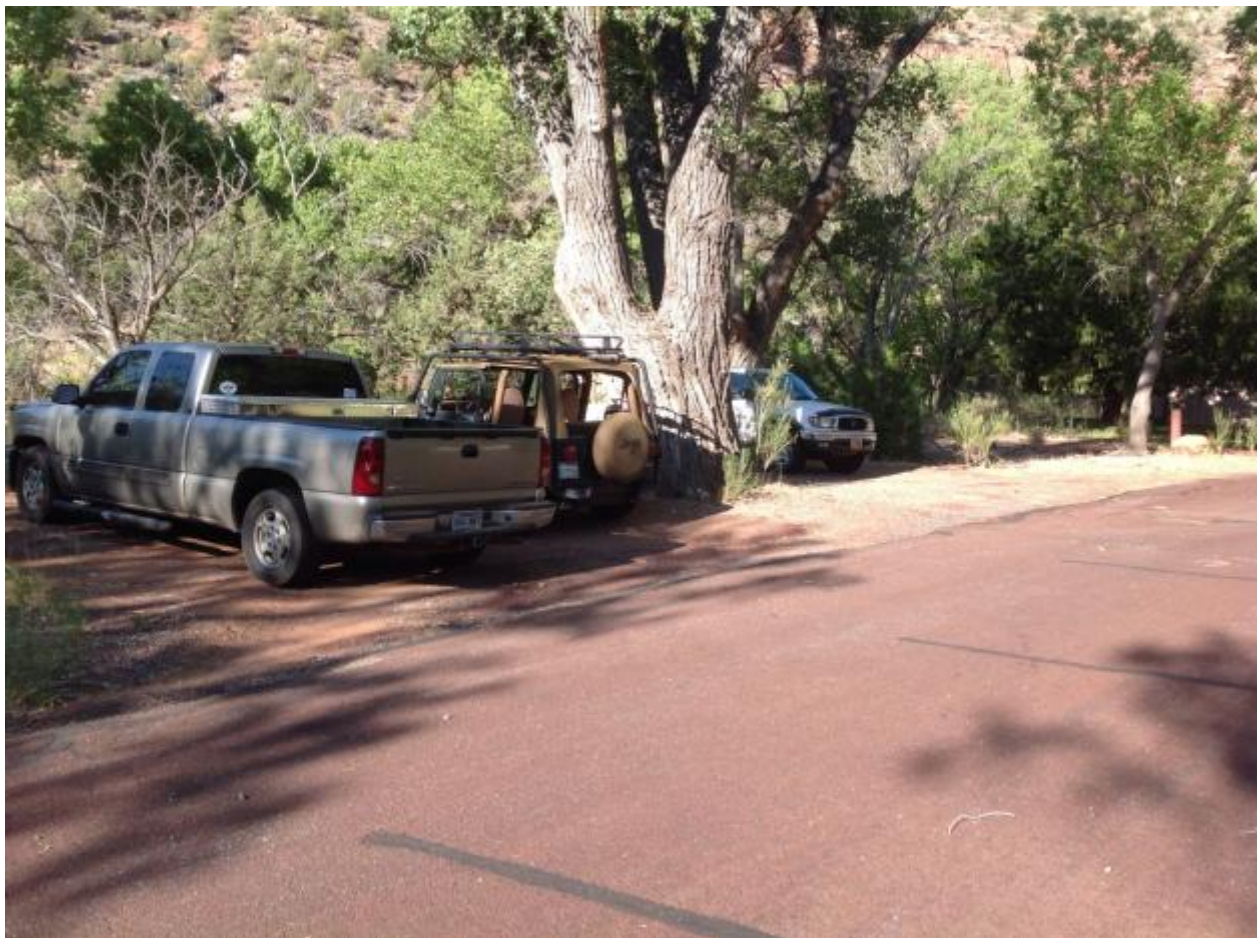
Name of Property: Oak Creek Historic District
City or Vicinity: Springdale
County: Washington
State: Utah
Photographer: Russell Cash
Date Photographed: 8/1/2014
Description: Parking Lot Southwest of Ranger Dormitory (HS-0005)
Feature Number: FEA-003b
View Aspect: Southwest
5 of 84

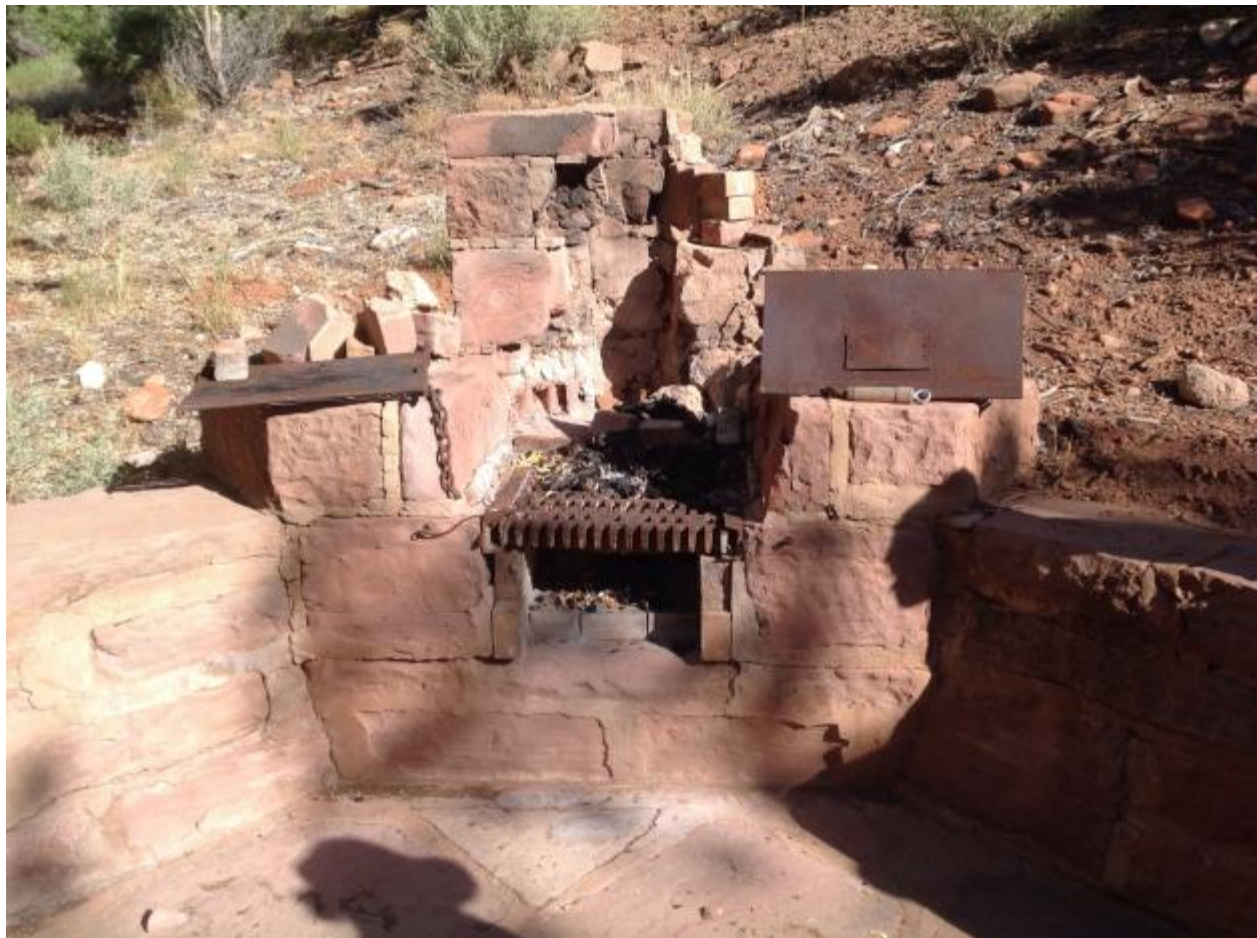
Name of Property: Oak Creek Historic District
City or Vicinity: Springdale
County: Washington
State: Utah
Photographer: Russell Cash
Date Photographed: 8/1/2014
Description: Patio hearth at Ranger Dormitory (HS-0005)
Feature Number: FEA-004
View Aspect: Northwest
6 of 84

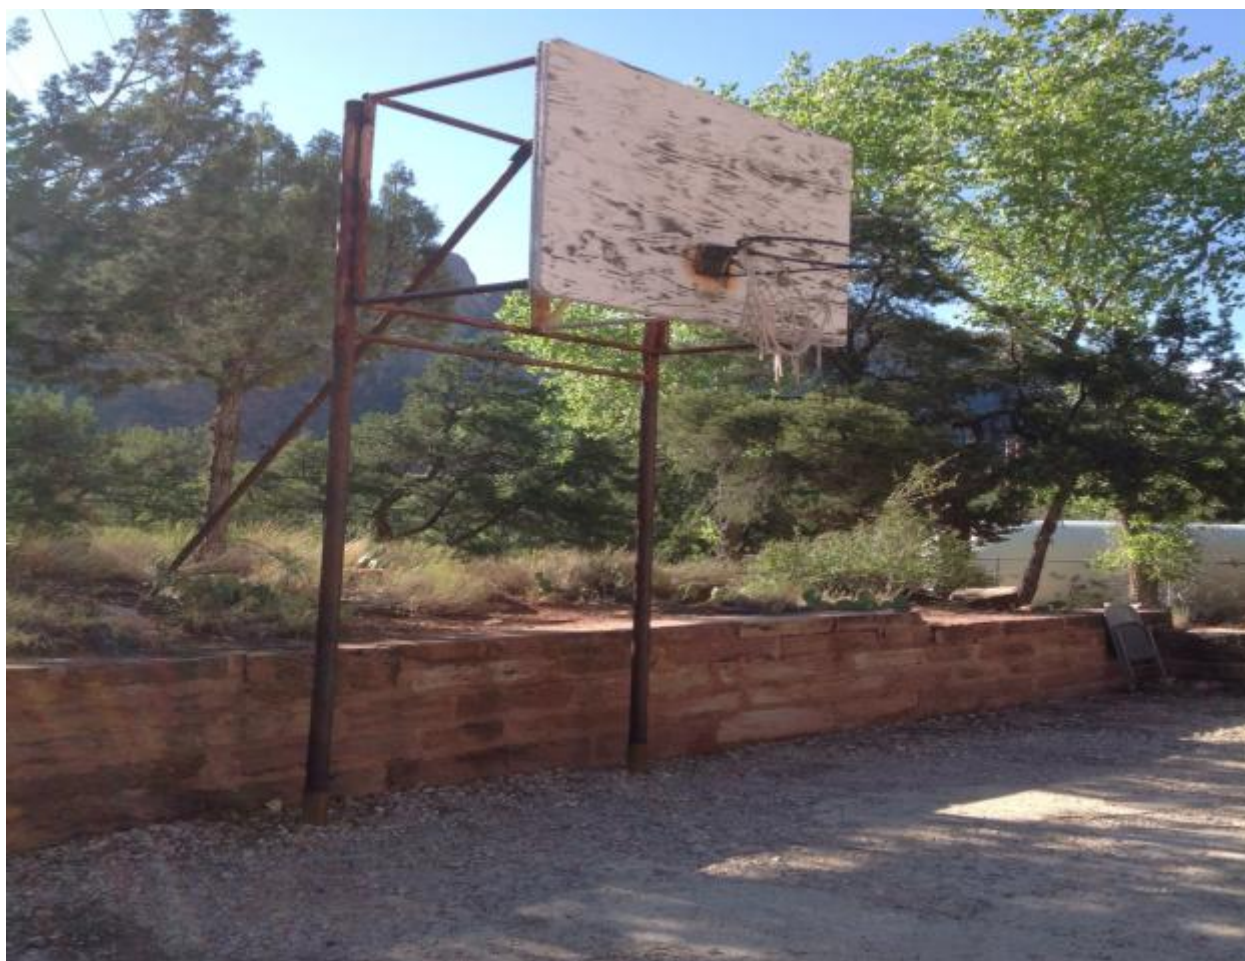
Name of Property: Oak Creek Historic District
City or Vicinity: Springdale
County: Washington
State: Utah
Photographer: Russell Cash
Date Photographed: 8/1/2014
Description: Basketball hoop in Ranger Dormitory (HS-0005) Courtyard
Feature Number: FEA-006
View Aspect: South-Southeast
8 of 84

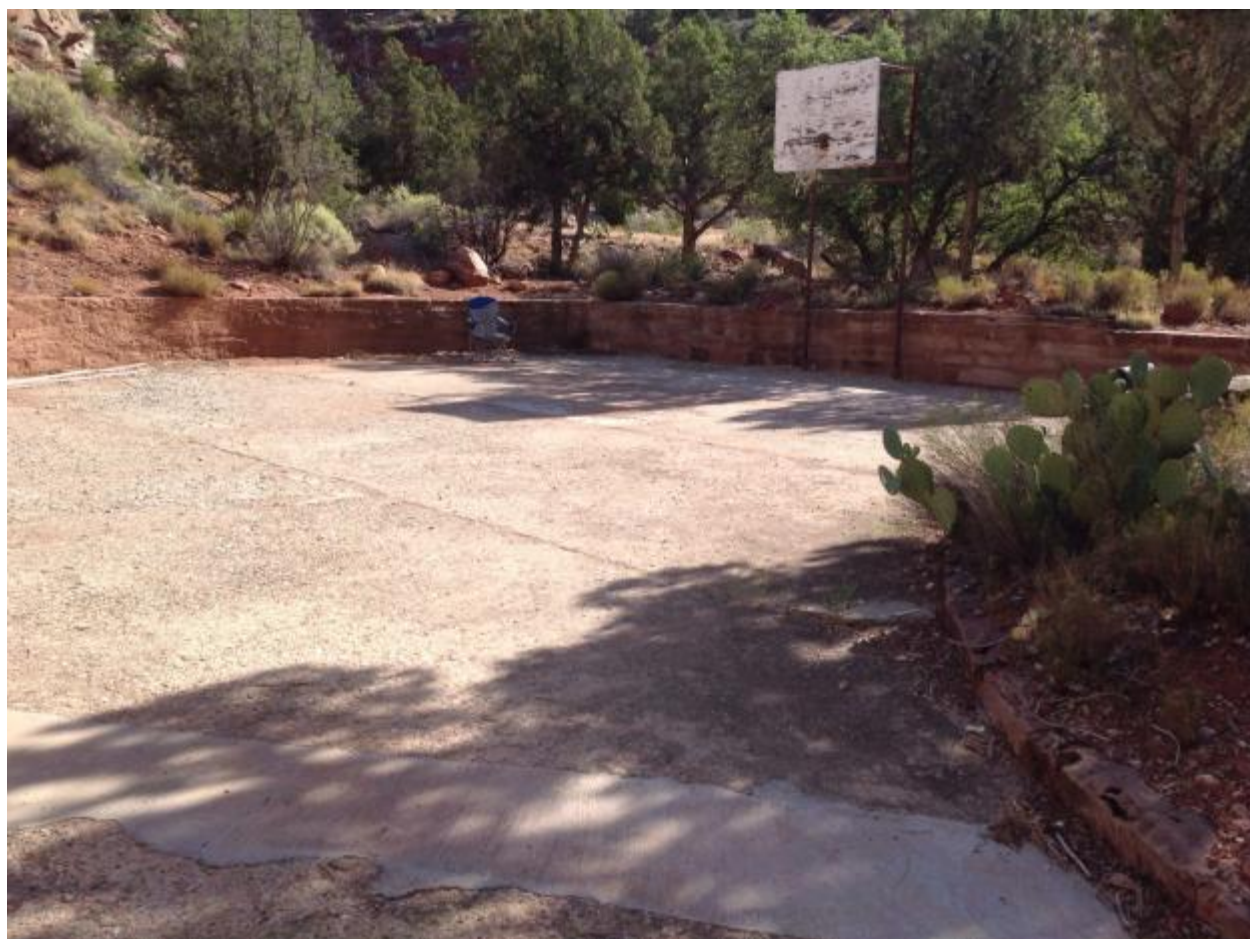
Name of Property: Oak Creek Historic District
City or Vicinity: Springdale
County: Washington
State: Utah
Photographer: Russell Cash
Date Photographed: 8/1/2014
Description: Ranger Dormitory (HS-0005) Courtyard
Feature Number: FEA-007
View Aspect: Northeast
9 of 84

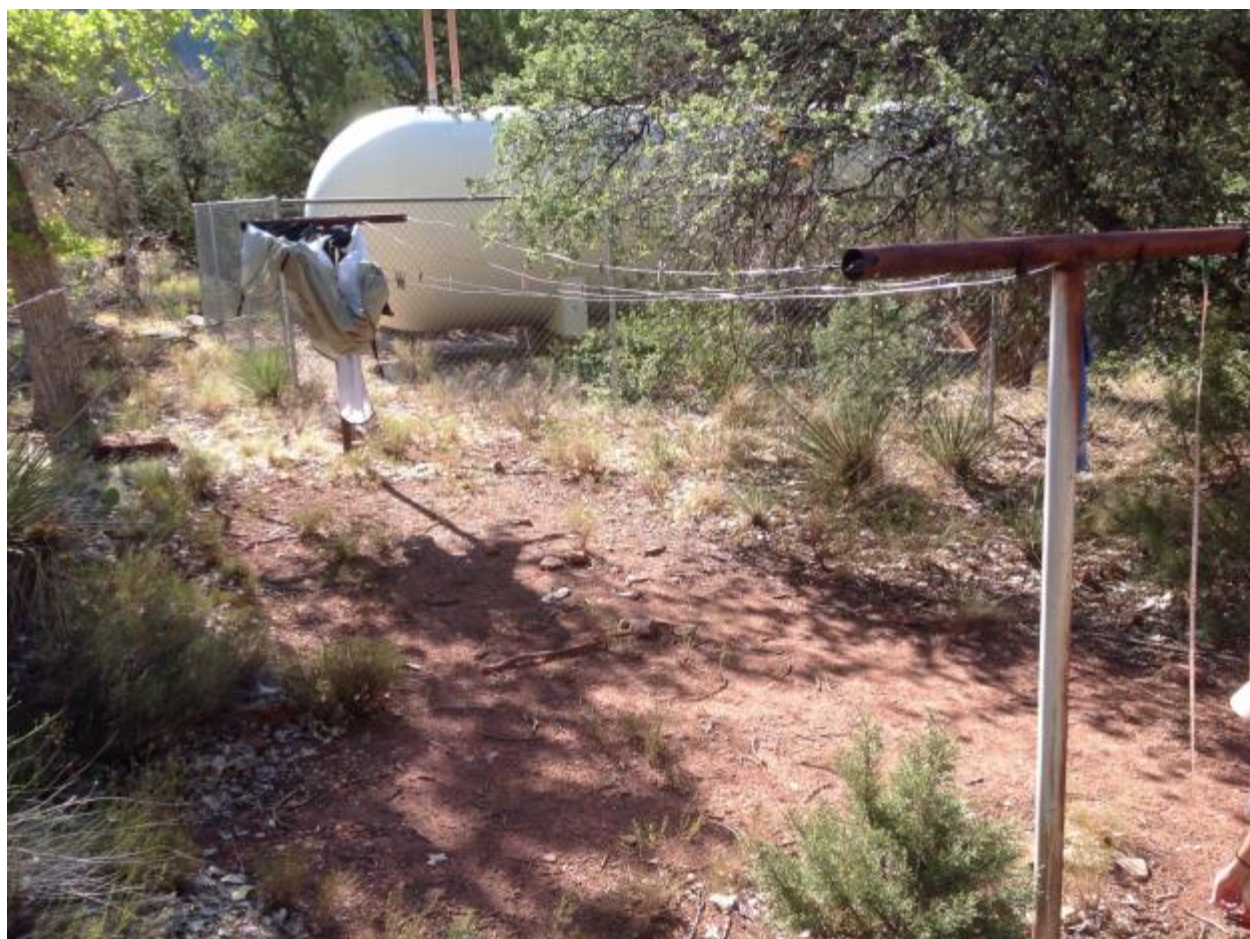
Name of Property: Oak Creek Historic District
City or Vicinity: Springdale
County: Washington
State: Utah
Photographer: Russell Cash
Date Photographed: 8/1/2014
Description: Ranger Dormitory (HS-0005) Clothesline
Feature Number: FEA-008
View Aspect: East
10 of 84

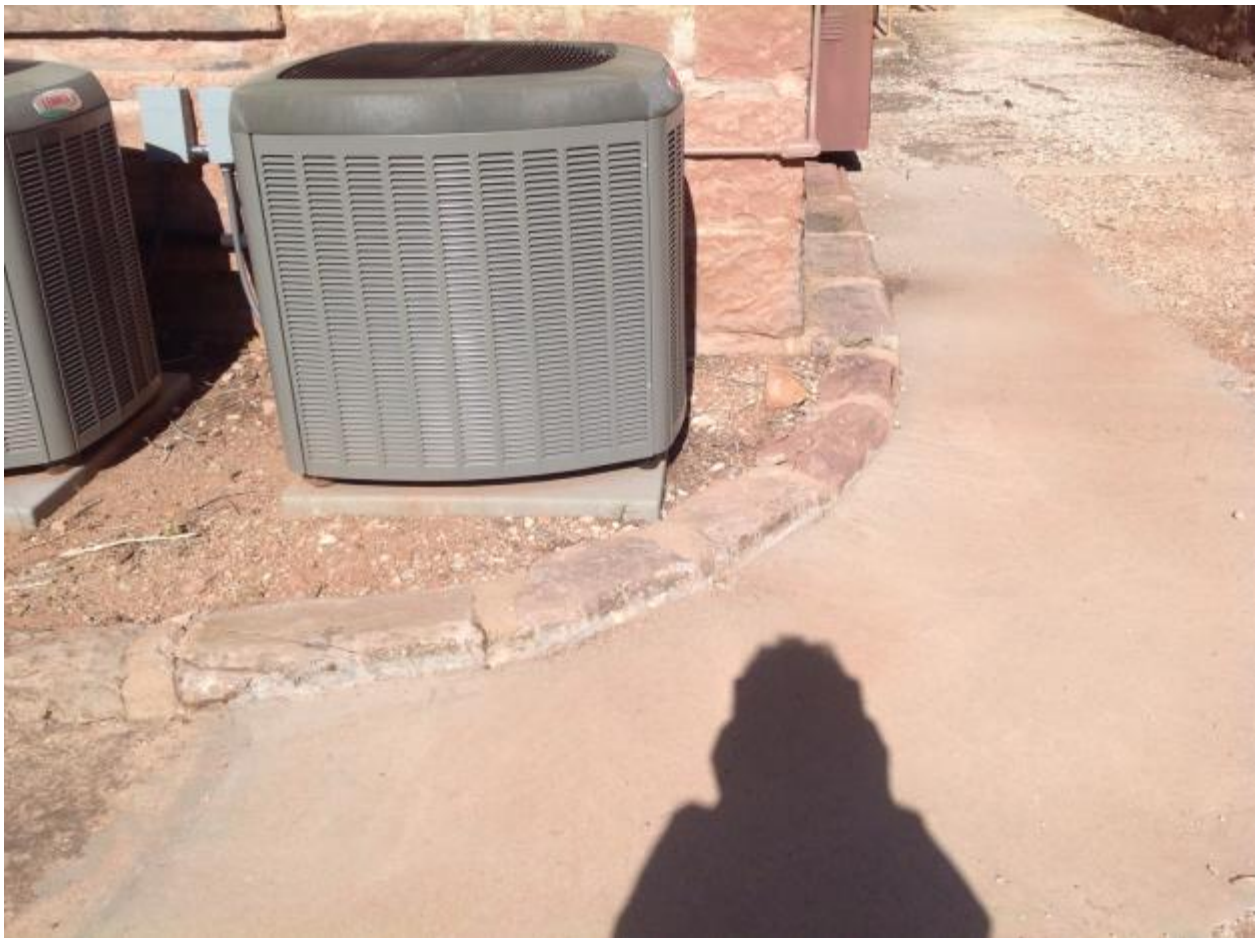
Name of Property: Oak Creek Historic District
City or Vicinity: Springdale
County: Washington
State: Utah
Photographer: Russell Cash
Date Photographed: 8/1/2014
Description: Ranger Dormitory (HS-0005) Courtyard Curb
Feature Number: FEA-009
View Aspect: West
11 of 84

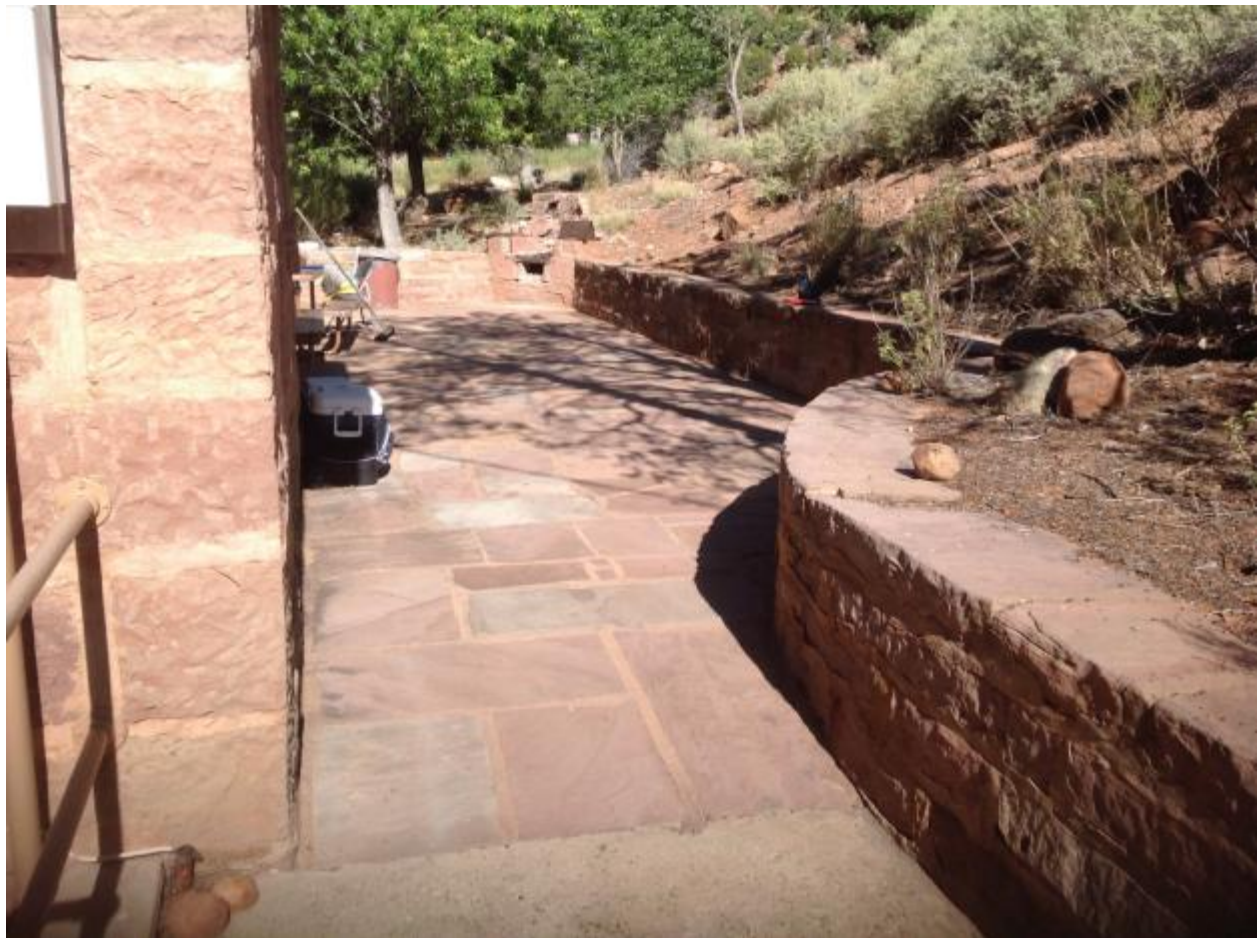
Name of Property: Oak Creek Historic District
City or Vicinity: Springdale
County: Washington
State: Utah
Photographer: Russell Cash
Date Photographed: 8/1/2014
Description: Ranger Dormitory (HS-0005) Patio Area
Feature Number: FEA-010
View Aspect: West
12 of 84

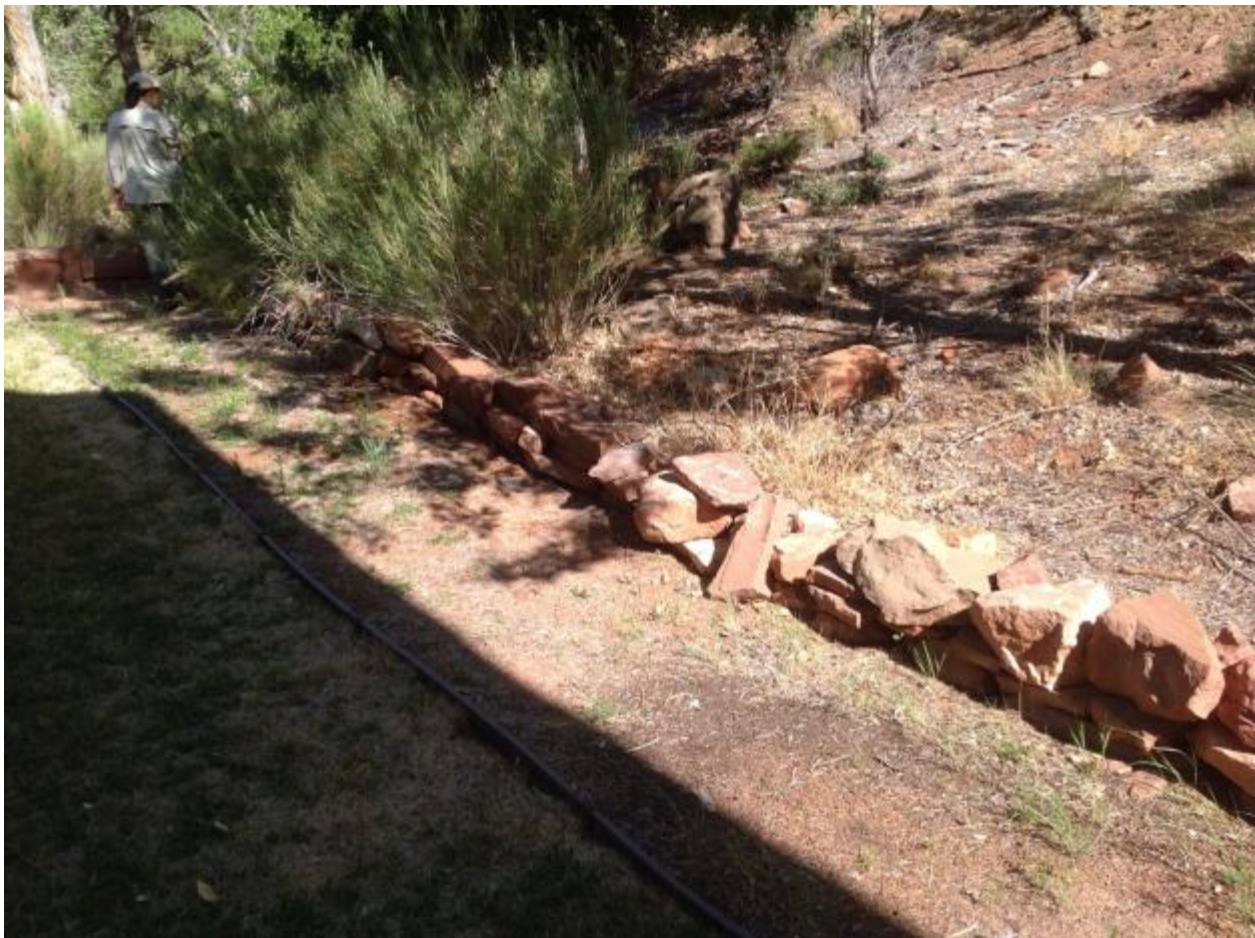
Name of Property: Oak Creek Historic District
City or Vicinity: Springdale
County: Washington
State: Utah
Photographer: Russell Cash
Date Photographed: 8/1/2014
Description: Walkway Retaining Wall at Ranger Dormitory (HS-0005)
Feature Number: FEA-011
View Aspect: East-Northeast
13 of 84

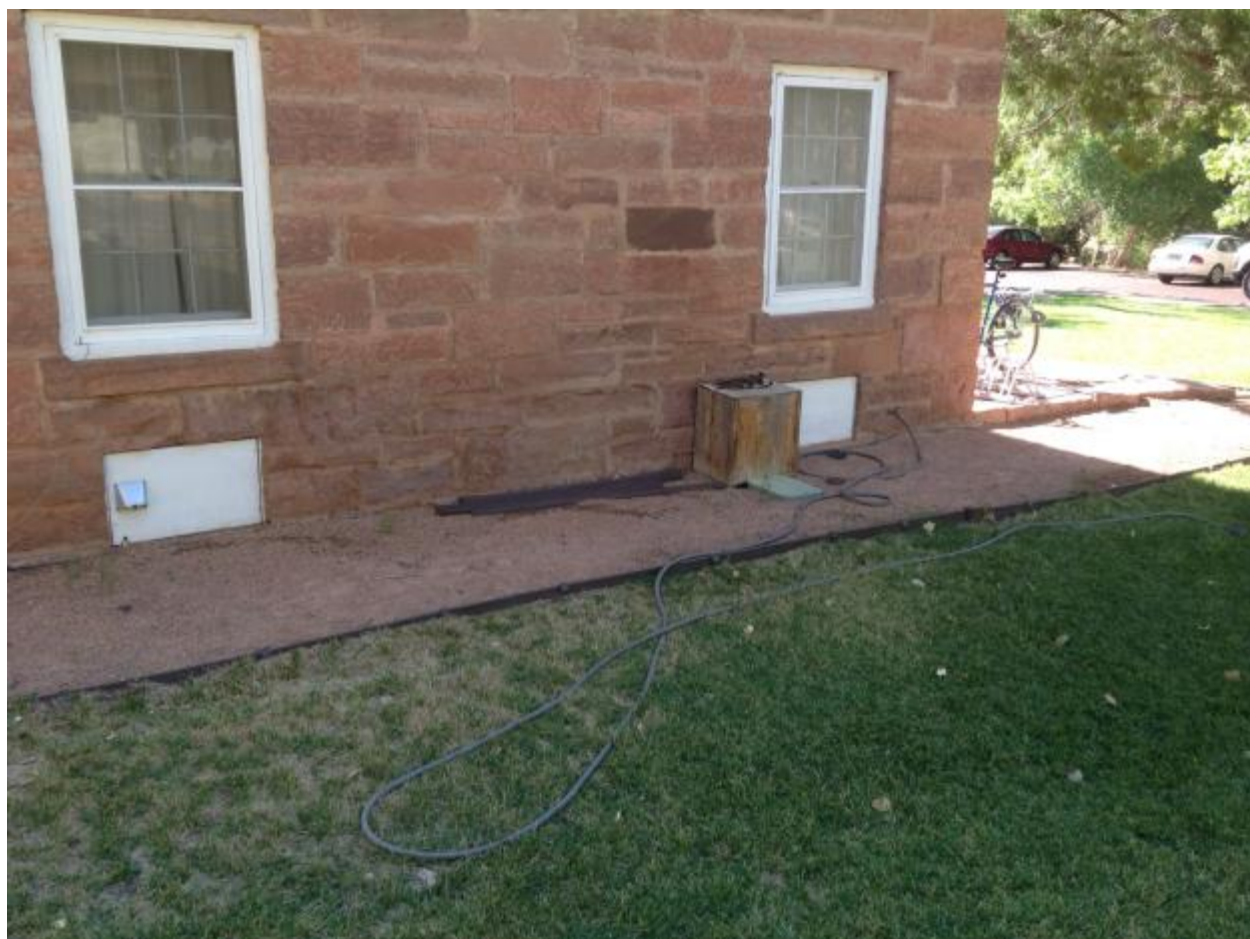
Name of Property: Oak Creek Historic District
City or Vicinity: Springdale
County: Washington
State: Utah
Photographer: Russell Cash
Date Photographed: 8/1/2014
Description: Ranger Dormitory (HS-0005) Walkway
Feature Number: FEA-012
View Aspect: East
14 of 84

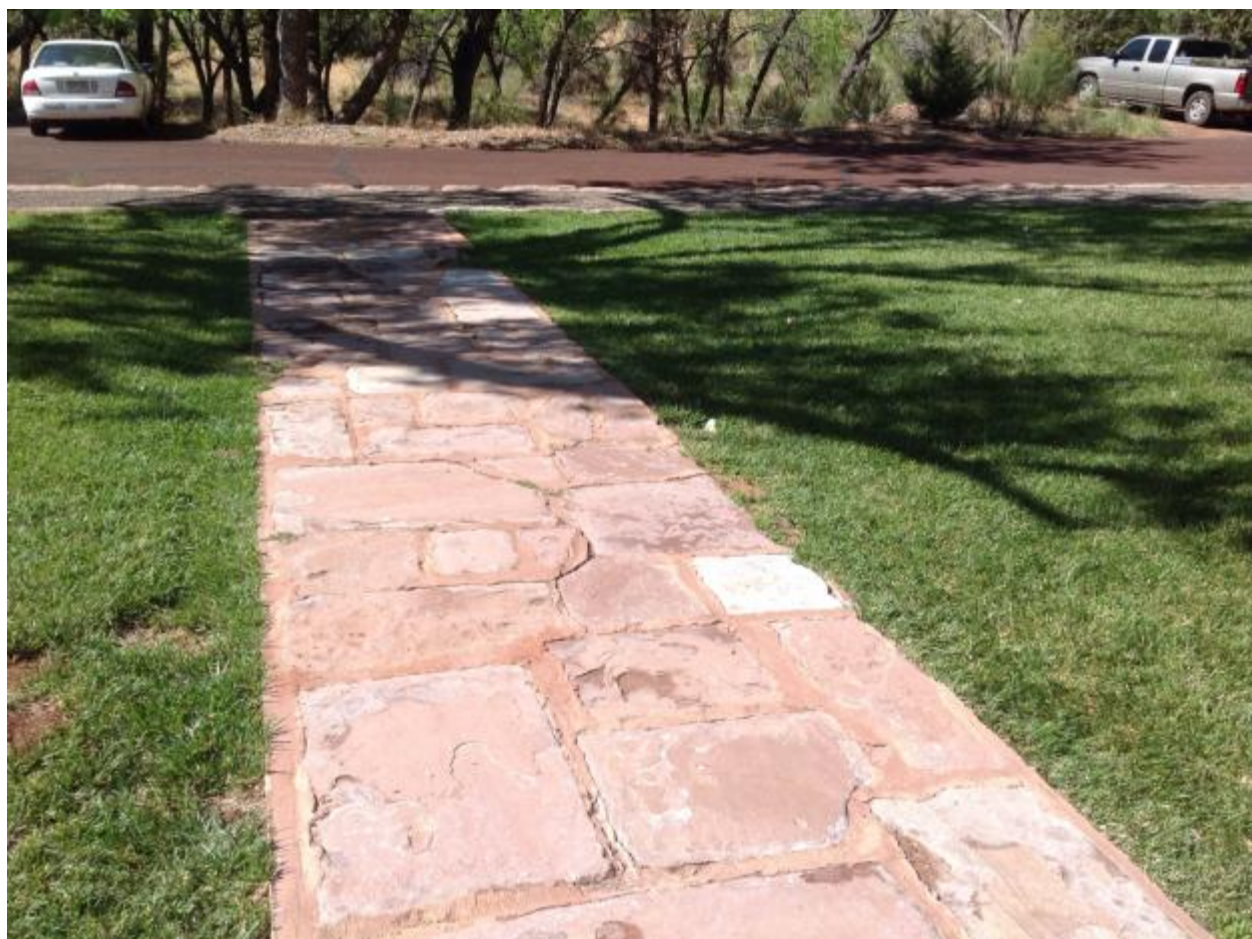
Name of Property: Oak Creek Historic District
City or Vicinity: Springdale
County: Washington
State: Utah
Photographer: Russell Cash
Date Photographed: 8/1/2014
Description: Ranger Dormitory (HS-0005) Front walkway
Feature Number: FEA-013
View Aspect: South
15 of 84

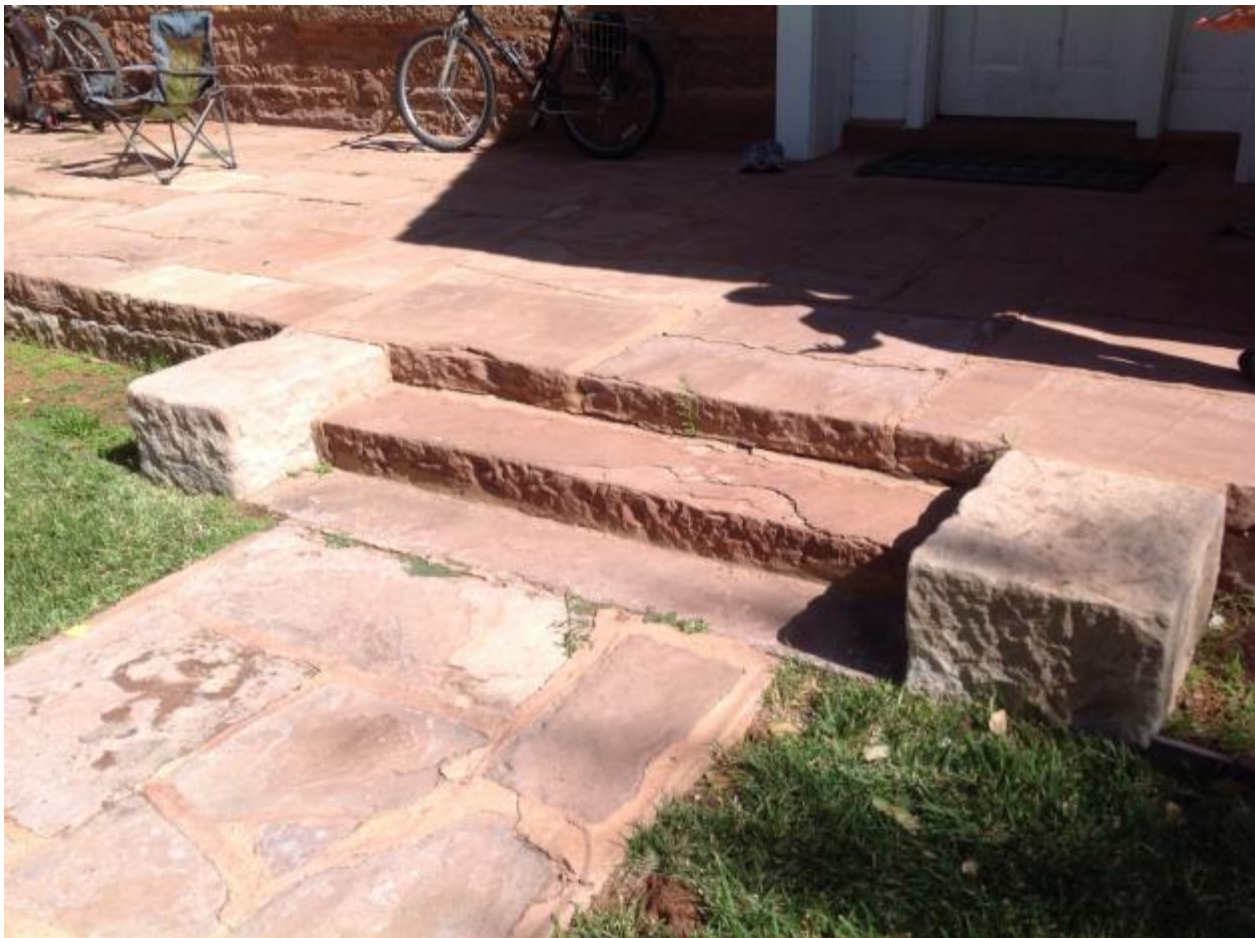
Name of Property: Oak Creek Historic District
City or Vicinity: Springdale
County: Washington
State: Utah
Photographer: Russell Cash
Date Photographed: 8/1/2014
Description: Ranger Dormitory (HS-0005) Front Patio
Feature Number: FEA-014
View Aspect: West-Northwest
16 of 84

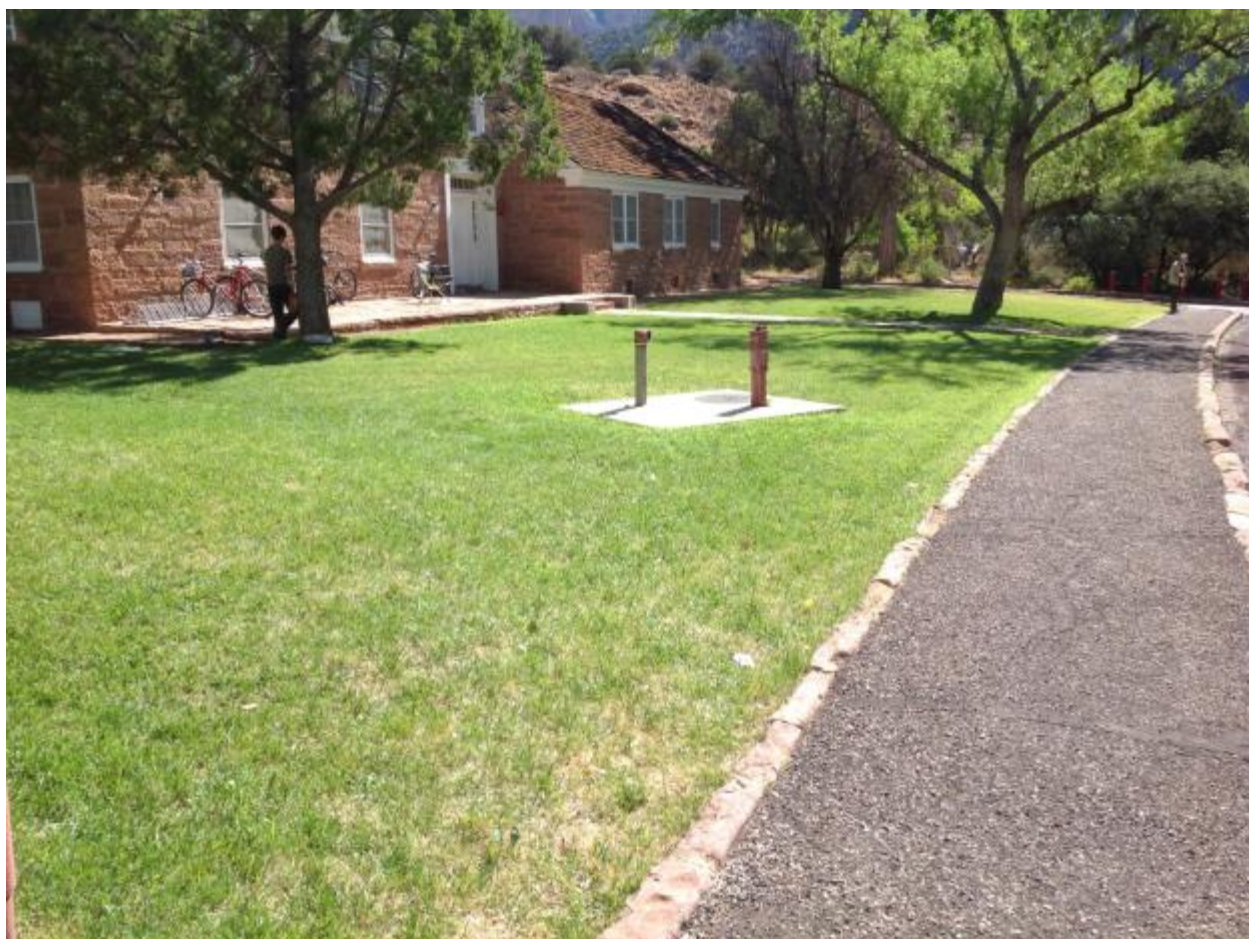
Name of Property: Oak Creek Historic District
City or Vicinity: Springdale
County: Washington
State: Utah
Photographer: Russell Cash
Date Photographed: 8/1/2014
Description: Ranger Dormitory (HS-0005) Yard
Feature Number: FEA-015
View Aspect: East
17 of 84

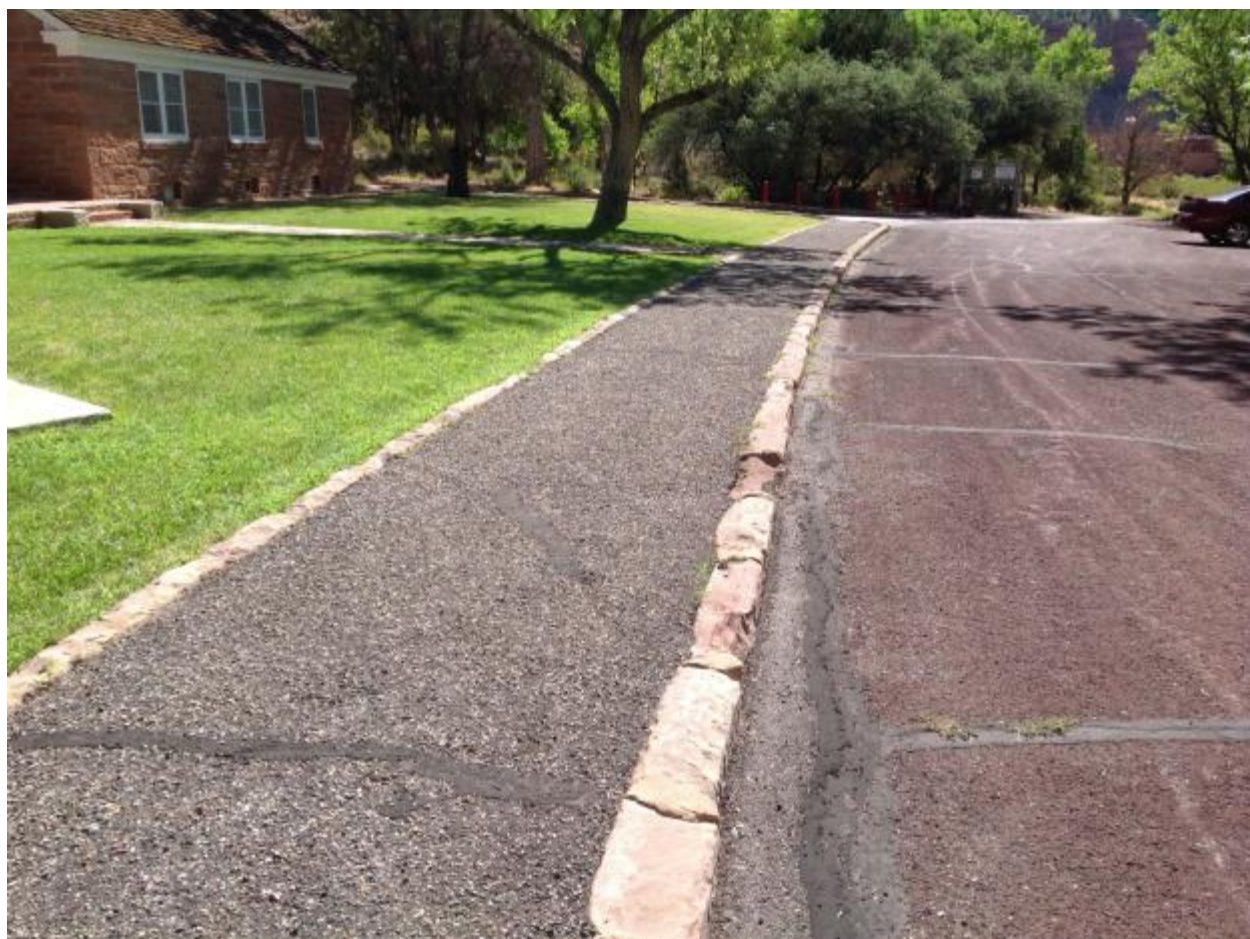
Name of Property: Oak Creek Historic District
City or Vicinity: Springdale
County: Washington
State: Utah
Photographer: Russell Cash
Date Photographed: 8/1/2014
Description: Sidewalk
Feature Number: FEA-016
View Aspect: East
18 of 84

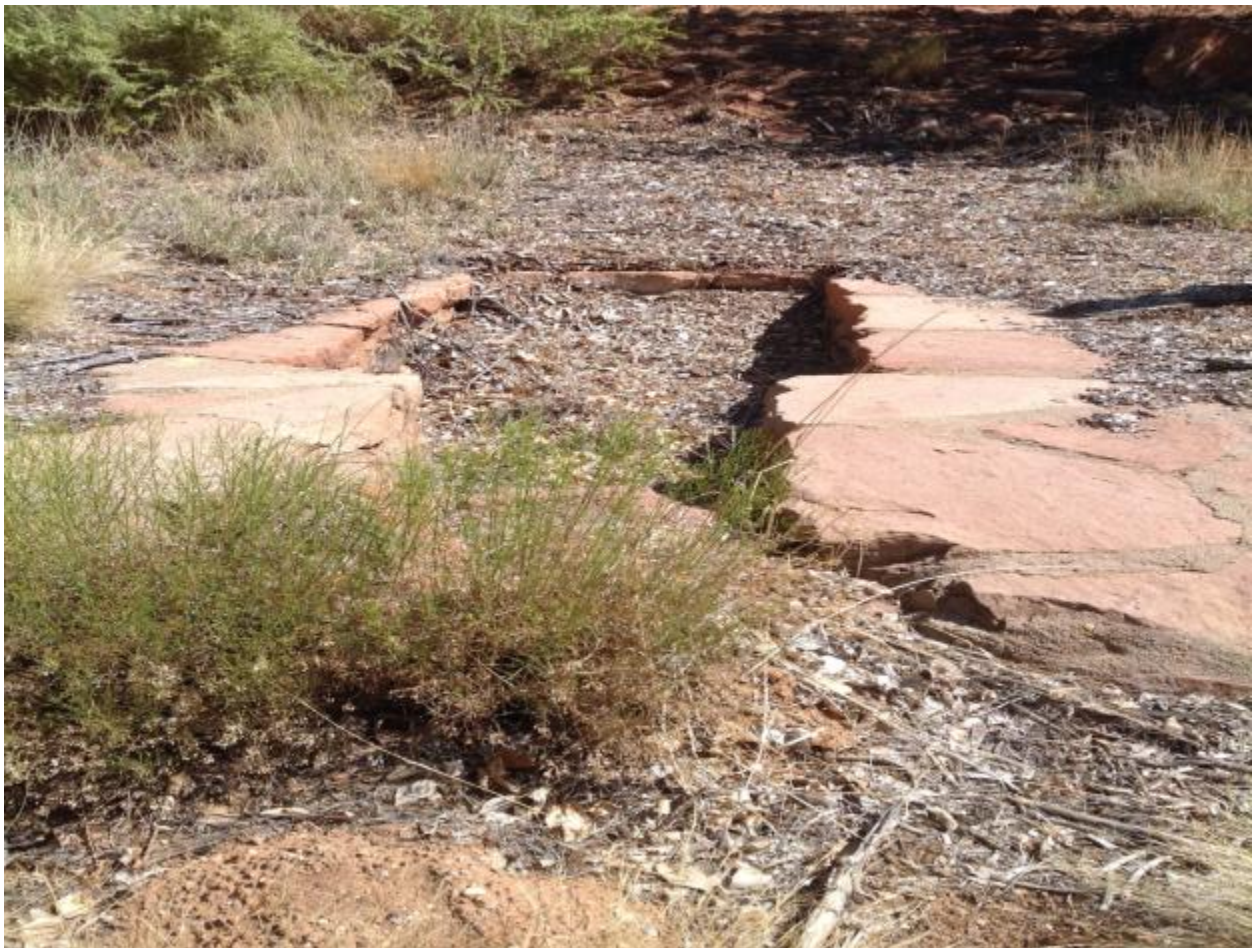
Name of Property: Oak Creek Historic District
City or Vicinity: Springdale
County: Washington
State: Utah
Photographer: Russell Cash
Date Photographed: 8/1/2014
Description: Pit
Feature Number: FEA-017
View Aspect: North
19 of 84
