National Register of Historic Places Registration Form

Historic name: Oak Creek Historic District
Other names/site number: _____
Name of related multiple property listing: Multiple Resources for Zion National Park
(Enter "N/A" if property is not part of a multiple property listing)

The 1987 nomination only listed the district's eligible buildings. This amendment addresses an additional eighty-four historic resources, fifty-five contributing and twenty-nine non-contributing. These features include water features, circulation networks, designed outdoor spaces, vegetation related to land use, and other landscape elements that mirror the "Rustic" style of their associated buildings. The district's period of significance under Criterion C for "NPS Rustic/Naturalistic Design" is 1932-1942. Furthermore, under Criterion A, this amendment adds the context of the Civilian Conservation Corps (CCC) for its work constructing the buildings and

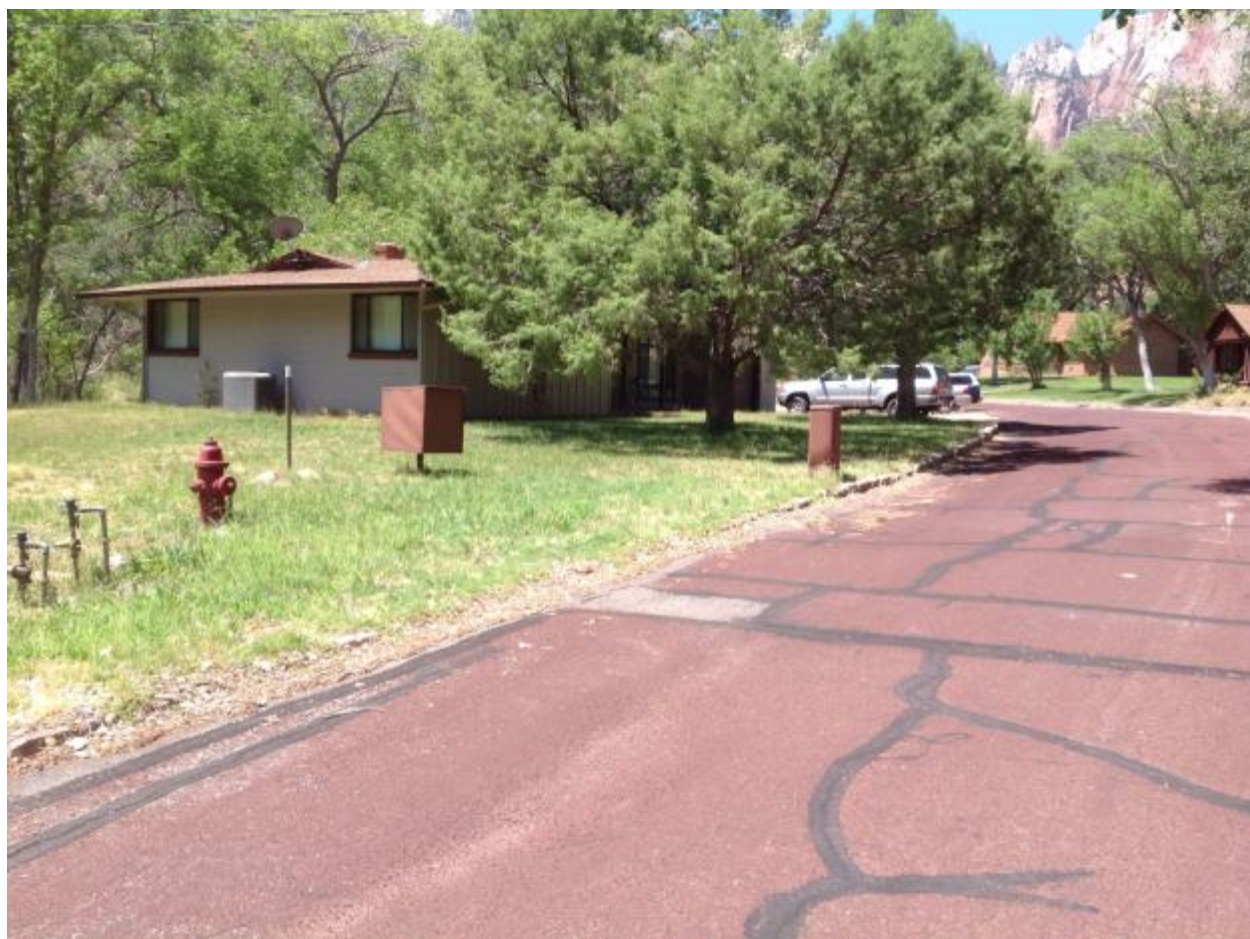
Name of Property: Oak Creek Historic District
City or Vicinity: Springdale
County: Washington
State: Utah
Photographer: Russell Cash
Date Photographed: 8/1/2014
Description: Curb along HS-0014 and Oak Creek Road
Feature Number: FEA-019
View Aspect: South-Southwest
21 of 84

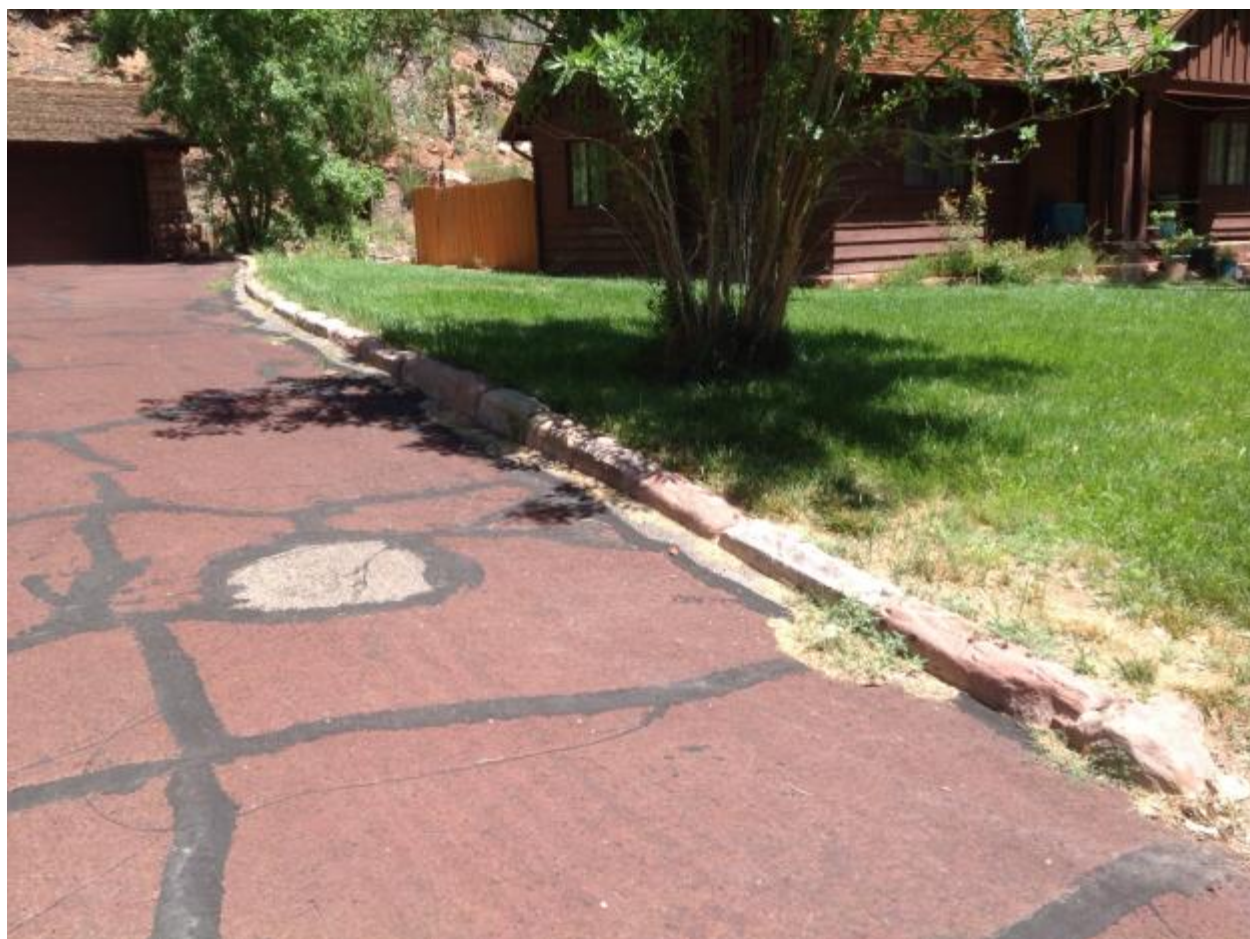
Name of Property: Oak Creek Historic District
City or Vicinity: Springdale
County: Washington
State: Utah
Photographer: Russell Cash
Date Photographed: 8/1/2014
Description: Curb for driveway of HS-0008/HS-0009
Feature Number: FEA-020a
View Aspect: Northeast
22 of 84

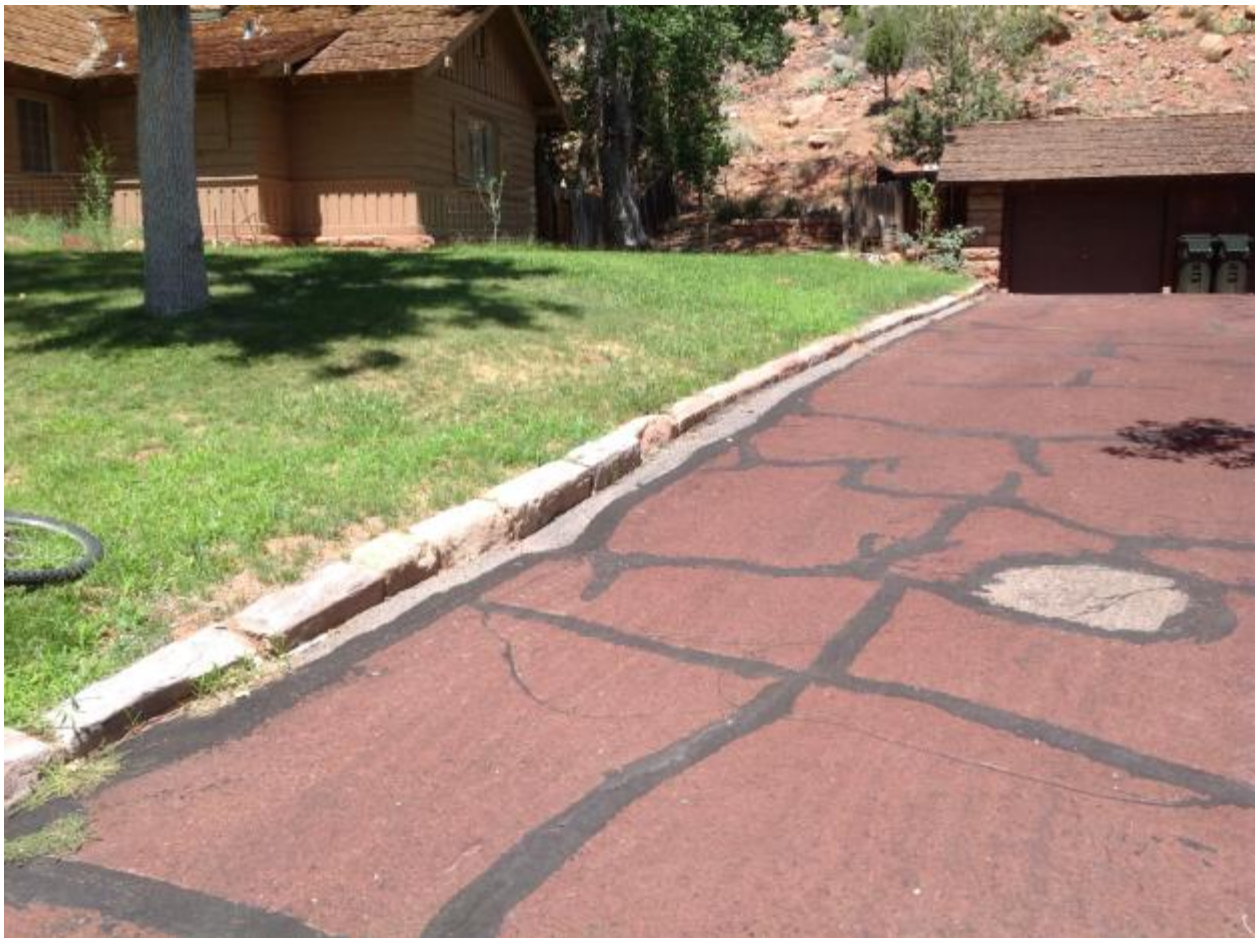
Name of Property: Oak Creek Historic District
City or Vicinity: Springdale
County: Washington
State: Utah
Photographer: Russell Cash
Date Photographed: 8/1/2014
Description: Curb of driveway of HS-0008/HS-0009
Feature Number: FEA-020b
View Aspect: Northwest
23 of 84

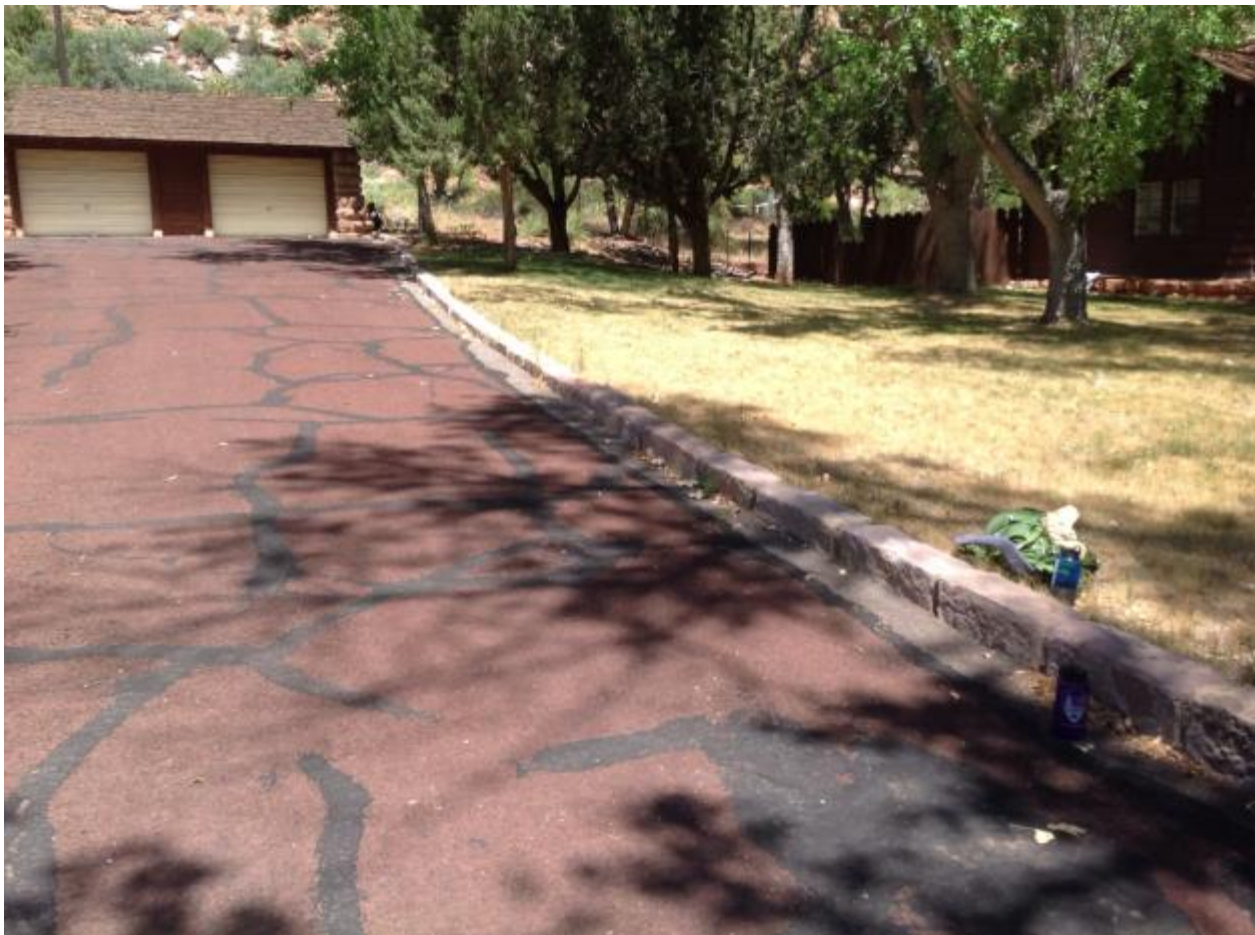
Name of Property: Oak Creek Historic District
City or Vicinity: Springdale
County: Washington
State: Utah
Photographer: Russell Cash
Date Photographed: 8/1/2014
Description: Curb for driveway of HS-0010/HS-0011
Feature Number: FEA-021a
View Aspect: Northeast
24 of 84

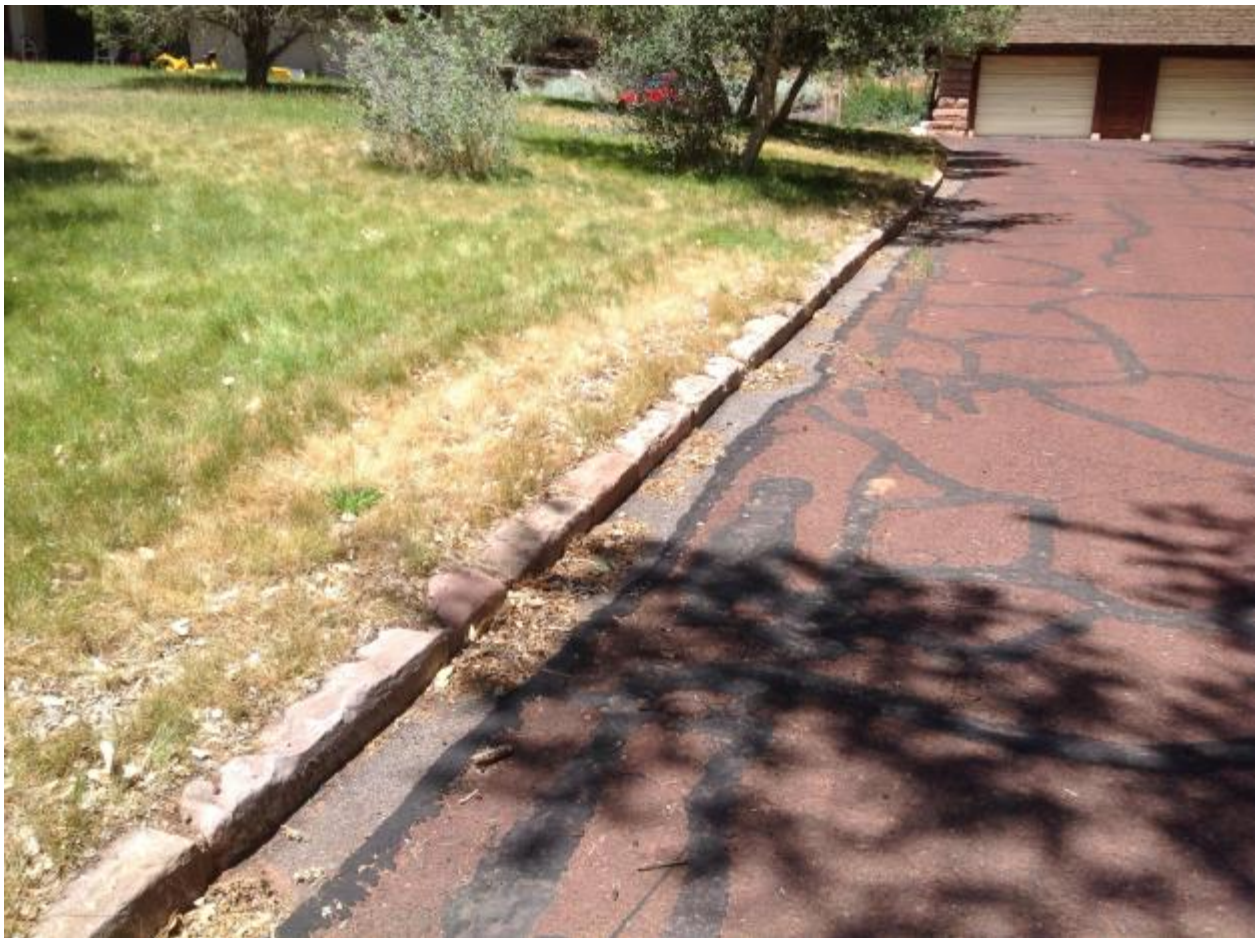
Name of Property: Oak Creek Historic District
City or Vicinity: Springdale
County: Washington
State: Utah
Photographer: Russell Cash
Date Photographed: 8/1/2014
Description: Curb for driveway of HS-0010/HS-0011
Feature Number: FEA-021b
View Aspect: Northwest
25 of 84

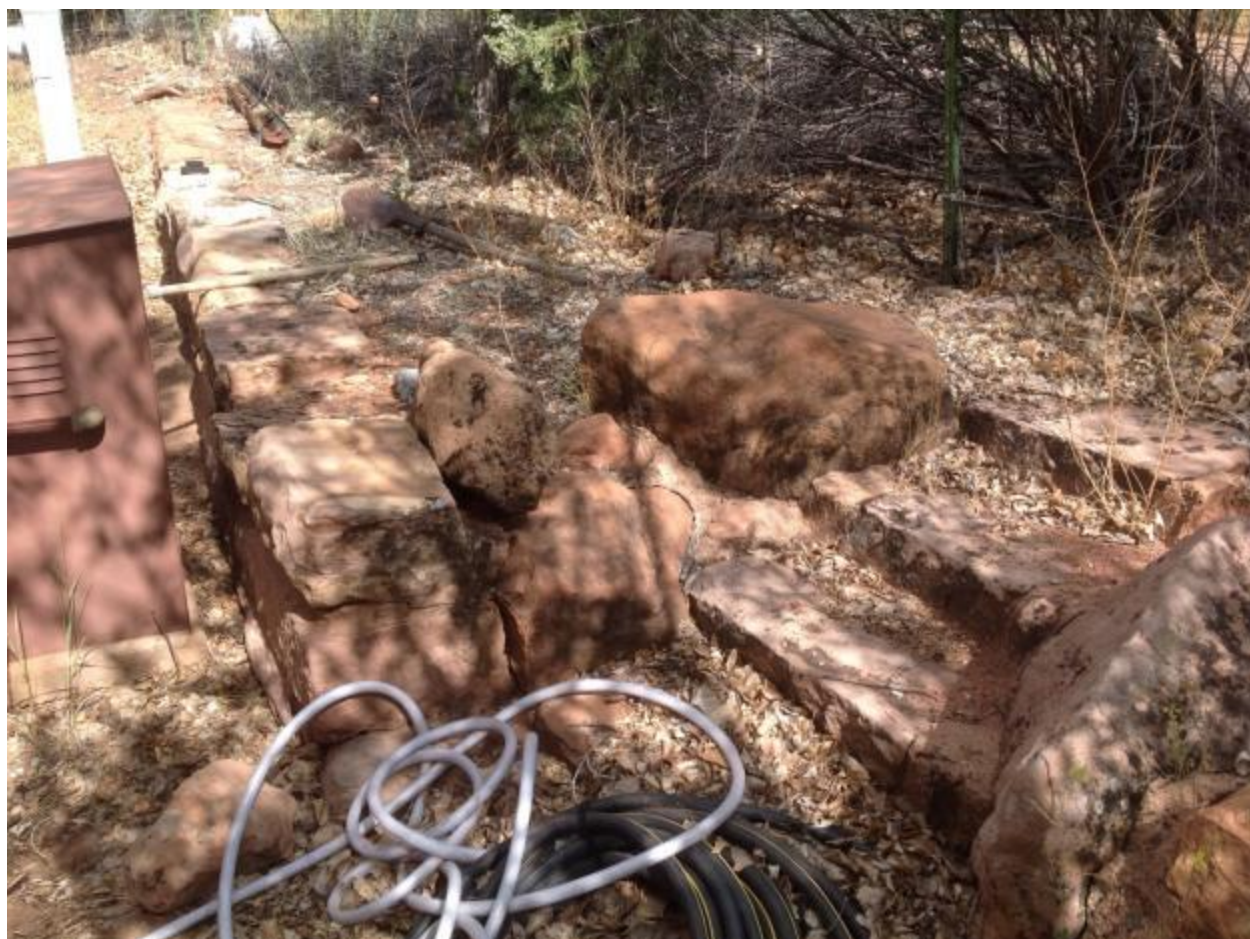
Name of Property: Oak Creek Historic District
City or Vicinity: Springdale
County: Washington
State: Utah
Photographer: Russell Cash
Date Photographed: 8/1/2014
Description: Foundation for former residence HS-0007
Feature Number: FEA-022
View Aspect: West-Northwest
26 of 84

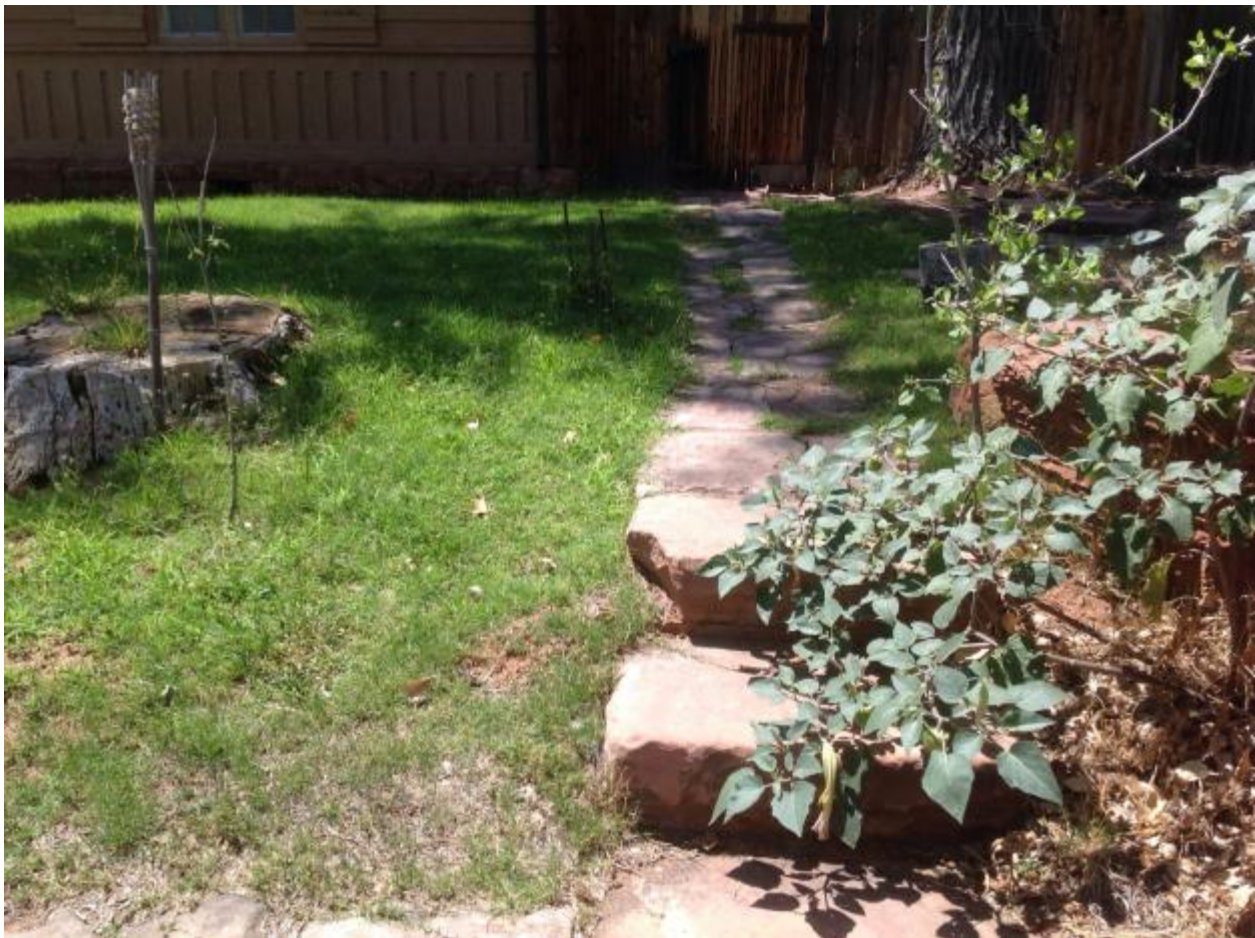
Name of Property: Oak Creek Historic District
City or Vicinity: Springdale
County: Washington
State: Utah
Photographer: Russell Cash
Date Photographed: 8/1/2014
Description: Walkway for HS-0009
Feature Number: FEA-024
View Aspect: West
28 of 84

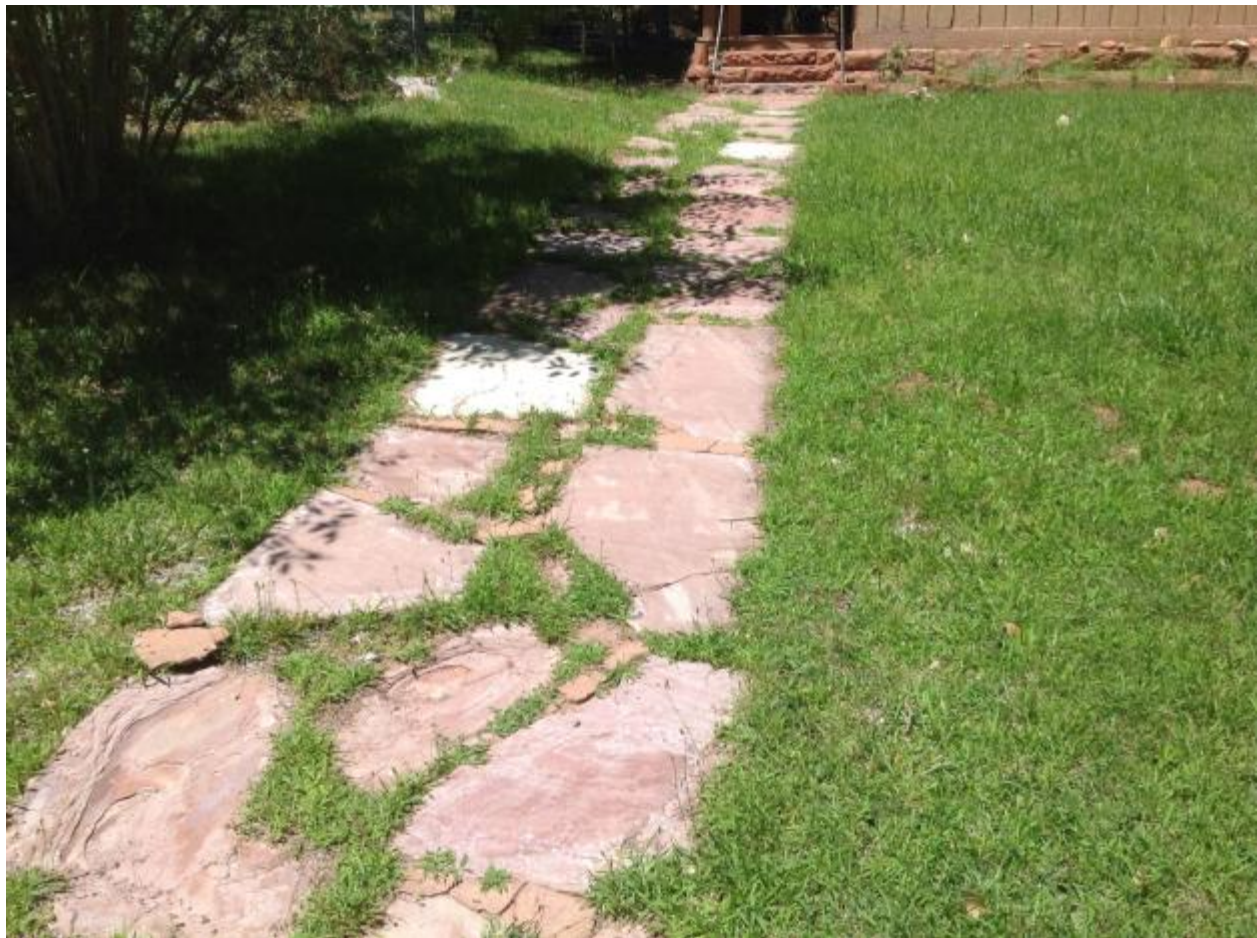
Name of Property: Oak Creek Historic District
City or Vicinity: Springdale
County: Washington
State: Utah
Photographer: Russell Cash
Date Photographed: 8/1/2014
Description: Walkway for HS-0009
Feature Number: FEA-025
View Aspect: North
29 of 84

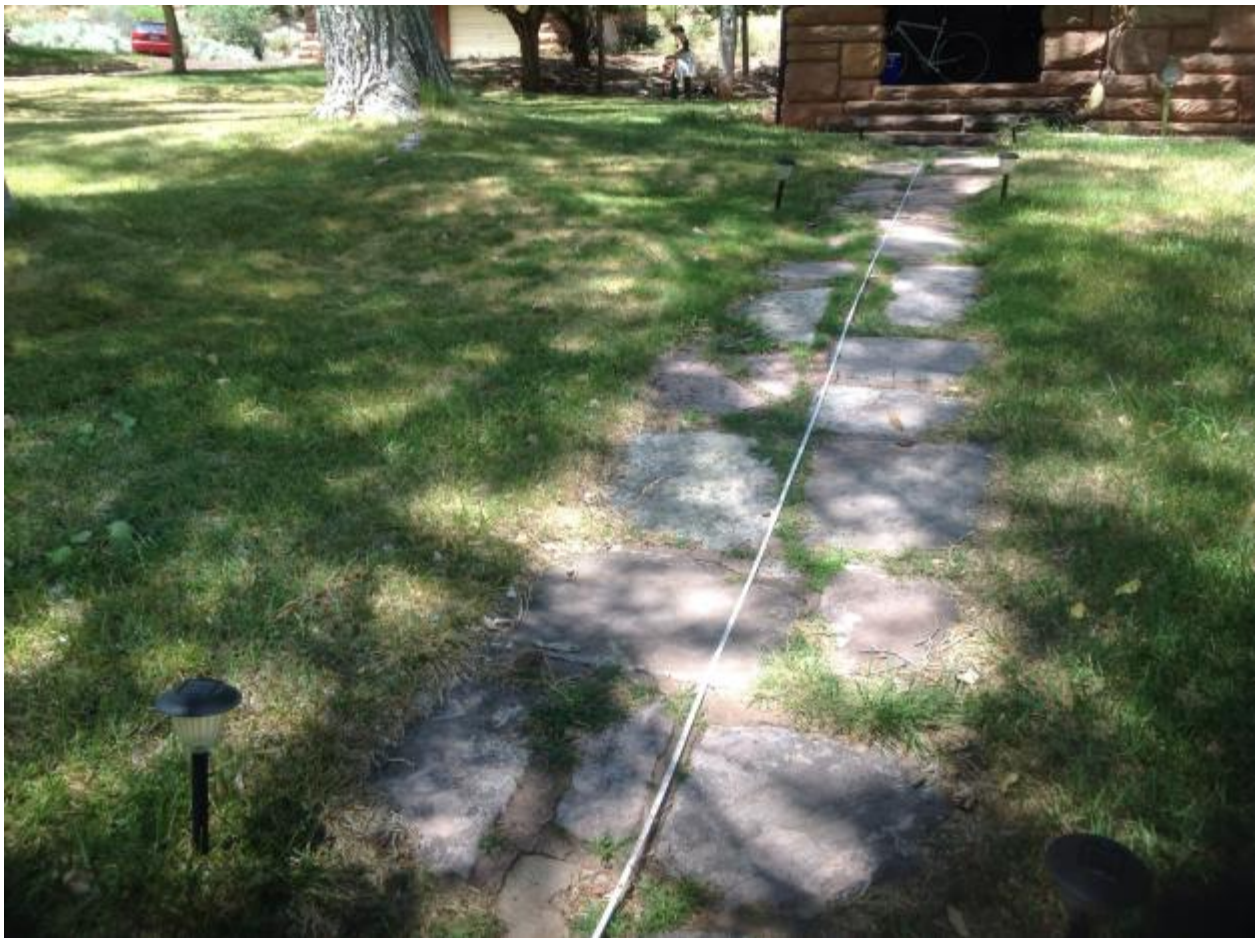
Name of Property: Oak Creek Historic District
City or Vicinity: Springdale
County: Washington
State: Utah
Photographer: Russell Cash
Date Photographed: 8/1/2014
Description: Walkway for HS-0010
Feature Number: FEA-026
View Aspect: North
30 of 84

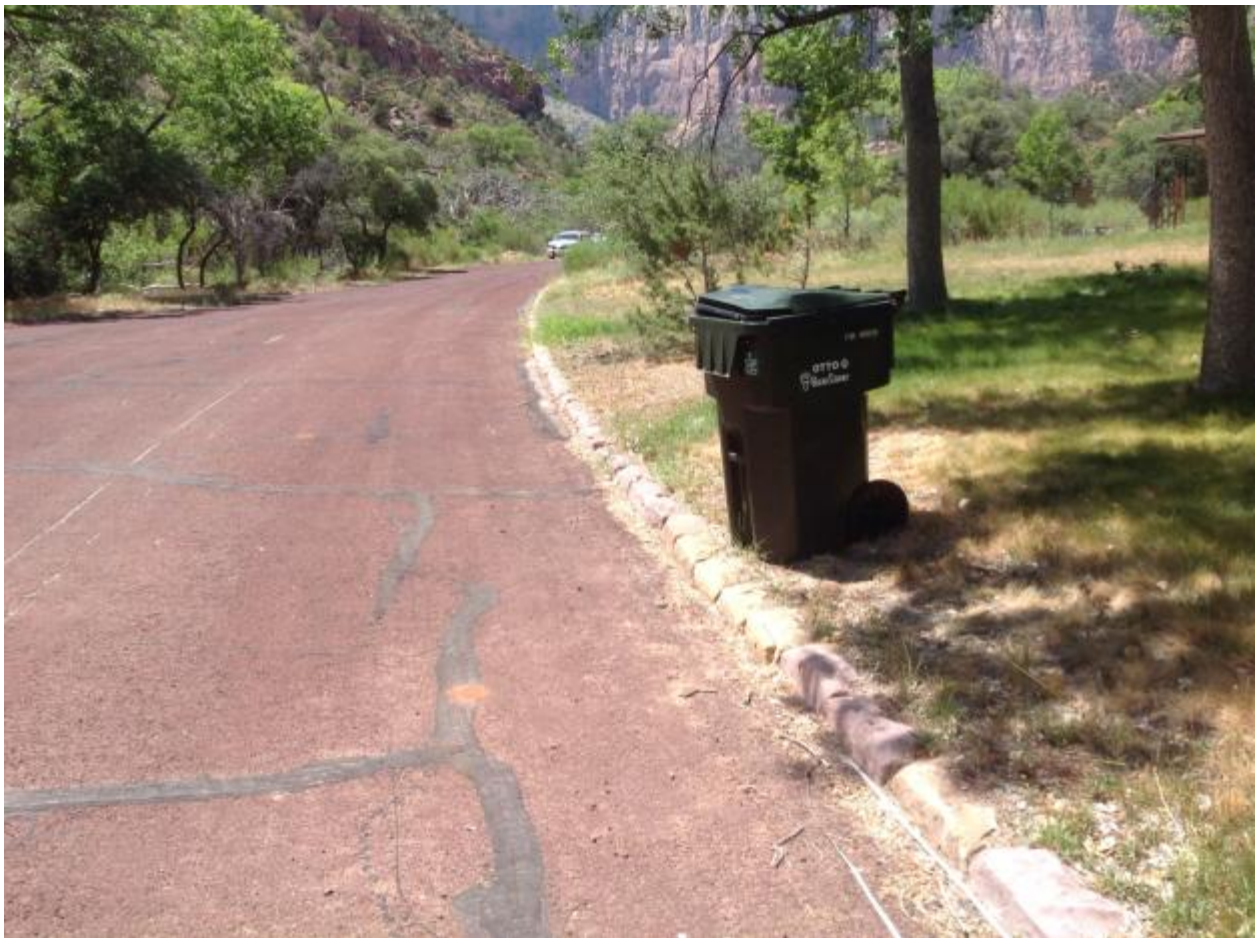
Name of Property: Oak Creek Historic District
City or Vicinity: Springdale
County: Washington
State: Utah
Photographer: Russell Cash
Date Photographed: 8/1/2014
Description: Curb along HS-0011 and Oak Creek Road
Feature Number: FEA-027
View Aspect: West-Northwest
31 of 84

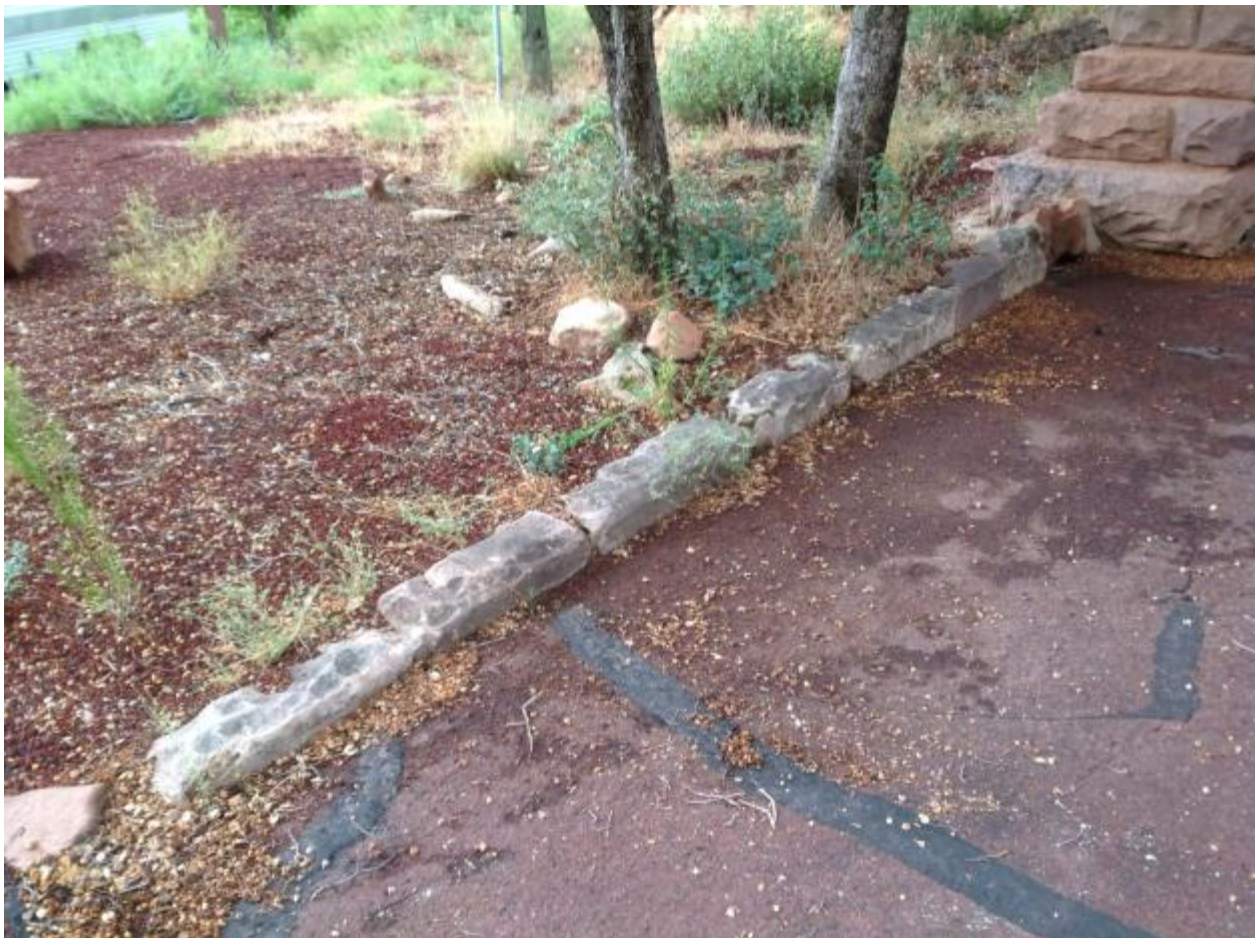
Name of Property: Oak Creek Historic District
City or Vicinity: Springdale
County: Washington
State: Utah
Photographer: Russell Cash
Date Photographed: 8/1/2014
Description: Curb along driveway of garage HS-0111
Feature Number: FEA-028
View Aspect: East
32 of 84

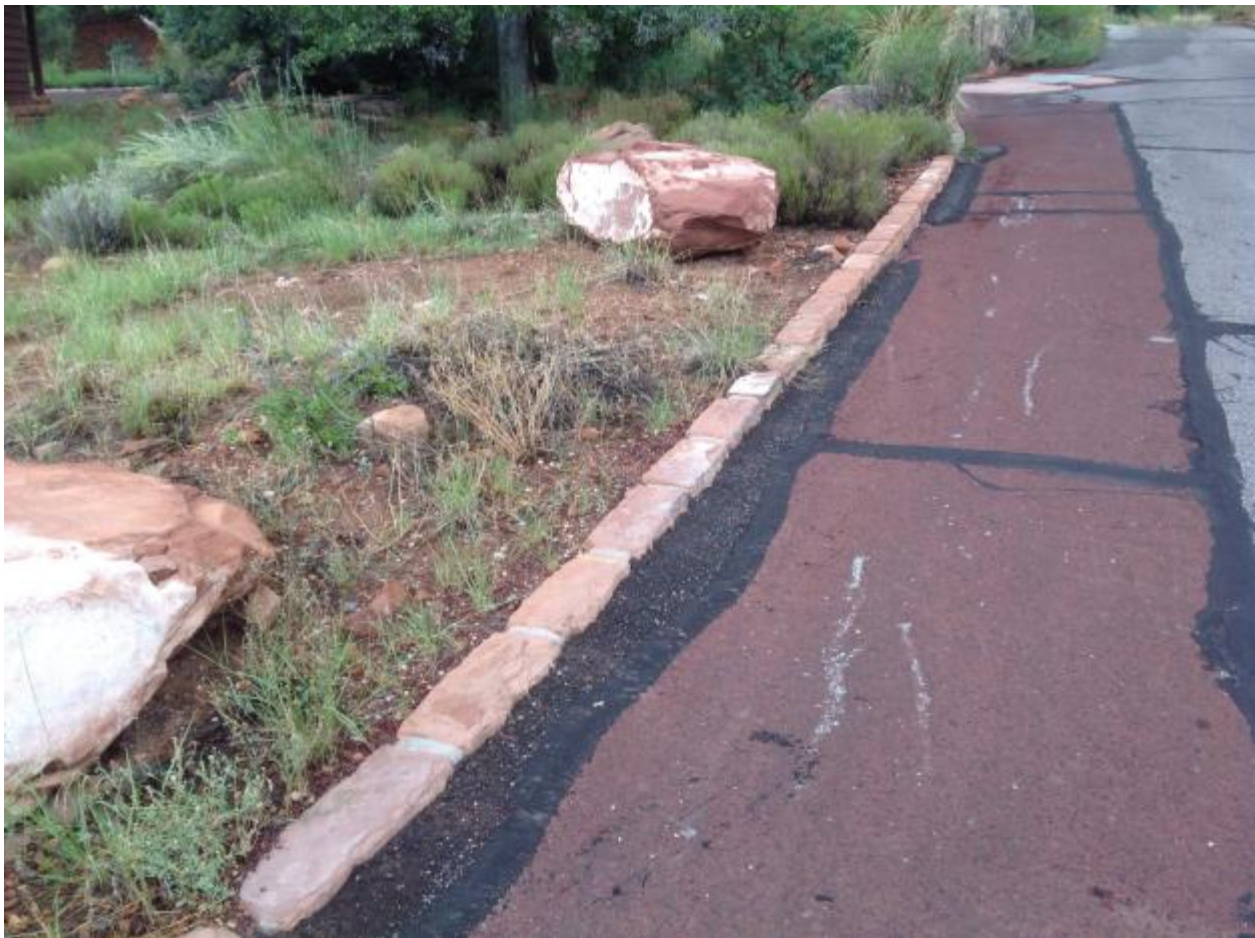
Name of Property: Oak Creek Historic District
City or Vicinity: Springdale
County: Washington
State: Utah
Photographer: Russell Cash
Date Photographed: 8/4/2014
Description: Curb along Garage HS-0111 and Oak Creek Road
Feature Number: FEA-029
View Aspect: West
33 of 84

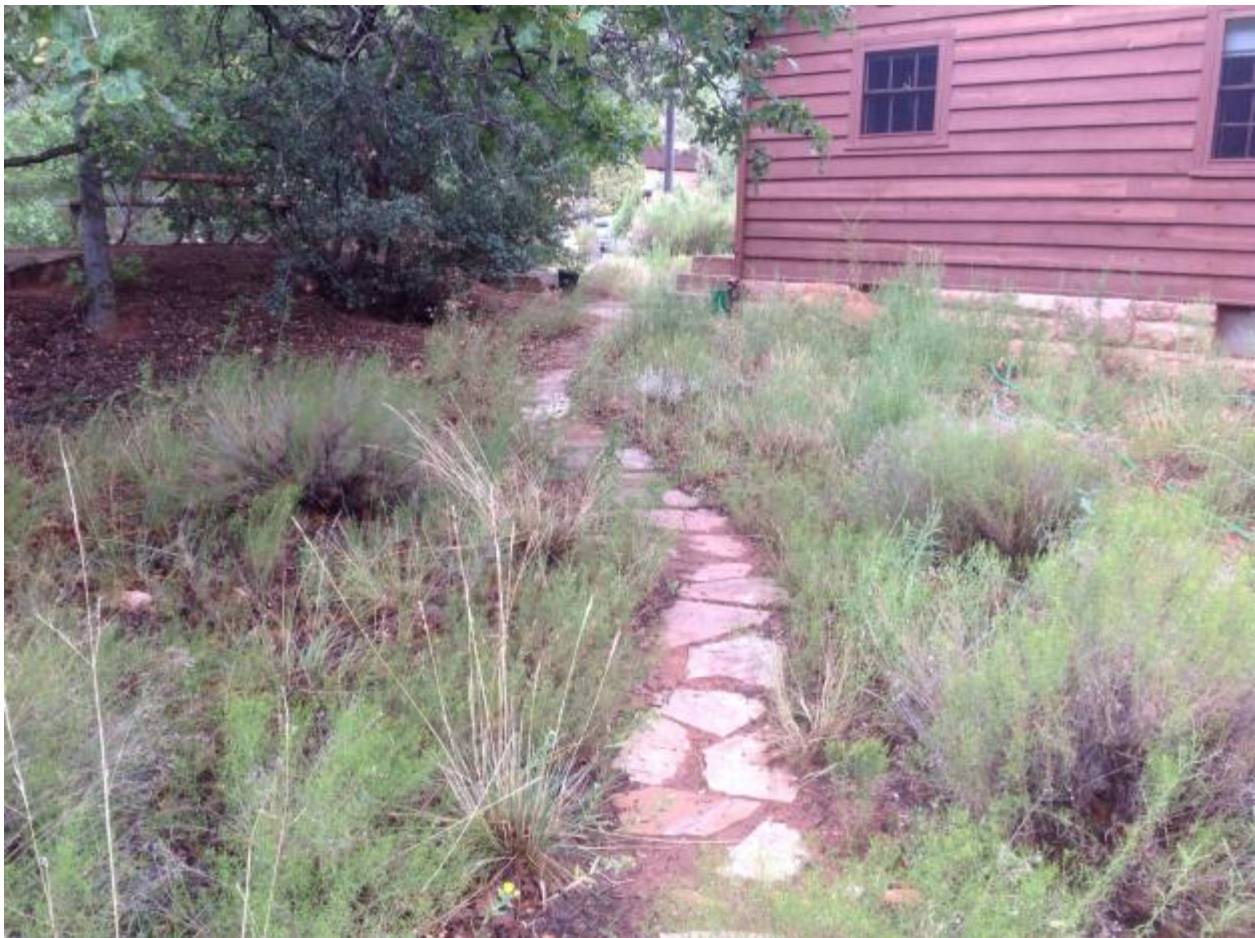
Name of Property: Oak Creek Historic District
City or Vicinity: Springdale
County: Washington
State: Utah
Photographer: Russell Cash
Date Photographed: 8/4/2014
Description: Walkway between HS-0111 and HS-0024
Feature Number: FEA-030
View Aspect: Southwest
34 of 84

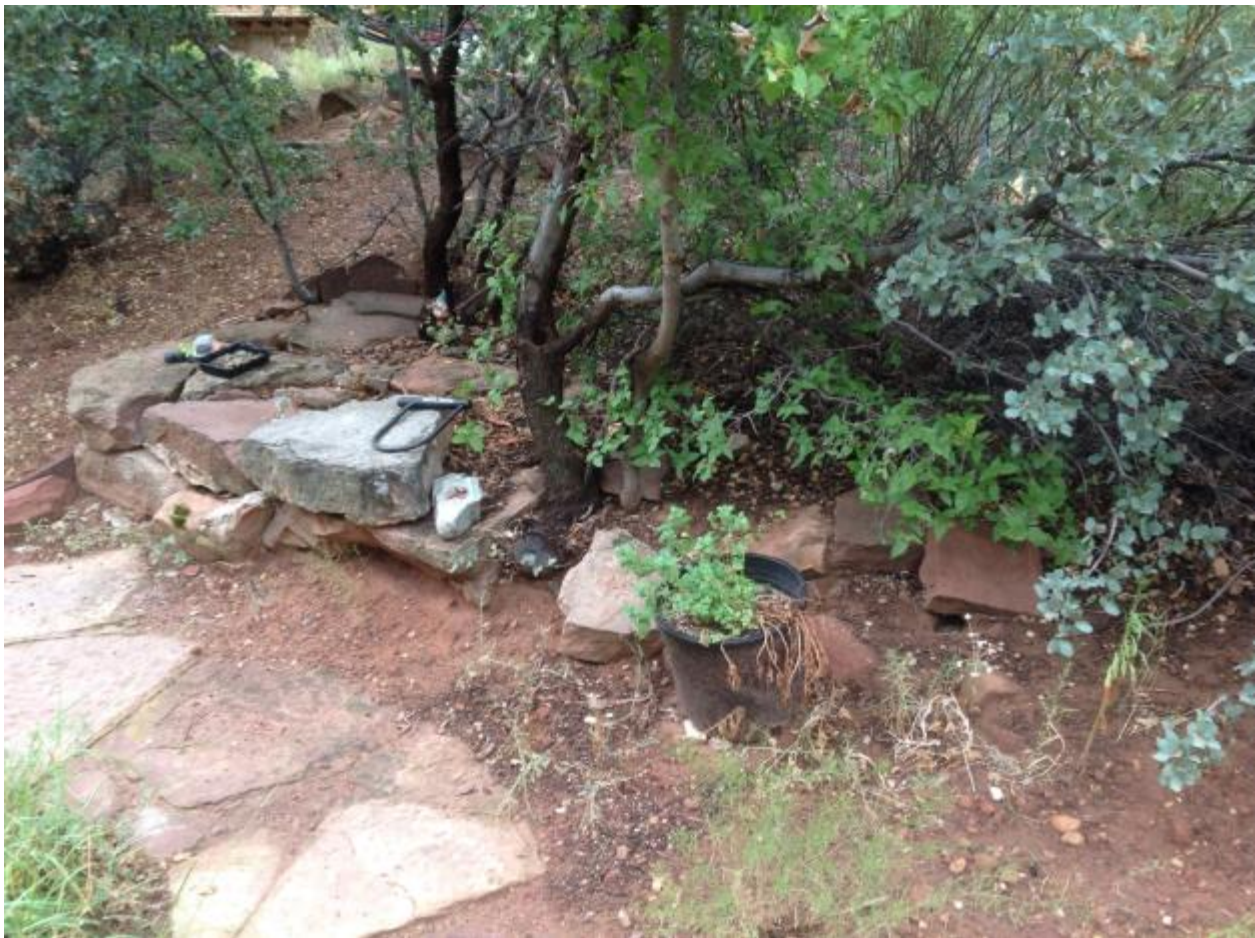
Name of Property: Oak Creek Historic District
City or Vicinity: Springdale
County: Washington
State: Utah
Photographer: Russell Cash
Date Photographed: 8/4/2014
Description: Retaining wall in back yard of HS-0024
Feature Number: FEA-031
View Aspect: Southeast
35 of 84

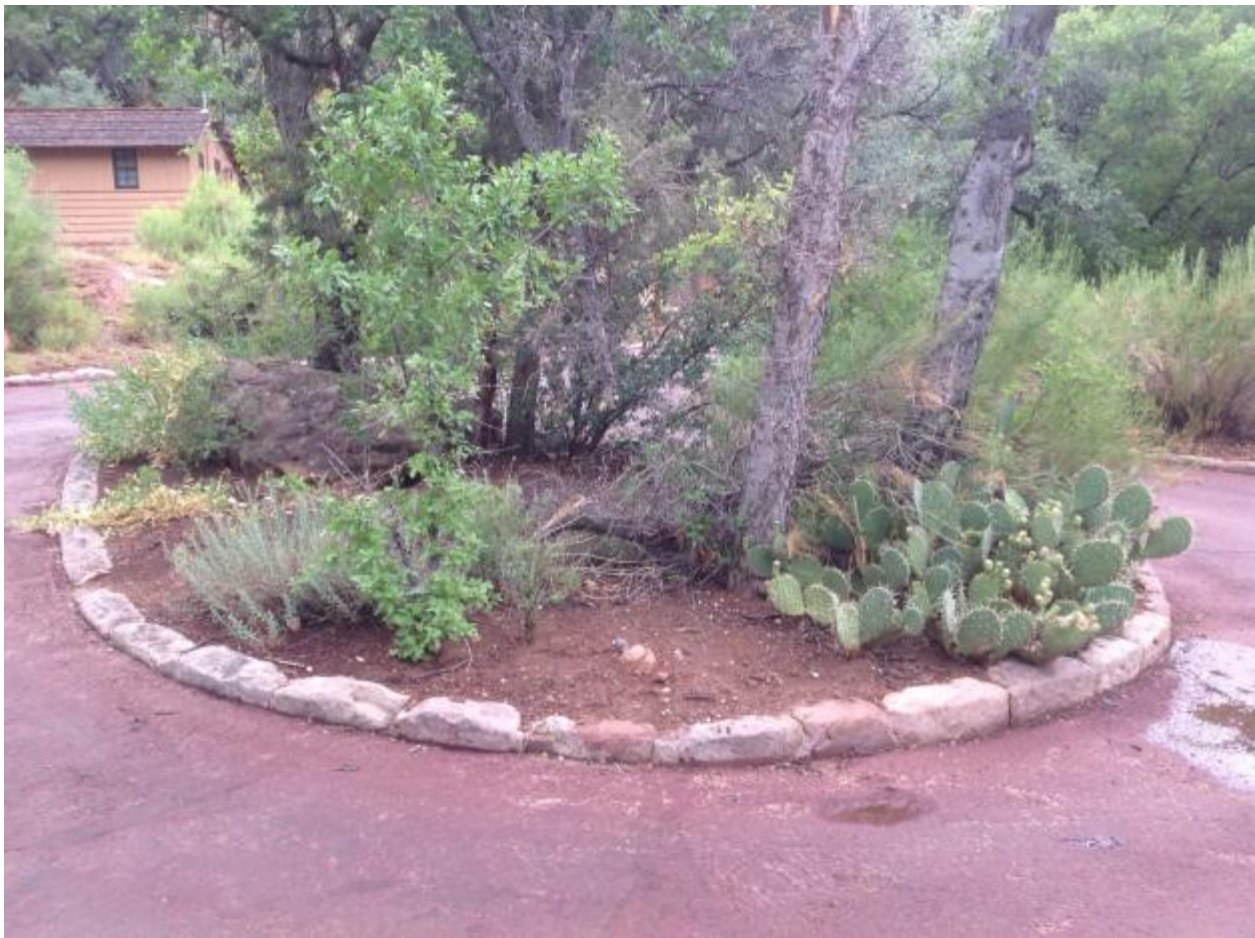
Name of Property: Oak Creek Historic District
City or Vicinity: Springdale
County: Washington
State: Utah
Photographer: Russell Cash
Date Photographed: 8/4/2014
Description: Island with curbing between HS-0024 and HS-0025
Feature Number: FEA-032
View Aspect: Northeast
36 of 84

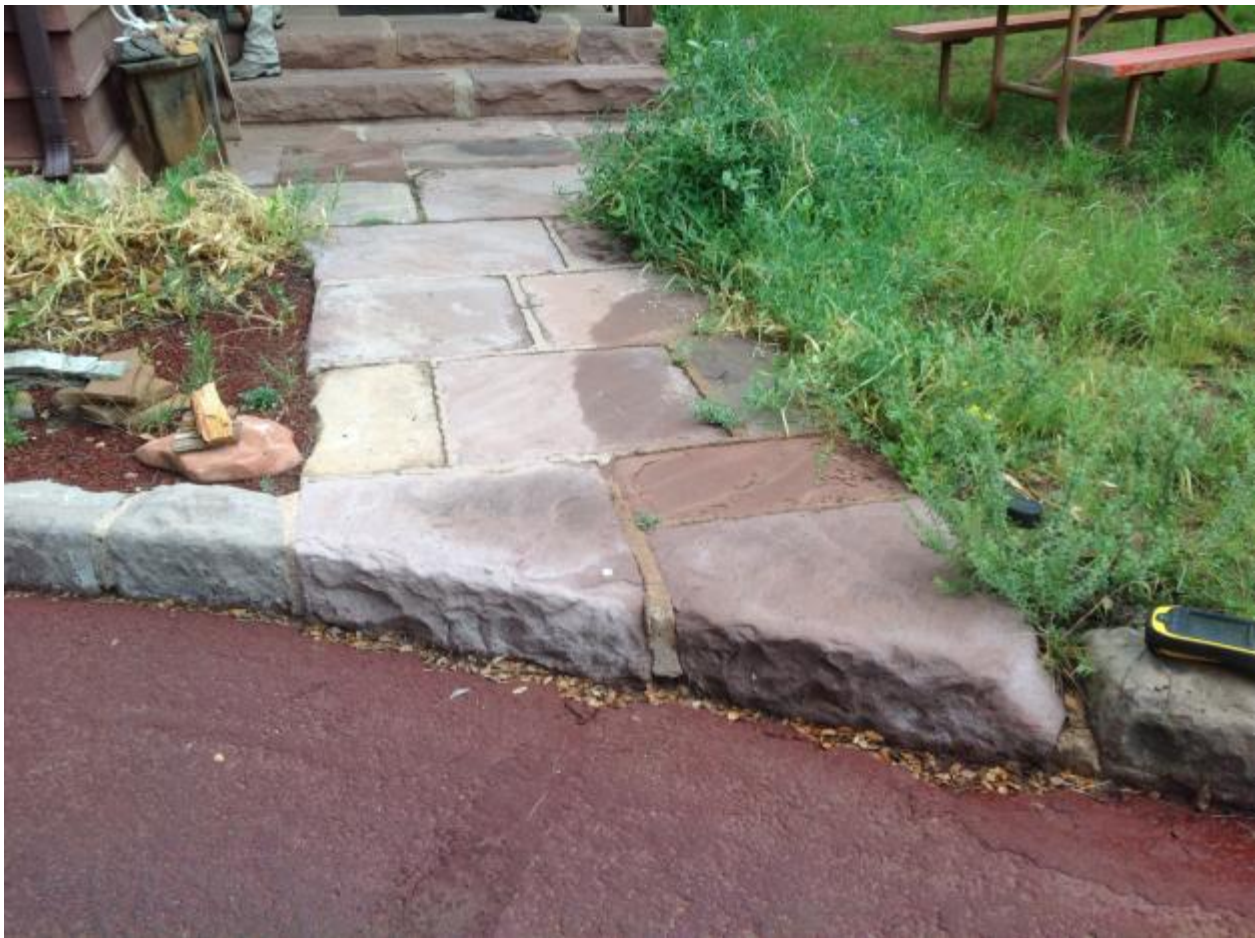
Name of Property: Oak Creek Historic District
City or Vicinity: Springdale
County: Washington
State: Utah
Photographer: Russell Cash
Date Photographed: 8/4/2014
Description: Front walkway of HS-0025
Feature Number: FEA-033
View Aspect: West-Southwest
37 of 84

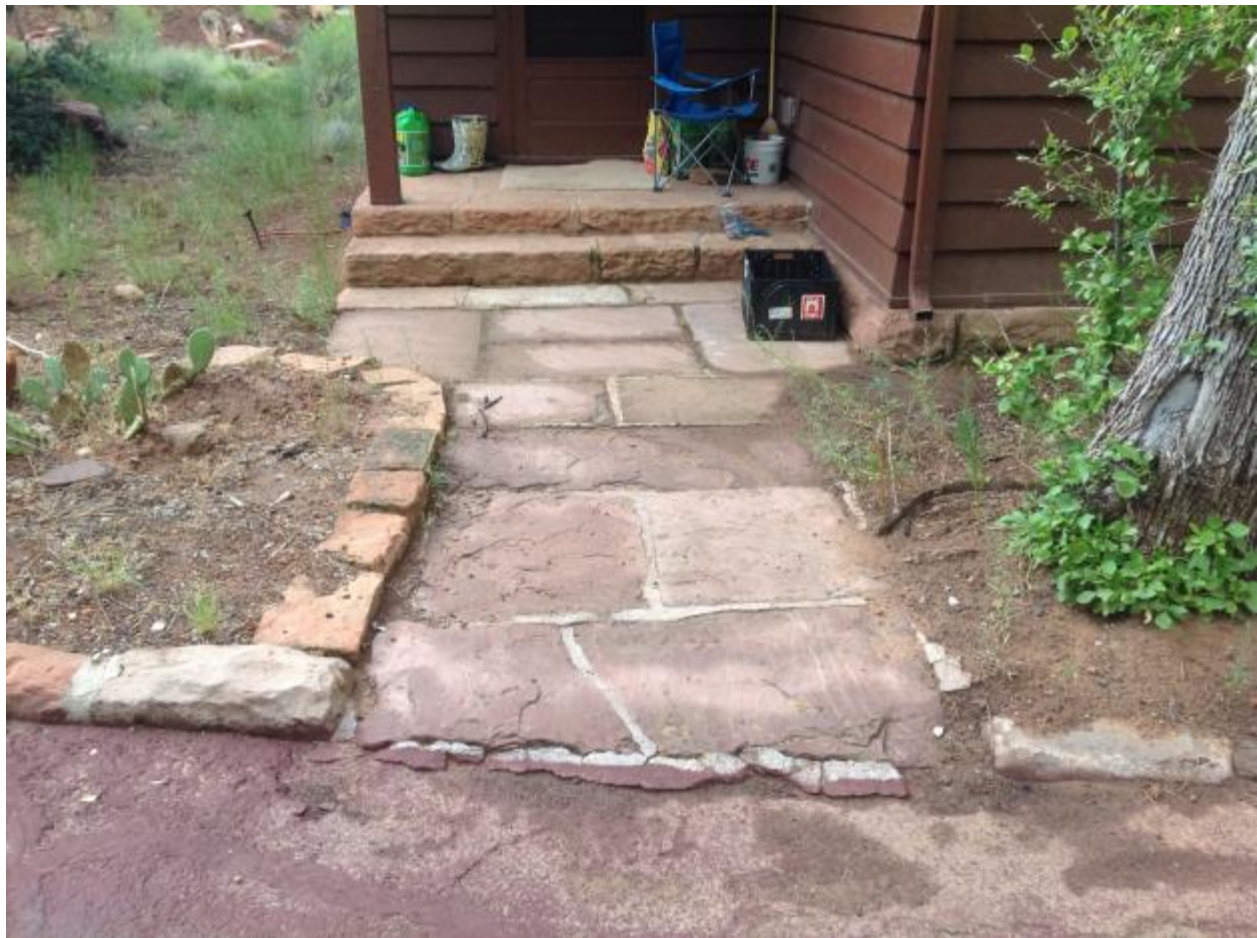
Name of Property: Oak Creek Historic District
City or Vicinity: Springdale
County: Washington
State: Utah
Photographer: Russell Cash
Date Photographed: 8/4/2014
Description: Front walkway of HS-0024
Feature Number: FEA-034
View Aspect: East-Southeast
38 of 84

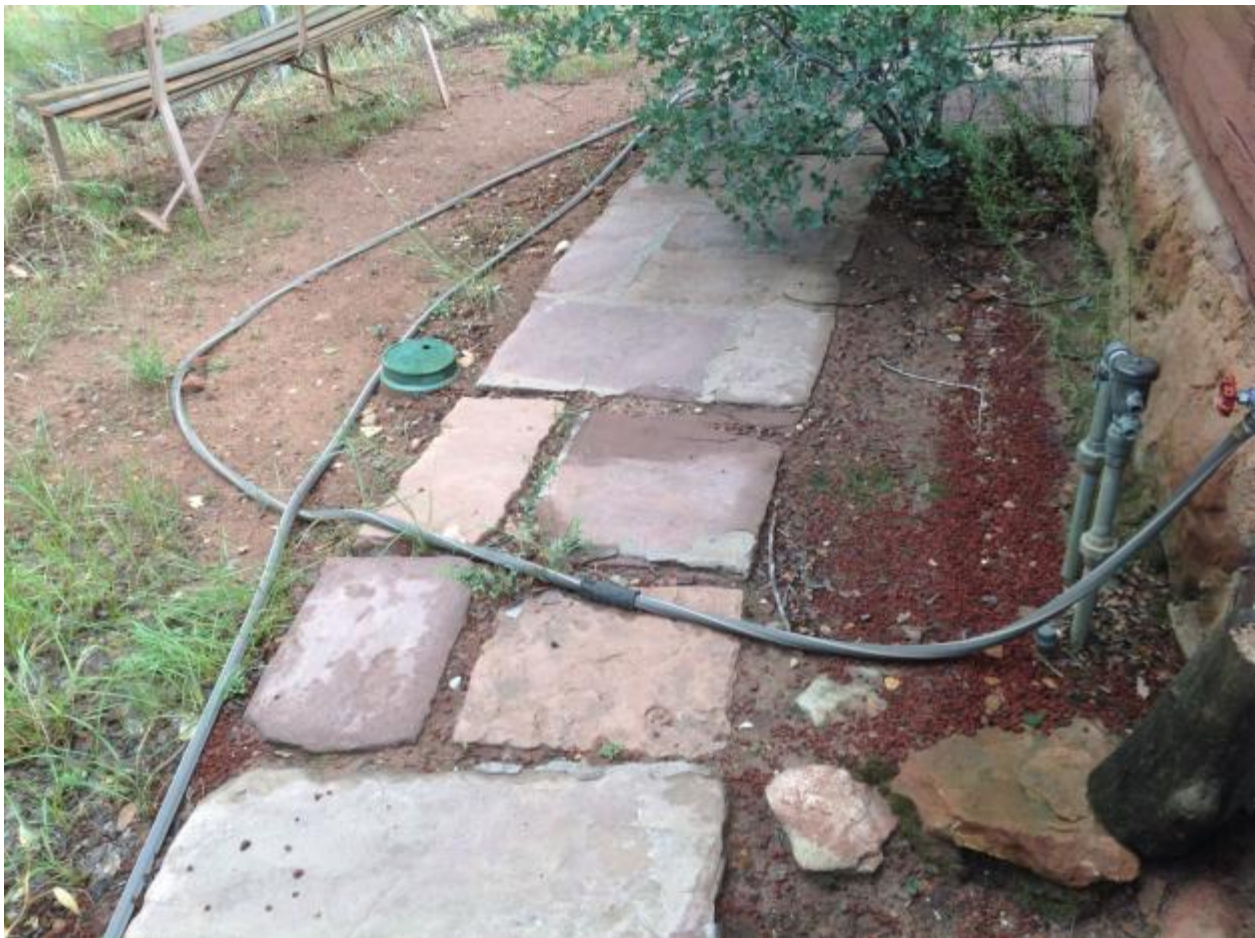
Name of Property: Oak Creek Historic District
City or Vicinity: Springdale
County: Washington
State: Utah
Photographer: Russell Cash
Date Photographed: 8/4/2014
Description: Walkway around HS-0025
Feature Number: FEA-025
View Aspect: West
39 of 84
