National Register of Historic Places Registration Form

Historic name: Oak Creek Historic District
Other names/site number: _____
Name of related multiple property listing: Multiple Resources for Zion National Park
(Enter "N/A" if property is not part of a multiple property listing)

The 1987 nomination only listed the district's eligible buildings. This amendment addresses an additional eighty-four historic resources, fifty-five contributing and twenty-nine non-contributing. These features include water features, circulation networks, designed outdoor spaces, vegetation related to land use, and other landscape elements that mirror the "Rustic" style of their associated buildings. The district's period of significance under Criterion C for "NPS Rustic/Naturalistic Design" is 1932-1942. Furthermore, under Criterion A, this amendment adds the context of the Civilian Conservation Corps (CCC) for its work constructing the buildings and

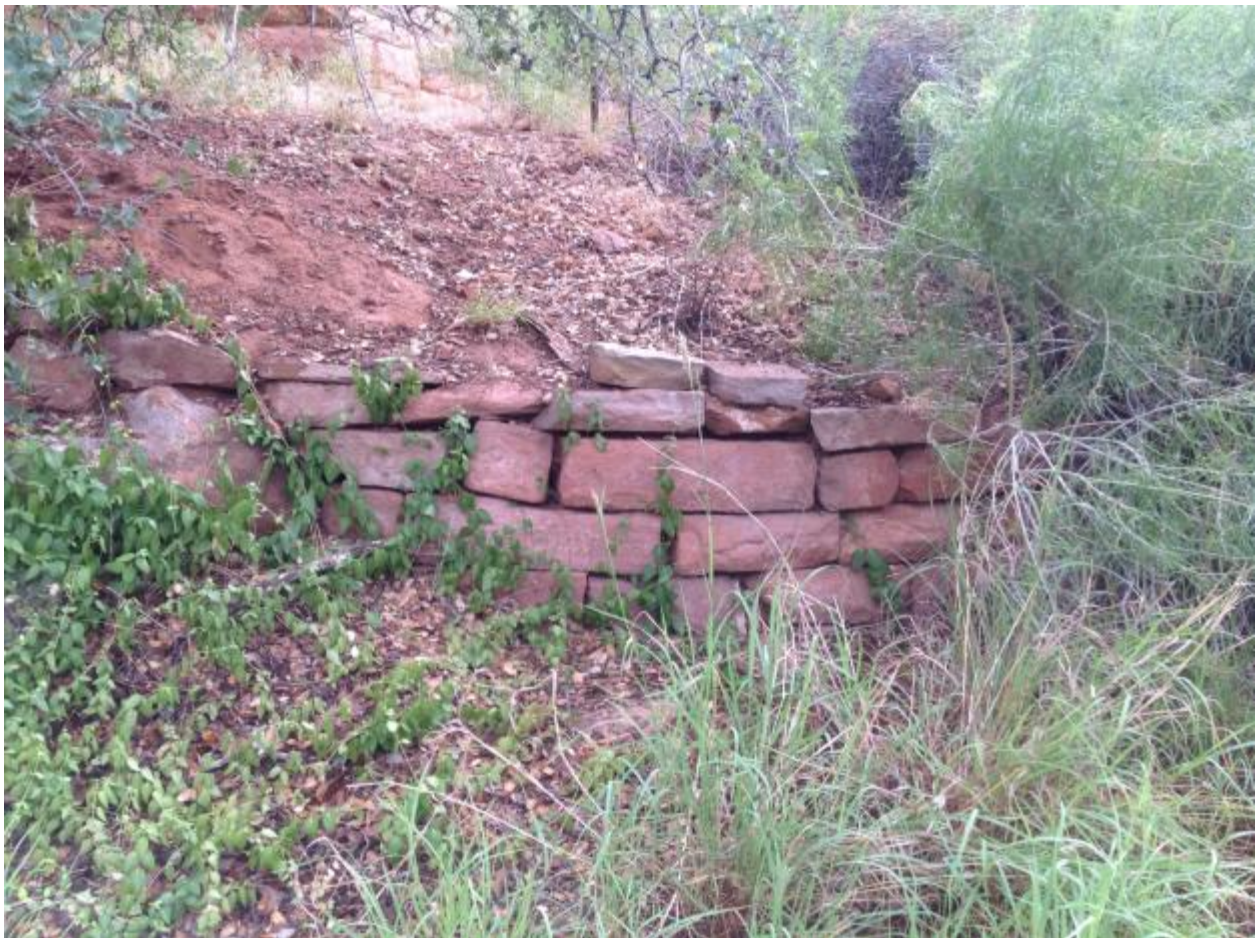
Retaining walls found throughout the historic district exhibit rustic sandstone work. These appear in the residential area and in the engineering of Oak Creek. Retaining walls such as FEA-037 and FEA-038, built with their associated structures between 1935 and 1937, secured hillsides that were susceptible to erosion and sliding during heavy rains. Both features consist of stones dry laid against the hill without mortar. These are particularly rustic due to their rough finish (many stones may have come from the site rather than the quarry) and the lack of skilled labor required for construction. A later retaining wall example is at the dormitory where retaining walls enclosed the courtyard and rear patio (FEA-002, constructed 1941-42) that held back a hill and stabilized these outdoor spaces. With finished sandstone, even coursing, and substantial use of mortar, this retaining wall reflects the "Rustic" style and pioneer building techniques and design also used in the dorm. Retaining walls (FEA-058 and FEA-059) along Oak Creek maintain bank structure and protect the maintenance area and the access road, which runs parallel to the creek. These walls include rough finished local sandstone with uneven coursing, and substantial mortar because of the need to withstand the force of water.

Name of Property: Oak Creek Historic District
City or Vicinity: Springdale
County: Washington
State: Utah
Photographer: Russell Cash
Date Photographed: 8/4/2014
Description: Retaining wall between HS-0025 and HS-0026
Feature Number: FEA-037
View Aspect: North
41 of 84

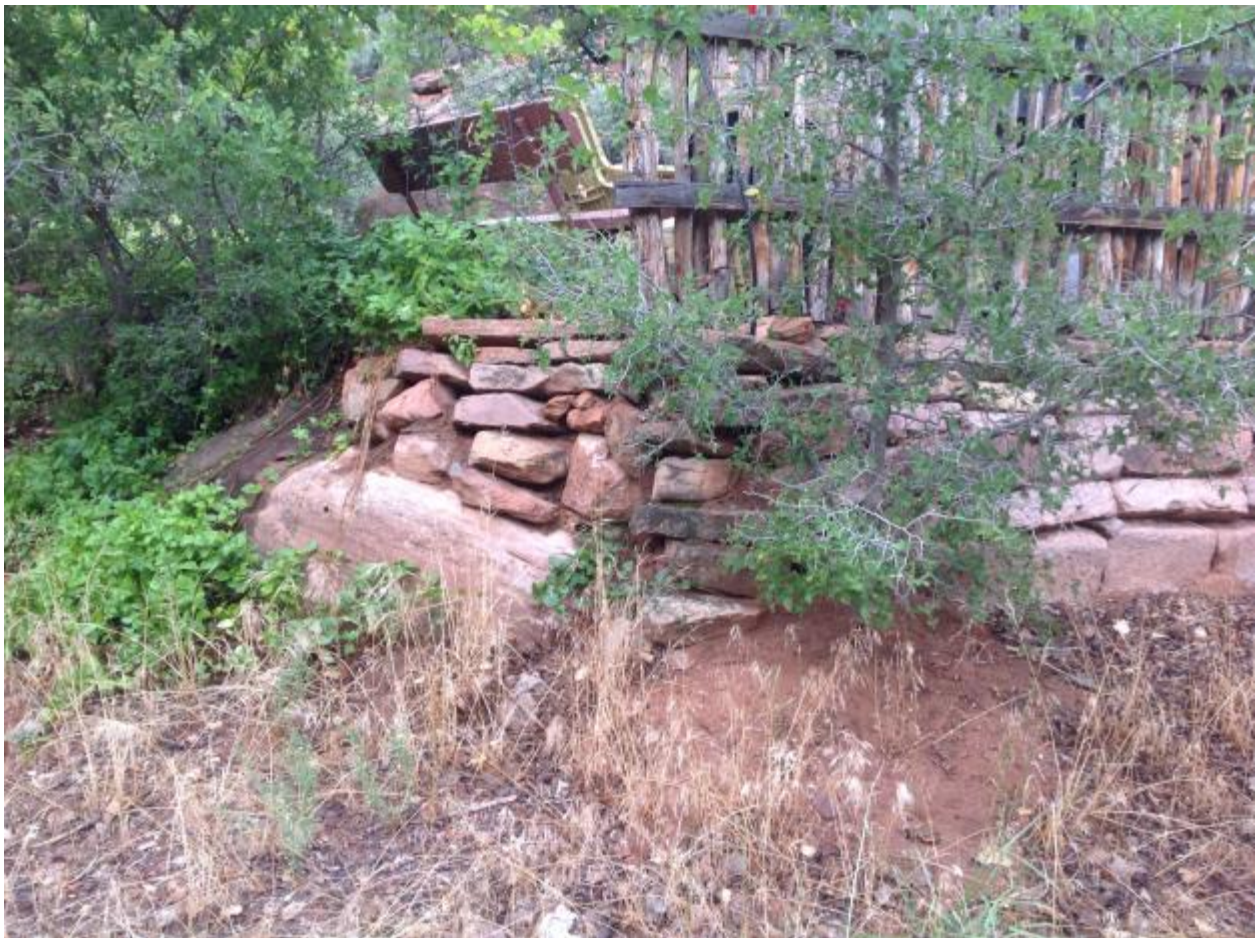
Name of Property: Oak Creek Historic District
City or Vicinity: Springdale
County: Washington
State: Utah
Photographer: Russell Cash
Date Photographed: 8/4/2014
Description: Retaining wall around backyard of HS-0026
Feature Number: FEA-038
View Aspect: North
42 of 84

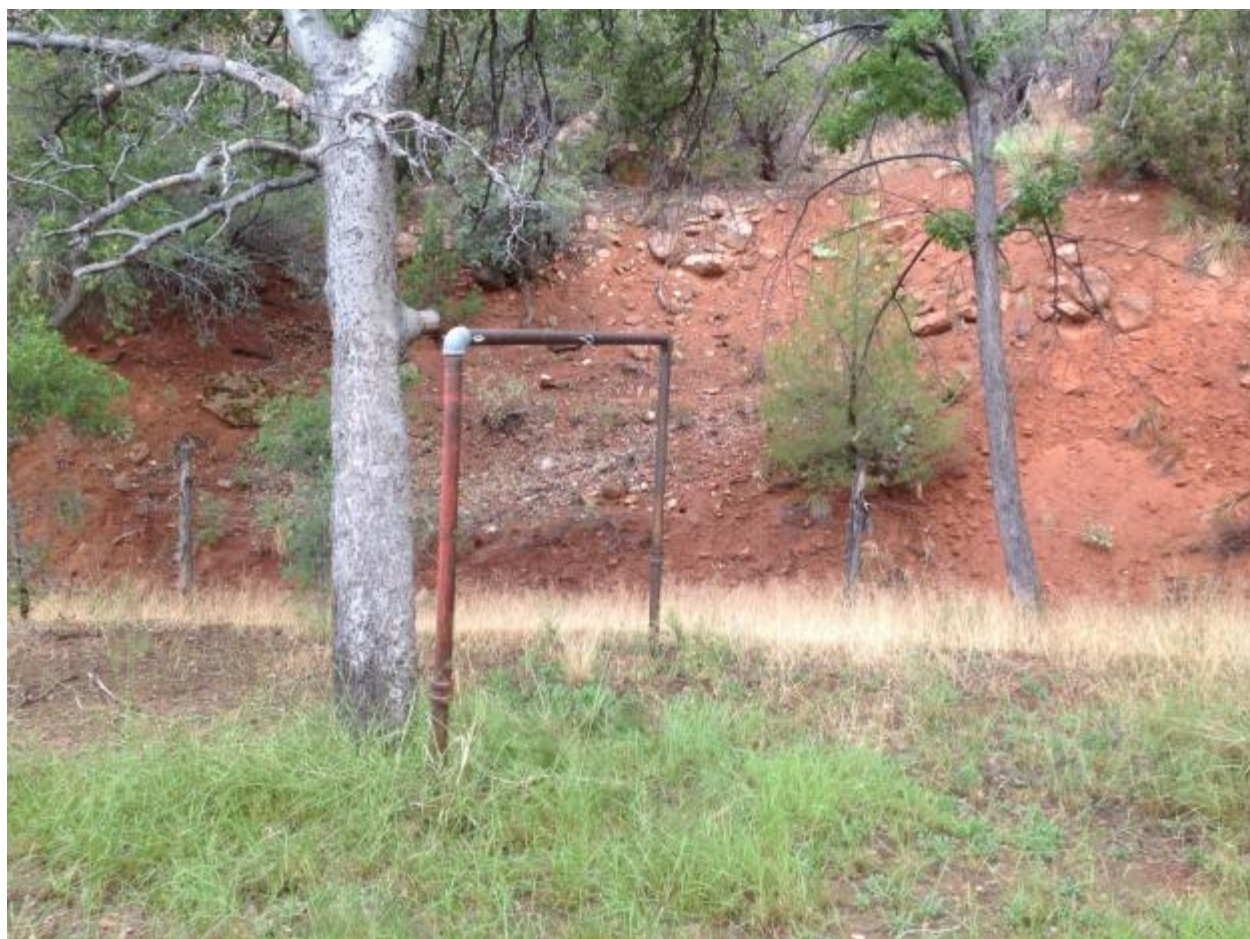
Name of Property: Oak Creek Historic District
City or Vicinity: Springdale
County: Washington
State: Utah
Photographer: Russell Cash
Date Photographed: 8/4/2014
Description: Clothesline for HS-0025
Feature Number: FEA-039
View Aspect: Southwest
43 of 84

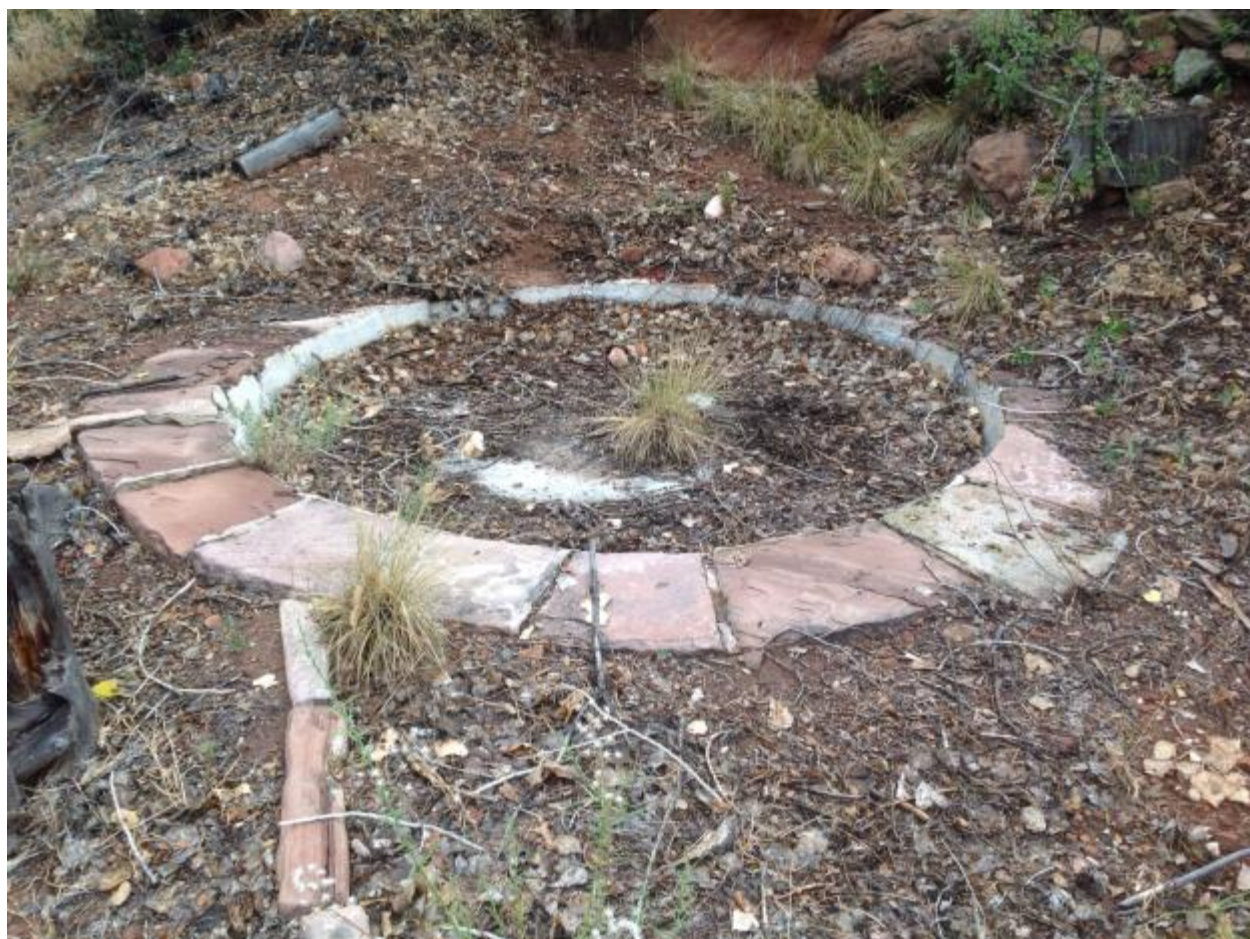
Additional structures in Oak Creek Historic District utilized local sandstone to meet the "NPS Rustic/Naturalistic Design" standards. These features include a hearth (FEA-004) built into the retaining wall around the Ranger Dormitory at the same time as construction of other contributing features associated with the dorm in 1941-42; two stone-lined pits (FEA-017 and FEA-018), a fire pit of unknown date (FEA-040), and the raised sandstone loading dock (FEA-076) in the maintenance area.

Name of Property: Oak Creek Historic District
City or Vicinity: Springdale
County: Washington
State: Utah
Photographer: Russell Cash
Date Photographed: 8/4/2014
Description: Fire pit behind HS-0025 and HS-0026
Feature Number: FEA-040
View Aspect: North
44 of 84

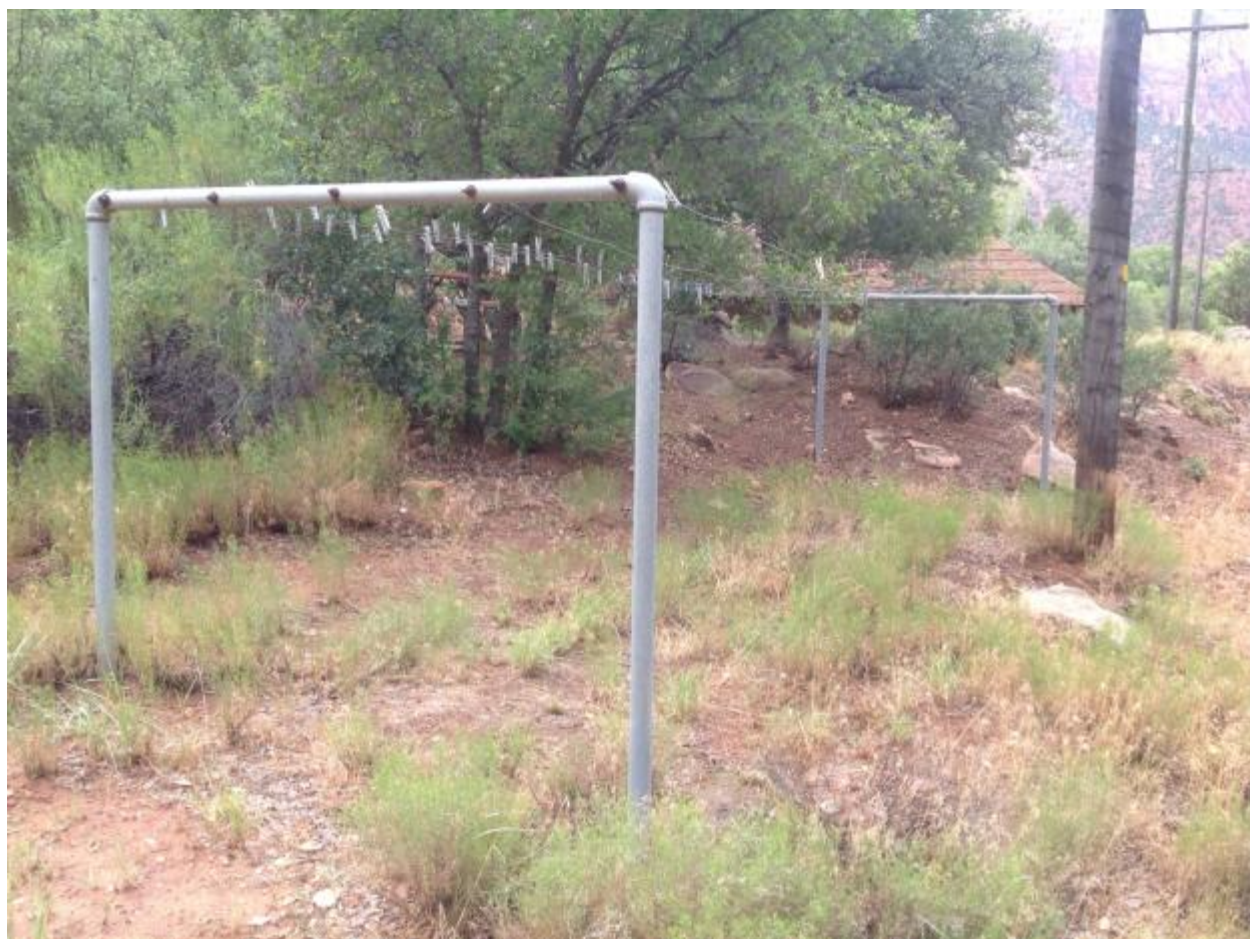
Name of Property: Oak Creek Historic District
City or Vicinity: Springdale
County: Washington
State: Utah
Photographer: Russell Cash
Date Photographed: 8/4/2014
Description: Clothesline for HS-0024
Feature Number: FEA-041
View Aspect: Northeast
45 of 84

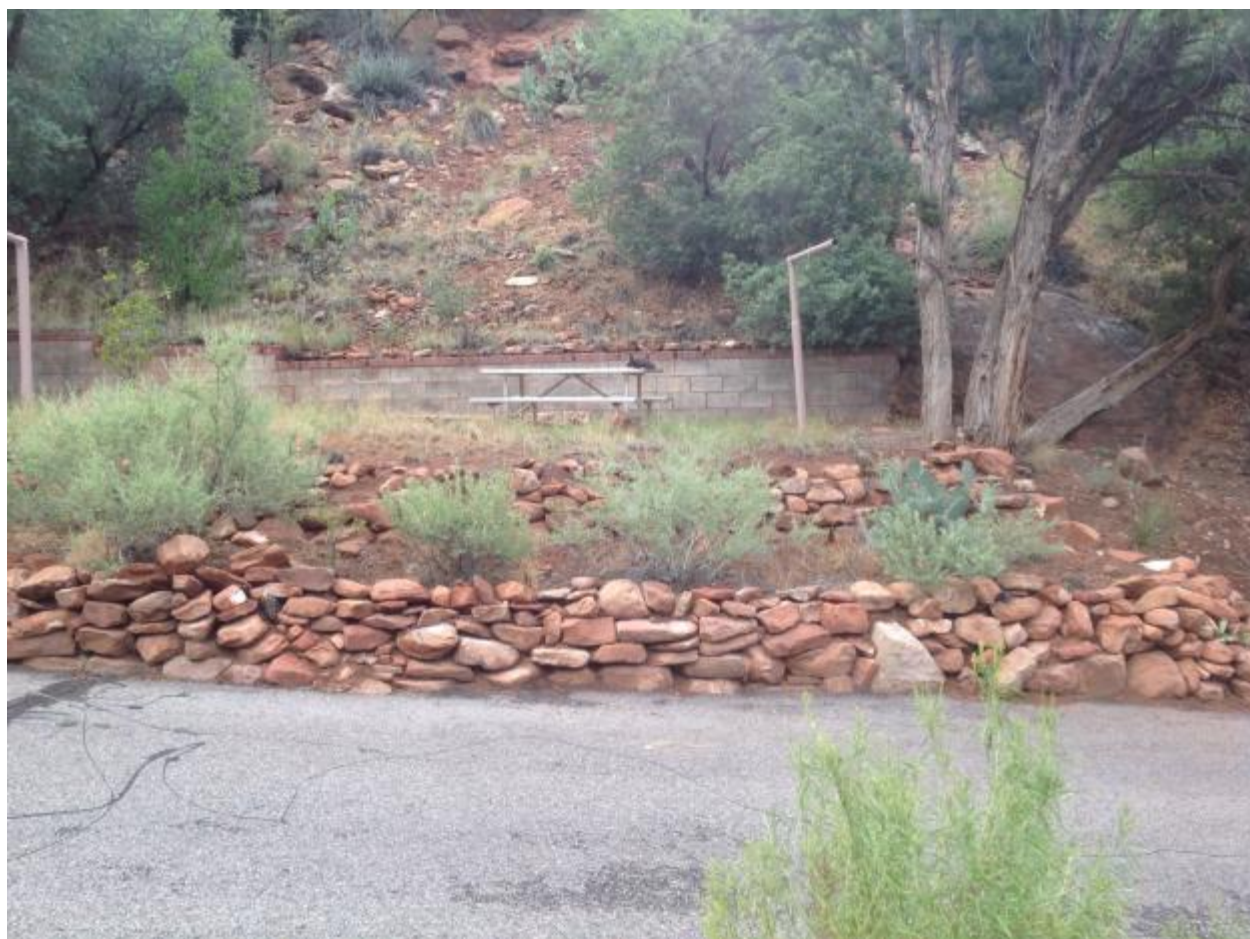
Name of Property: Oak Creek Historic District
City or Vicinity: Springdale
County: Washington
State: Utah
Photographer: Russell Cash
Date Photographed: 8/4/2014
Description: Retaining wall along Oak Creek Road near HS-0021
Feature Number: FEA-042
View Aspect: East
46 of 84

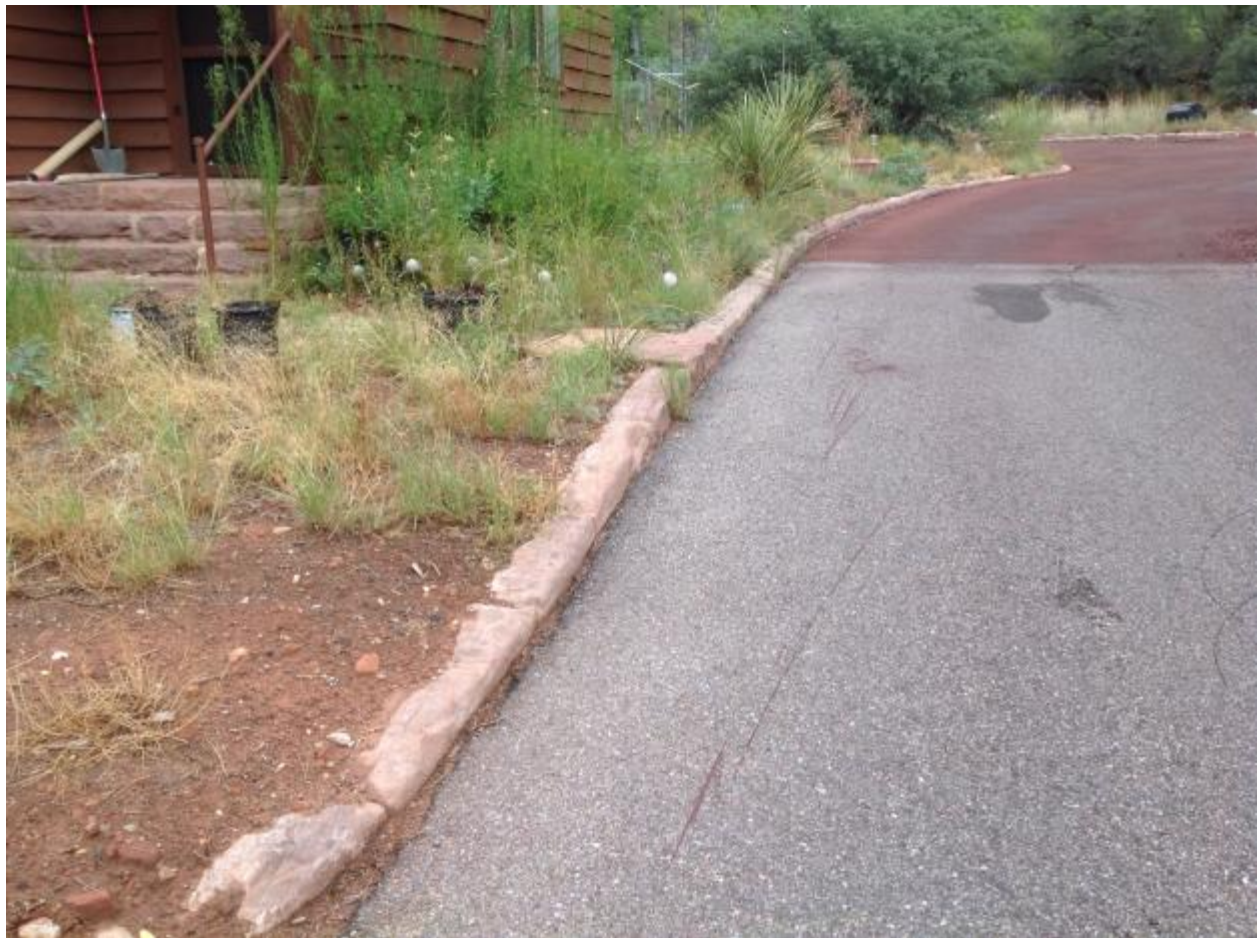
Name of Property: Oak Creek Historic District
City or Vicinity: Springdale
County: Washington
State: Utah
Photographer: Russell Cash
Date Photographed: 8/4/2014
Description: Curb around parking area for HS-0021 and HS-0026
Feature Number: FEA-043
View Aspect: Northwest
47 of 84

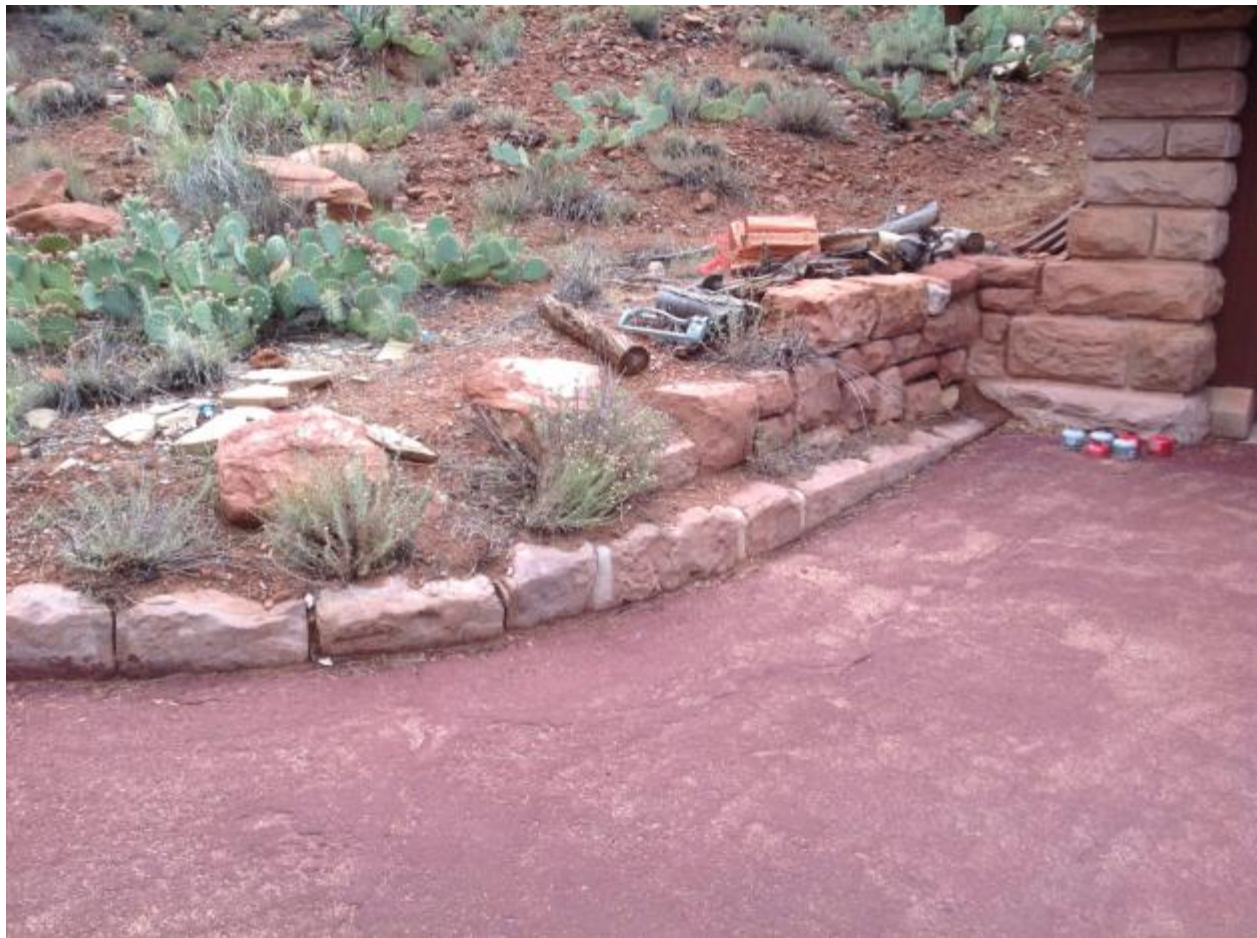
Name of Property: Oak Creek Historic District
City or Vicinity: Springdale
County: Washington
State: Utah
Photographer: Russell Cash
Date Photographed: 8/4/2014
Description: Curb near HS-0112
Feature Number: FEA-043b
View Aspect: East
48 of 84

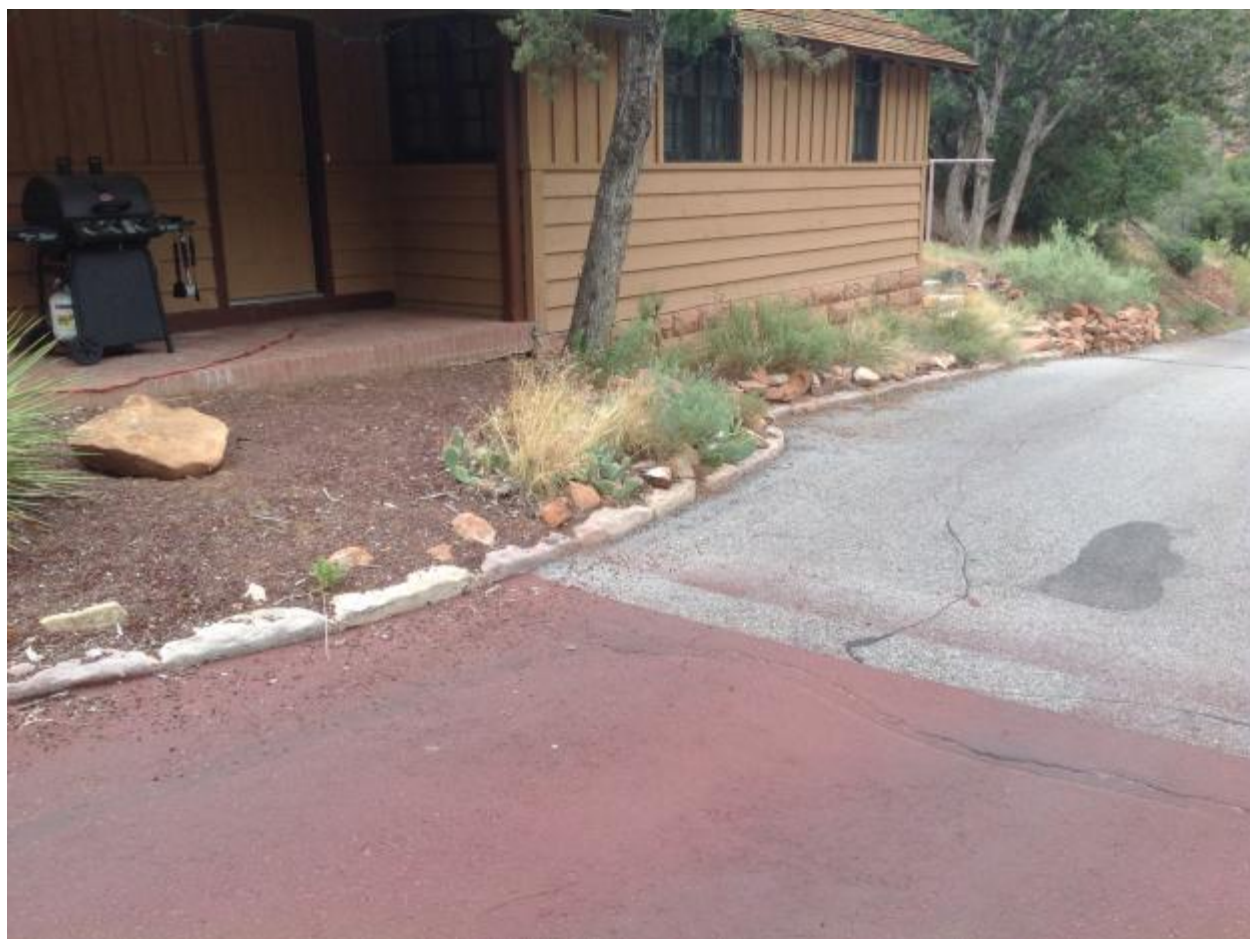
Name of Property: Oak Creek Historic District
City or Vicinity: Springdale
County: Washington
State: Utah
Photographer: Russell Cash
Date Photographed: 8/4/2014
Description: Curbing around HS-0021
Feature Number: FEA-043c
View Aspect: East
49 of 84

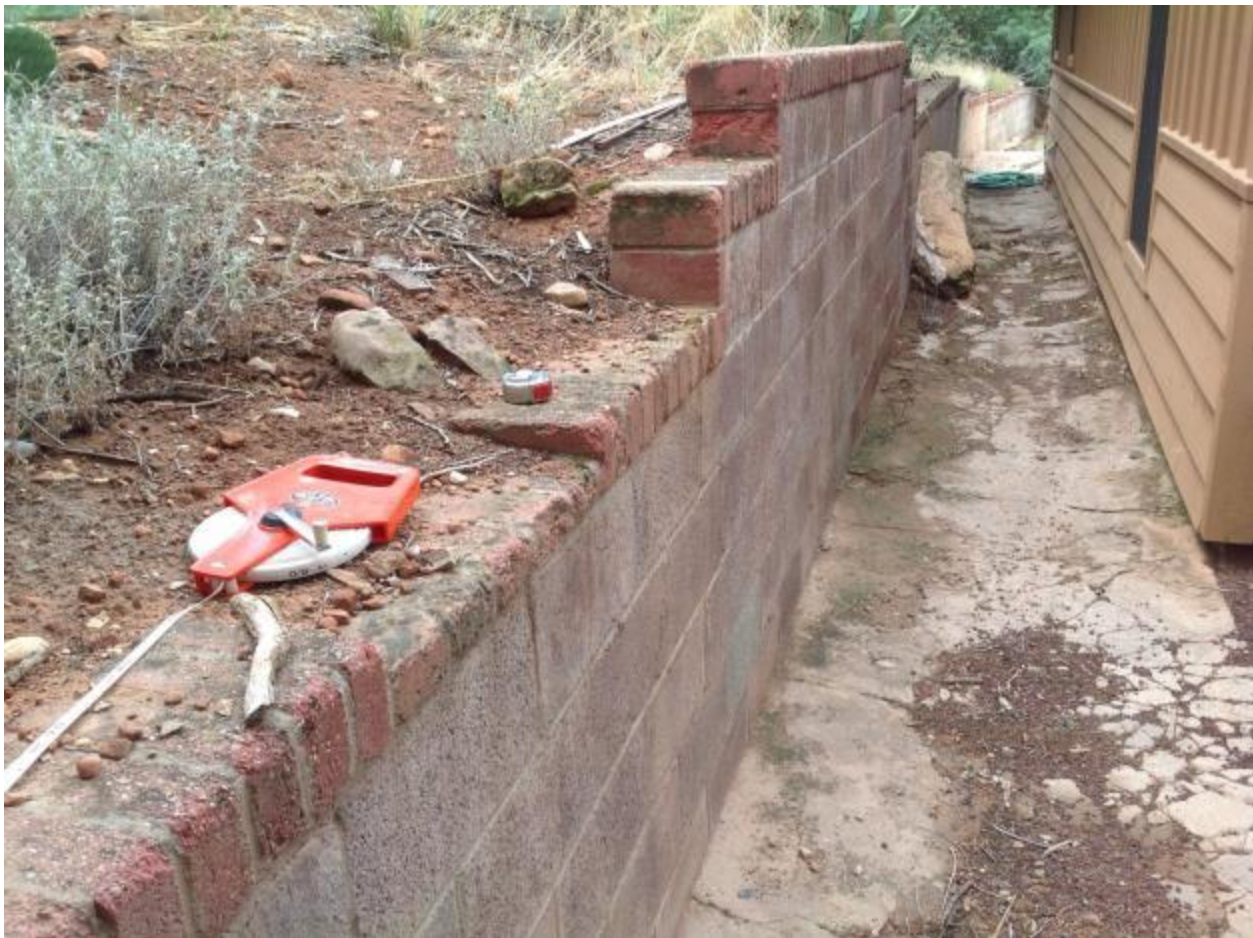
Name of Property: Oak Creek Historic District
City or Vicinity: Springdale
County: Washington
State: Utah
Photographer: Russell Cash
Date Photographed: 8/4/2014
Description: Retaining wall behind HS-0021
Feature Number: FEA-044
View Aspect: East
50 of 84

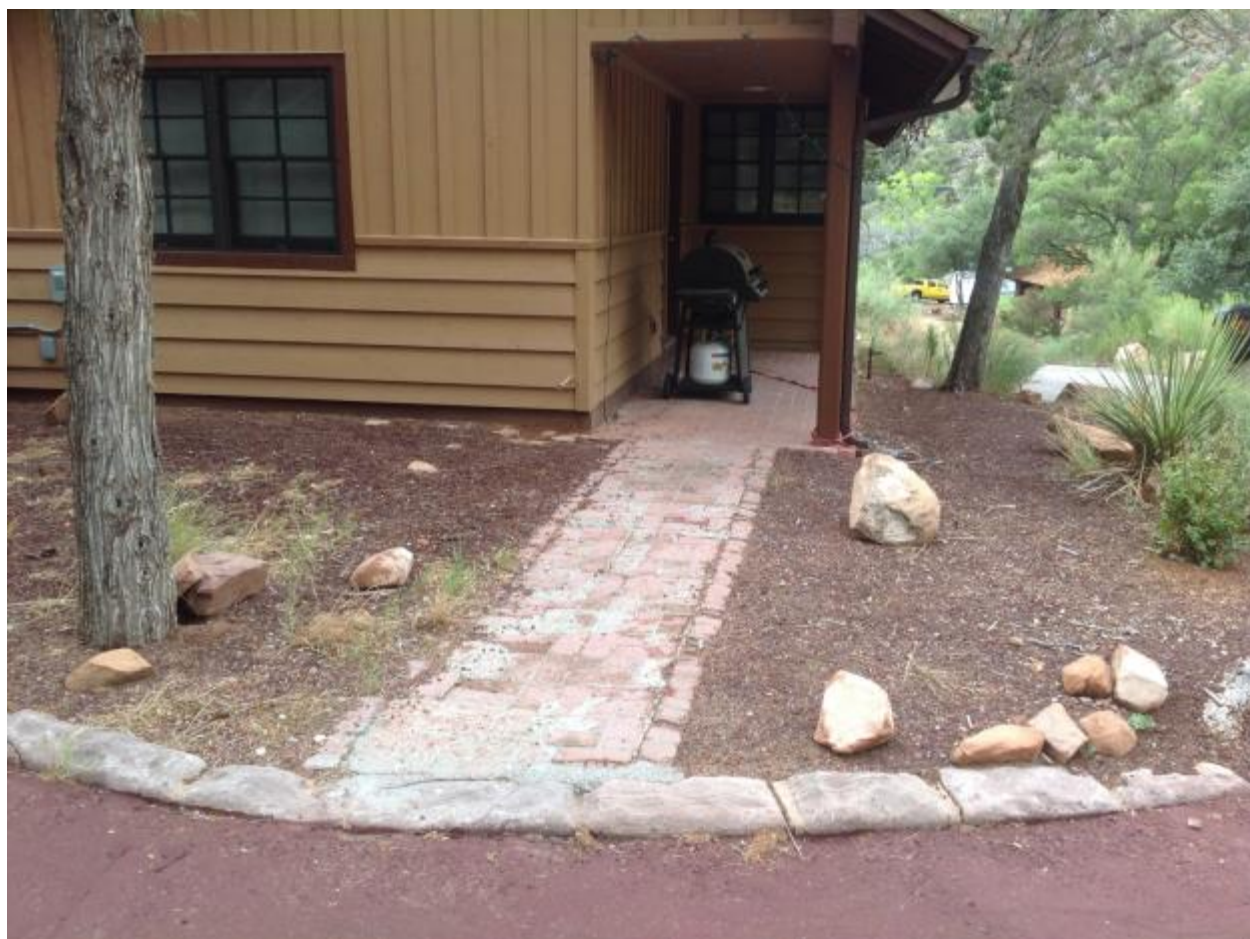
Name of Property: Oak Creek Historic District
City or Vicinity: Springdale
County: Washington
State: Utah
Photographer: Russell Cash
Date Photographed: 8/4/2014
Description: Walkway and patio to HS-0021
Feature Number: FEA-045
View Aspect: Southeast
51 of 84

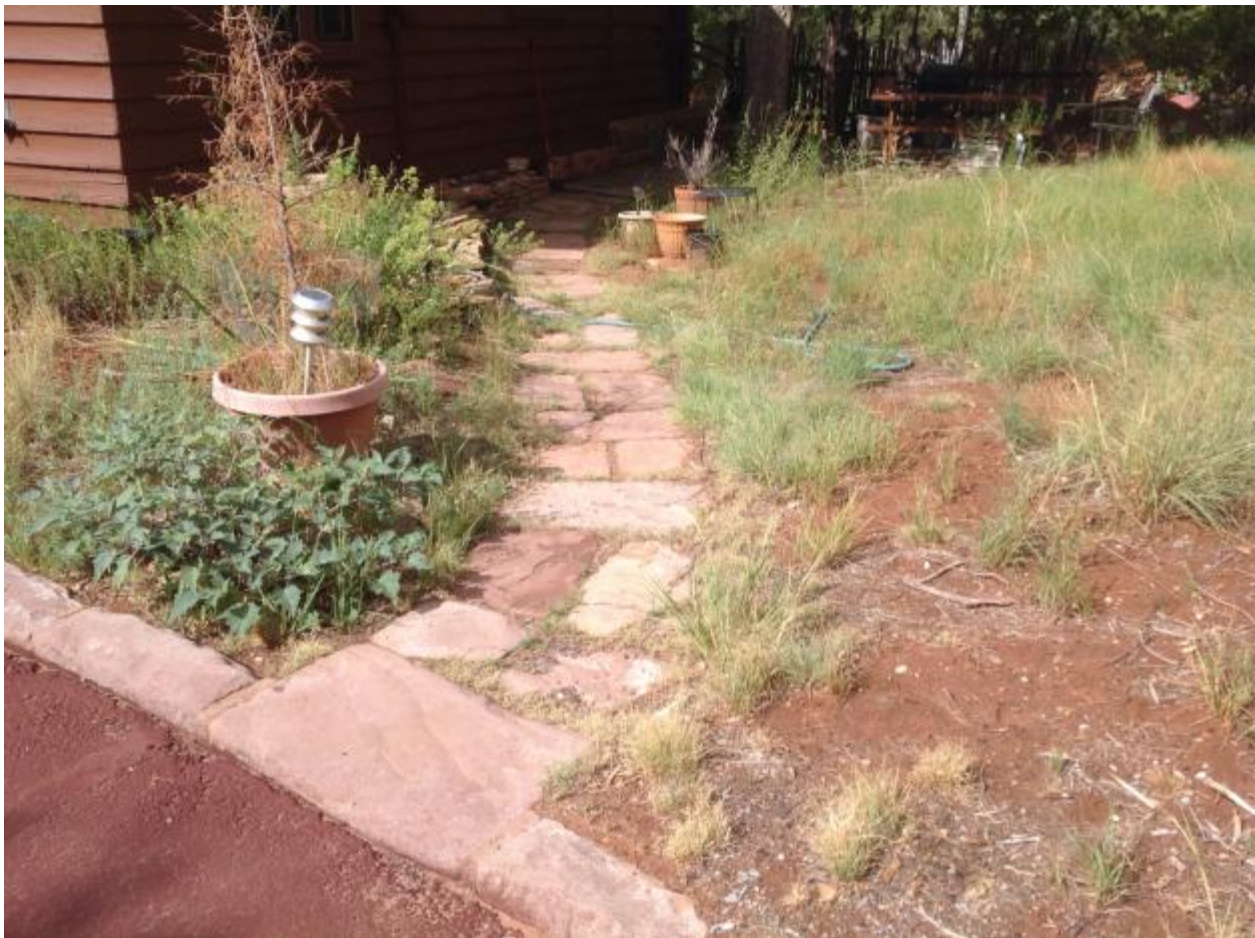
Name of Property: Oak Creek Historic District
City or Vicinity: Springdale
County: Washington
State: Utah
Photographer: Russell Cash
Date Photographed: 8/4/2014
Description: Rear walkway and patio to HS-0026
Feature Number: FEA-046
View Aspect: West
52 of 84

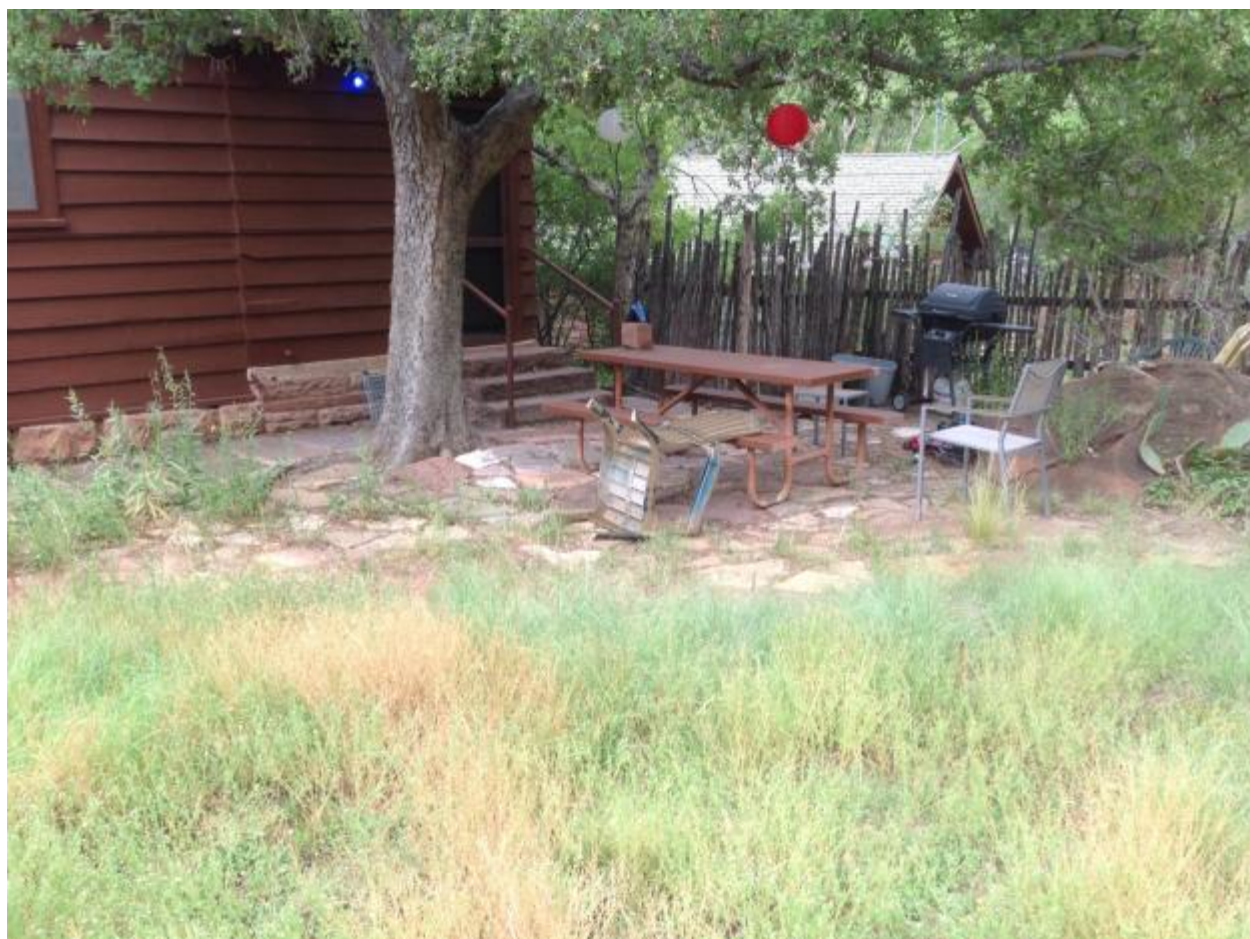
Name of Property: Oak Creek Historic District
City or Vicinity: Springdale
County: Washington
State: Utah
Photographer: Russell Cash
Date Photographed: 8/4/2014
Description: Back patio of HS-0026
Feature Number: FEA-047
View Aspect: West
53 of 84

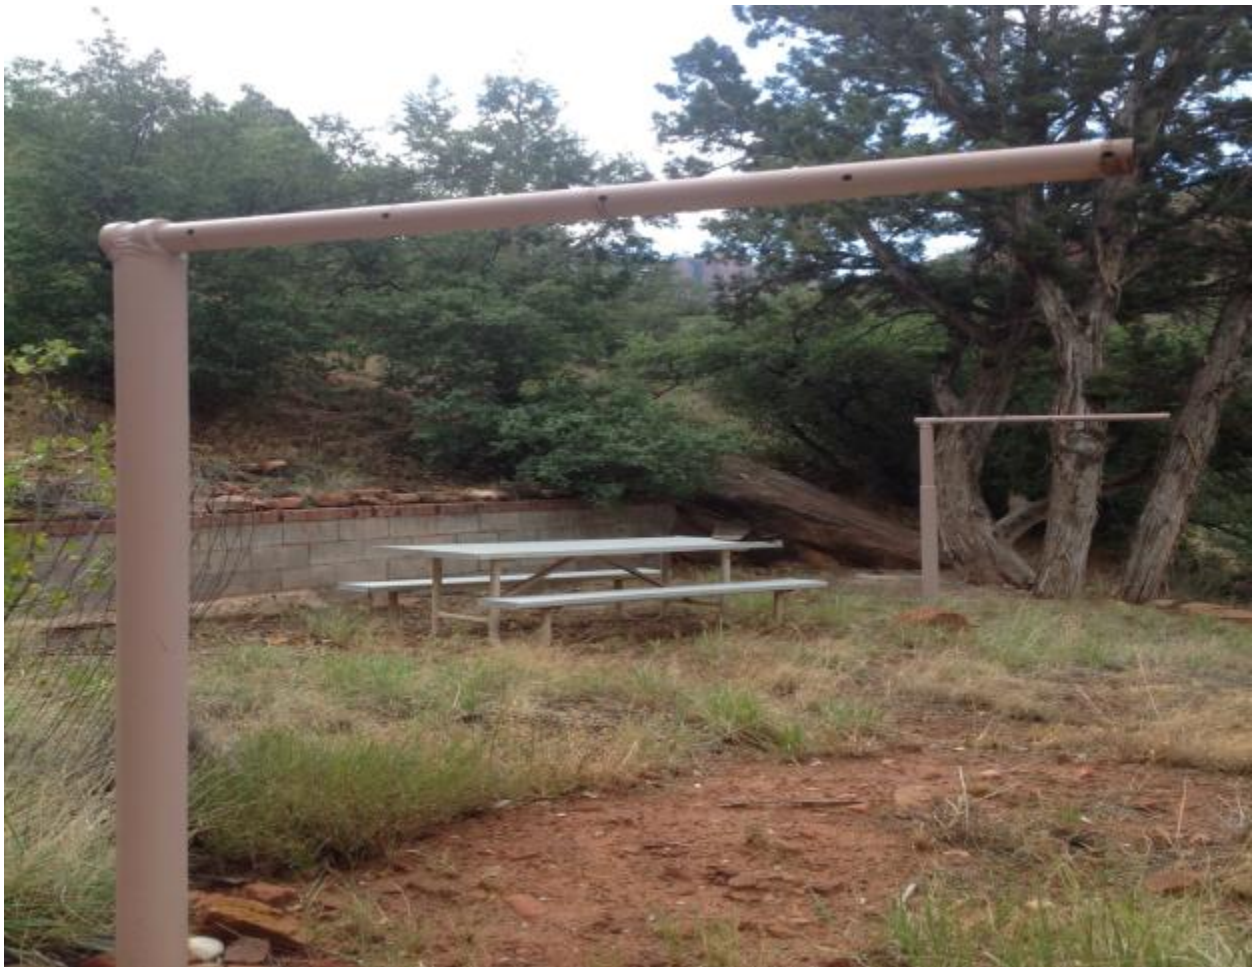
Name of Property: Oak Creek Historic District
City or Vicinity: Springdale
County: Washington
State: Utah
Photographer: Russell Cash
Date Photographed: 8/4/2014
Description: Clothesline to HS-0021
Feature Number: FEA-048
View Aspect: East
54 of 84

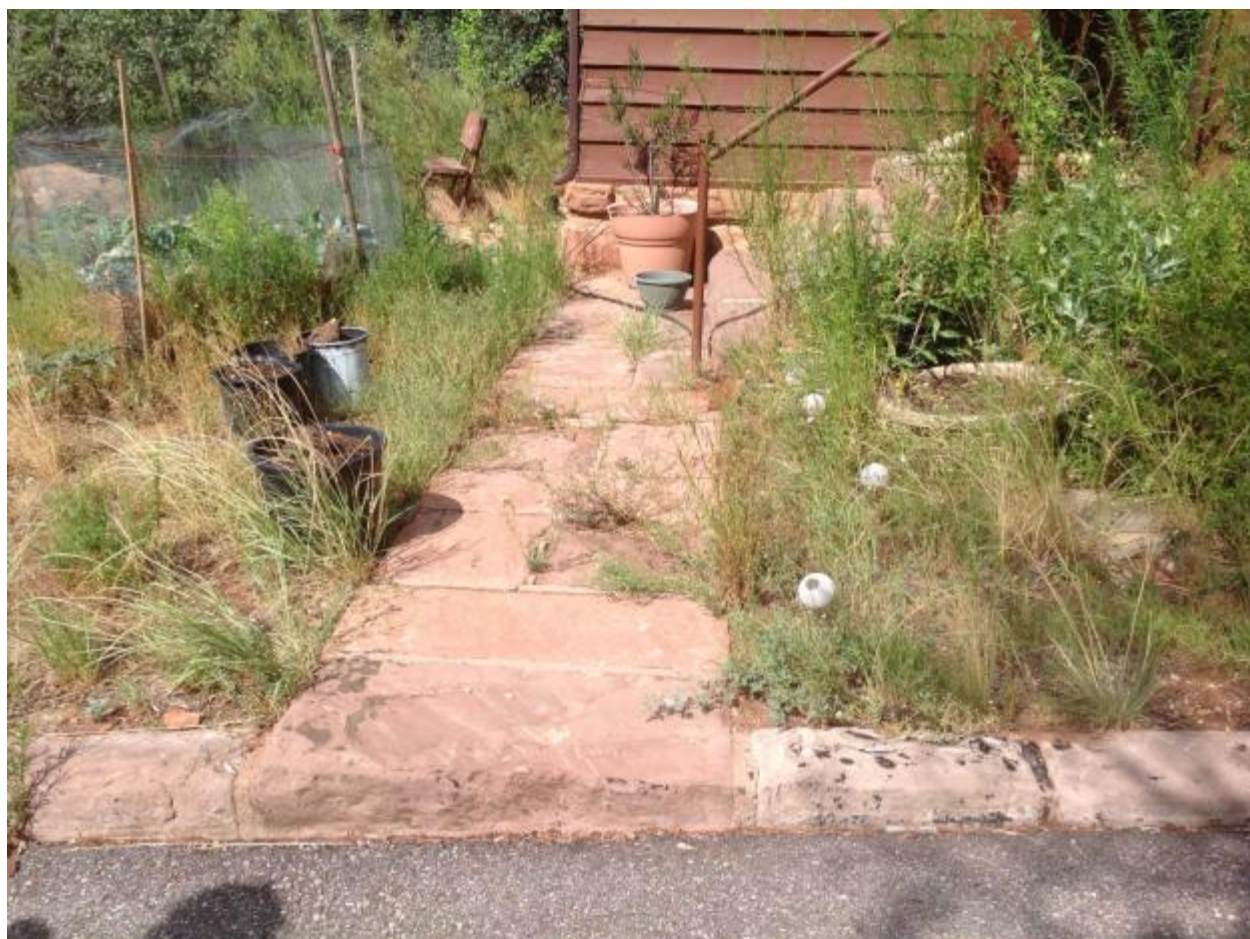
Name of Property: Oak Creek Historic District
City or Vicinity: Springdale
County: Washington
State: Utah
Photographer: Russell Cash
Date Photographed: 8/4/2014
Description: Front walkway to HS-0026
Feature Number: FEA-049
View Aspect: West
55 of 84

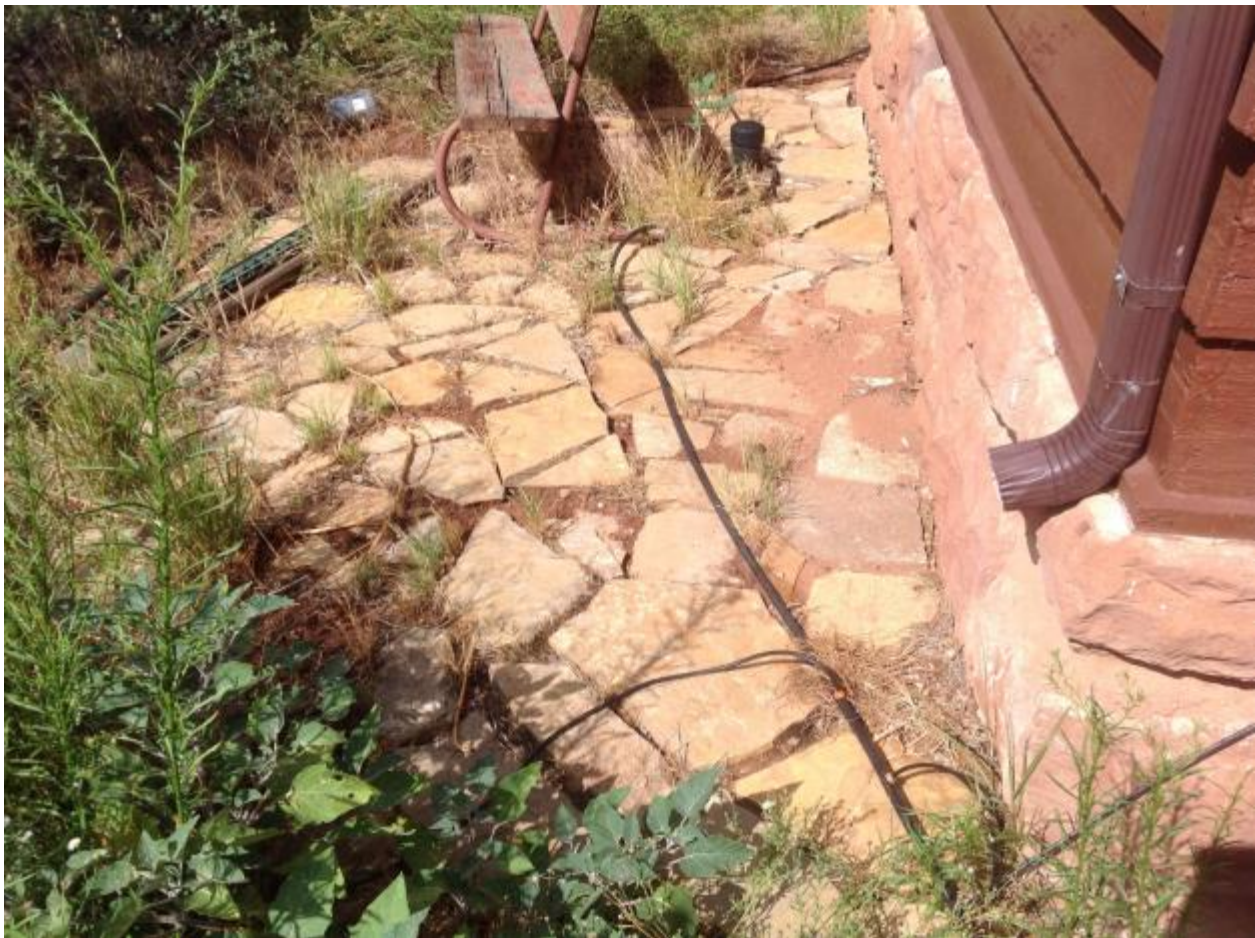
Name of Property: Oak Creek Historic District
City or Vicinity: Springdale
County: Washington
State: Utah
Photographer: Russell Cash
Date Photographed: 8/4/2014
Description: Front patio to HS-0026
Feature Number: FEA-050
View Aspect: West
56 of 84

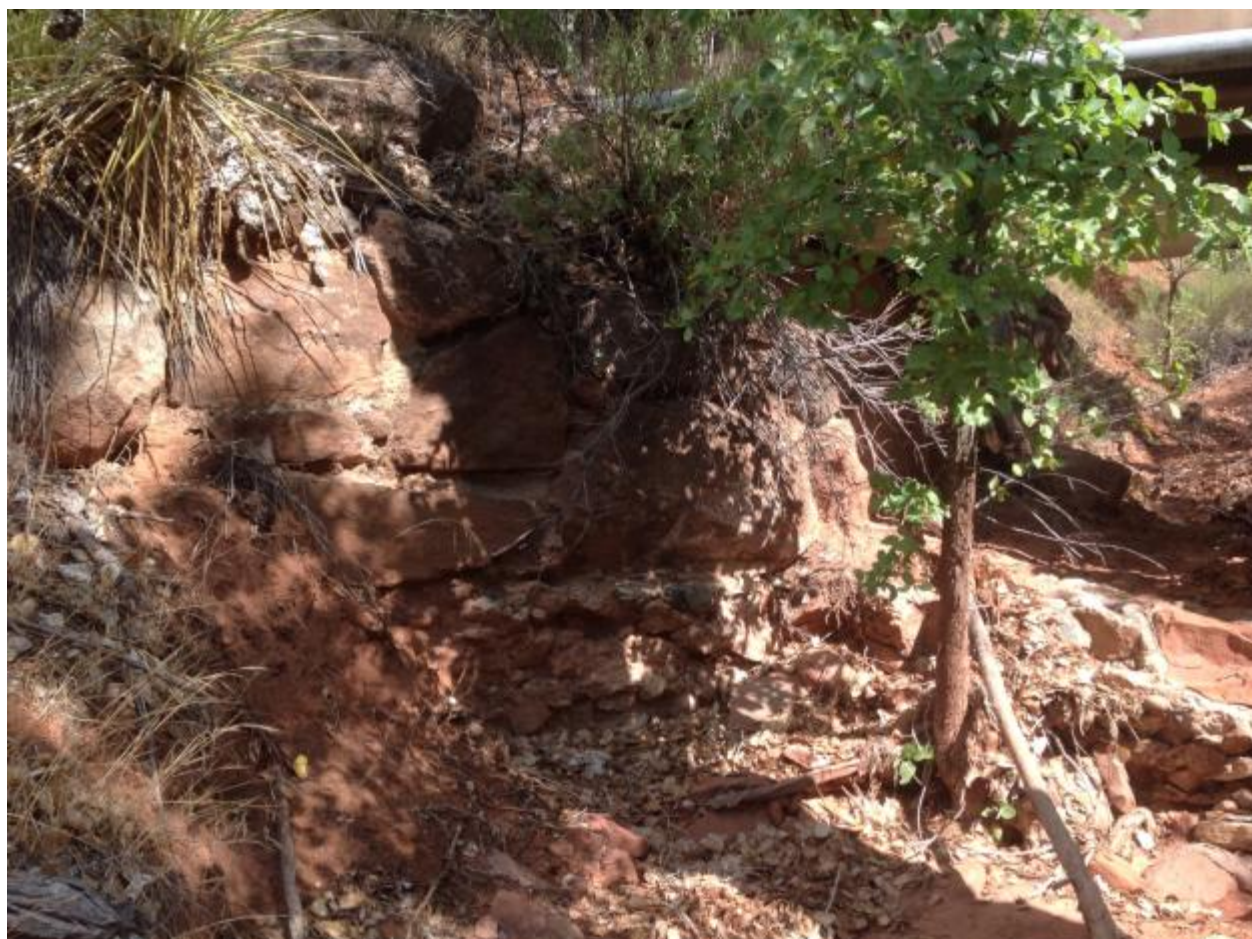
Name of Property: Oak Creek Historic District
City or Vicinity: Springdale
County: Washington
State: Utah
Photographer: Russell Cash
Date Photographed: 8/4/2014
Description: Retaining wall along Oak Creek by footbridge
Feature Number: FEA-052
View Aspect:
58 of 84
