National Register of Historic Places Registration Form

Historic name: Oak Creek Historic District
Other names/site number: _____
Name of related multiple property listing: Multiple Resources for Zion National Park
(Enter "N/A" if property is not part of a multiple property listing)

The 1987 nomination only listed the district's eligible buildings. This amendment addresses an additional eighty-four historic resources, fifty-five contributing and twenty-nine non-contributing. These features include water features, circulation networks, designed outdoor spaces, vegetation related to land use, and other landscape elements that mirror the "Rustic" style of their associated buildings. The district's period of significance under Criterion C for "NPS Rustic/Naturalistic Design" is 1932-1942. Furthermore, under Criterion A, this amendment adds the context of the Civilian Conservation Corps (CCC) for its work constructing the buildings and

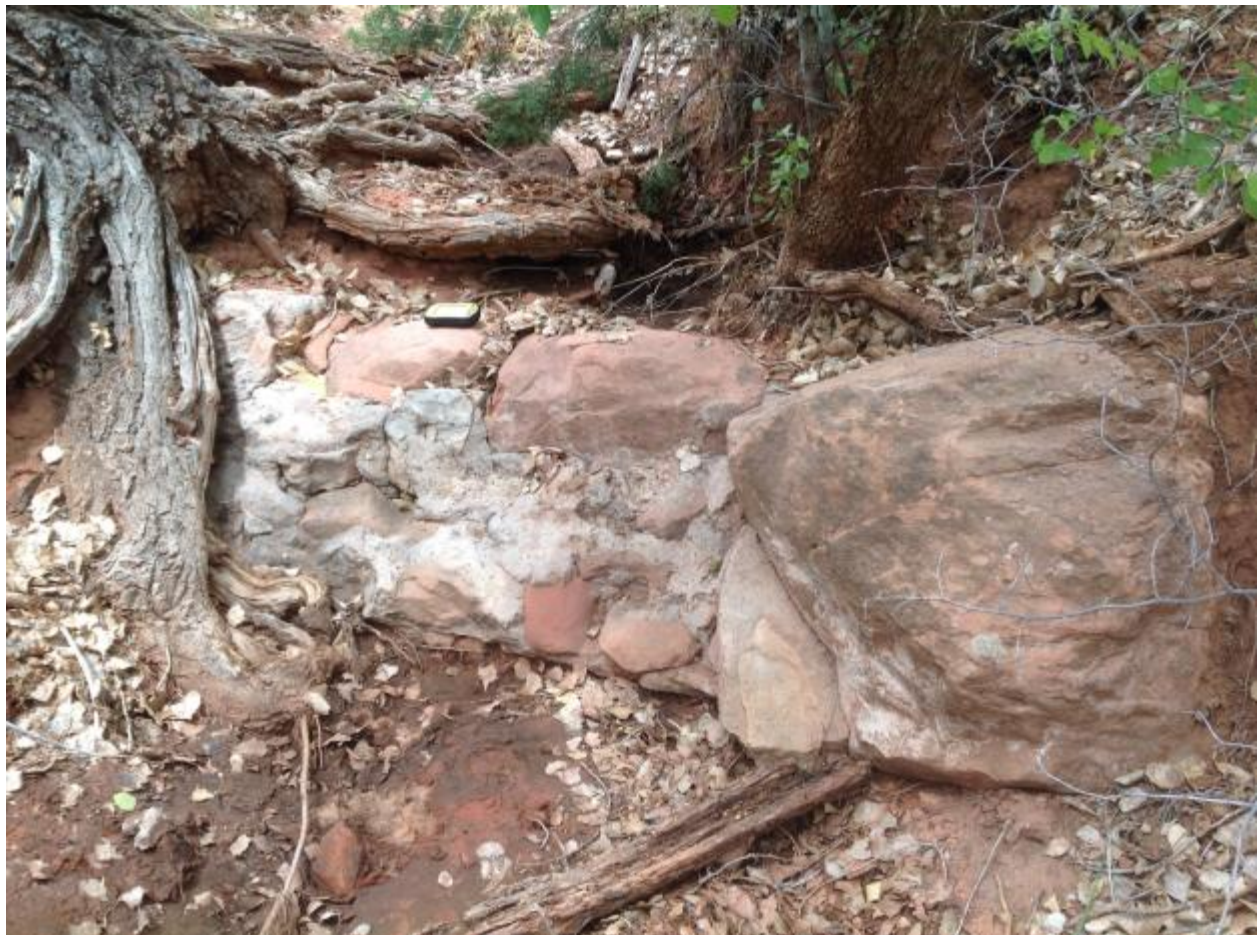
Name of Property: Oak Creek Historic District
City or Vicinity: Springdale
County: Washington
State: Utah
Photographer: Russell Cash
Date Photographed: 8/4/2014
Description: Check dam in drainage along Oak Creek
Feature Number: FEA-055
View Aspect:
61 of 84

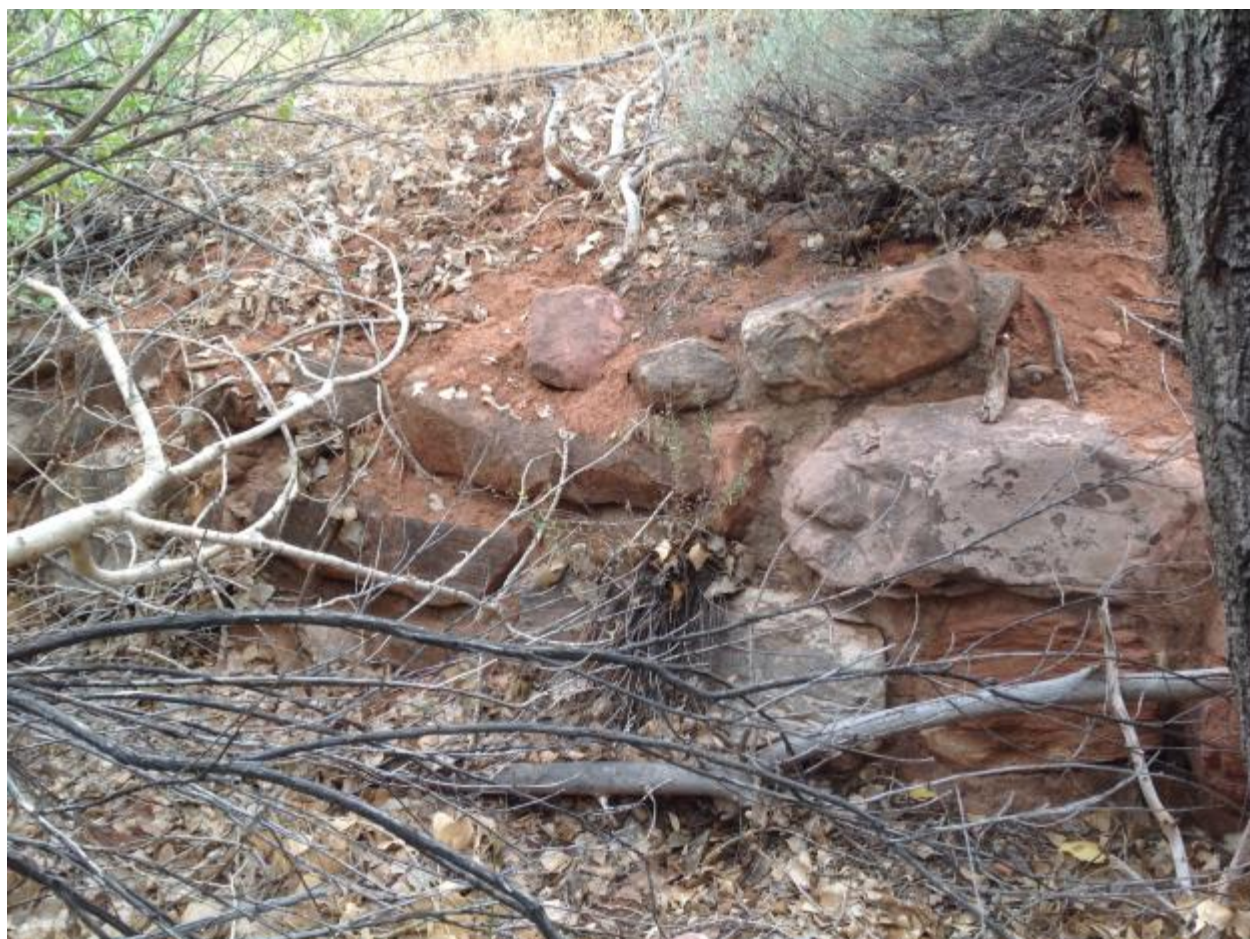
Name of Property: Oak Creek Historic District
City or Vicinity: Springdale
County: Washington
State: Utah
Photographer: Russell Cash
Date Photographed: 8/4/2014
Description: Retaining wall in drainage along Oak Creek Road
Feature Number: FEA-056
View Aspect: West-Northwest
62 of 84

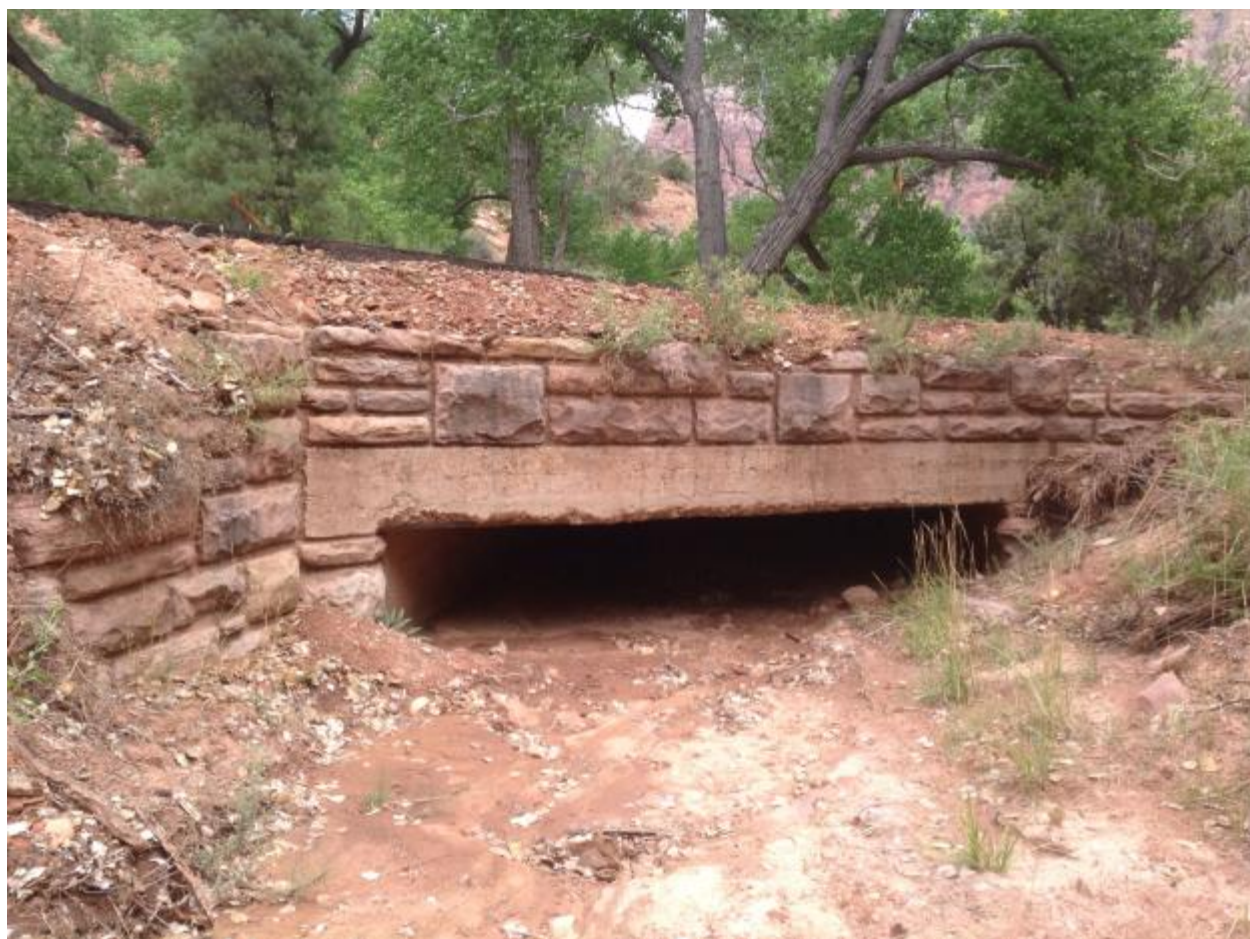
Name of Property: Oak Creek Historic District
City or Vicinity: Springdale
County: Washington
State: Utah
Photographer: Russell Cash
Date Photographed: 8/4/2014
Description: Oak Creek drainage bridge
Feature Number: FEA-057
View Aspect: East
63 of 84

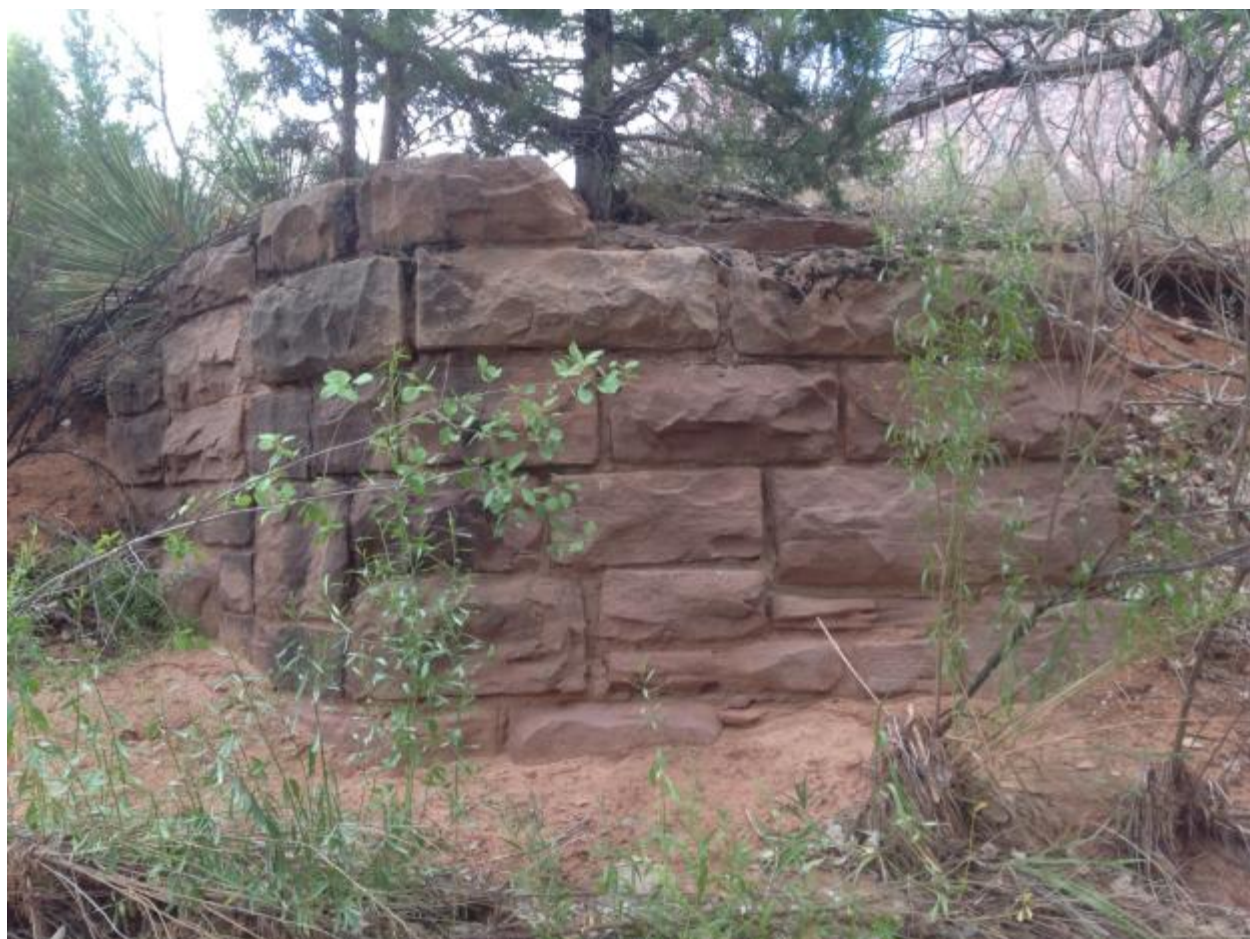
Name of Property: Oak Creek Historic District
City or Vicinity: Springdale
County: Washington
State: Utah
Photographer: Russell Cash
Date Photographed: 8/4/2014
Description: Retaining wall in Oak Creek drainage adjacent to road
Feature Number: FEA-058
Aspect: East-Northeast
64 of 84

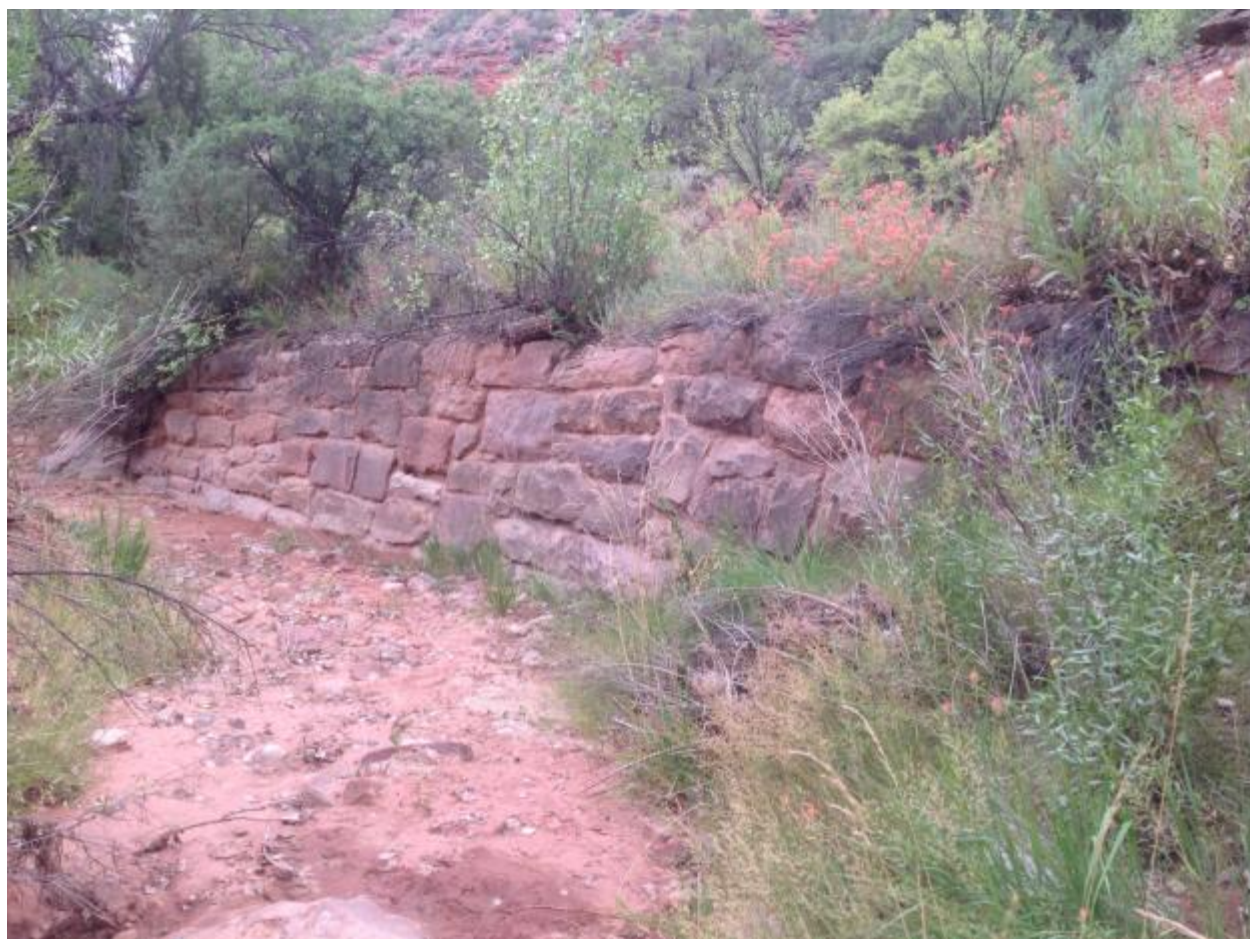
Name of Property: Oak Creek Historic District
City or Vicinity: Springdale
County: Washington
State: Utah
Photographer: Russell Cash
Date Photographed: 8/4/2014
Description: Retaining wall in Oak Creek drainage
Feature Number: FEA-059
View Aspect: Southeast
65 of 84

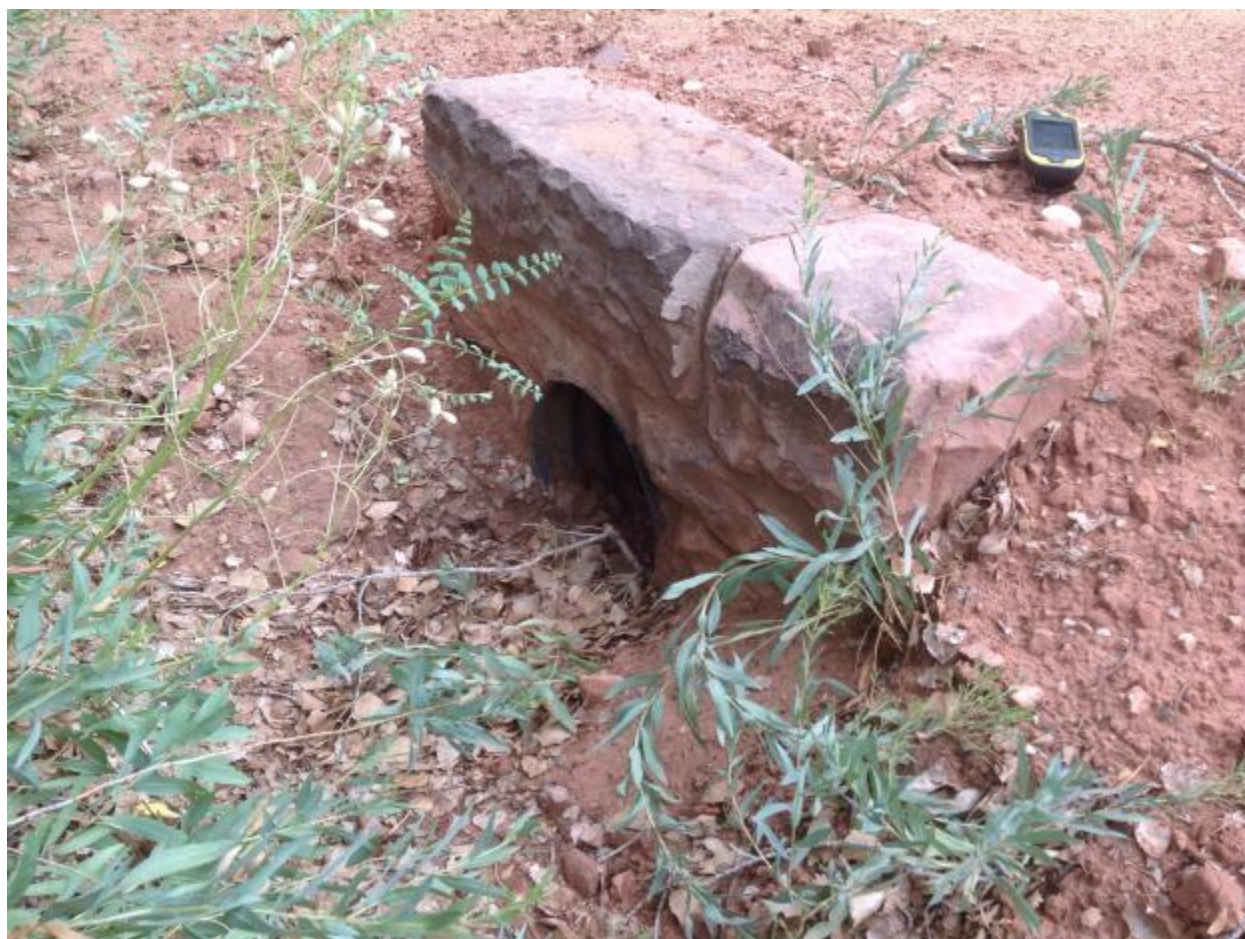
Name of Property: Oak Creek Historic District
City or Vicinity: Springdale
County: Washington
State: Utah
Photographer: Russell Cash
Date Photographed: 8/4/2014
Description: Culvert in retaining wall in Oak Creek Road
Feature Number: FEA-060
View Aspect: East
66 of 84

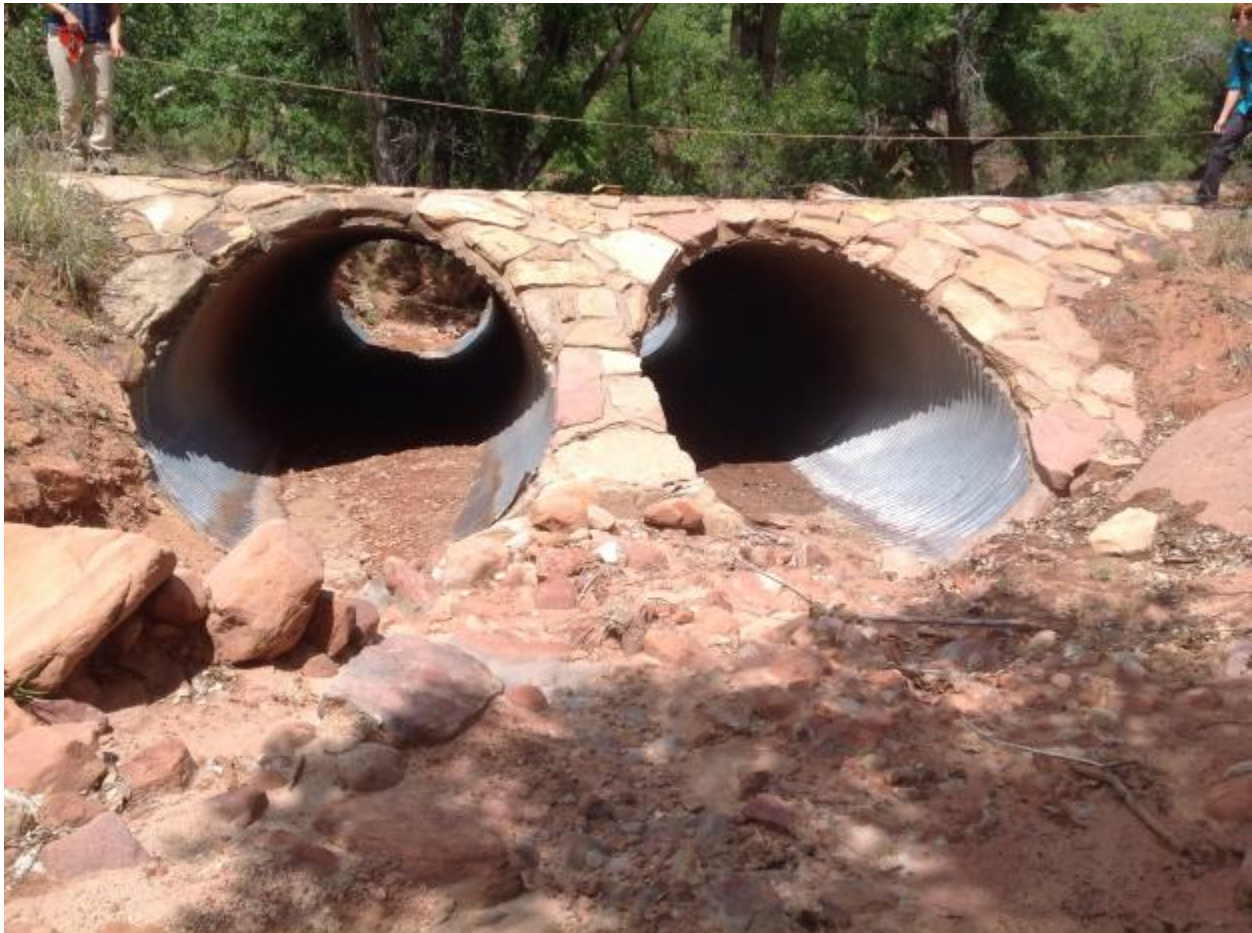
Name of Property: Oak Creek Historic District
City or Vicinity: Springdale
County: Washington
State: Utah
Photographer: Russell Cash
Date Photographed: 8/4/2014
Description: Culvert/bridge over Oak Creek drainage
Feature Number: FEA-061
View Aspect: North-Northeast
67 of 84

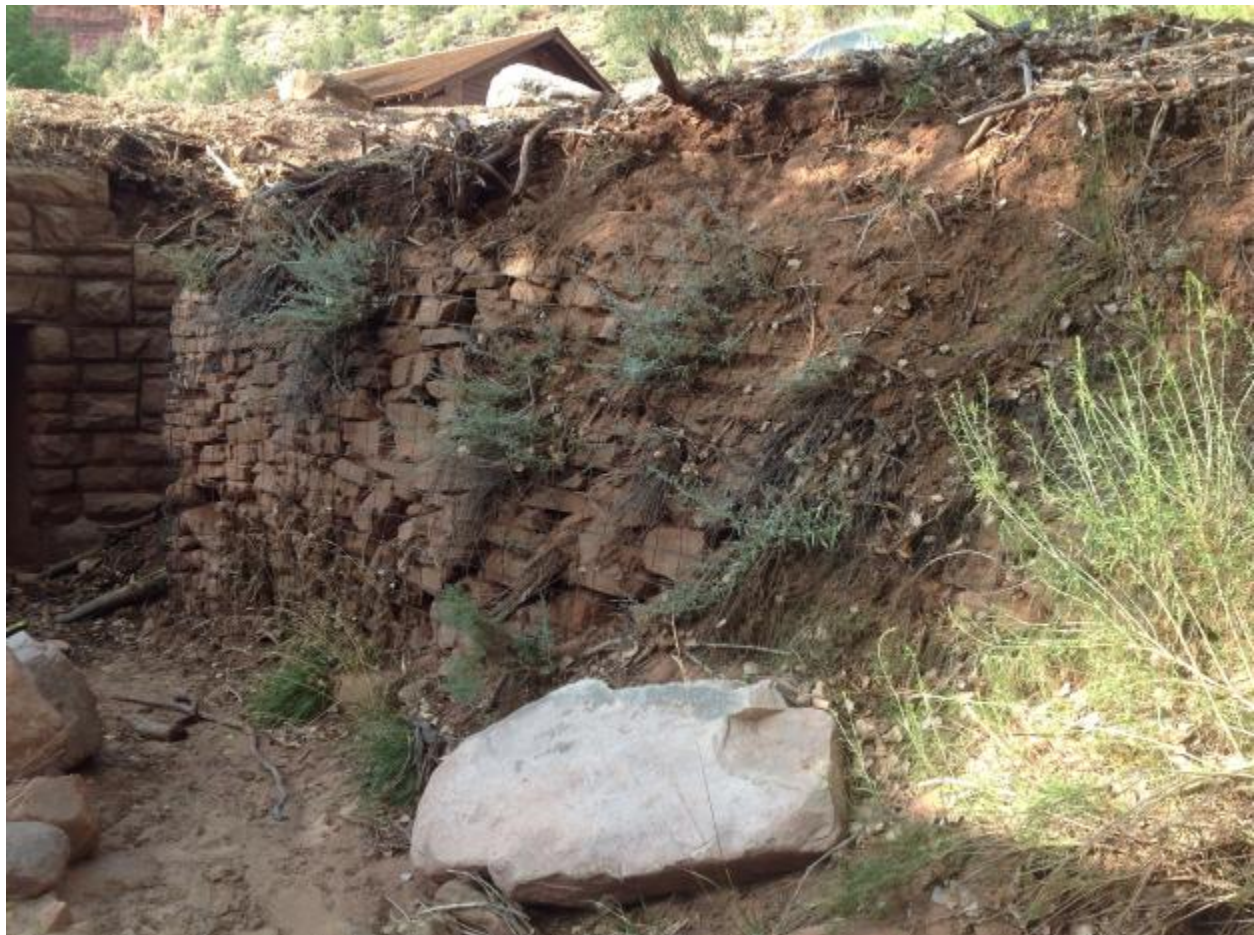
Name of Property: Oak Creek Historic District
City or Vicinity: Springdale
County: Washington
State: Utah
Photographer: Russell Cash
Date Photographed: 8/4/2014
Description: Revetments along Oak Creek by maintenance area
Feature Number: FEA-062
View Aspect: Southwest
68 of 84

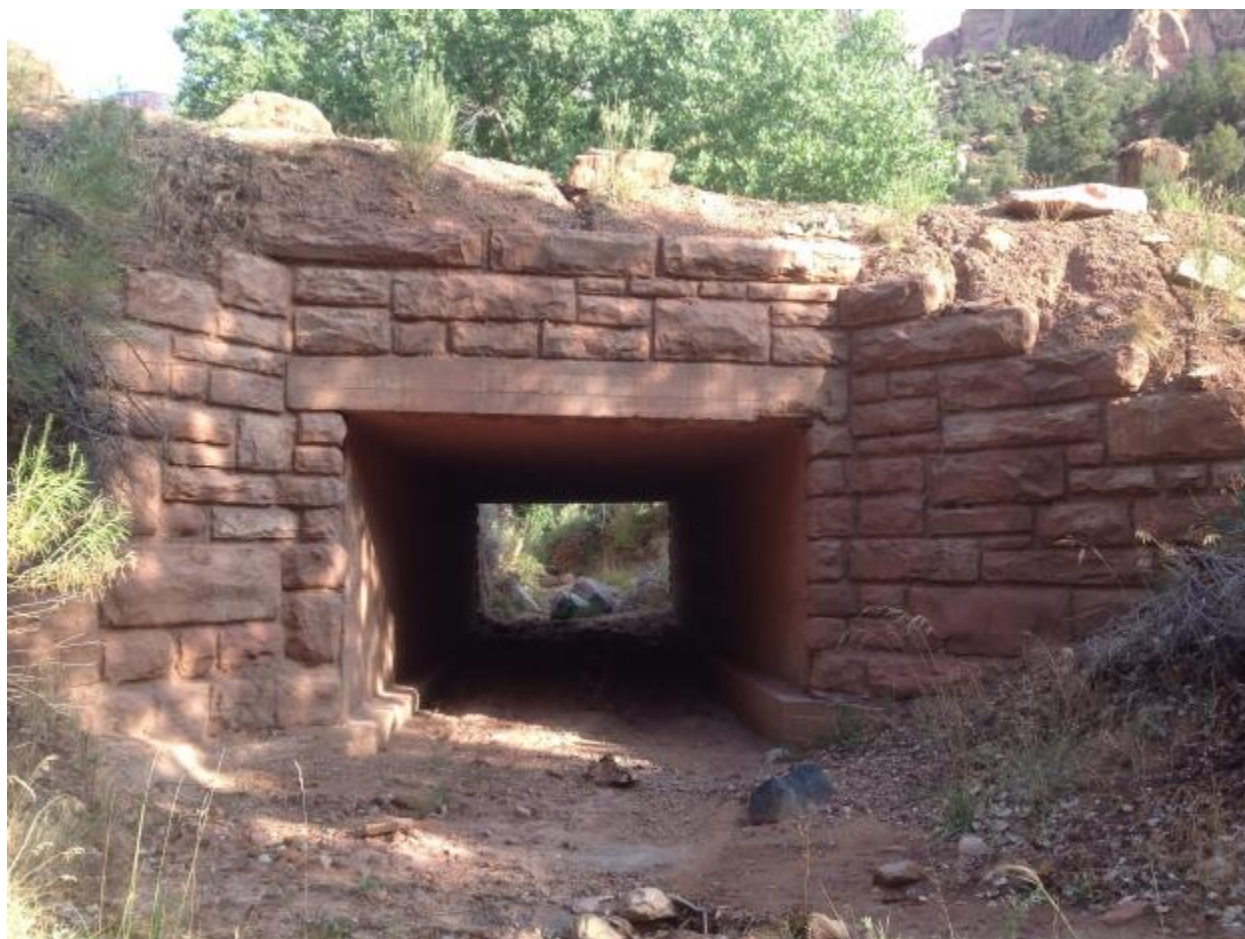
Other important contributing water features are the bridges and culverts found along Oak Creek. Designer Albert H. Good advised park planners to take care in designing bridges because "we are never unconscious of the presence of a bridge," whereas "a culvert...being merely a retaining wall pierced by a drain, can often be so treated that the casual passerby is unaware of its presence."⁶⁴ National park historian McClelland argues that "culverts were an essential feature of park roads," and "important in protecting the natural landscape, they also required designs that harmonized with the natural setting." Weathered or roughly finished stones were to be used "and all stones were to be laid with their larger dimension horizontal, and no four joints were to come together."⁶⁵ Oak Creek Historic District contains a variety of bridge and culvert designs. Culvert FEA-057 and bridge FEA-063 exhibit similar patterns of rough sandstone and uneven coursing

Name of Property: Oak Creek Historic District
City or Vicinity: Springdale
County: Washington
State: Utah
Photographer: Russell Cash
Date Photographed: 8/4/2014
Description: Bridge over Oak Creek to maintenance yard
Feature Number: FEA-063
View Aspect: East-Northeast
69 of 84

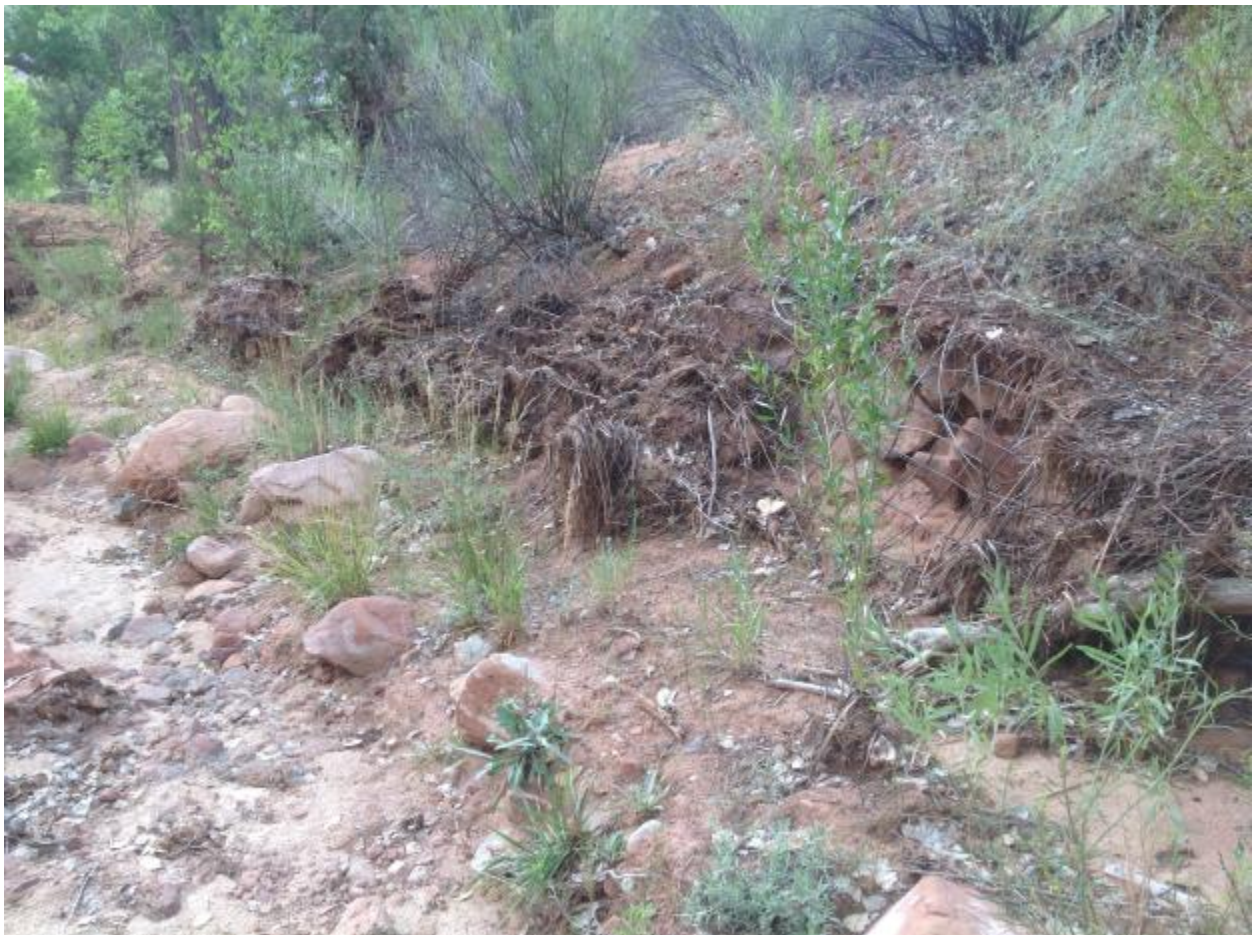
Name of Property: Oak Creek Historic District
City or Vicinity: Springdale
County: Washington
State: Utah
Photographer: Russell Cash
Date Photographed: 8/4/2014
Description: Revetments in Oak Creek
Feature Number: FEA-065
View Aspect: Southeast
71 of 84

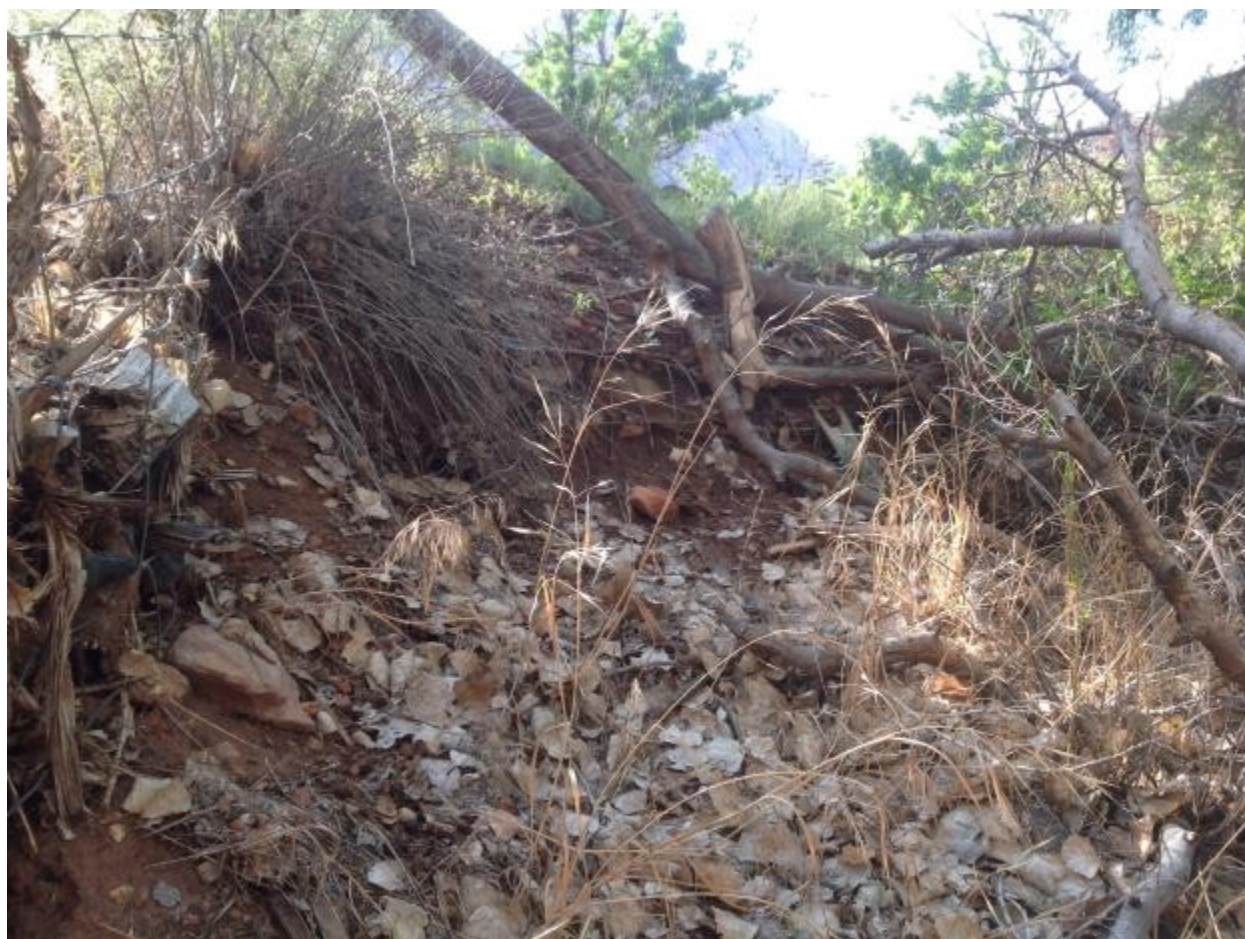
Name of Property: Oak Creek Historic District
City or Vicinity: Springdale
County: Washington
State: Utah
Photographer: Russell Cash
Date Photographed: 8/4/2014
Description: Part of buried revetments near HS-0025
Feature Number: FEA-066
View Aspect: East
72 of 84

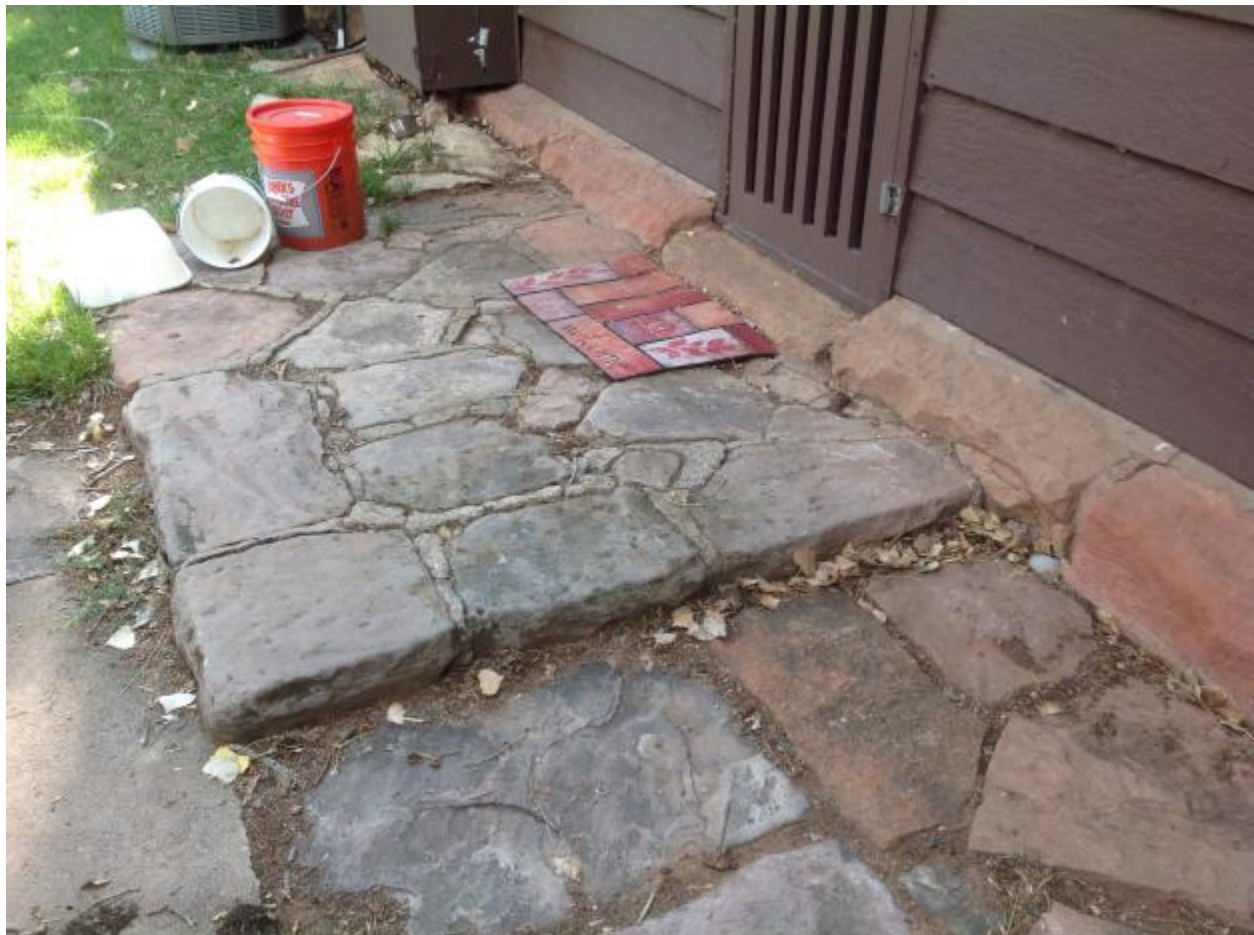
Name of Property: Oak Creek Historic District
City or Vicinity: Springdale
County: Washington
State: Utah
Photographer: Russell Cash
Date Photographed: 8/5/2014
Description: Stoop on back of HS-0010
Feature Number: FEA-067
View Aspect: East
73 of 84

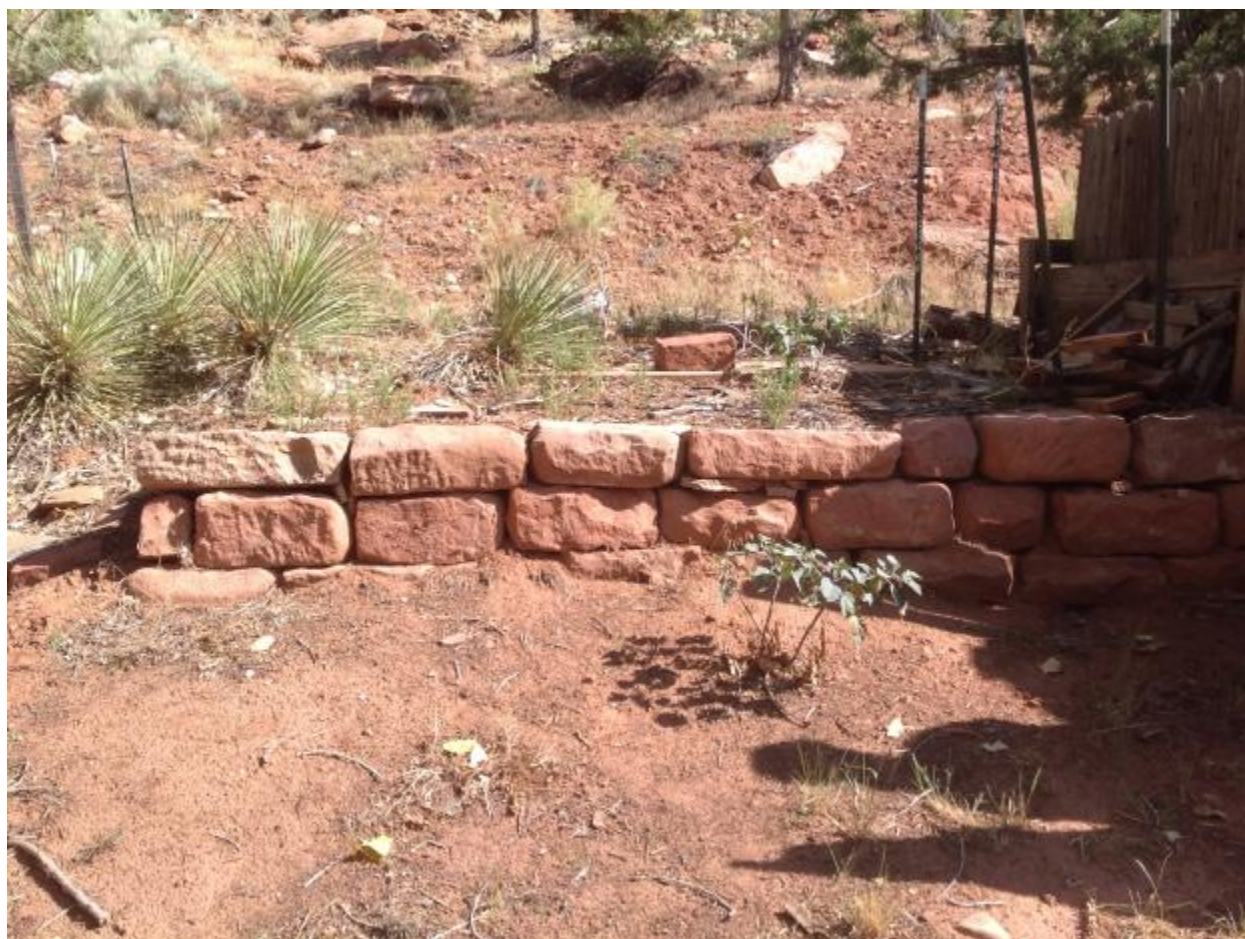
Name of Property: Oak Creek Historic District
City or Vicinity: Springdale
County: Washington
State: Utah
Photographer: Russell Cash
Date Photographed: 8/5/2014
Description: Retaining wall adjacent to HS-0009
Feature Number: FEA-069
View Aspect: North
75 of 84

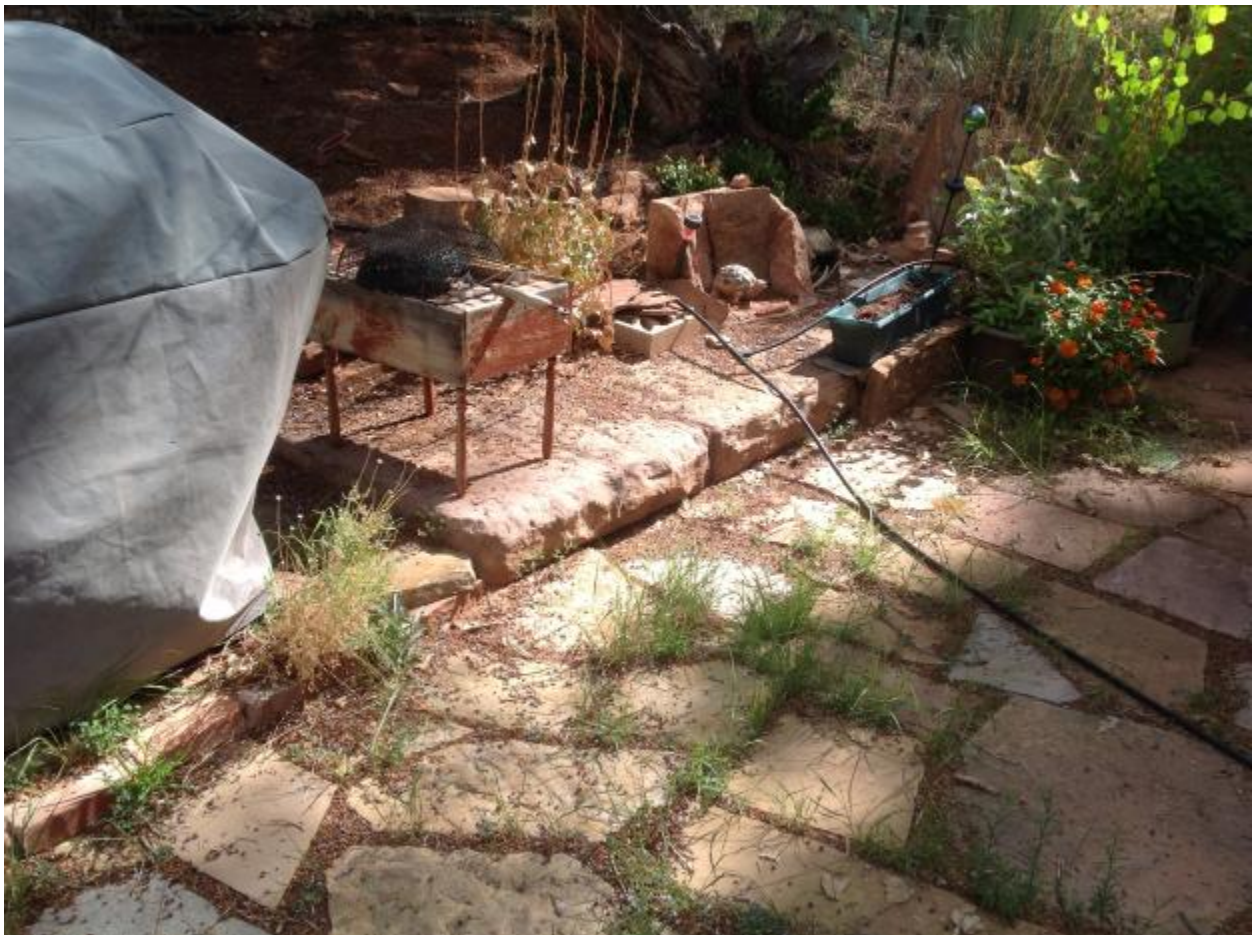
Name of Property: Oak Creek Historic District
City or Vicinity: Springdale
County: Washington
State: Utah
Photographer: Russell Cash
Date Photographed: 8/5/2014
Description: Sandstone pad behind HS-0008
Feature Number: FEA- 070
View Aspect: East-Northeast
76 of 84

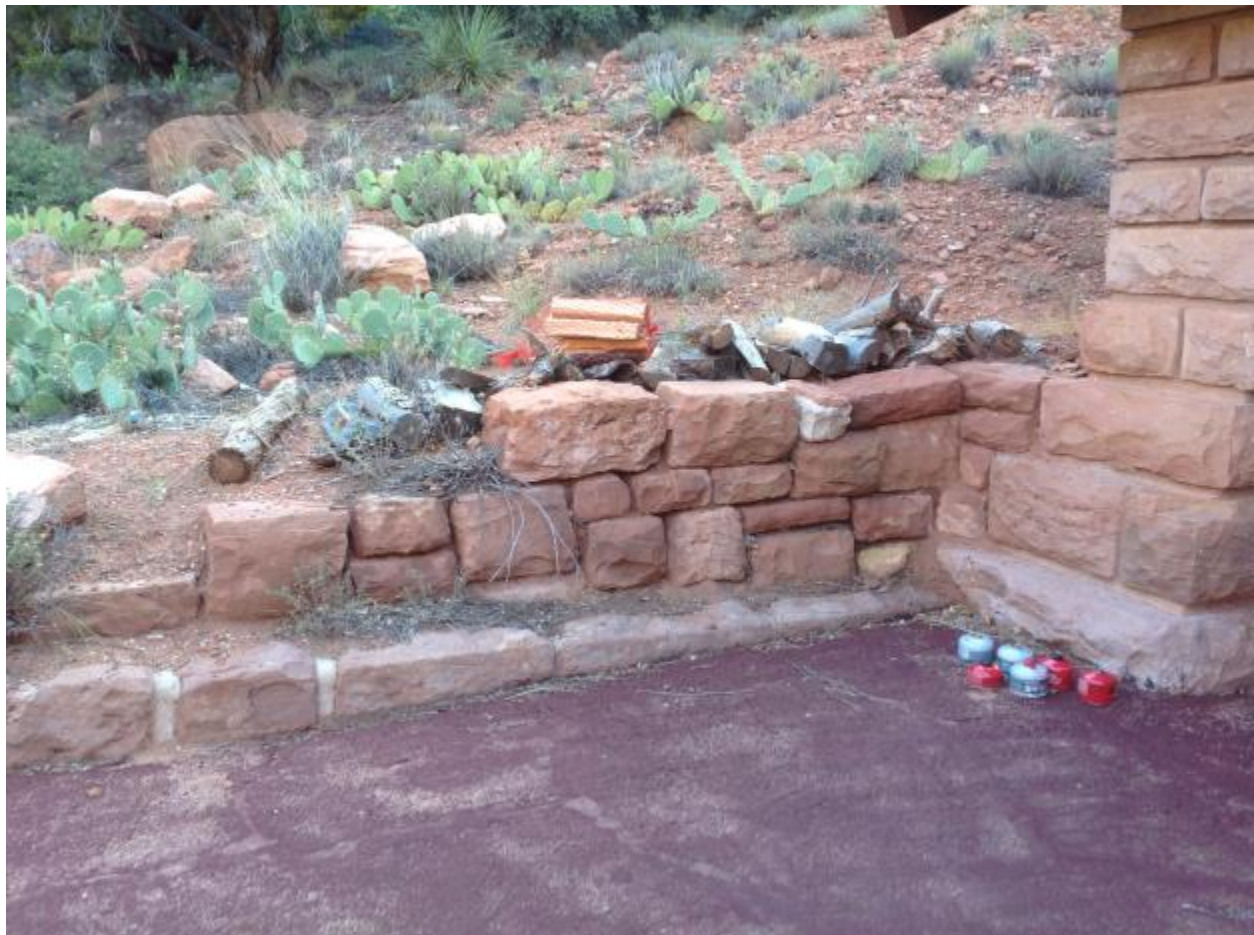
Name of Property: Oak Creek Historic District
City or Vicinity: Springdale
County: Washington
State: Utah
Photographer: Russell Cash
Date Photographed: 8/6/2014
Description: Retaining wall next to garage HS-0112
Feature Number: FEA-072
View Aspect: North
78 of 84

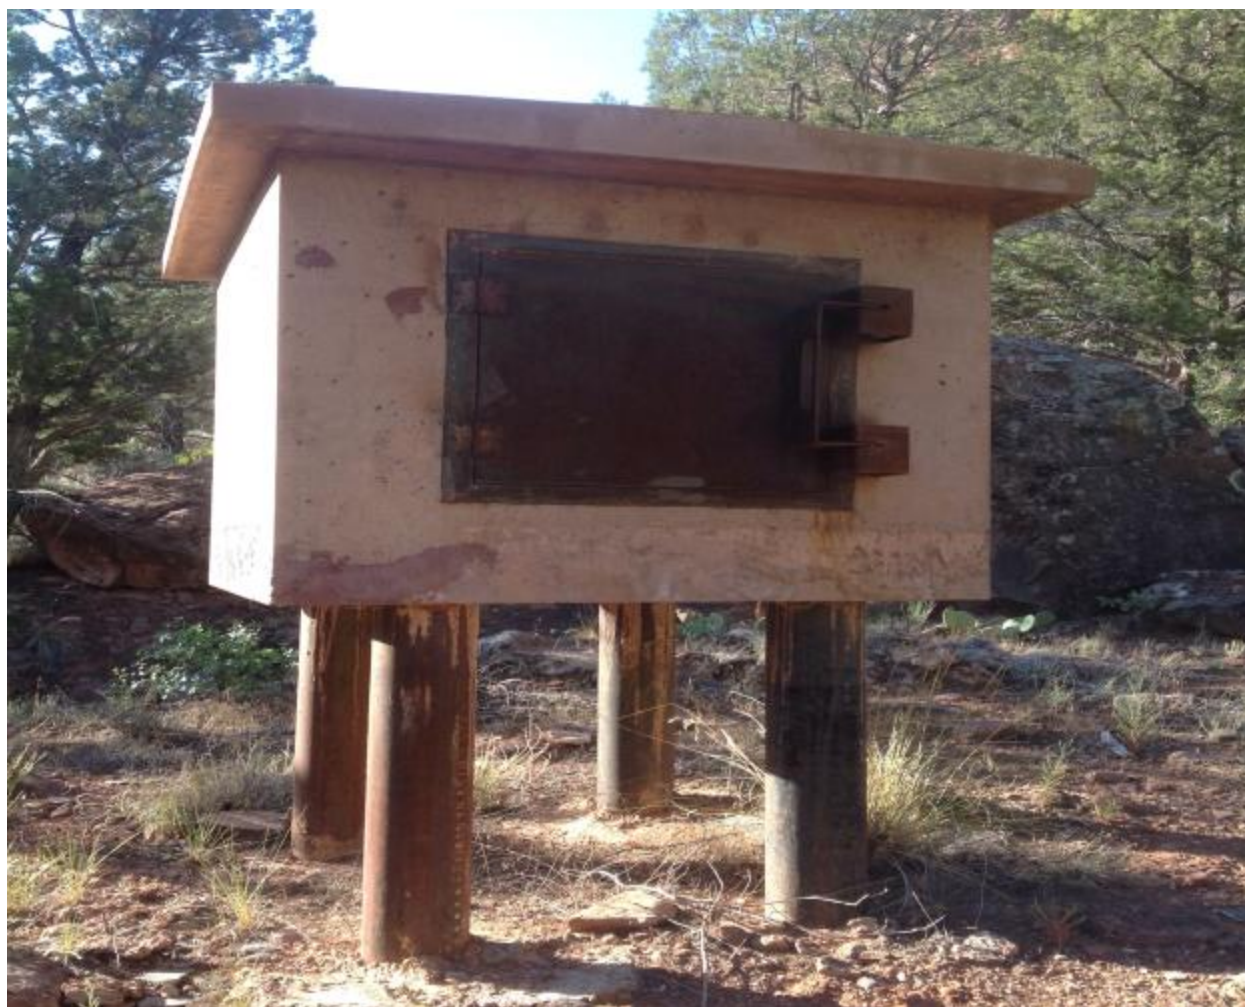
Name of Property: Oak Creek Historic District
City or Vicinity: Springdale
County: Washington
State: Utah
Photographer: Russell Cash
Date Photographed: 8/6/2014
Description: Concrete box behind maintenance yard
Feature Number: FEA-073
View Aspect: Southeast
79 of 84

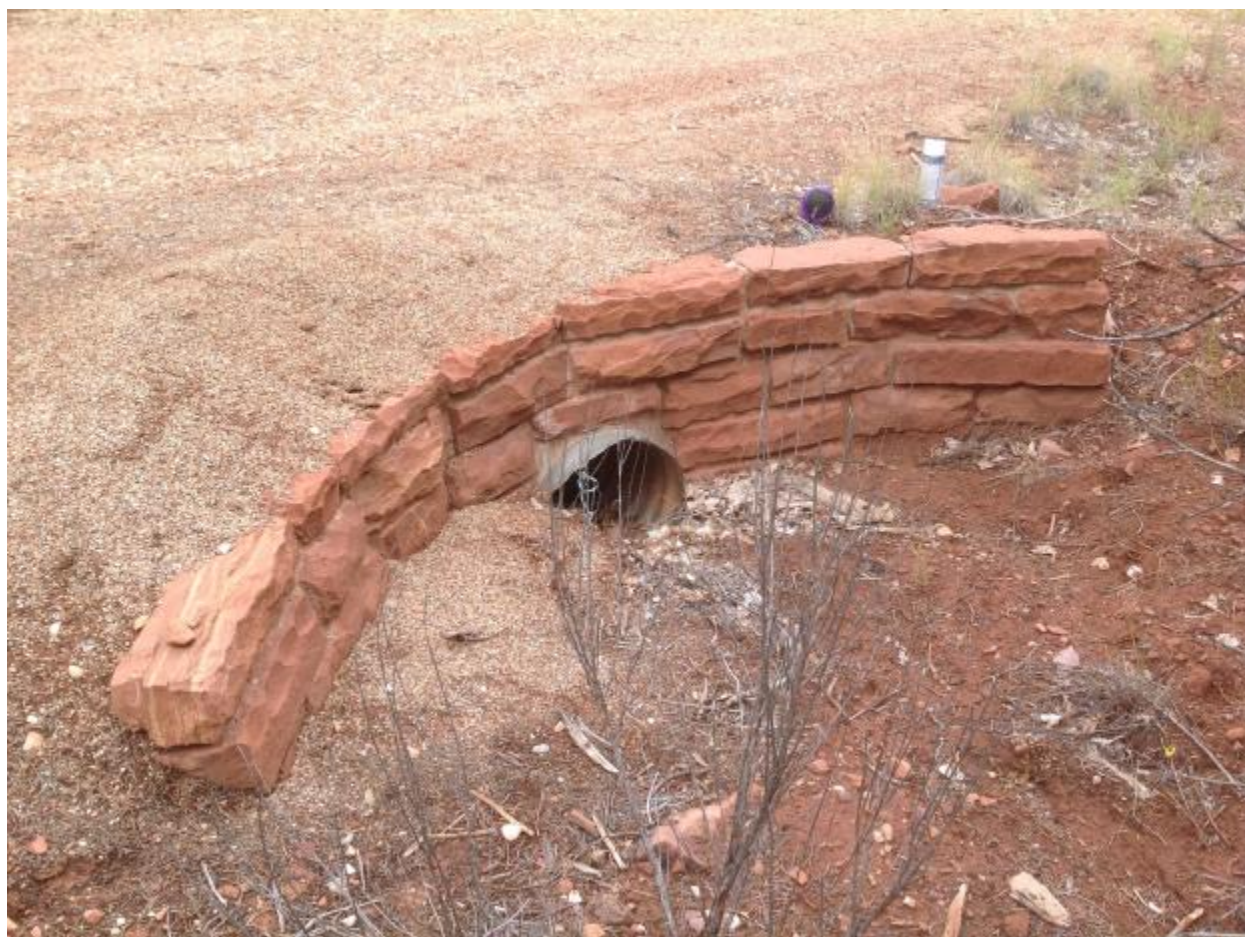
Name of Property: Oak Creek Historic District
City or Vicinity: Springdale
County: Washington
State: Utah
Photographer: Russell Cash
Date Photographed: 8/6/2014
Description: Culvert southwest end, along Oak Creek Maintenance Road
Feature Number: FEA-074
View Aspect: East
80 of 84

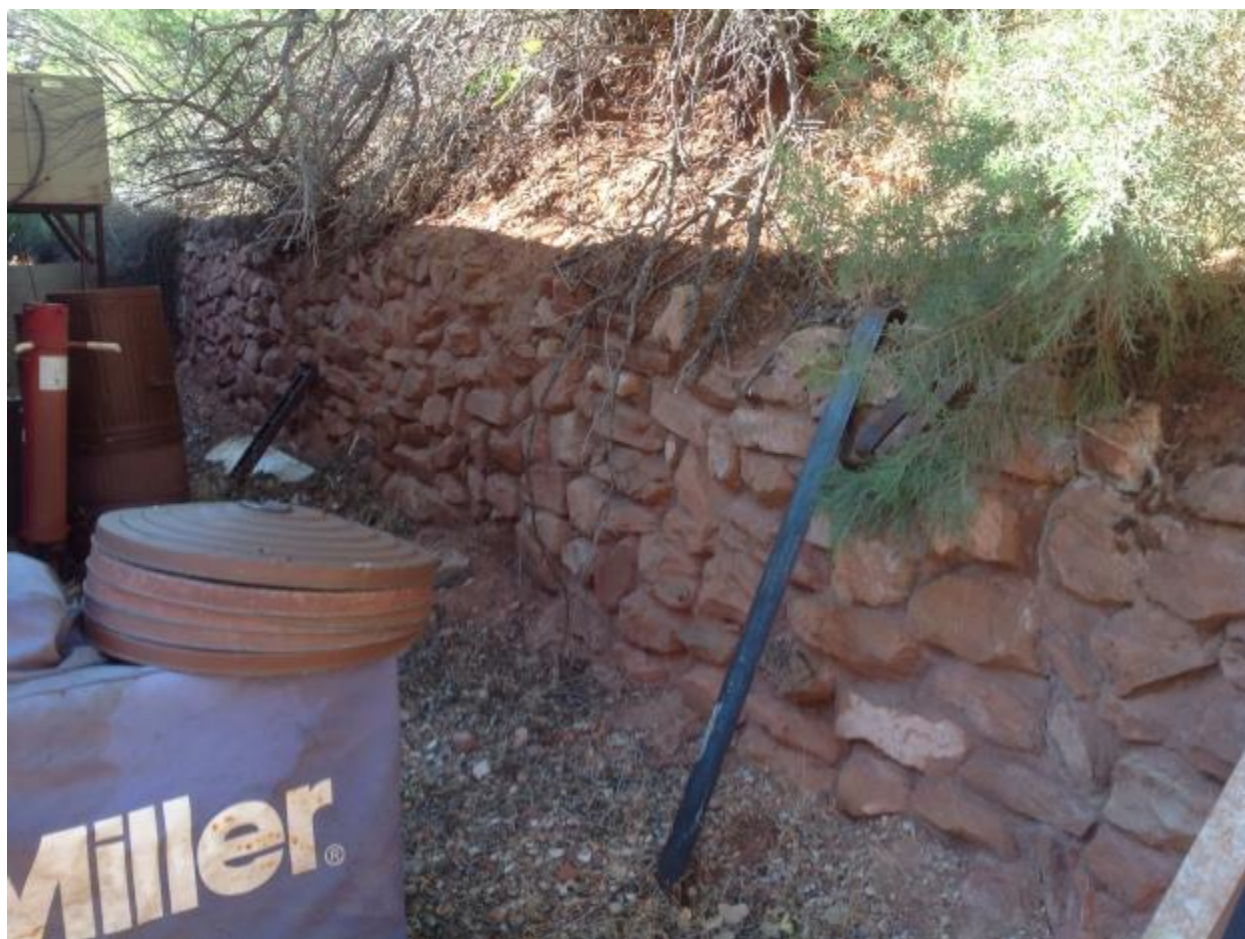
Name of Property: Oak Creek Historic District
City or Vicinity: Springdale
County: Washington
State: Utah
Photographer: Russell Cash
Date Photographed: 8/6/2014
Description: Retaining wall behind trails shop in maintenance area
Feature Number: FEA-075
View Aspect: East
81 of 84
