National Register of Historic Places Registration Form

Historic name: Oak Creek Historic District
Other names/site number: _____
Name of related multiple property listing: Multiple Resources for Zion National Park
(Enter "N/A" if property is not part of a multiple property listing)

The 1987 nomination only listed the district's eligible buildings. This amendment addresses an additional eighty-four historic resources, fifty-five contributing and twenty-nine non-contributing. These features include water features, circulation networks, designed outdoor spaces, vegetation related to land use, and other landscape elements that mirror the "Rustic" style of their associated buildings. The district's period of significance under Criterion C for "NPS Rustic/Naturalistic Design" is 1932-1942. Furthermore, under Criterion A, this amendment adds the context of the Civilian Conservation Corps (CCC) for its work constructing the buildings and

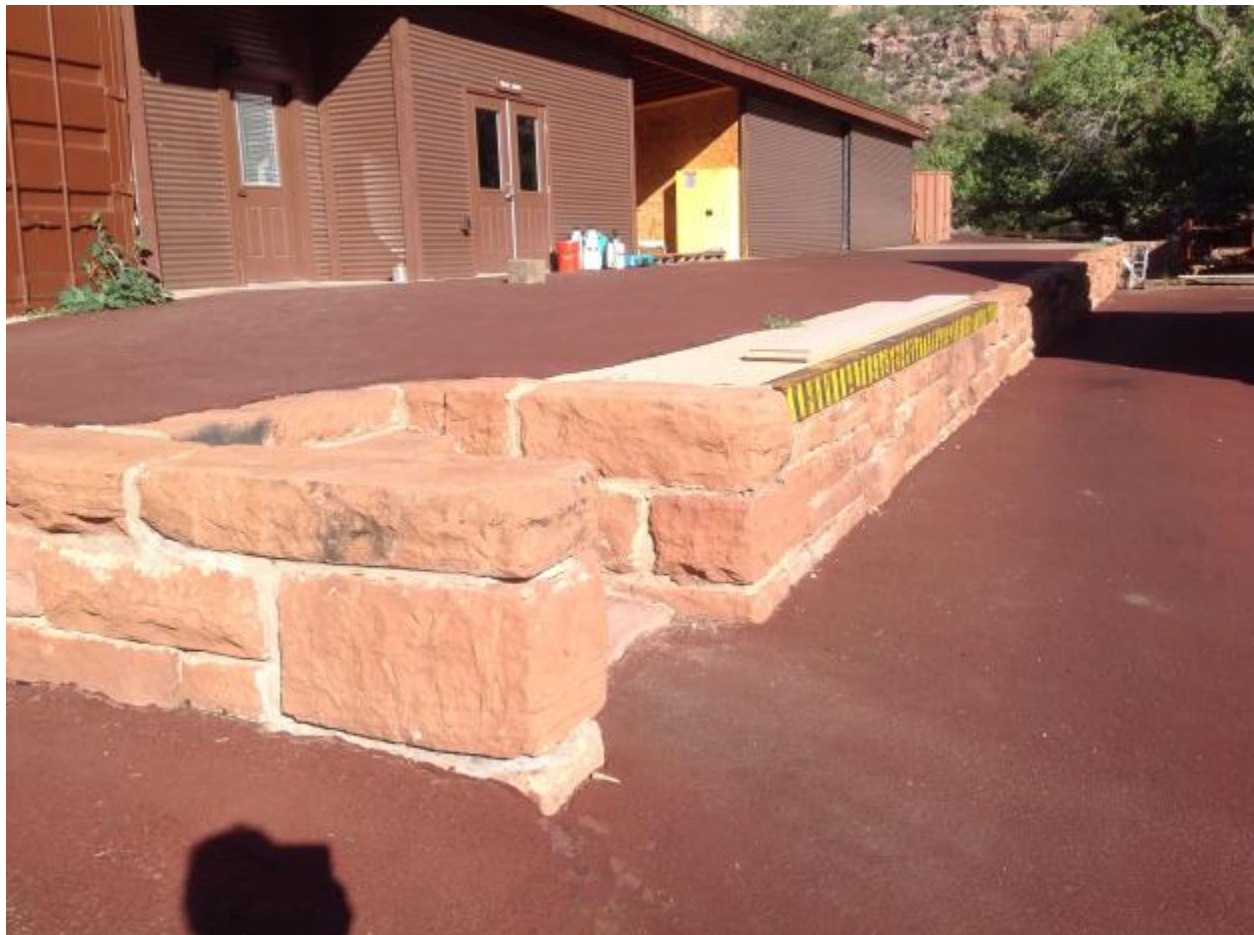
Name of Property: Oak Creek Historic District
City or Vicinity: Springdale
County: Washington
State: Utah
Photographer: Russell Cash
Date Photographed: 8/6/2014
Description: Loading dock at trails shop in maintenance area
Feature Number: FEA-076
View Aspect: West
82 of 84

Additional structures in Oak Creek Historic District utilized local sandstone to meet the "NPS Rustic/Naturalistic Design" standards. These features include a hearth (FEA-004) built into the retaining wall around the Ranger Dormitory at the same time as construction of other contributing features associated with the dorm in 1941-42; two stone-lined pits (FEA-017 and FEA-018), a fire pit of unknown date (FEA-040), and the raised sandstone loading dock (FEA-076) in the maintenance area.

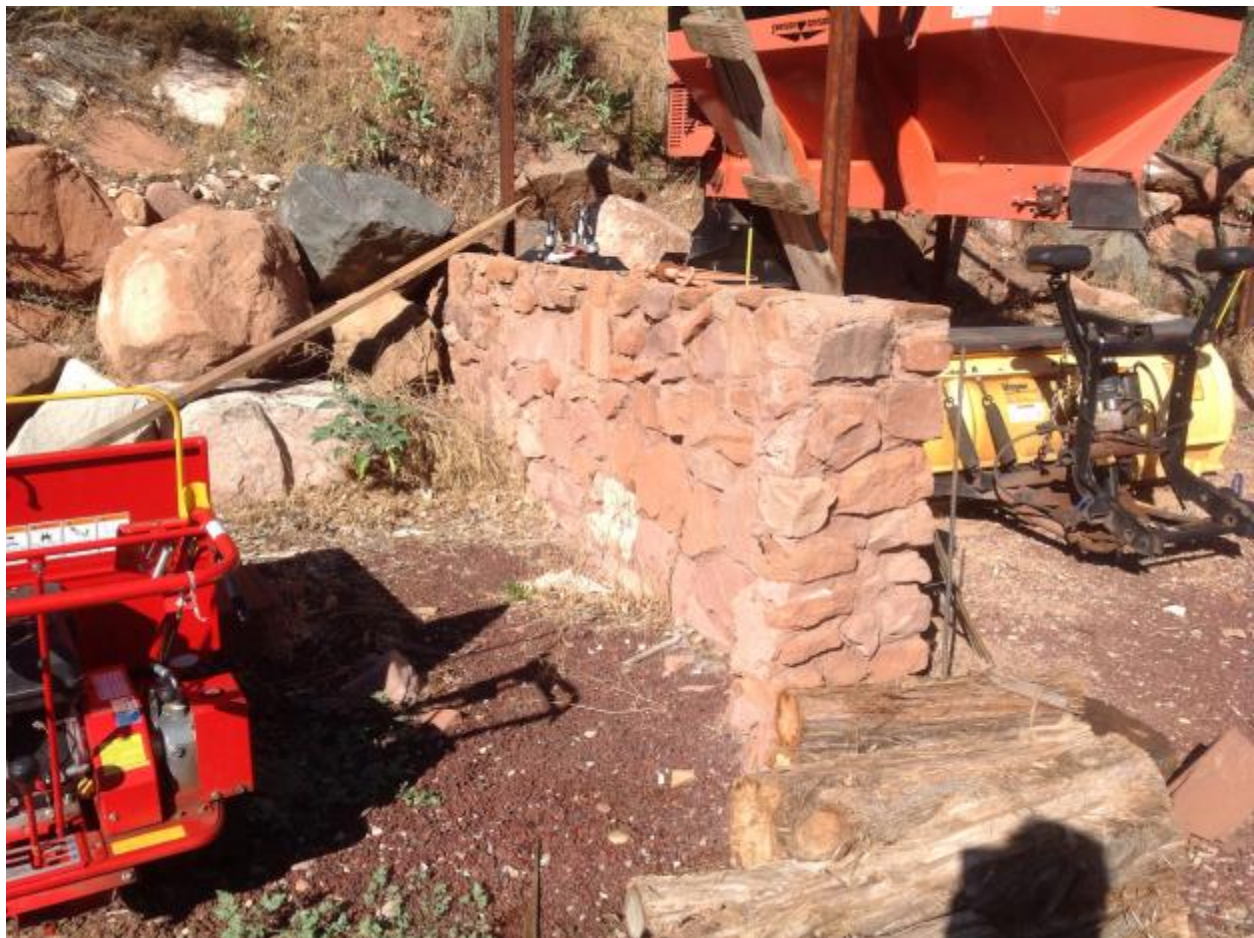
Name of Property: Oak Creek Historic District
City or Vicinity: Springdale
County: Washington State: Utah
Photographer: Russell Cash
Date Photographed: 8/6/2014
Description: Retaining wall by trails shop parking area
Feature Number: FEA-077
View Aspect: West
83 of 84

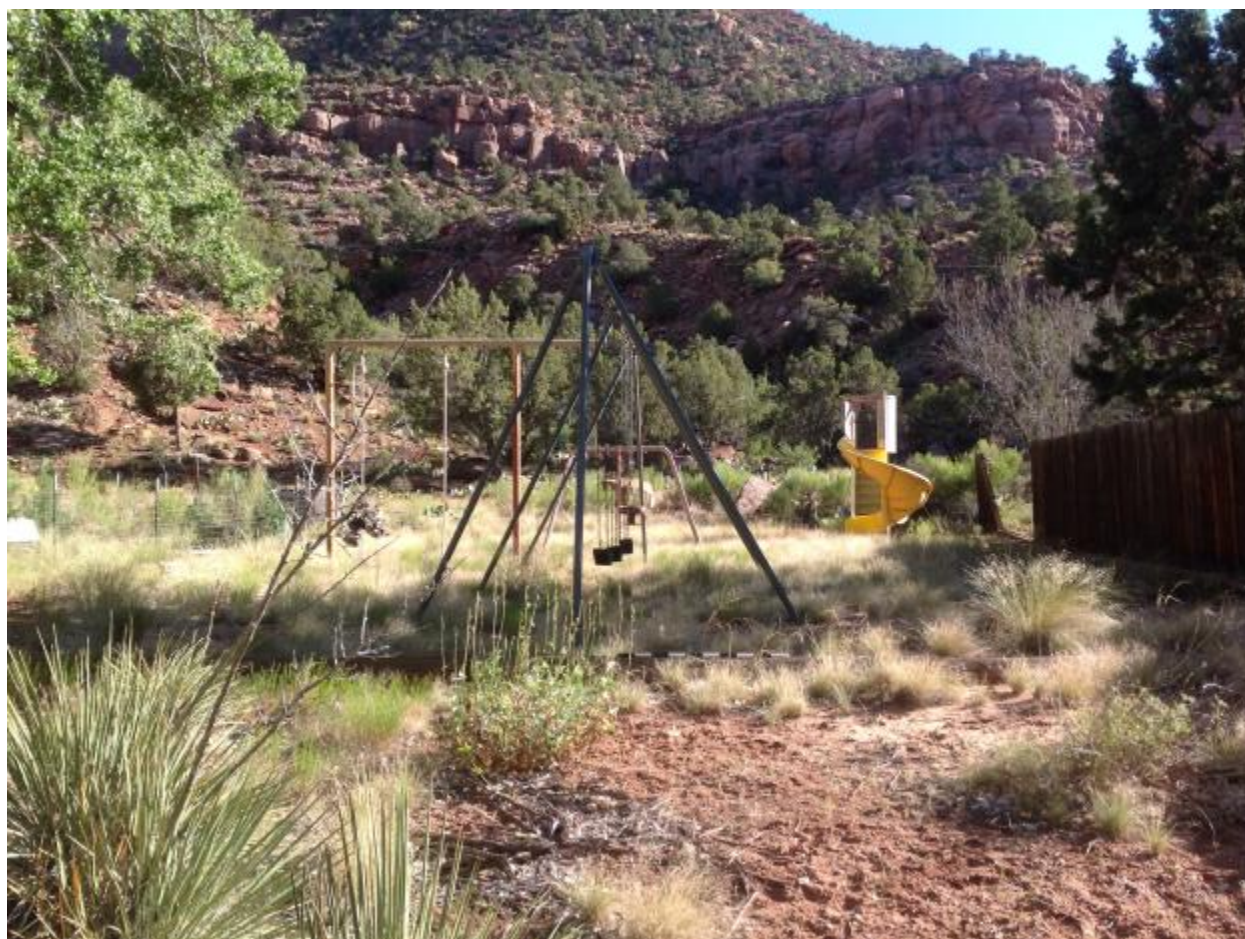
Name of Property: Oak Creek Historic District
City or Vicinity: Springdale
County: Washington
State: Utah
Photographer: Jason O'Brien
Date Photographed: 8/6/2014
Description: Playground between recreational vehicle lot and HS-0008
Feature Number: FEA-078
View Aspect: North
84 of 84

FEA-078	Playground	Fair	Non-Contributing		Post-NPS Rustic/CCC Period: Later rubble construction
