Technical Support for Trail Restoration and Maintenance for Arches and Canyonlands National  
Parks

Henry Shovic, PhD

Project Report: Arches Devil's Garden Trails  
Field Review, Analysis, Conclusions, and Recommendations  
Henry Shovic, PhD  
Rocky Mountain Cooperative Ecosystems Study Unit  
Jan 23, 2009

Project Report: Canyon Lands Fort Bottom Trails  
Field Review, Analysis, Conclusions, and Recommendations  
Henry Shovic, PhD  
Rocky Mountain Cooperative Ecosystems Study Unit  
Mar 4, 2009

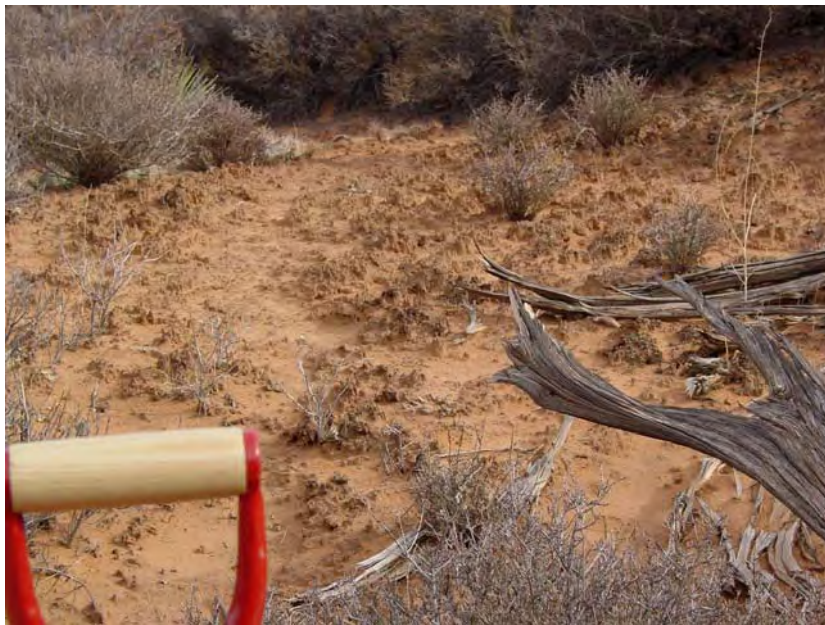
25% bedrock; 5% weakly-cemented sandstone rock layers (distributed as noted in field review notes). Off-trail soil biologic crust is wide-spread, with an average of 50% of surface cover.

Relatively undisturbed soil surface showing biologic soil crust and sandy texture.

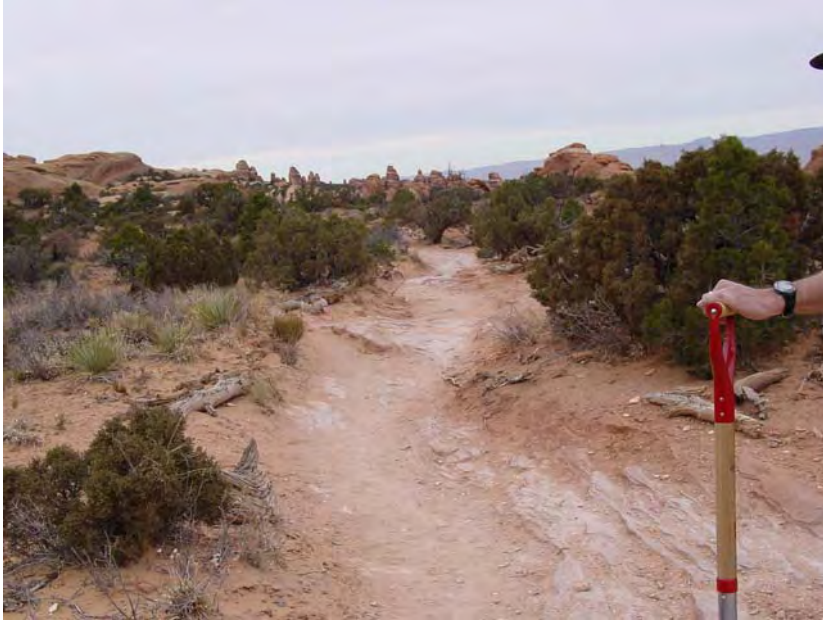
Trails that are in “Good” condition require little maintenance. They are relatively stable (either on bedrock, mechanically stabilized, or in relatively-stable colluvium).

A trail rated in “Good” condition.

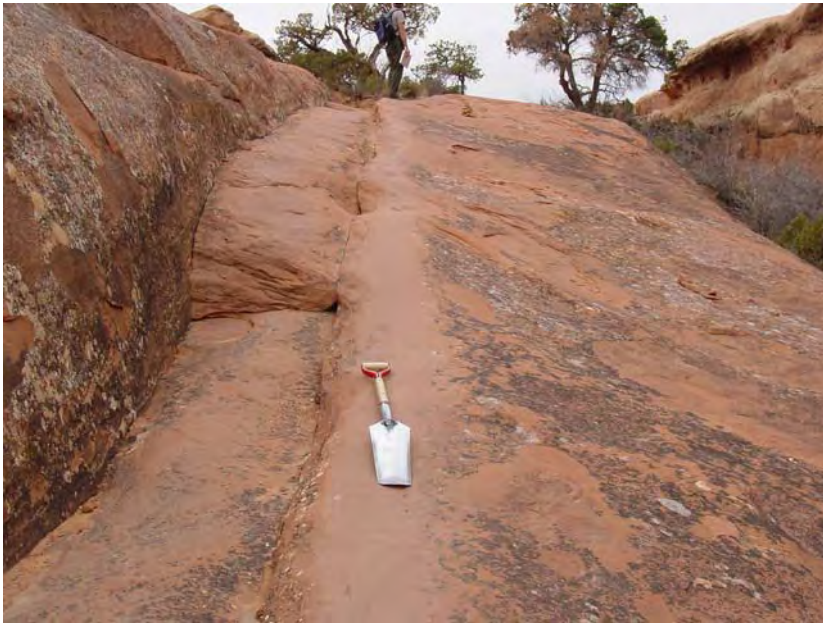
Those rated “Good” would still benefit from maintenance and signing to reduce creation of social trails. However, some impacts are still apparent (removal of lichen beds).

Bedrock trail showing lichen removal.

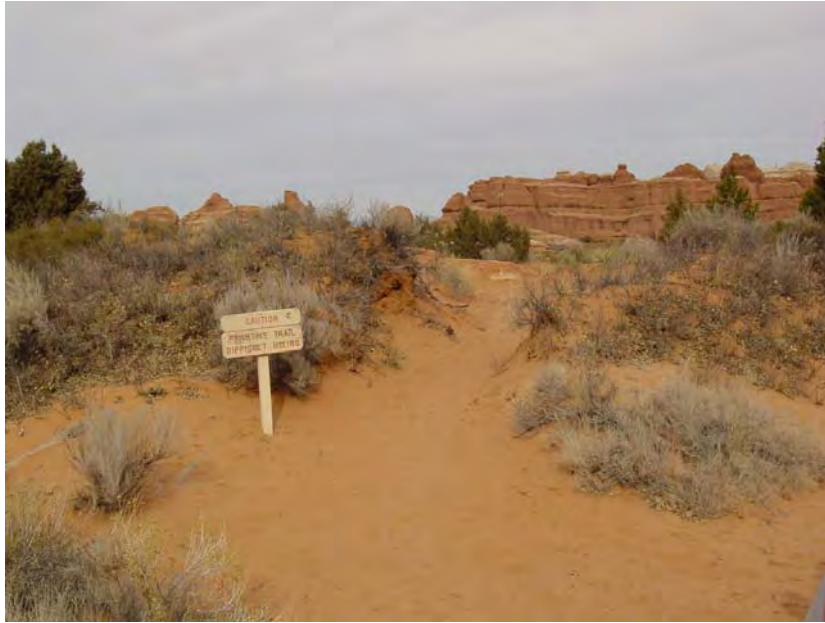
Trails in “Poor” condition are unstable, and are actively damaging resources, both on-site (soils, vegetation), and off-site (sediment, trail widening). They should be stabilized along their entire length, given additional maintenance, or closed.

Trail in “Poor” Condition

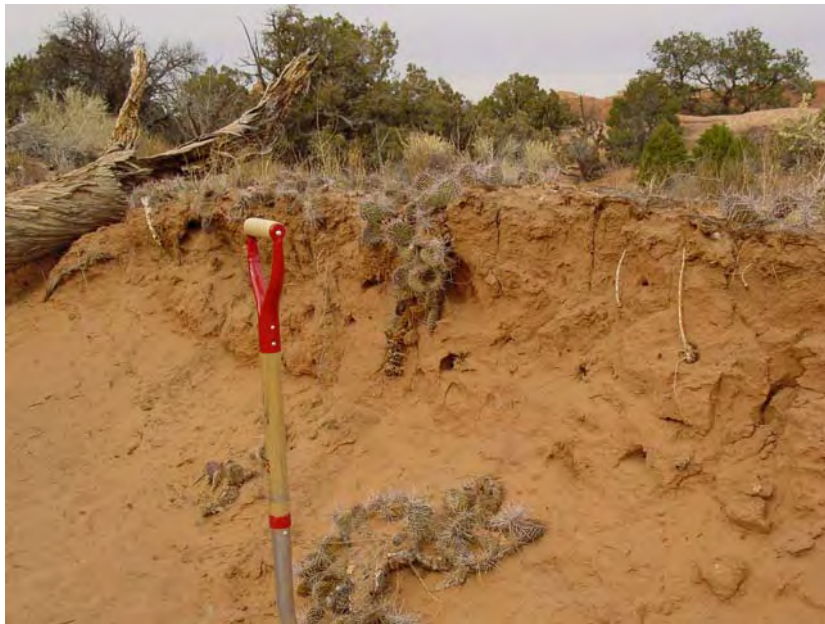
Natural revegetation is unlikely to occur on steep, eroding cutslopes. This is probably because of active removal of tread material, which oversteepens banks. Vegetation slough is common in eroding areas.

Active erosion, vegetation slough, and steep downcuts.

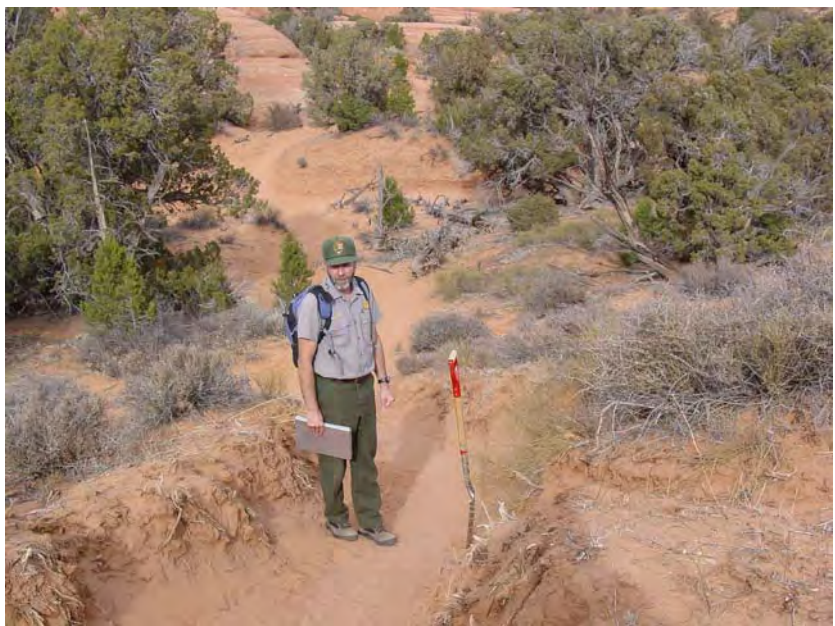
Trail in “Moderate” condition showing areas of stabilization needs in foreground and better condition in background.

Trails in “Moderate” condition should be reviewed for spot stabilization on steep grades or in sandy portions, and trail margin marking with stones where widening is occurring. Stabilization needs are estimated at 10% of the trail length.

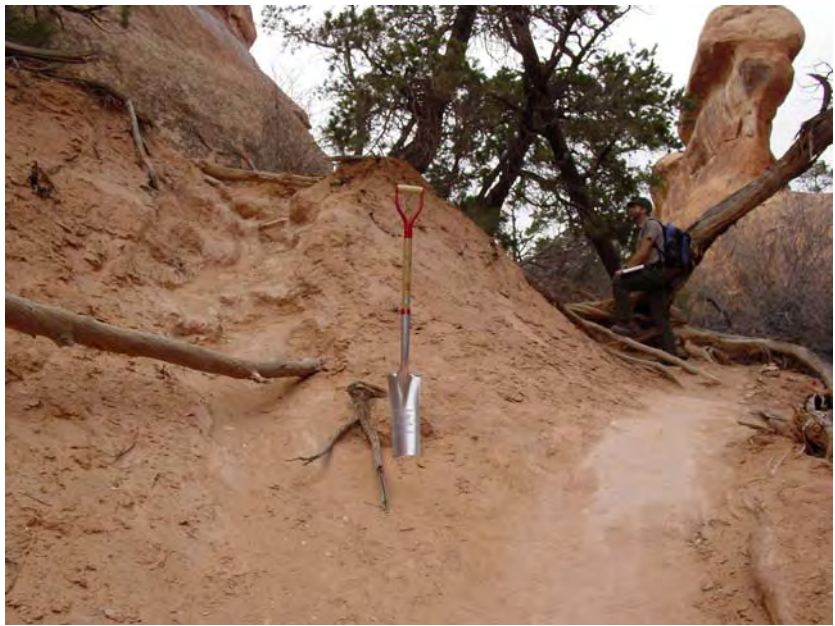
Geological tread “armor” occurs in some places. It is apparently a weakly-cemented sandstone/siltstone layer that is relatively resistant to further erosion, when the overlying sand has been eroded. This layer may be advantageous to stabilization efforts, but is not considered in the above recommendations. This is because its occurrence is sporadic and may not be at the final recommended design grade for trail stabilization.

Actively-eroding social trail on left, with geological armor on lower trail.

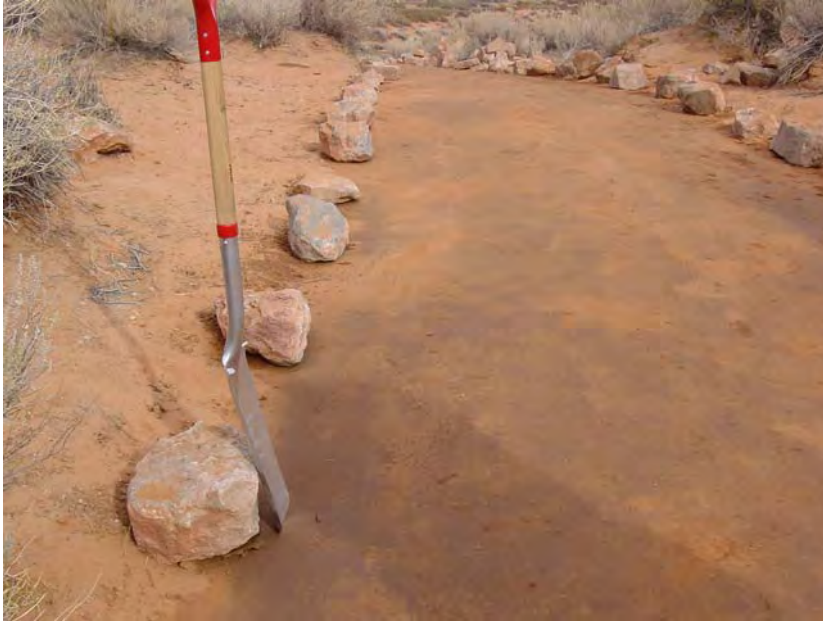
Chemical trail stabilization including rock borders.

Based on this field review of local methods effectiveness, adequate stabilization can be achieved using magnesium-chloride cementation on a graded base of native or imported material. The stabilized material should be at least six inches in depth, and have a well-packed base. Trail widening and cutslope steepening can be reduced by rock borders in areas having high potential for off-trail use.

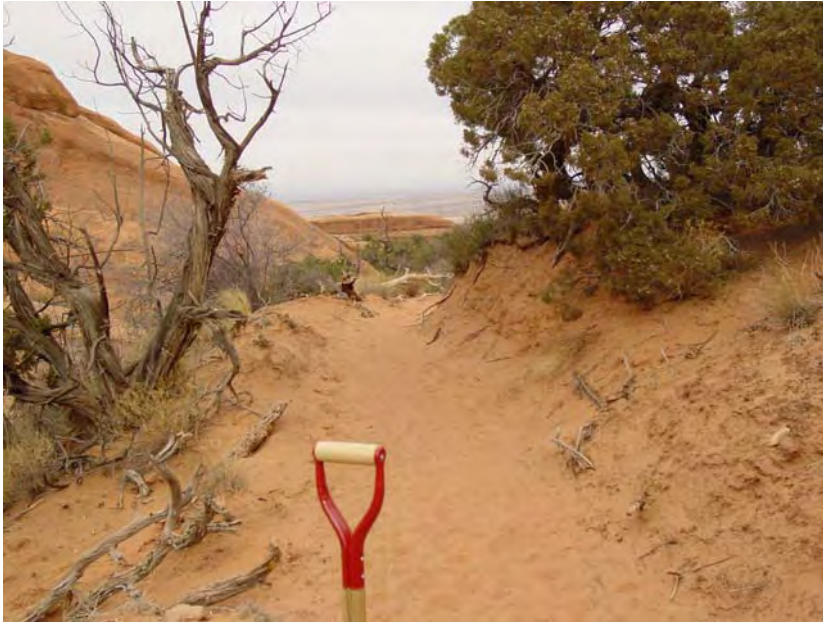
Most trails in “Poor” condition have steep, actively eroding cutslopes. Trail stabilization measures will not directly improve these cutslopes. However, tread improvement will slow their development by decreasing oversteepening and mechanical trampling, giving vegetation a better chance of re-establishment.

Steep cutslopes

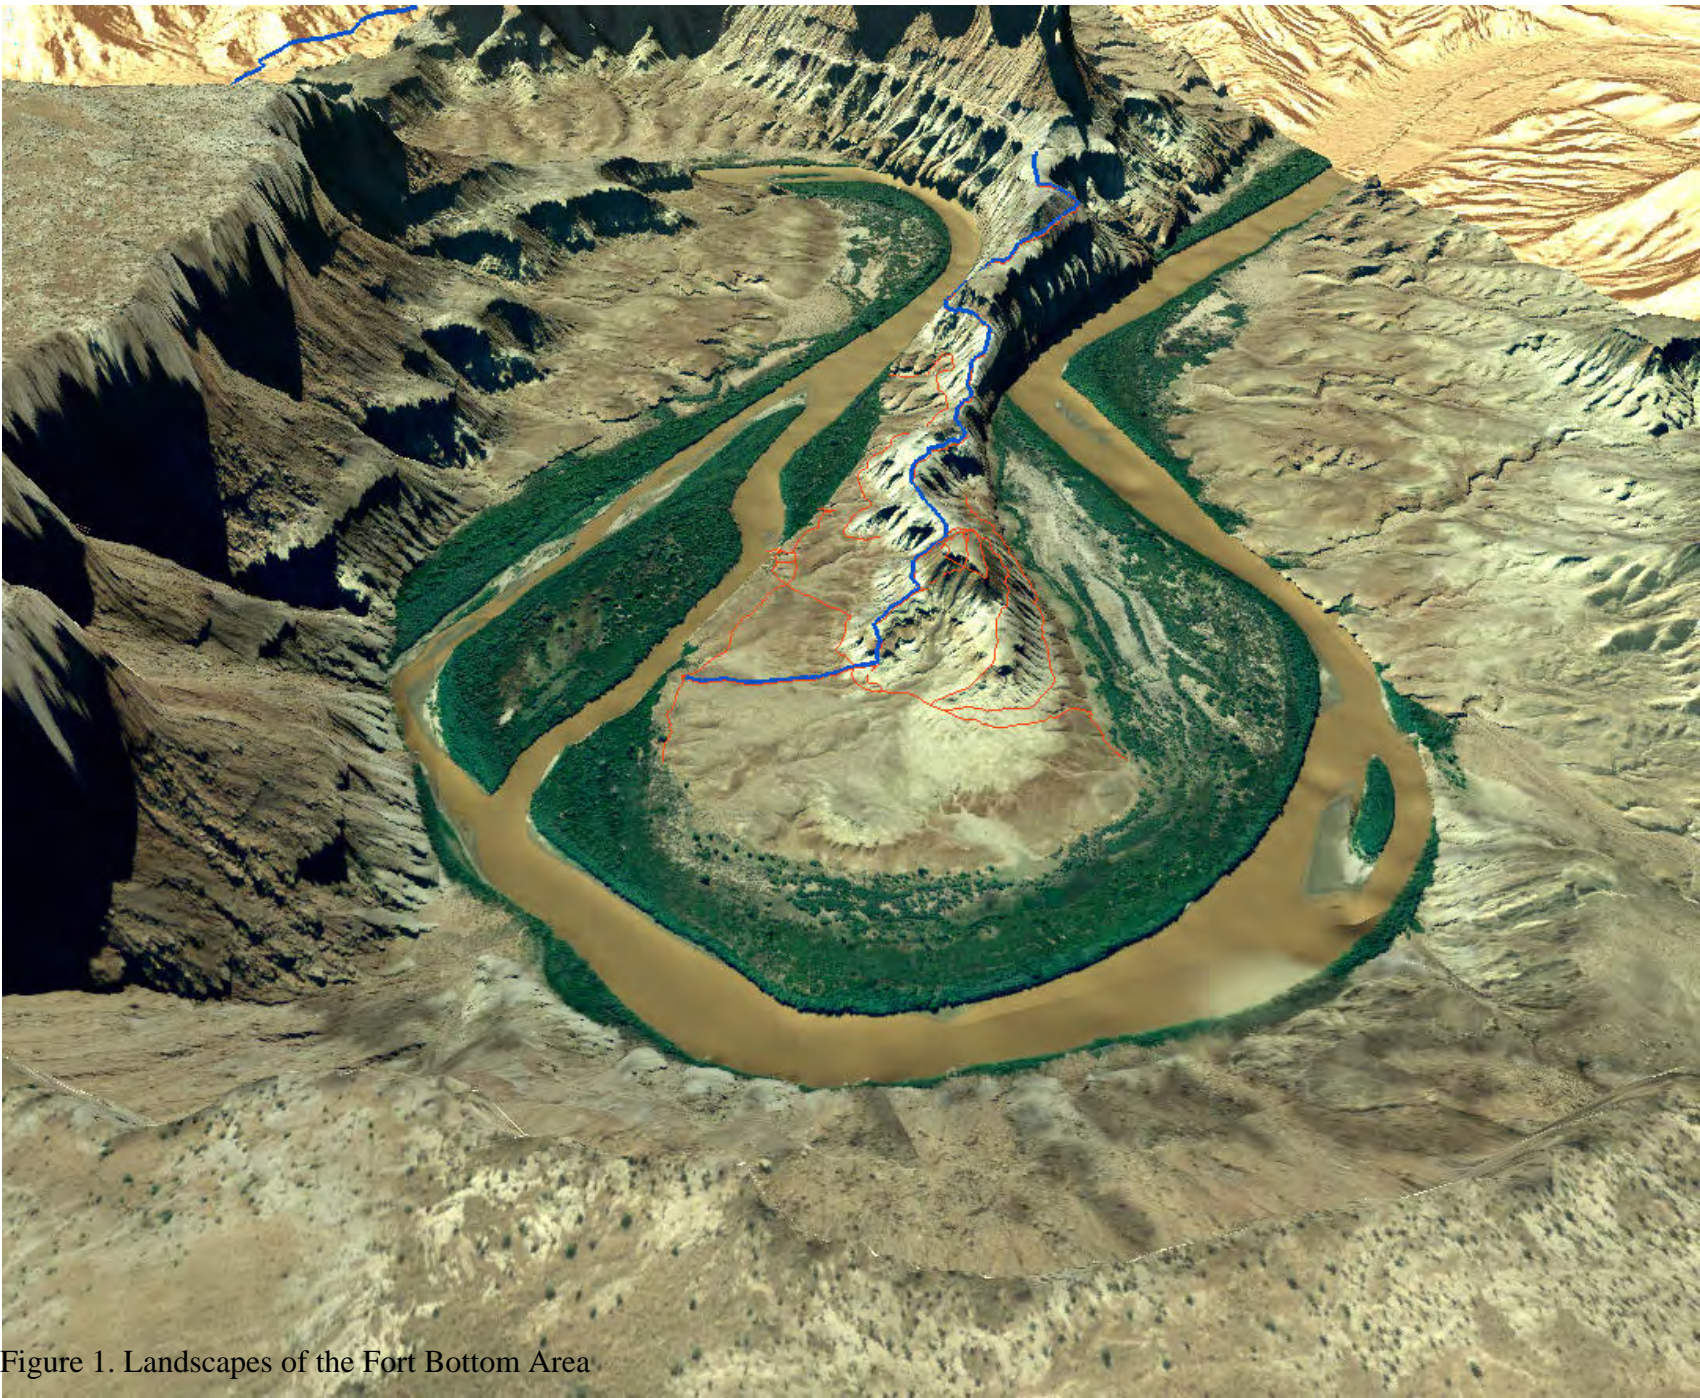
Figure 1. Landscapes of the Fort Bottom Area

The underlying landform is an eroded, colluvial slope having little vegetation. The gently-sloping alluvial “bottom” is heavily vegetated with Tamarask and other shrubs. This area can be reached by a primitive and difficult 4WD road, which limits user density. However, the Green River provides most access, and users from the river are probably responsible for most social trail development.

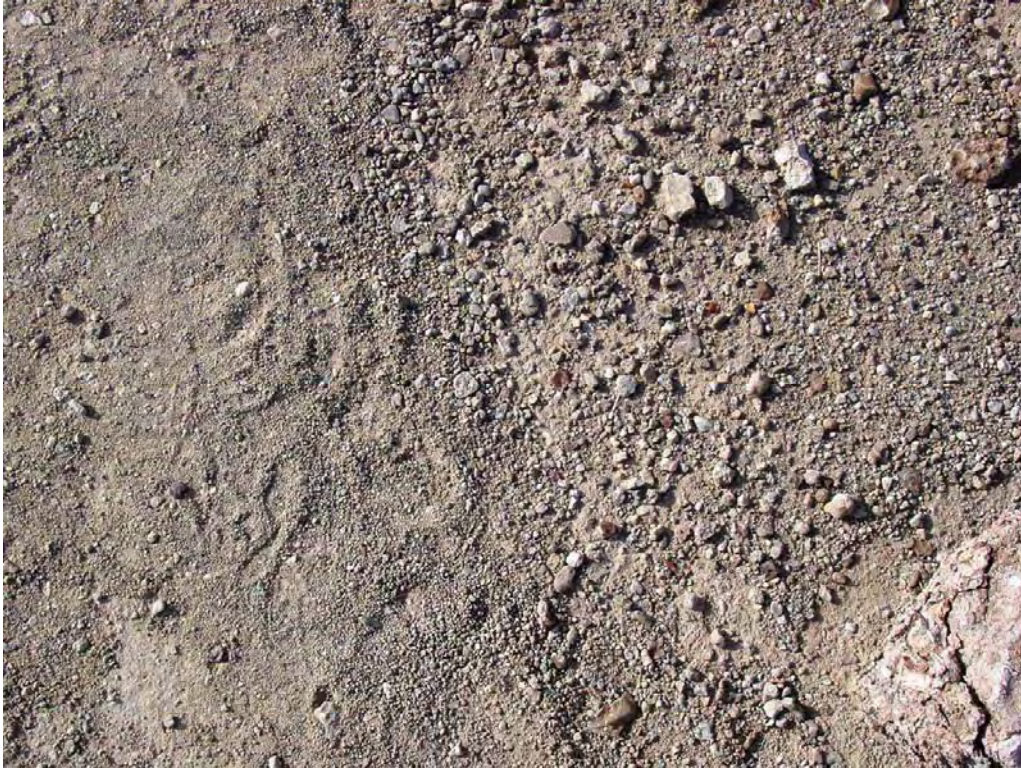
Soils on the Main Fort Bottom Trail eastern part – from field review

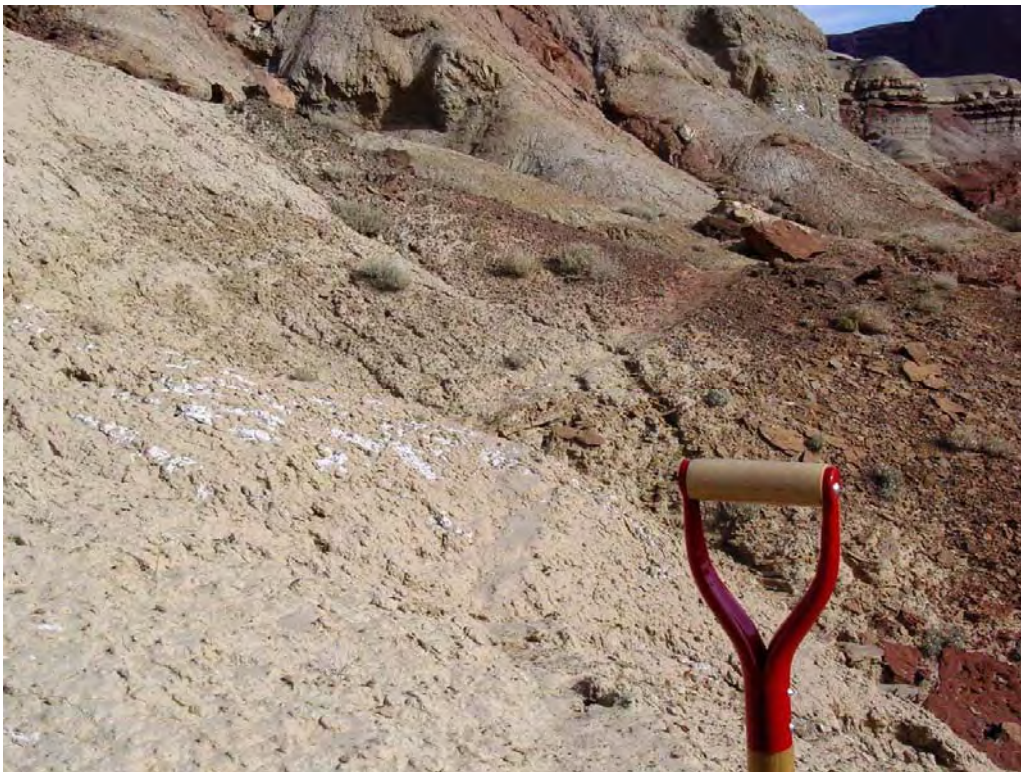
Soils on the non-system trails on the southern side, showing absence of bio-crust – from field review

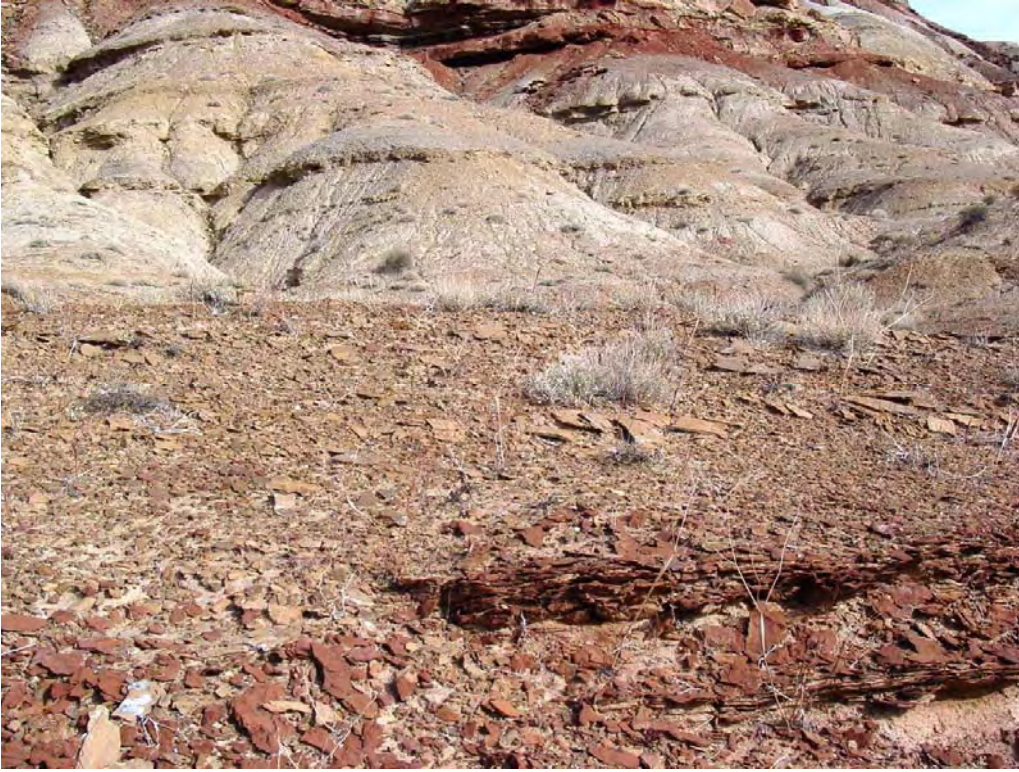
Desert pavement on relatively-stable parts of the western “badlands” area.

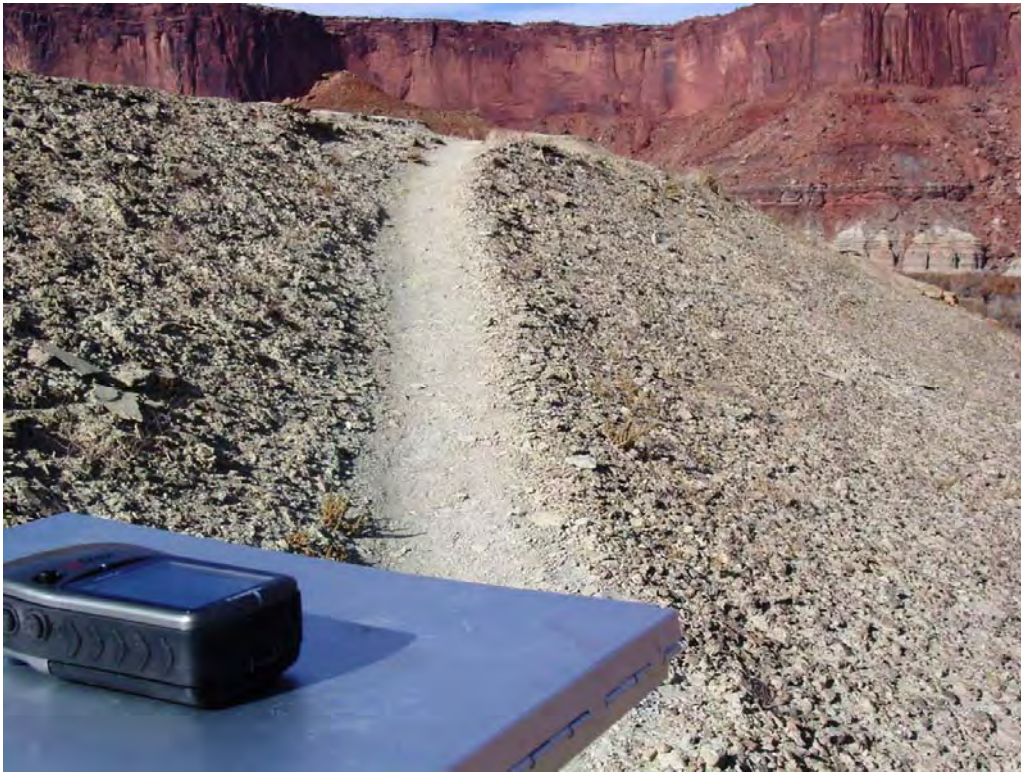
Trails having “Low” sensitivity require little maintenance. They are relatively stable (either on bedrock, mechanically stabilized, or in relatively-stable colluvium).

A trail having “Low” sensitivity. Slopes are gentle, and soils have a stable matrix of mixed materials.

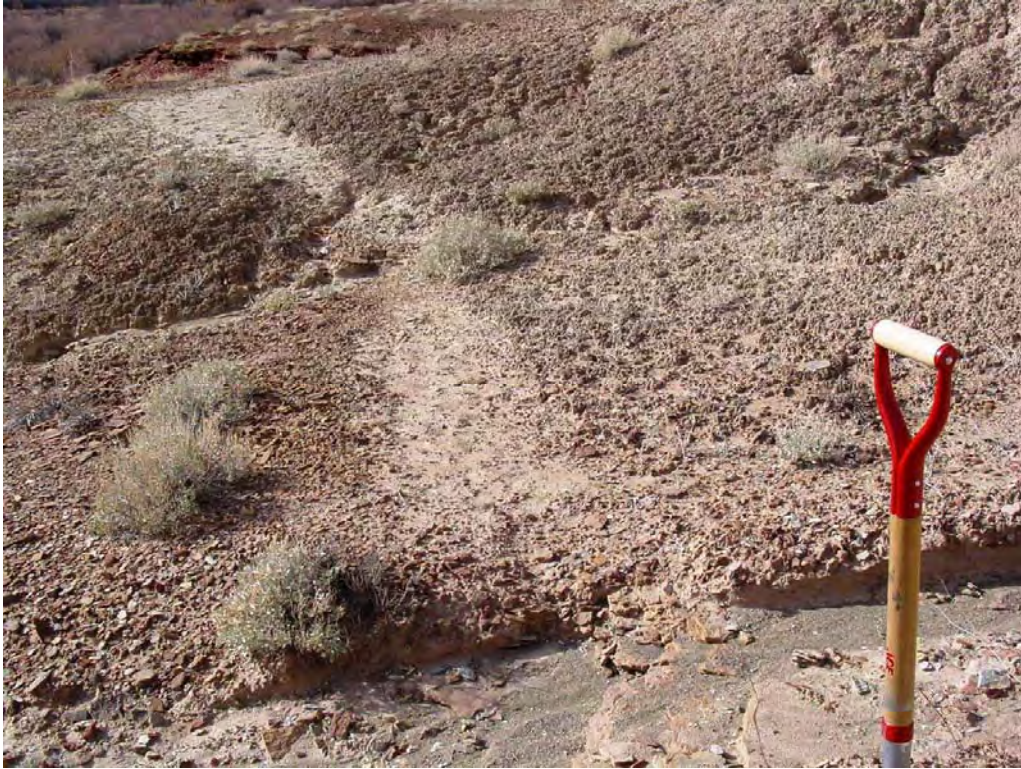
Trails with “High” sensitivity are unstable even with low use, and are likely to become very erosive if subjected to high, sustained use. They have potential for actively damaging resources, both on-site (soils, vegetation), and off-site (sediment, trail widening). They should be stabilized along their entire length, given additional maintenance, or closed.

Trail having “High” sensitivity.

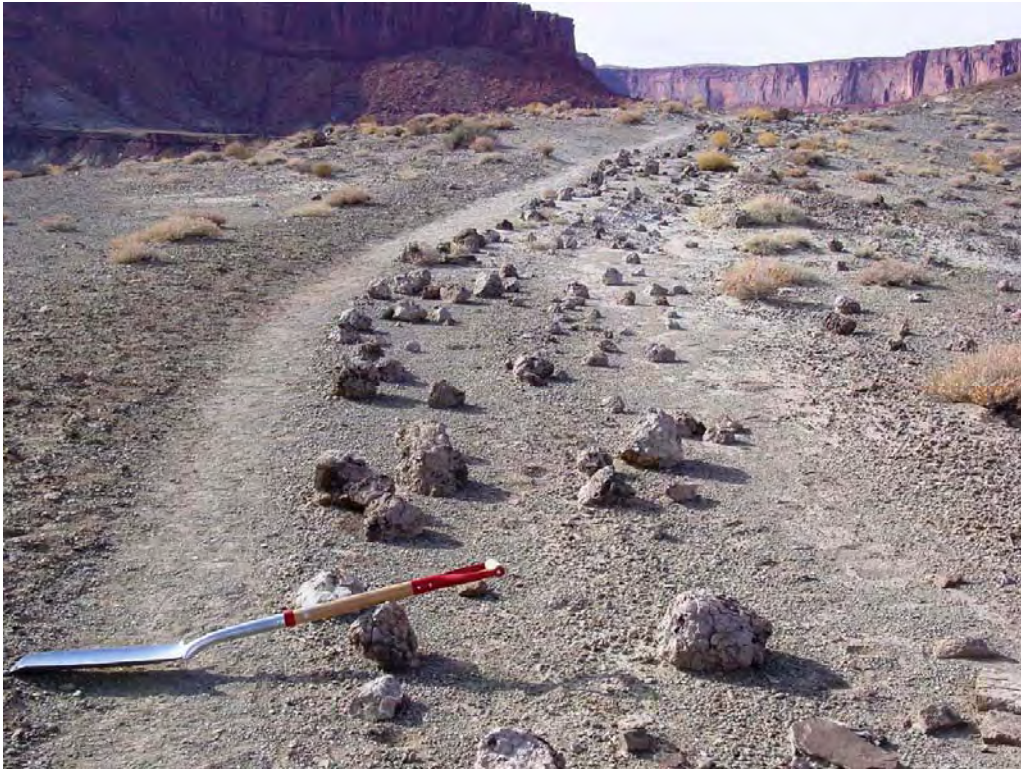
Observed stabilization methods include rock borders to define trail tread and reduce off-trail use, rock barriers to discourage social trail use, and “puncheons”, which are small holes excavated in the tread, probably to discourage use and to reduce erosion.

Rock Borders

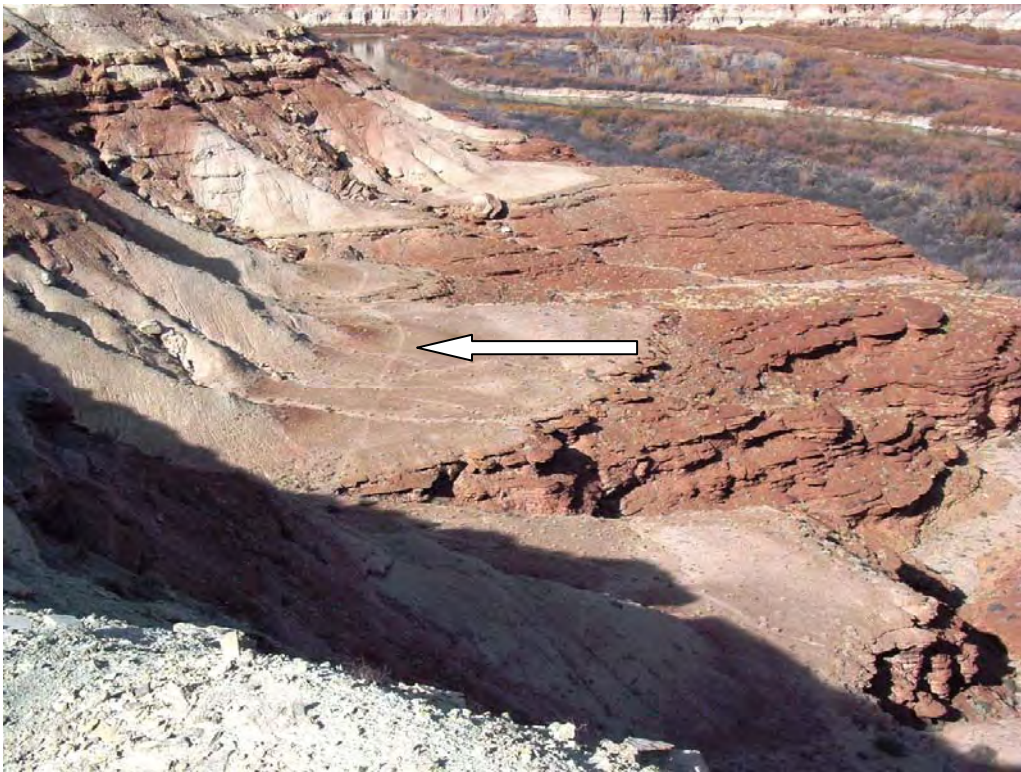
Spur3 Trail

The Spur3 trail is also relatively stable, and is not being widened, but is located in erosive material. It is highly visible, and appears to be located on steep slopes (Figure 5) but actually “snakes around” on gently-sloping benches.

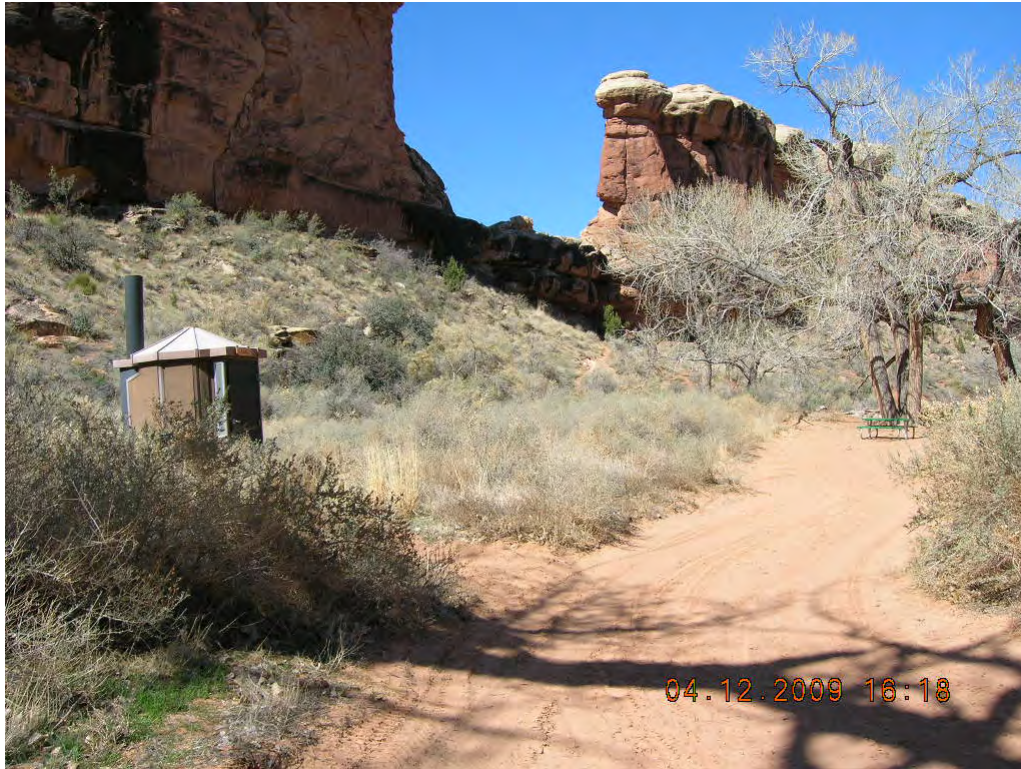
Soil materials in the vicinity of the stream are primarily alluvium and wind-deposited sand, modified by floodwaters (Appendix One). All soils are extremely sandy with occasional cobble or gravel layers. These kinds of soils have low productivity and fertility, and low resistance to erosion.

Sandy soils at Peekaboo Campground

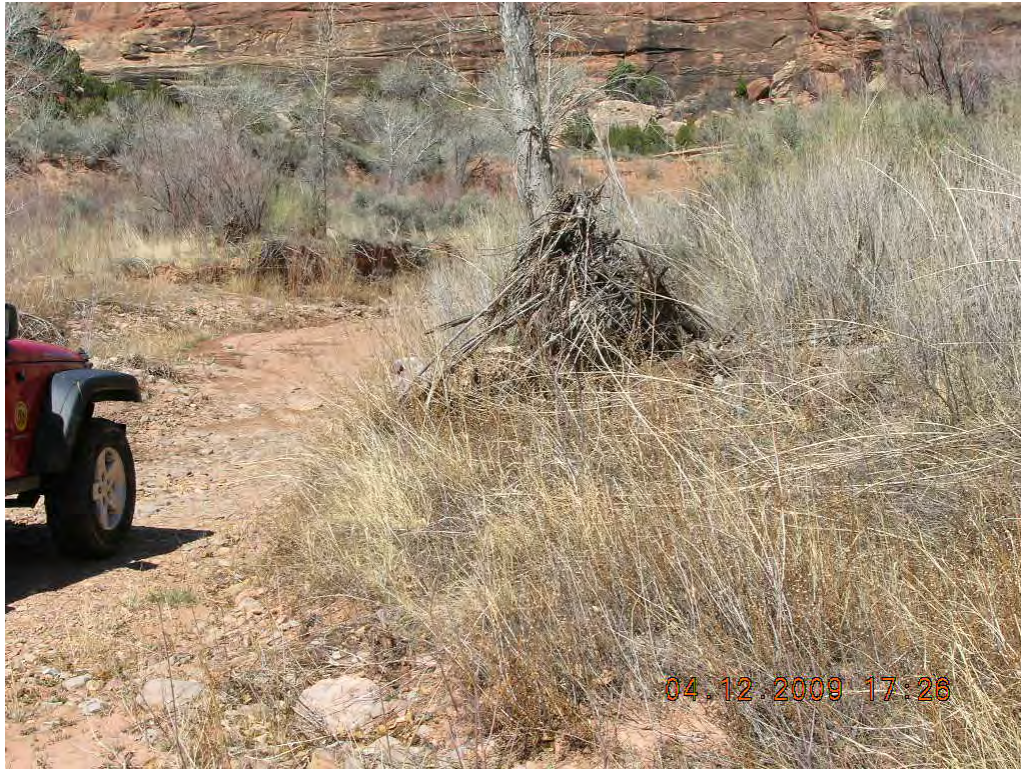
Evidence of flooding below the campground in Salt Creek

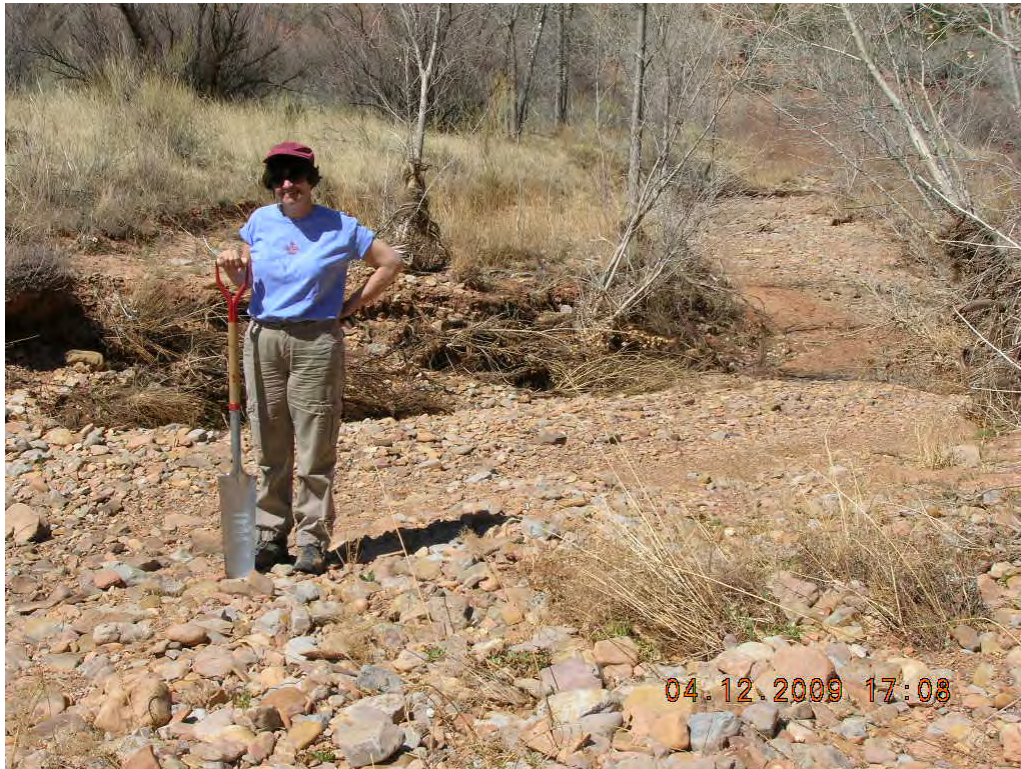
Salt Creek was flowing as of April 12, 2009 from Point 23 to 57 (about 2 miles of a total of 3). It is apparently one of only two perennial streams in Canyonlands National Park (the other is the Colorado River). The floodway's upper channel (from Point 20 to 44 or about one mile) has a substrate of gravel and cobbles with a well defined and incised channel, and is sandy with a well-defined channel to 57, then a poorly defined channel occurs below point 57. This may indicate stream scour is likely the primary flood erosive mechanism above Point 57 with deposition occurring below that point and most occurring below Point 57.

Gravel and cobble stream bed on upper channel

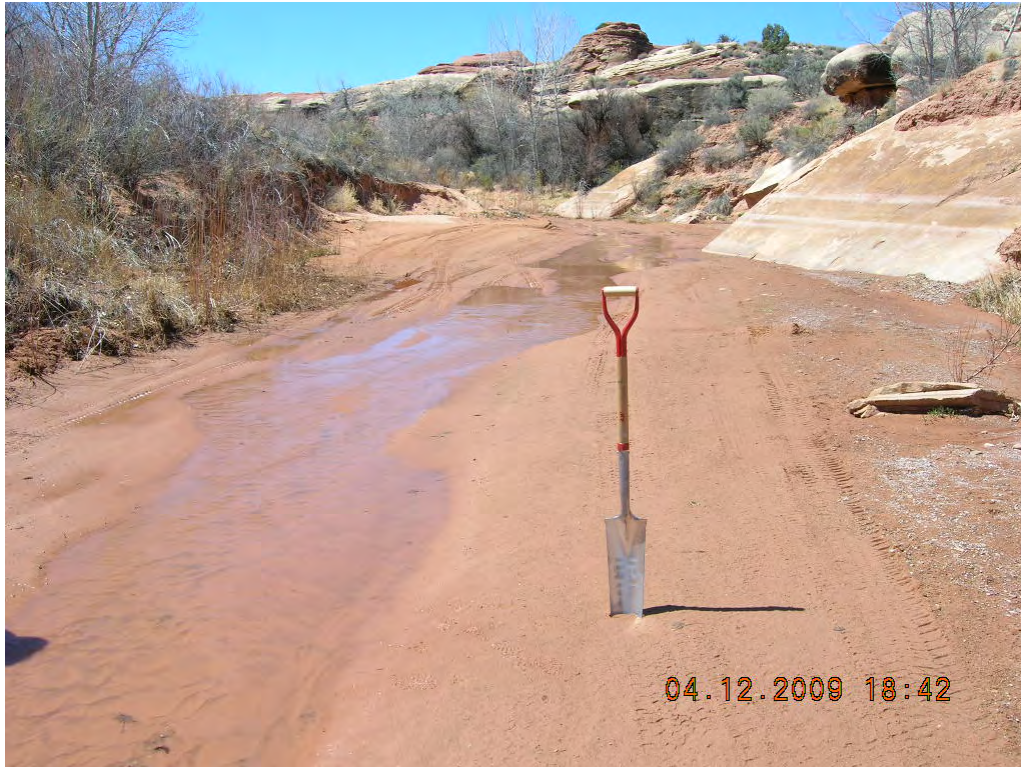
Sandy stream bed midway on lower channel

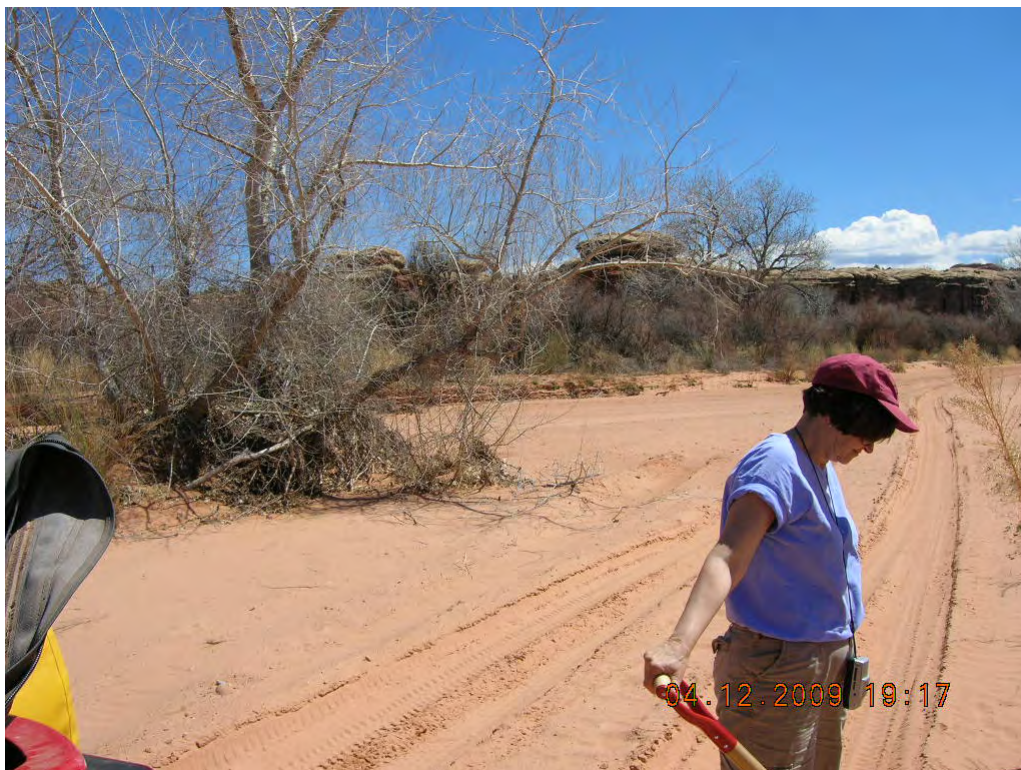
Sandy, poorly-defined stream bed on the lower channel.

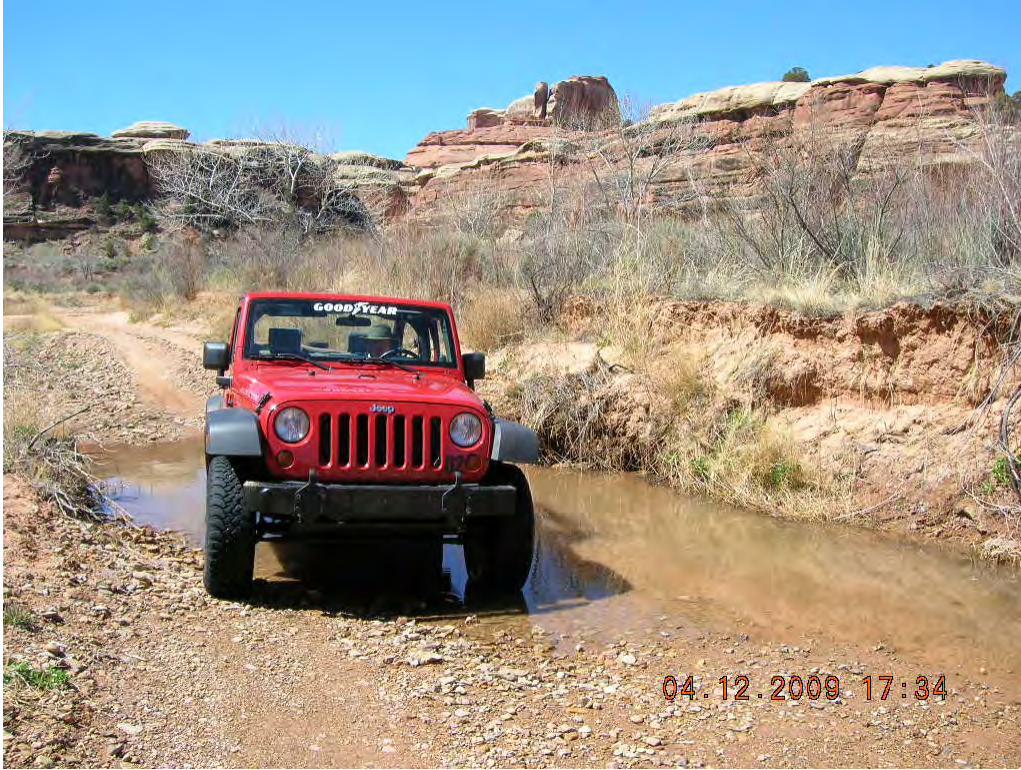
- The Floodway (including the active channel) has no vegetation and probably flows every year.

Floodway

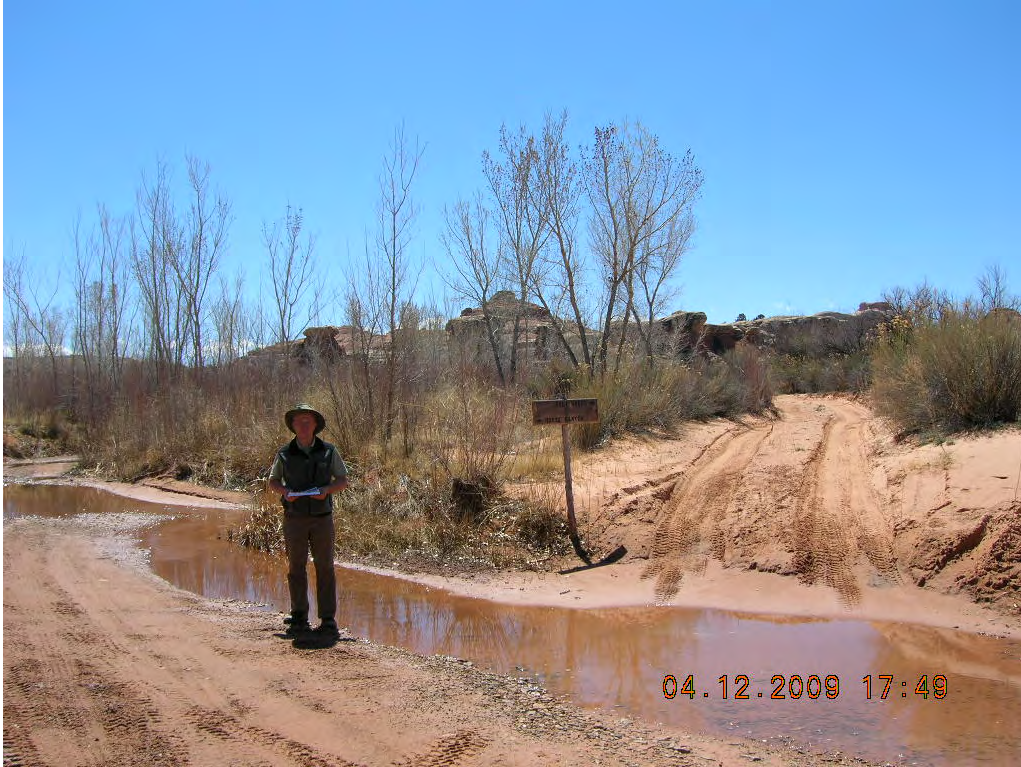
- The Low Terrace (represented by Point 49) is about five feet above the Floodway. This terrace shows evidence of occasional flooding and has a very sandy substrate.

Low Terrace

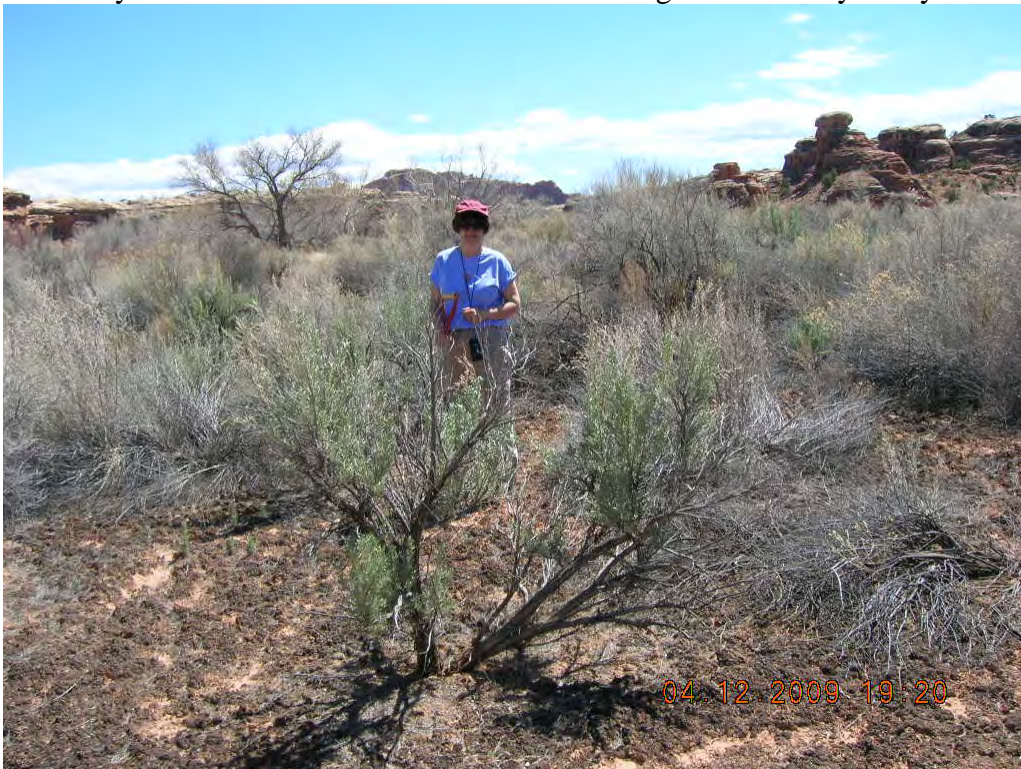
- The High Terrace (represented by Point 55 and 60) is about eight to thirty feet above the Floodway and shows no evidence of recent flooding. It has a very sandy substrate.

## High Terrace

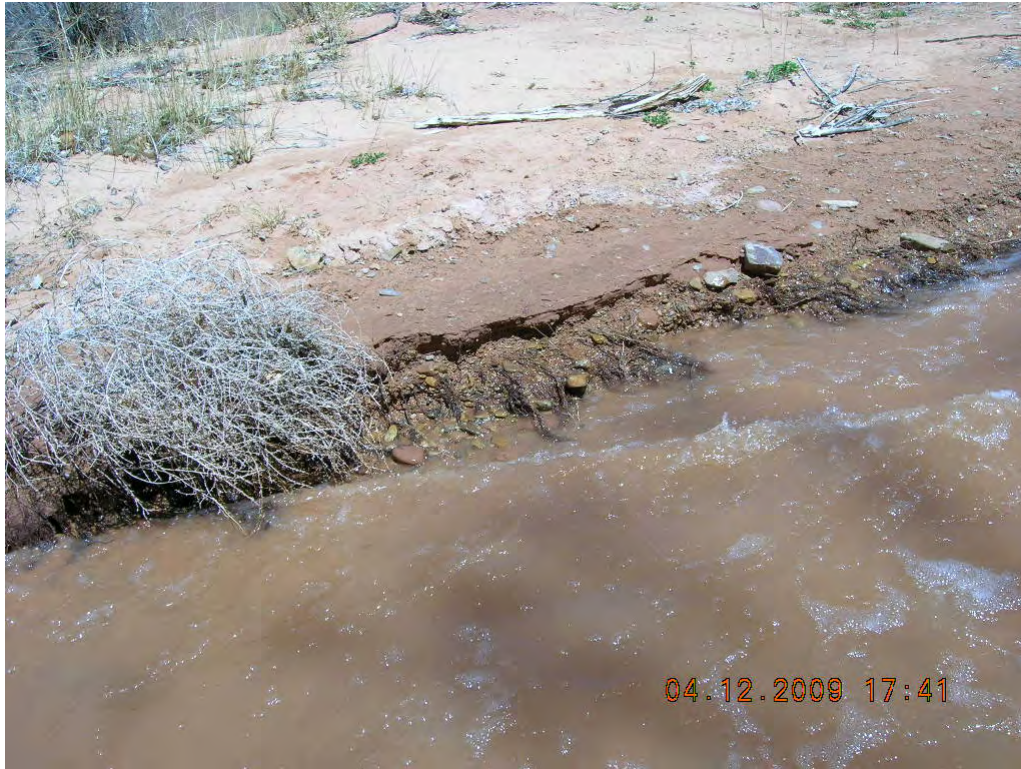
Vehicle impacts appear to be significant in the flowing part of the stream (Point 23 to 57). Disturbance is significant from even a very slow traverse (less than 1 mph), with apparent erosion of side banks, exposure of roots, and turbidity. These are all probably detrimental to bank vegetation and invertebrate health.

Erosion, turbidity, and root exposure from low velocity vehicle traverse

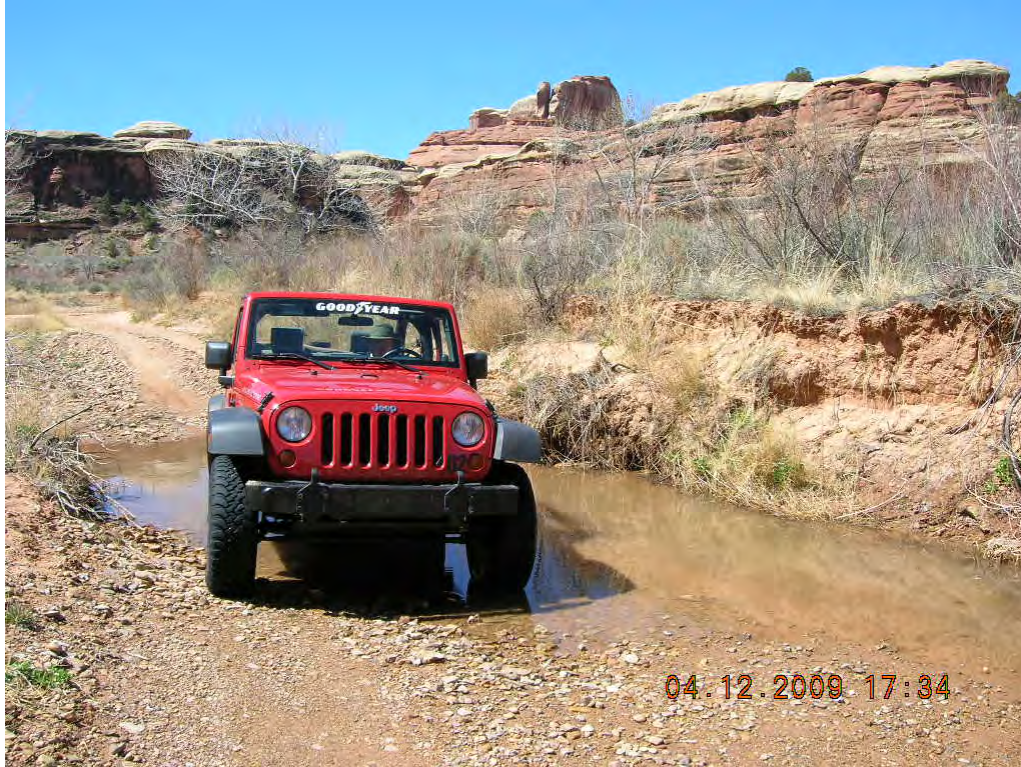
Large holes occur in the active channel. These are apparently related to vehicle use, similar to the formation of potholes or washboards on other native surface roads. These holes can be large enough to affect stream flow (Point 40).

Pothole probably caused by repeated vehicle traverse
