Technical Support for Trail Restoration and Maintenance for Arches and Canyonlands National  
Parks

Henry Shovic, PhD

Project Report: Arches Devil's Garden Trails  
Field Review, Analysis, Conclusions, and Recommendations  
Henry Shovic, PhD  
Rocky Mountain Cooperative Ecosystems Study Unit  
Jan 23, 2009

Project Report: Canyon Lands Fort Bottom Trails  
Field Review, Analysis, Conclusions, and Recommendations  
Henry Shovic, PhD  
Rocky Mountain Cooperative Ecosystems Study Unit  
Mar 4, 2009

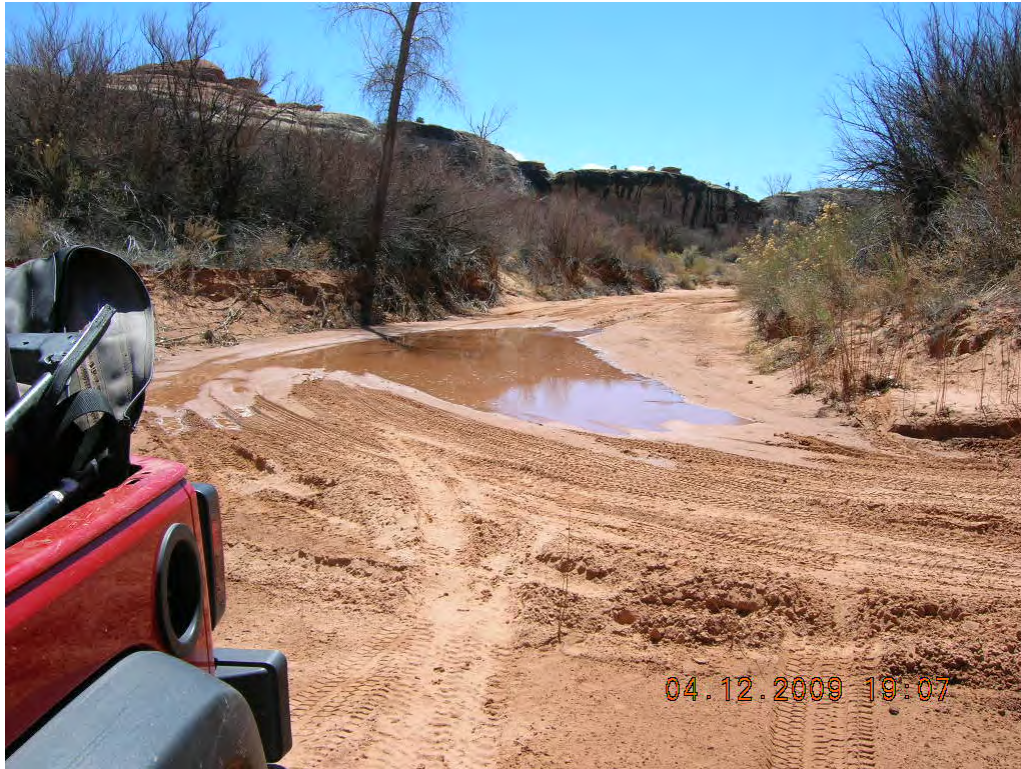
Stream channel characteristics appear to be different in areas without the impacts of vehicle traffic. At Point 56, a segment of stream channel shows no evidence of vehicle use. The channel is significantly different than the nearby road/channel. No large holes or unconnected pools occur in the un-driven area. In nearby stream channels with no apparent vehicle use, vegetation is present in the channel and it is less disrupted by large holes.

Stream character with vehicle use

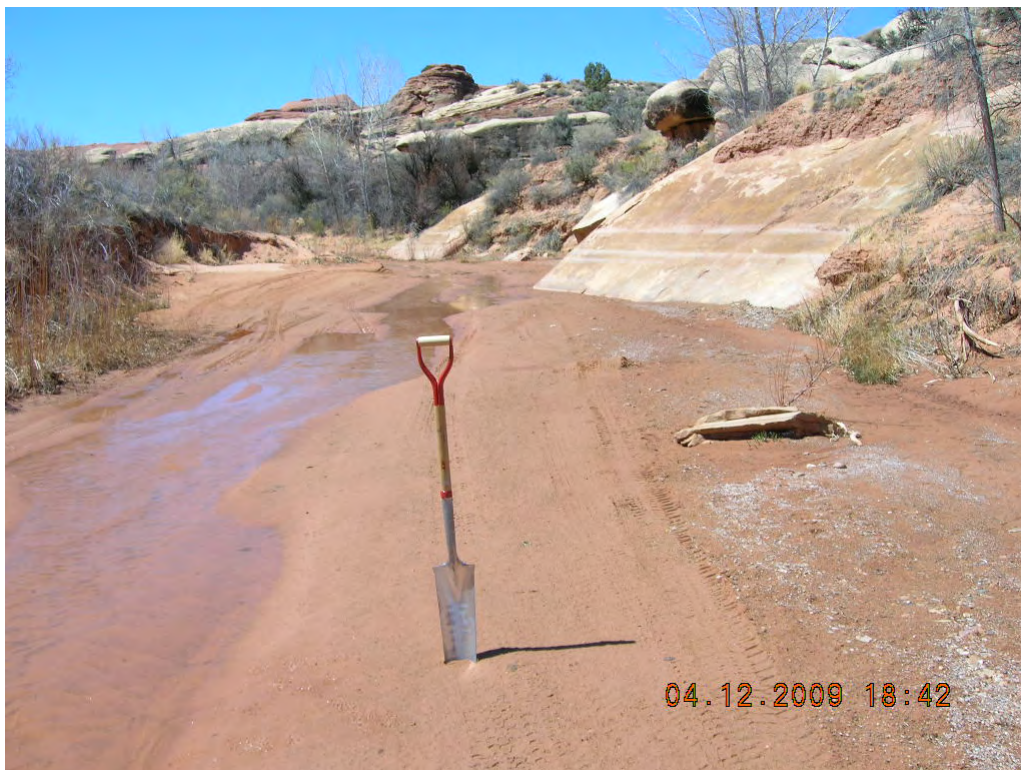
Stream character with vehicle use (bathtub ring area)

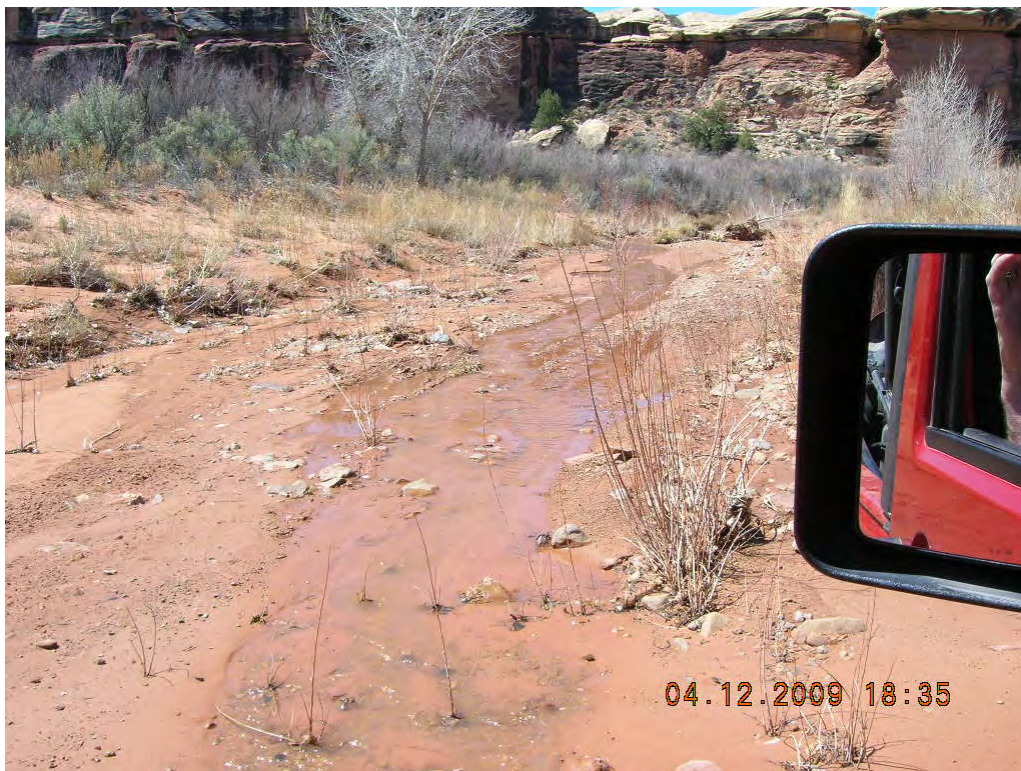
Stream character and vegetation without vehicle use

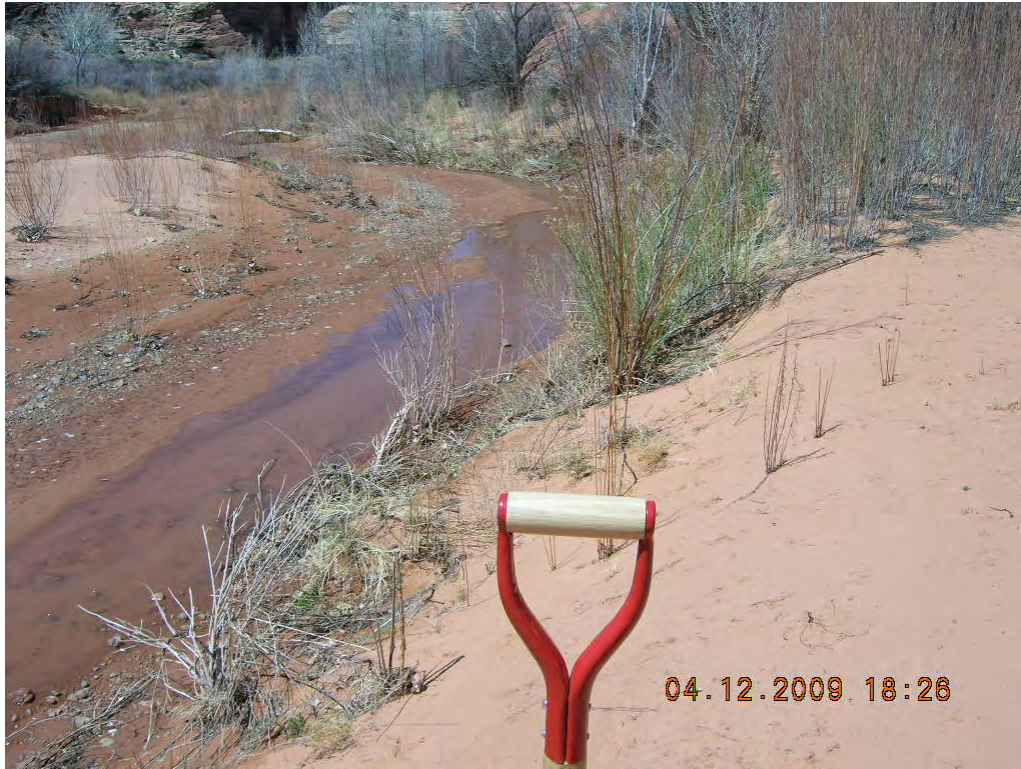
Stream character and vegetation without vehicle use

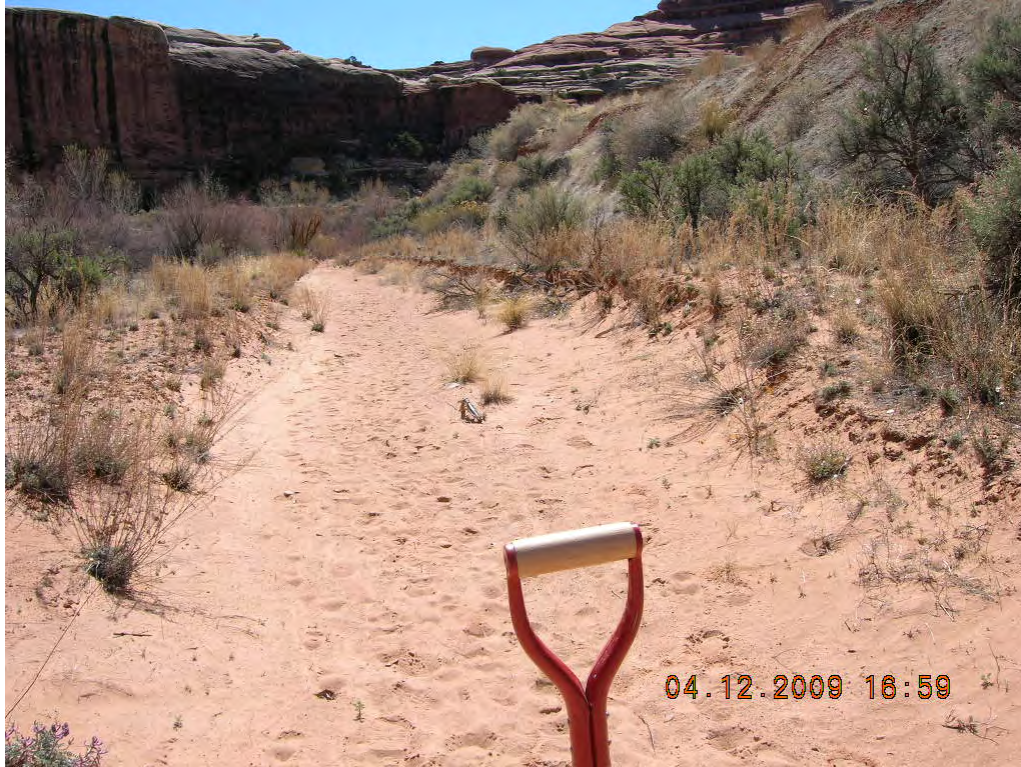
Removing vehicle traffic from channels or roads was observed to be enough to initiate vegetative recovery. At Point 20, past the gate closure, cut banks are sloughing towards a stable slope. At Point 21, an unused road has vegetation and incipient biological soil crust.

Natural sloughing and filling of unused road

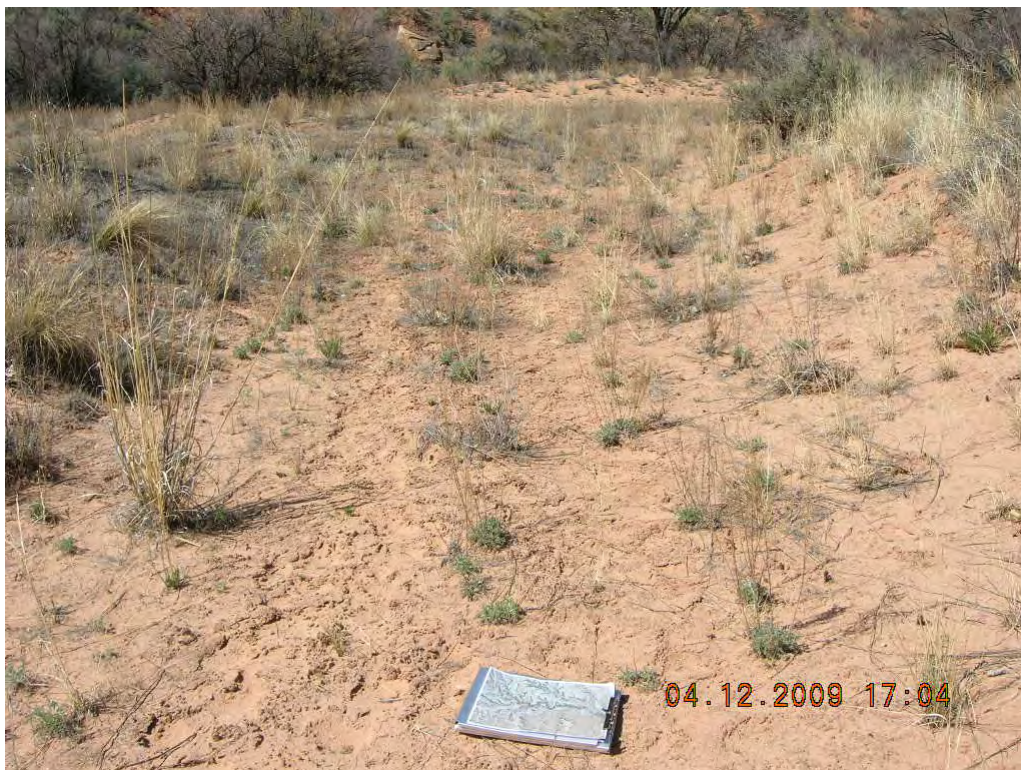
Natural revegetation and biologic soil crust formation on unused road

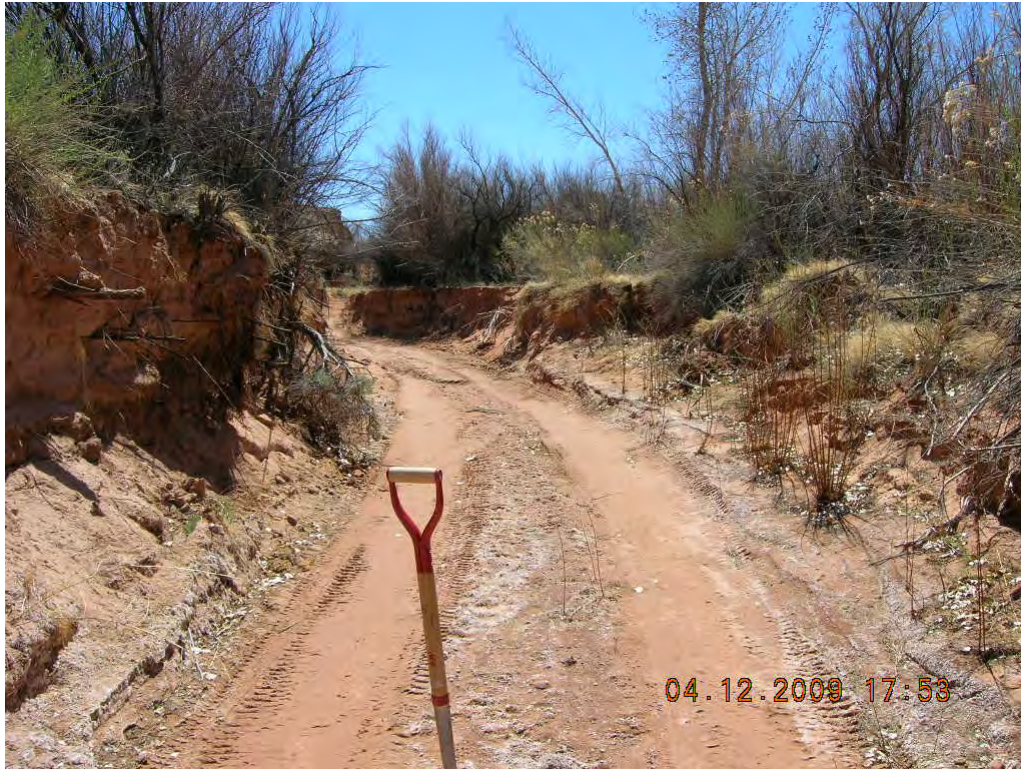
Erosion on Horse Canyon road on steep sections

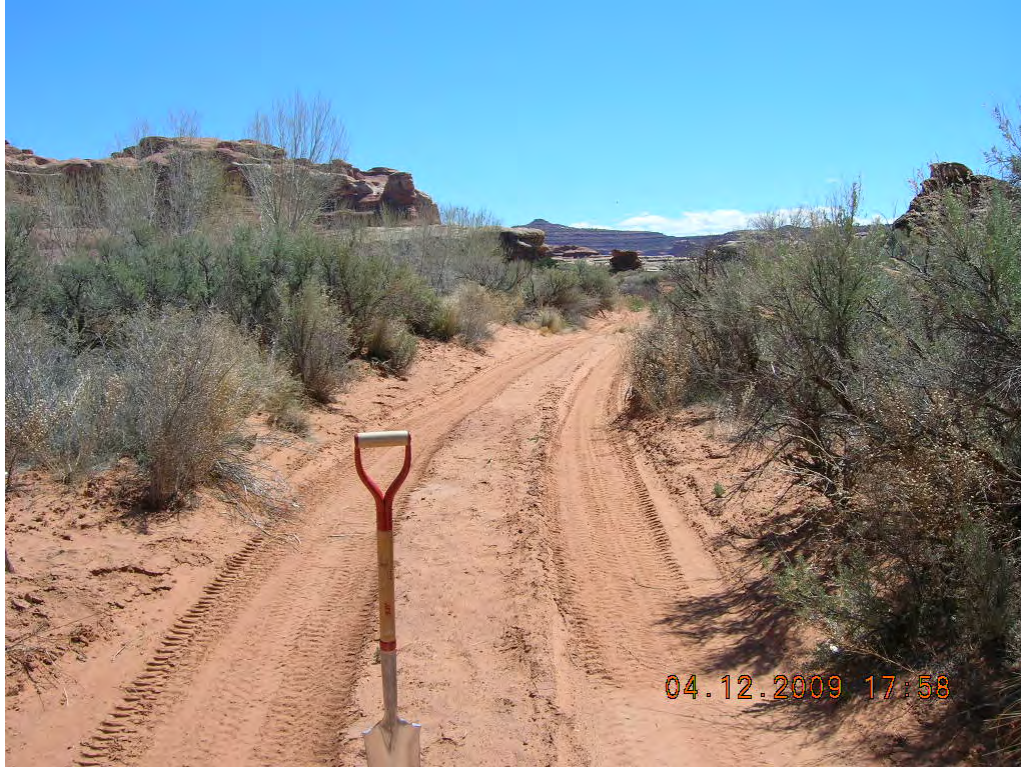
Erosion on Horse Canyon road on gently-sloping area

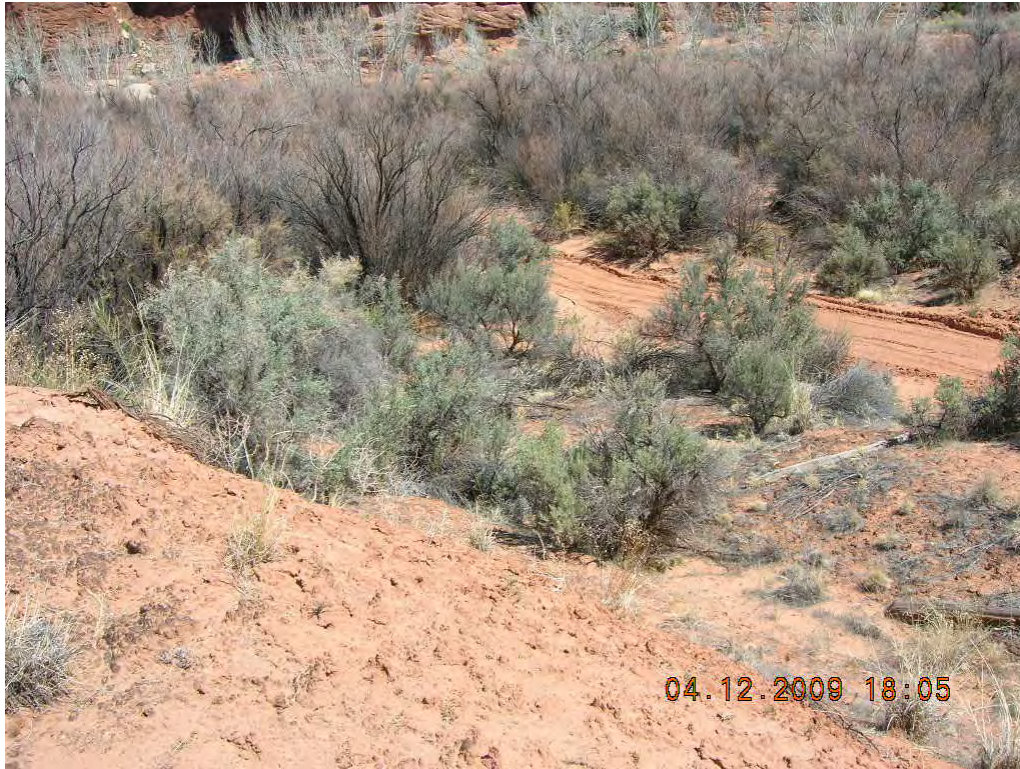
Overview showing steep, sandy bluff and Horse Canyon road below
