# **FINAL REPORT**

**Assessment of Septic Leachate:**

**A Survey of Lake McDonald**

**Glacier National Park**

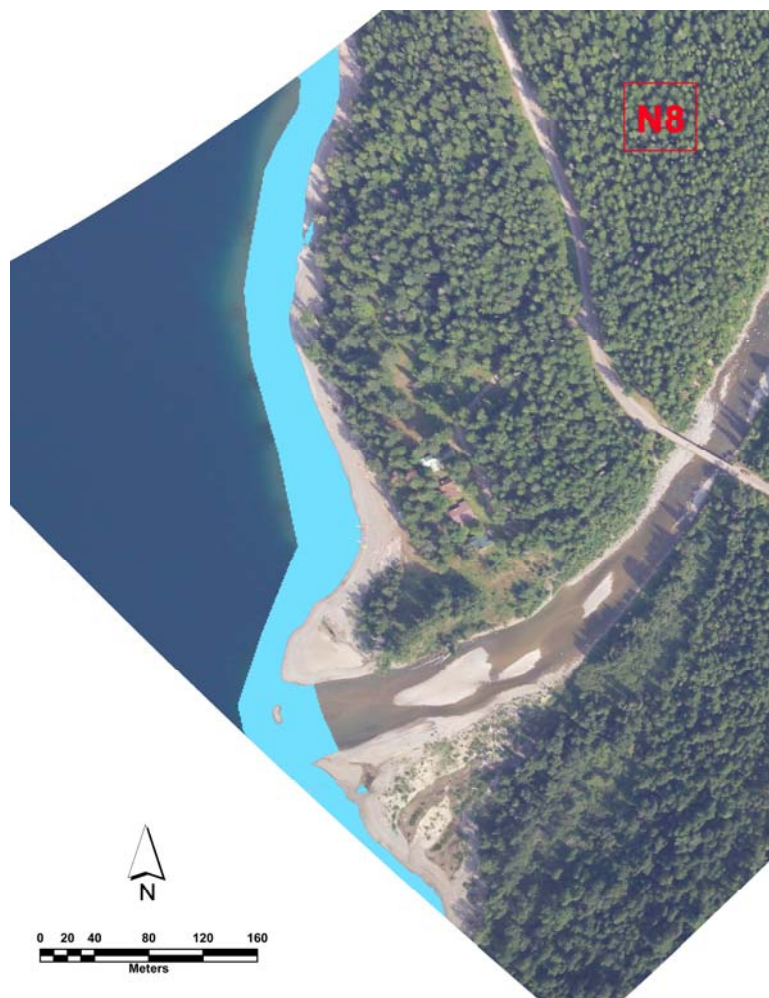
Nor did we see evidence of leachates at the far north end of the lake near the McDonald Creek inflow to the lake (sample sites 23-24); Figure 5 (also see Appendix A – Fig. A10 [Section N7]). Likewise, the sample sites along the northeast shoreline from sample sites 25-28 that include the shorelines near the Lake McDonald lodge also showed no evidence of leachates, although we did observe patches of what appeared to be more dense diatom growth (shown in yellow classification); Figures 6 - 10 (also see Appendix A – Fig. A12 through A16 [Sections N9 – N13]).

Figure 5. Classified image of Section N8, North Lake McDonald. The shoreline has been analyzed for algal spectral signature. Light blue = no-low algal reflectance, orange = diatom reflectance, red = green algal reflectance.

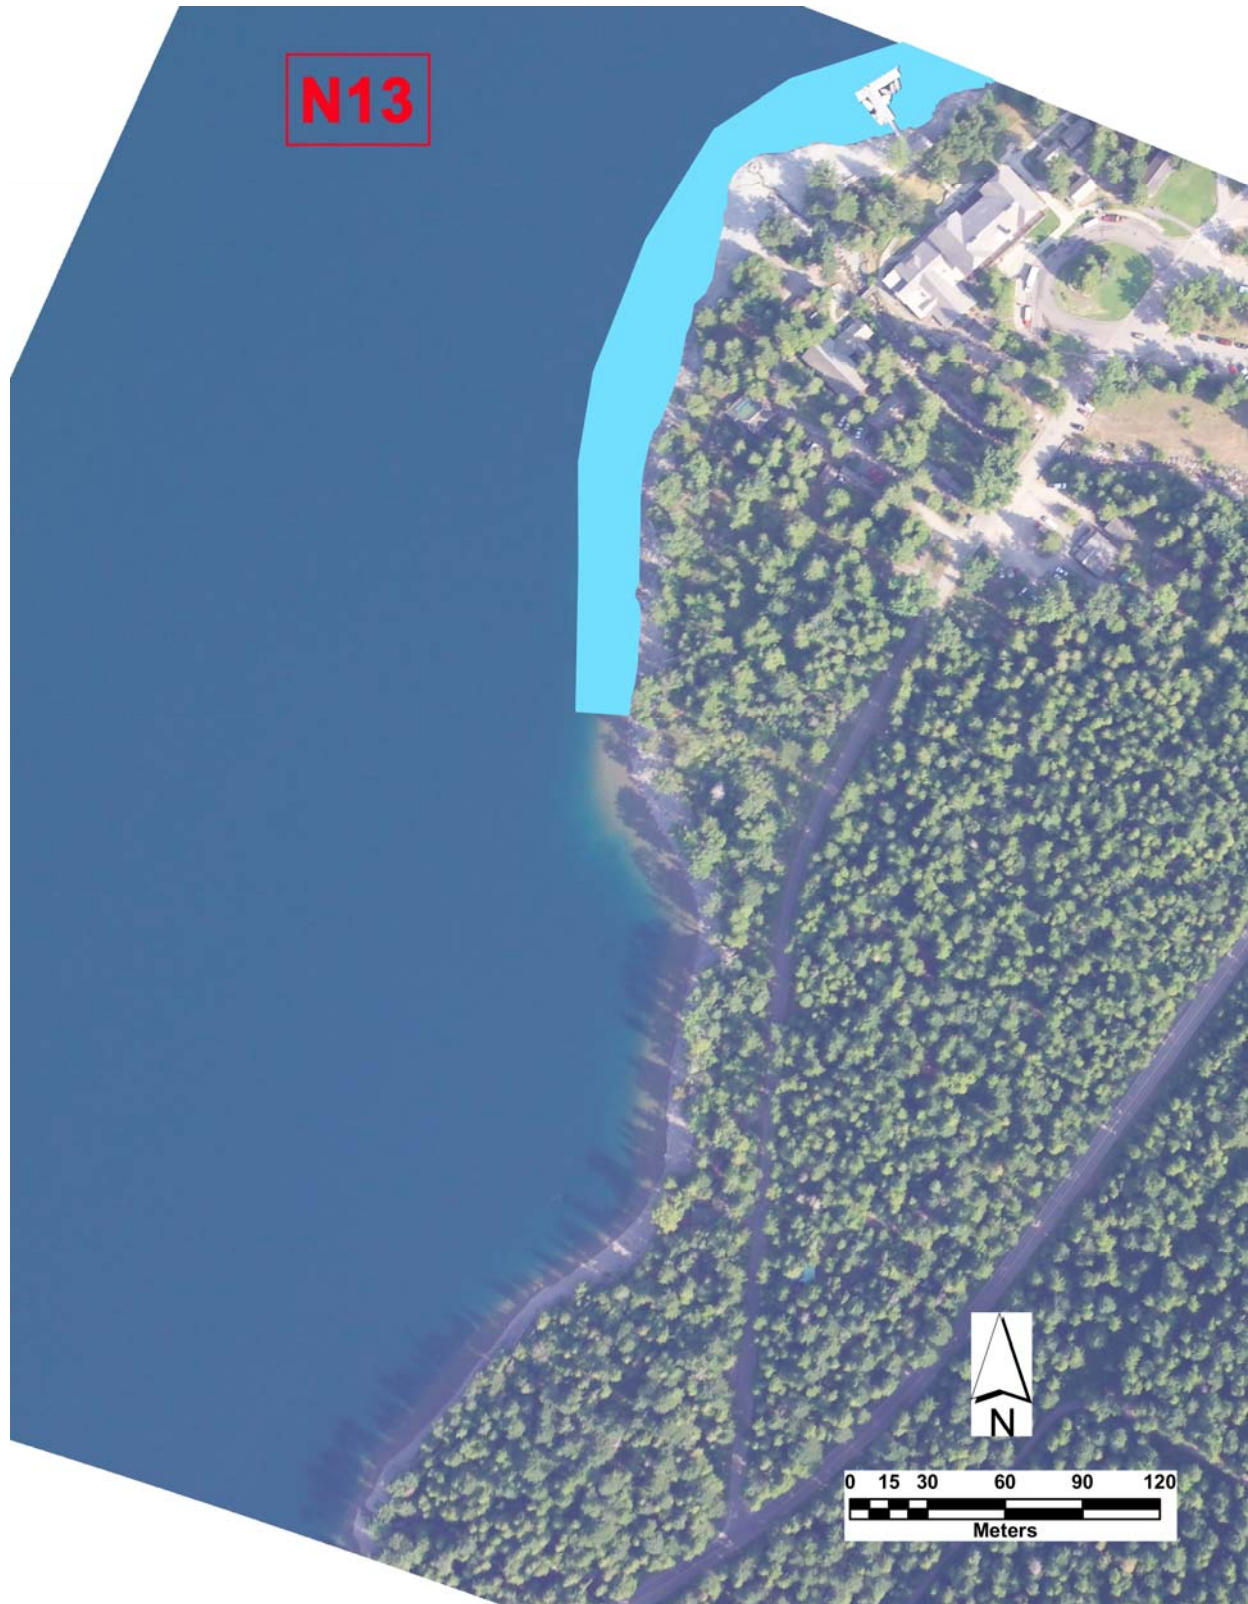
Figure 6. Classified image of Section N9, North Lake McDonald. The shoreline has been analyzed for algal spectral signature. Light blue = no-low algal reflectance, yellow = diatom reflectance, red = green algal reflectance.

Figure 7. Classified image of Section N10, North Lake McDonald. The shoreline has been analyzed for algal spectral signature. Light blue = no-low algal reflectance, yellow = diatom reflectance, red = green algal reflectance.

Figure 8. Classified image of Section N11, North Lake McDonald. The shoreline has been analyzed for algal spectral signature. Light blue = no-low algal reflectance, yellow = diatom reflectance, red = green algal reflectance.

Figure 9. Classified image of Section N12, North Lake McDonald. The shoreline has been analyzed for algal spectral signature. Light blue = no-low algal reflectance, yellow = diatom reflectance, red = green algal reflectance.

Figure 10. Classified image of Section N13, North Lake McDonald. The shoreline has been analyzed for algal spectral signature. Light blue = no-low algal reflectance, yellow = diatom reflectance, red = green algal reflectance.

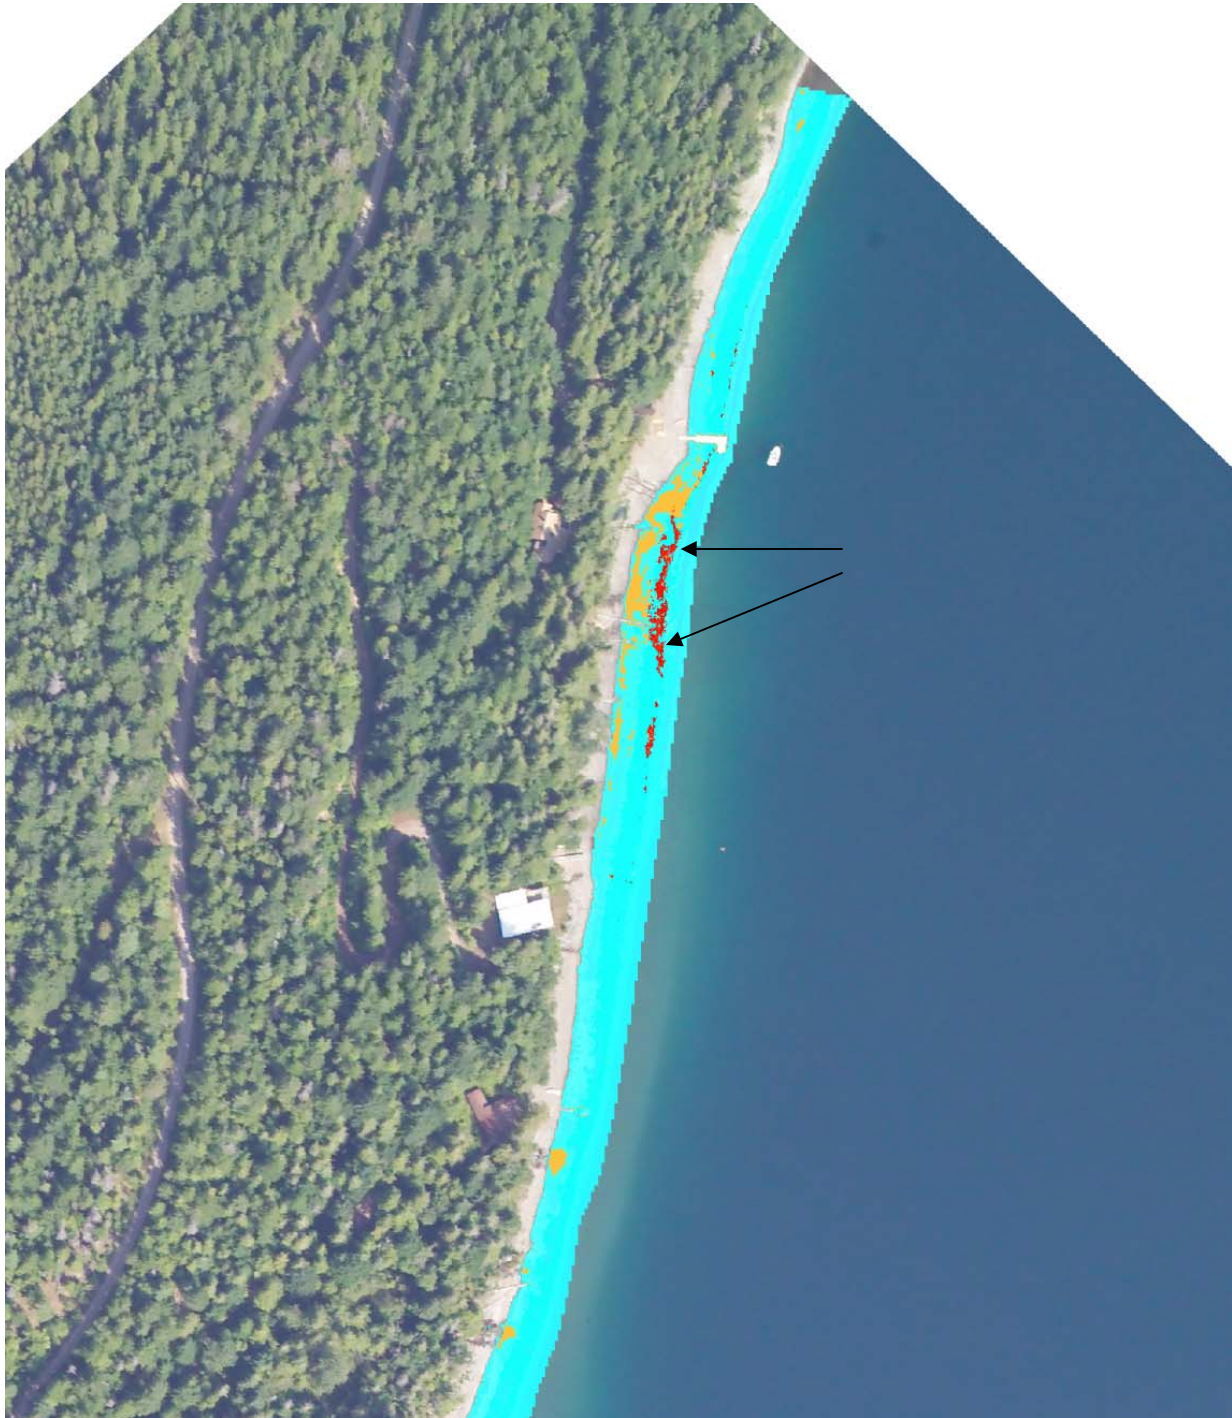
Corroborating the fluorimetric, water chemistry, and field algal sampling data, we observed green algal spectral reflectance along the shoreline in Sections S2 and S3. Herein, we present close-up, classified images of the shorelines showing sites of increased green algal production (Figs. 11 and 12)[also see Appendix A, Figs A2 and A3 for spatial reference].

Figure 12. Classified image of northern end of Section S3, South Lake McDonald. The shoreline has been analyzed for algal spectral signature. Light blue = no-low algal reflectance, yellow = diatom reflectance, red = green algal reflectance. See also Appendix A, Figure A3. Arrows indicate sites of increased algal biomass.

- Many homes that are within reach of the existing sewage collection system between Lake McDonald Lodge area on the southeastern shore to the Fish Creek campground located on the northwestern shore are already connected to that collection system. However, several of the homes have not been connected to the central system. All homes that are within the central system area should be connected within the next 5 years.
- Septic leach fields have an exhaustion date after which they become very poor at processing sewage and removal of nutrients. Because of the sensitivity of Lake McDonald to nutrient pollution, homes not in the proximity of the GNP centralized sewage collection system should have their systems checked annually by a sanitation engineer. This should be done at the end of the summer season, which is the primary season of home use.

- Many of the locations around the lake have very shallow groundwaters. An integral part of keeping septic derived nutrients out of the lake is to have the septic leach fields away from the lake. Thus, all septic leach fields should be at least 200 meters away from the shoreline of the lake. Where this is not possible because the private properties are too small, the Park Administration should work with the home owners to facilitate a community-based leach field that is at least 500 meters from the lake shore. For example, there is a cluster of homes at Kelly Camp. Many of these homes do not have a single-home leach field that is at least 200 meters from the shore line. Thus, these homes may need to enter into a cooperative agreement with each other and with the Park to establish a community leach field.
