# Physical History

## **Prehistory and Settlement History Prior to the Establishment of Glacier National Park**

### **First Phase of Headquarters Area Development, 1917-1941**

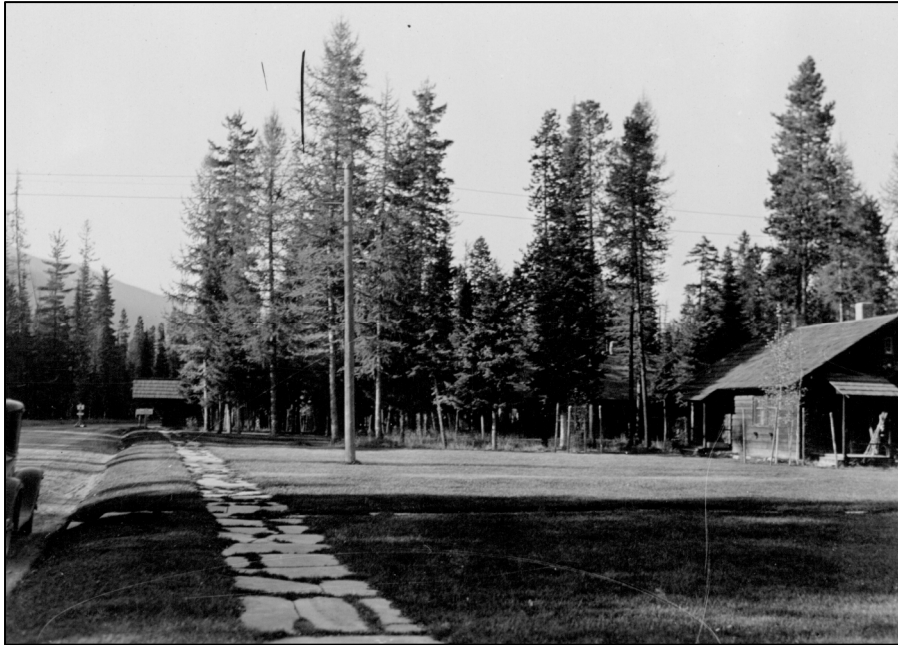
**Figure 12. Flagstone path. View north Mather Drive, September 1934. Photo caption states that it was built by CCC camp NP 1. Photo No. HPF 2185.**

The CCC proved to be a valuable source of labor for finishing the work of landscape naturalization begun in the late 1920s. Laborers from CCC Camp NP-1 built a network of flagstone walkways in the summer of 1934 (Figure 12, Photo HPF 2185). The same crew may have erected the street lamps, which featured glass lanterns hung from sturdy log posts and crossbeams (Figure 13, Photos HPF 1902, 1903, and 1904). Presumably it was also CCC labor that lined many of the footpaths and driveways in the area with cobbles that can be seen in several photos from this period (Photos HPF 724, 728, and 857). Historic photographs also show that numerous seedlings were planted around the residences and were protected from deer or other animals by wire exclosures (Photos HPF 208 and 345).

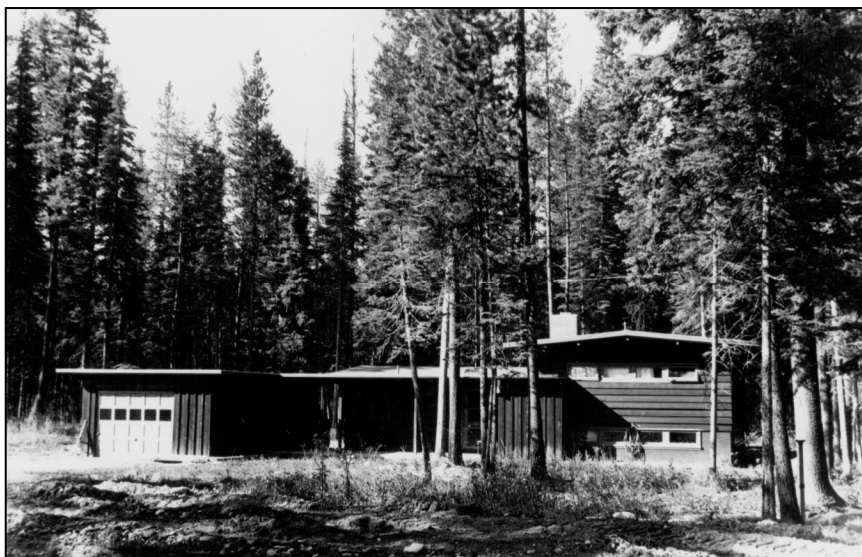
**Figure 19. Building 80, one of three employee housing units built between 1949 and 1953 and exhibiting the Midcentury Modern architectural style that would characterize Mission 66. Photo HPF 765.**

residences were significant architecturally because they marked the first break with the Park Service Rustic style that had characterized the complex up to that time. The first residence was a three-bedroom, two-bath Ranch Style house with an attached single-car garage, constructed for the assistant superintendent. The attached garage was a new feature in park housing. The outdoor living area included a covered porch. The house had a partial basement and was equipped with a hot water oil furnace. The house had distinctly modern lines when viewed from the street; the north façade was dominated by the centrally located garage and porch, while the flat roof of the garage and porch formed a strong horizontal element paralleling the ridgeline of the gable roof. The two houses built in 1952-53 were even more modern in style with low, almost flat roofs. Each was built according to a split-level L-plan, and featured a detached, flat-roofed, one-car garage connected to the house by an open breezeway (Wheaton, 2006, 3).
