National Park Service
Cultural Landscapes Inventory
2010

Murie Ranch Historic District
Grand Teton National Park

Murie Ranch Historic District

Grand Teton National Park

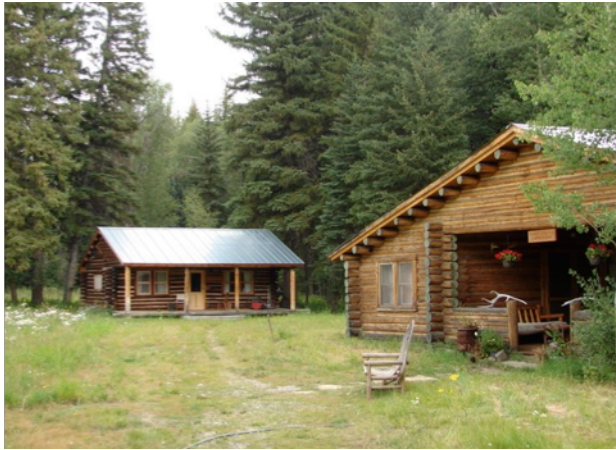
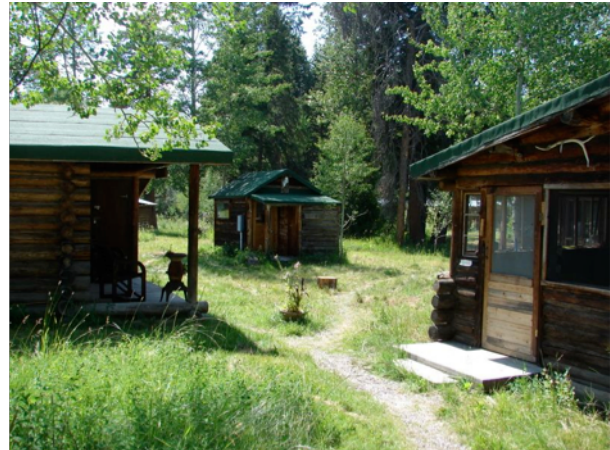
**Left: Olaus Murie Studio, #972, and Murie Cabin, #973
Right: Robin's Nest, #976, Moviewood, #977, Estes Cabin, #975**

Olaus Murie Studio (1972) – Rectangular log building with concrete wall foundation, saddle-notched log walls with pole chinking, and wood frame windows and doors with 5” butt joint trim and iron hardware;

Estes Cabin (1975) – Log building on concrete wall foundation, saddle-notched log walls with split-pole chinking, windows with varnished 6” butt joint milled lumber and 8” sill plates, and doors of 4” tongue-and-groove fir;

Robins Nest Cabin (1976) – Log building on stone pier foundation, saddle-notched log walls with split-pole chinking, and doors and windows trimmed with 5” butt joint oiled lumber;

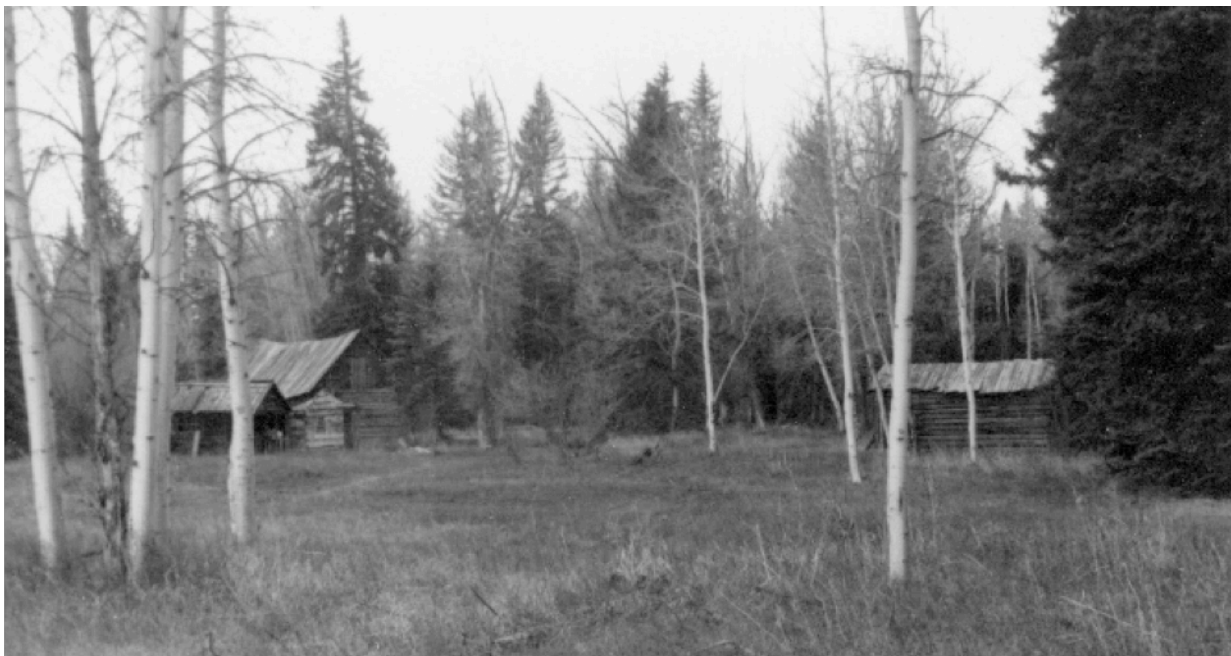
View of western portion of Murie Ranch Historic District. Only the Frame Cabin, #991 (far left of cluster) survives. The adjacent Barn, #990 and Storage Shed, #989 (barely visible between barn and Frame Cabin), were removed in the late 1970s, and the non-contributing Oil House, #988 (far right) has been burned since 1998. (Photo taken 1977; GRTE archives)

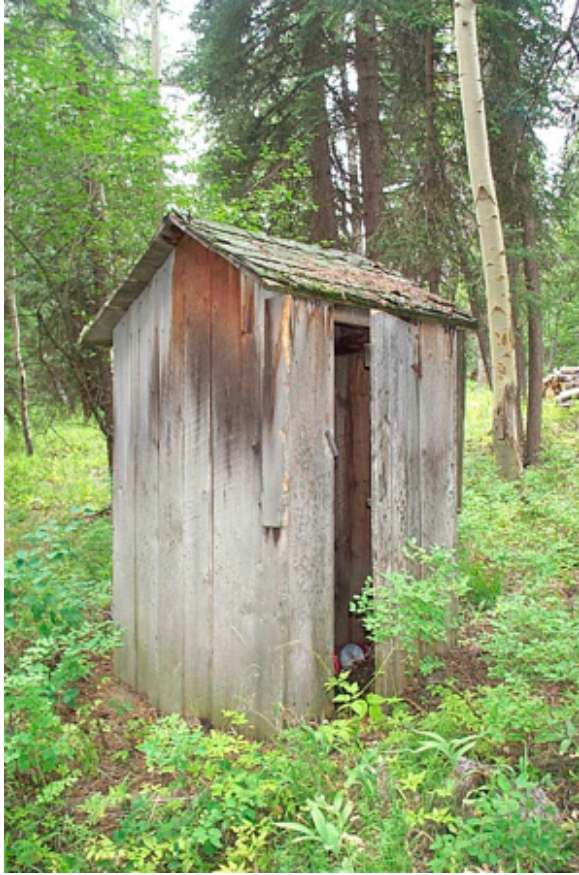
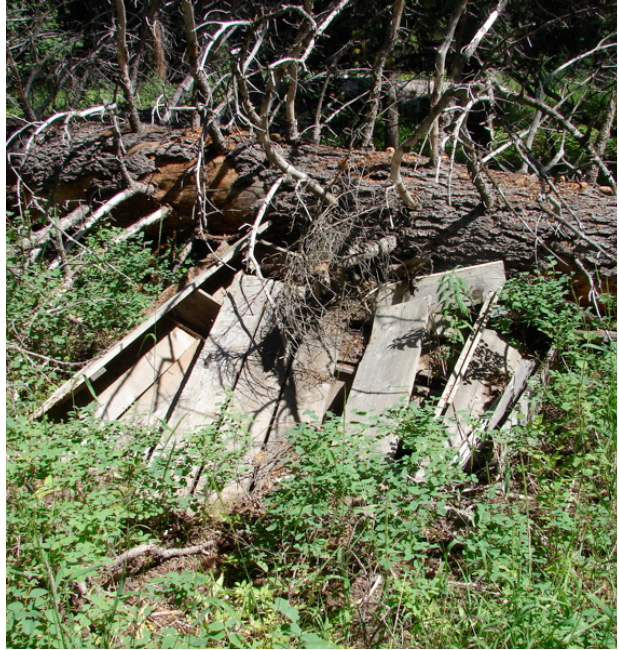
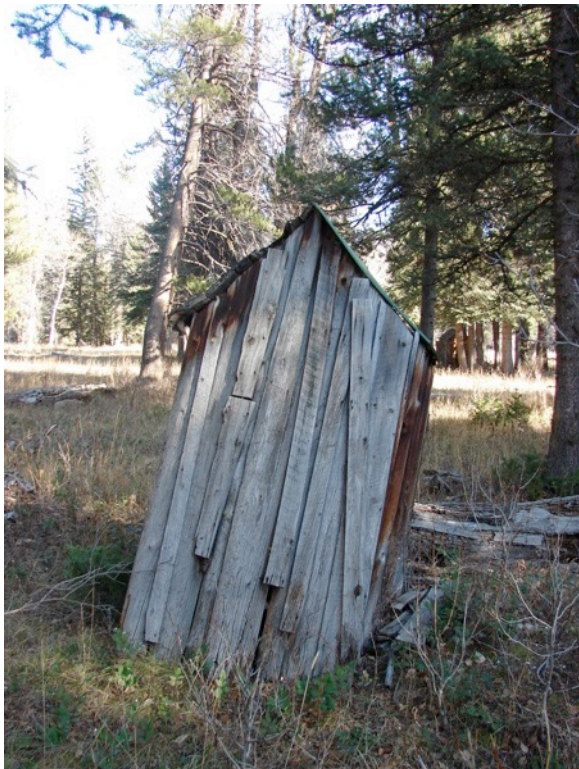
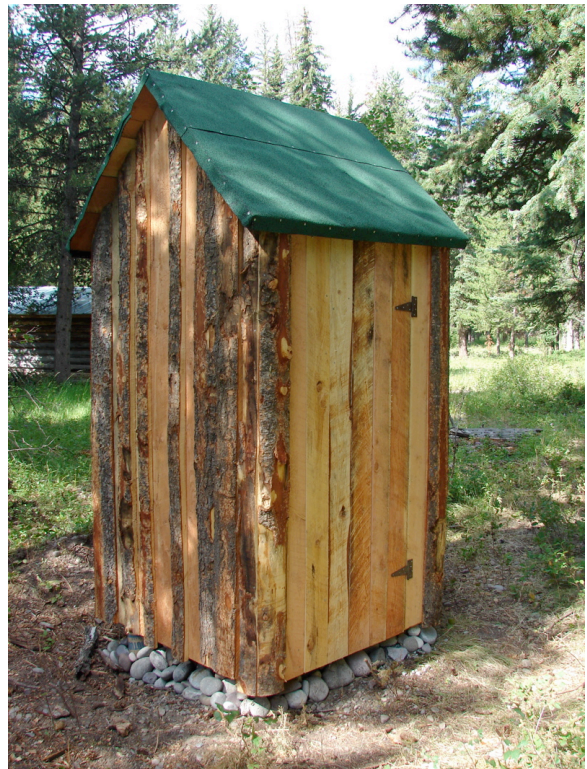
Since completion of the NHL in 2006, five contributing structures have been lost. The Polaris Outhouse, #982A, apparently met with a similar fate as the Murie Outhouse, and no longer exists. Four deteriorating outhouses were removed and reconstructed in 2009 as non-functioning replicas, and are described above as non-contributing structures. As noted in the 1998 National Register listing, “while minor resources such as outhouses do not define site layout or site significance to the same degree as the more substantial buildings, they remain an indicator of the degree of historic development and of the amenities offered ranch visitors: Murie Ranch was an unobtrusive, unpretentious human toe-hold at the edge of the West's undeveloped lands. If the scenery failed to remind visitors of that fact, the outhouses almost certainly would have.”

Left: Murie outhouse, #973A – photo in LCS database

Right: Murie outhouse, August 1, 2009

Below right: Rebuilt mock outhouse, Aug. 1, 2009

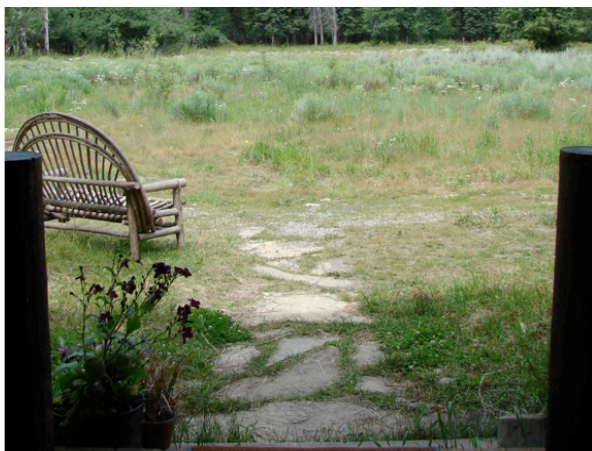
Stone path leading to Murie cabin

Stone path to Olaus and Margaret Murie Residence – This path is comprised of large flat stones, varying in size from large stoop at bottom of the step onto the porch (approximately 24" x 60") to stones as small as 12" across. The pavers are irregular in shape, and placed in a “jigsaw” pattern conforming to a 36" wide linear walk. Early photos show the walk extending straight out from porch at 90 degrees into meadow perhaps 40 feet. Today, it extends approximately 12 feet, before disappearing into recent gravel and then grass. It likely still exists partly buried, as vegetation growth shows a “ghost outline”.

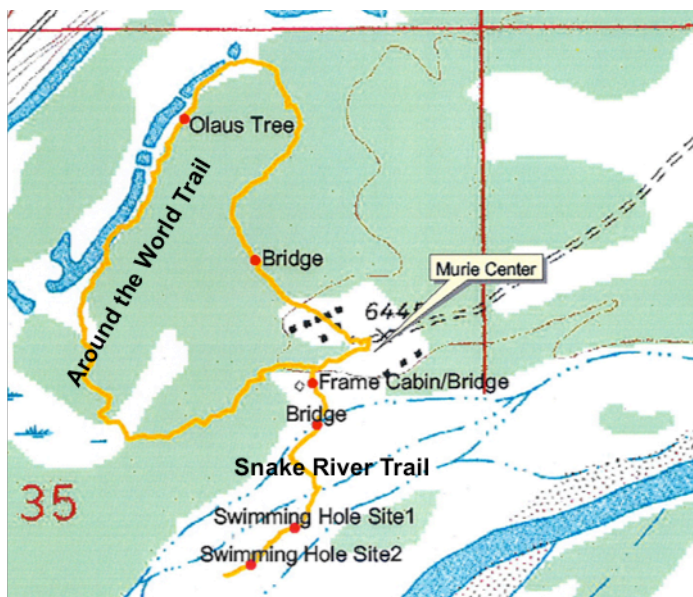
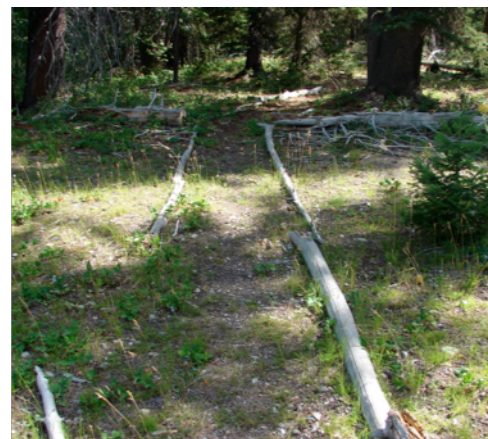
Around the World Trail – The alignment of this trail follows the original trail of the Muries. During the tenure of Nancy Shea (1998-2005), tree limbs and branches were placed along the side of the path in some places in order to mark the location of the trail before it became lost. A plank footbridge still exists in its original location, but planking has been replaced over time. The “Olaus Tree”, which was an observation post fashioned by Olaus Murie to observe wildlife in wetlands west of site by nailing stakes to a tree creating a “ladder”, has fallen and since decomposed.

Left: Murie Ranch trails map (NPS 2001)
Right: Around the World Trail, marked by fallen branches and logs

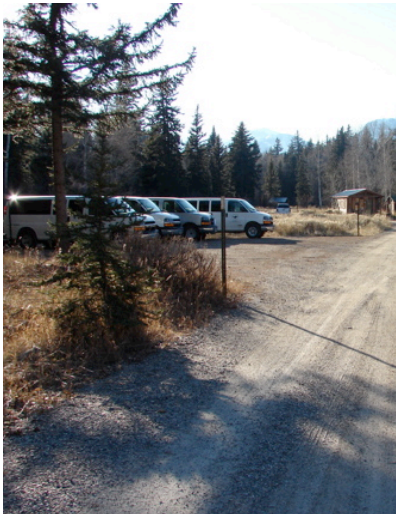
Left: New parking lot visually dominates entrance to site

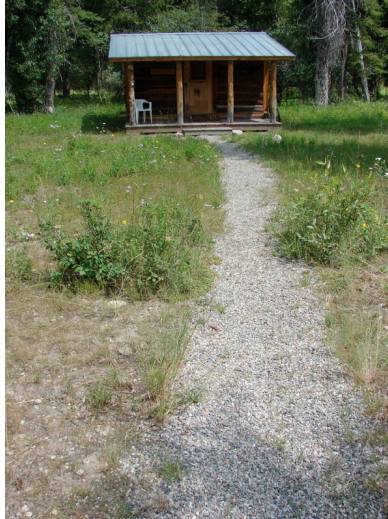
Center: recent surfacing of paths with crushed gravel contradicts Murie preference for natural paths

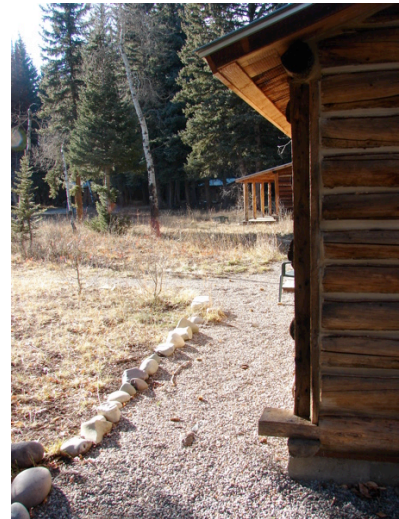
Path materials –Several of the walks are edged with rows of large cobbles, which, according to Nancy Shea, is a recent addition done during the Murie Center period. Most paths have recently been accentuated by addition of crushed gravel, which is a non-contributing material even though alignment of the paths in original locations is contributing. According to Nancy Shea, this was done following her tenure as director of the Murie Center, probably between 2005-2008.

Right: lining of cabin walks with cobbles

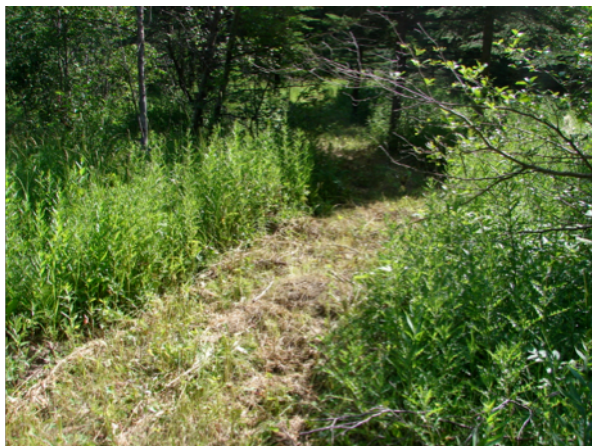
Below: informal mowed paths

Informal mowed paths – Several paths three to four feet in width have been cut through and around the meadow. These do follow historic routes, and are contrary to the Murie philosophy of treading lightly on the land and following the natural paths of wildlife.

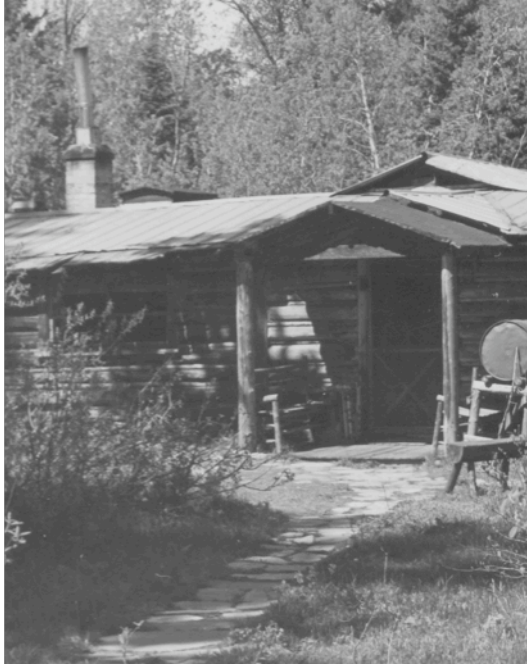
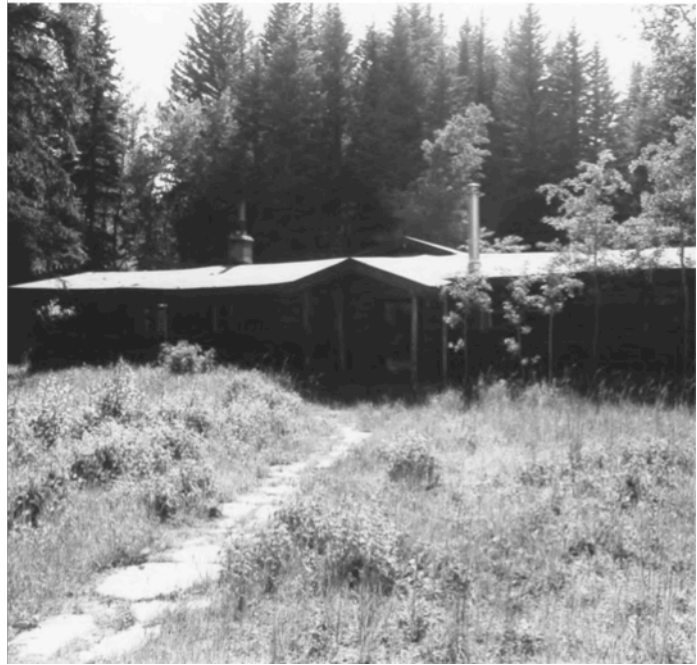
Left: View of Homestead Cabin, 1947, showing stone walk (Photo courtesy of the Murie Center archives; cropped image) Right: Similar view, 1995 (NRHP nomination package)

Missing stone path – Stone paths were constructed as part of the infrastructure improvements during the STS Dude Ranch era. These paths are clearly visible in photographs taken early in the period of significance, but are not in evidence today. They are not recalled by Nancy Shea or Steve Duerr (former and current Murie Center Directors). A stone path leading to the Homestead Cabin is clearly visible as recently as 1995, in a photograph submitted with the NRHP nomination filed in 1997. There is a good possibility these walks exist beneath surface accumulation, as the effort to remove them would have required significant effort of which there is no mention in Murie memoirs.

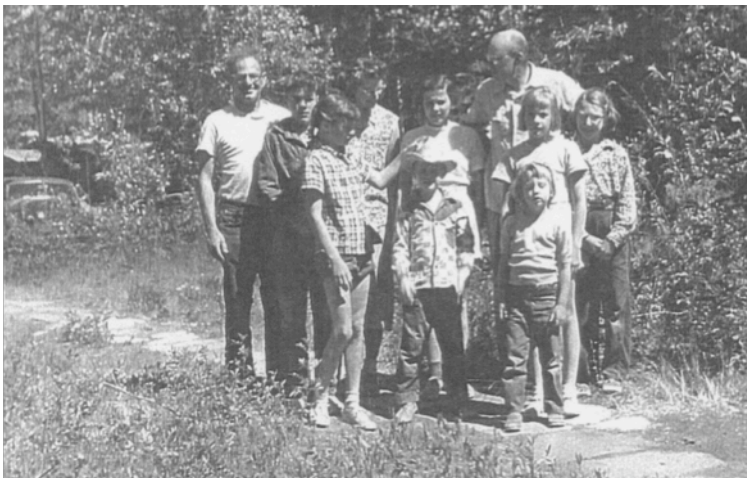
Stone walk, Robin's Nest Cabin in background, 1953 (Photo courtesy of the Murie Center Archives)

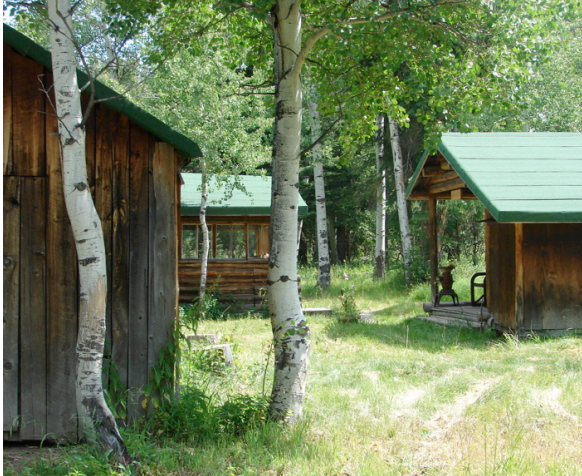
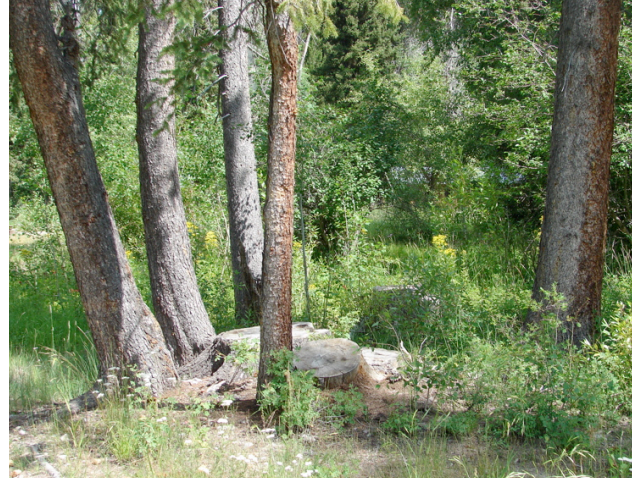
Left: Clustered pattern of Estes, Robins Nest, and Moviewood Cabins
Right: Spruce clustered around stump of parent tree

Cabin groupings – Guest cabins are arranged in an informal pattern, distributed to roughly enclose a large circle. Their casual siting creates interesting smaller cluster patterns, reinforced by groupings of spruce and aspen. An excellent example is afforded by the grouping of the Estes, Robin’s Nest, and Moviewood Cabins.

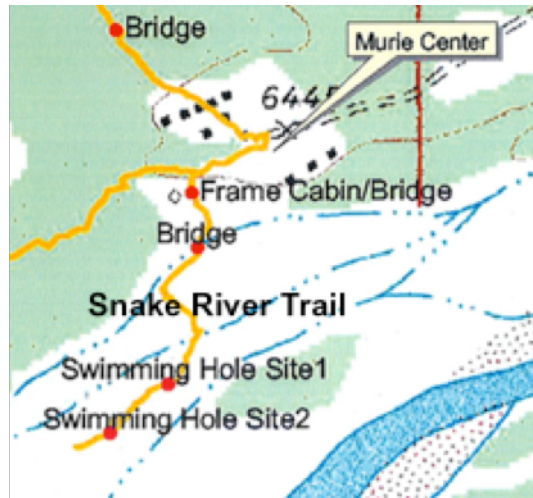
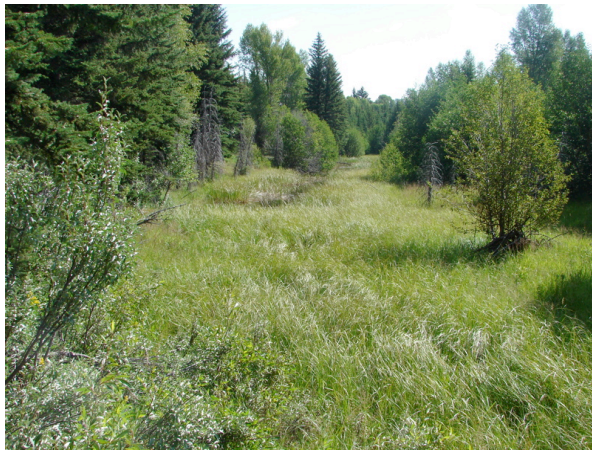
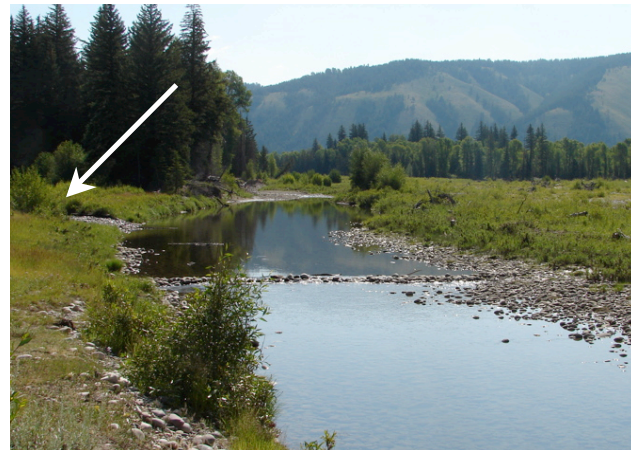
Right: Map showing swimming hole locations relative to Murie building complex (black squares)
Below Left: First swimming hole, since filled with sediment and plant growth
Below Right: Channel of Snake River, showing recent attempt to dam water in approximate location of second swimming hole. First hole location indicated by arrow.

Locations of former Murie swimming holes exist, although the river dynamics have caused water supply to shift away from these sites.

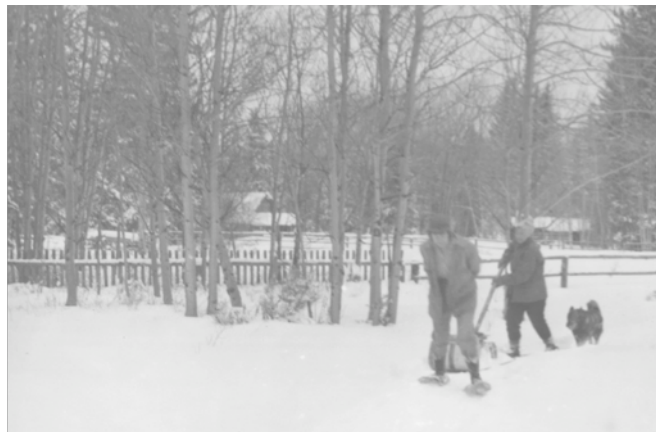
Mardy and Jo Murie hauling wood, 1950. Barn is seen in left background, along with picket fence in approximate location of Chena fence (see below) and buck-and rail fence. (courtesy of the Murie Center Archives; cropped image)

Early photographs taken shortly after the Murie purchase of the property show buck-and-rail and picket fencing in numerous locations across the site. Olaus was not fond of fences, however, and launched a vigorous removal effort to open the land to easy wildlife passage. The only remnant fence on the site from the earlier period was removed in 2009 after being damaged by a fallen tree, although some fence posts do remain.

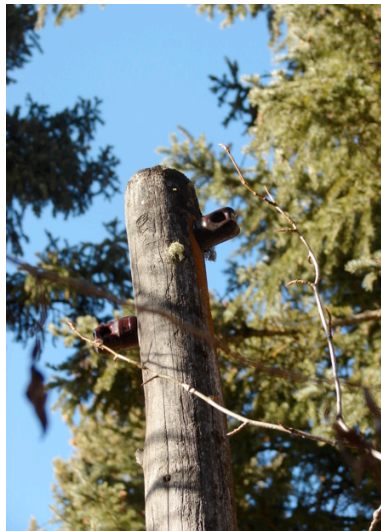
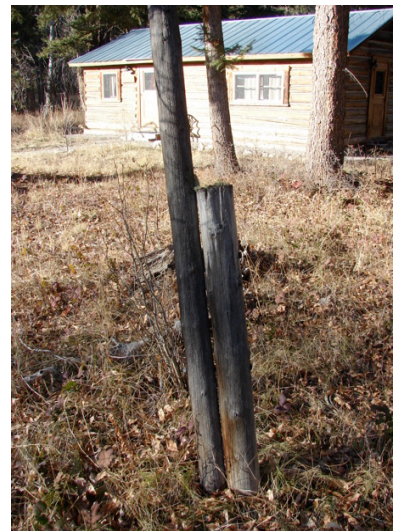
Early utility pole - only one pole survives the early years of electrification, southeast of the Alatna Cabin. The pole is trimmed and peeled lodgepole pine, approximately 6" diameter, provided with extra support with second shorter pole. A brown ceramic insulator remains at the top. This pole was listed as a contributing structure on the NHL nomination form.

Early electric pole: left image shows the top, with ceramic insulator, and right shows base supported by extra post.

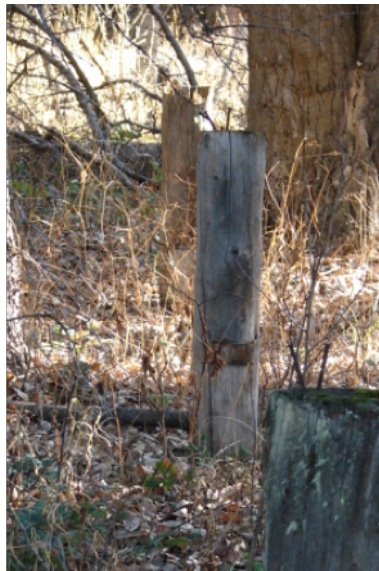
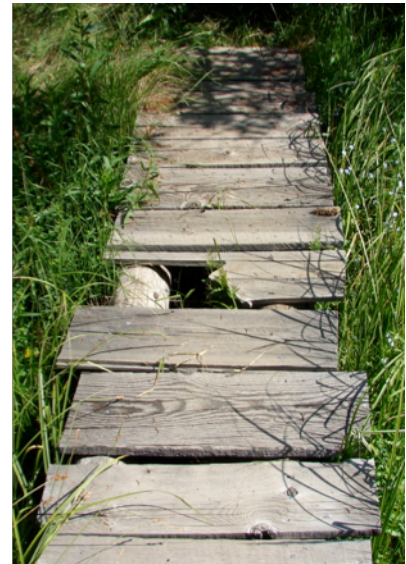
Remnant fence posts – Although all former fences have been removed from the site, numerous fence posts stand as reminders of the landscape inherited by the Muries, prior to their dismantling.

**Left: remnant fence posts behind Murie and Chena cabins
Right: plank boardwalk along Snake River Trail**

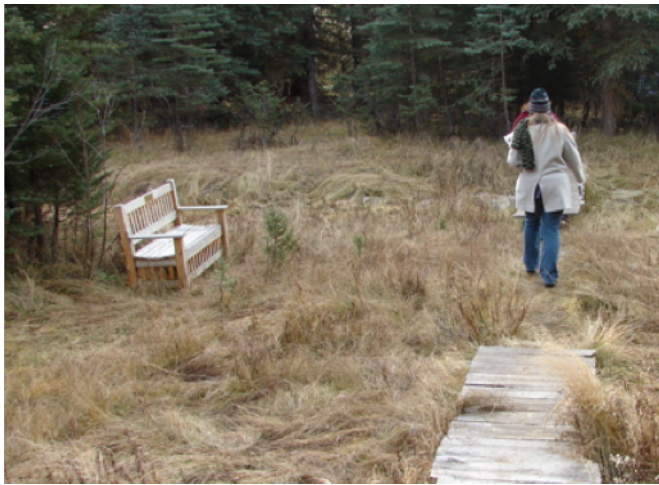
A recent memorial bench along the Snake River Trail is incongruous with the Murie ideal of minimal human intrusion on the natural scene.

Left: memorial bench along Snake River Trail

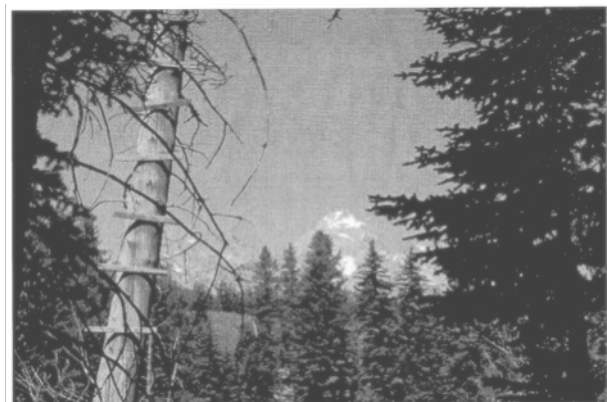
**Olaus tree, in photograph from 2001
Vegetation Assessment report on Murie
Ranch, NPS**

A large tree along the Around the World Trail was selected by Olaus Murie as an observation overlook from which he could watch moose and other wildlife in the beaver ponds. A ladder of slats facilitated access up the tree, and created a vantage point from which he could sketch and take notes. A photograph of the tree dated July, 2001, showed it still standing. The NHL nomination written in 2003 observed that it had fallen, but was still visible, although it has since disappeared.

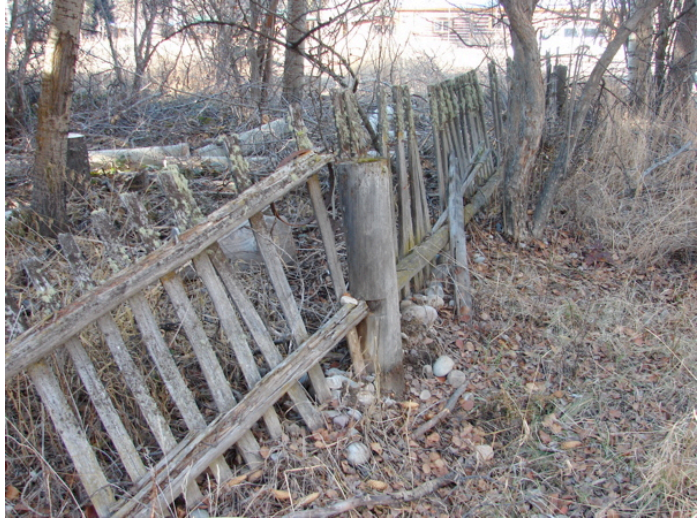
Chena fence, now gone, photographed in October, 2008

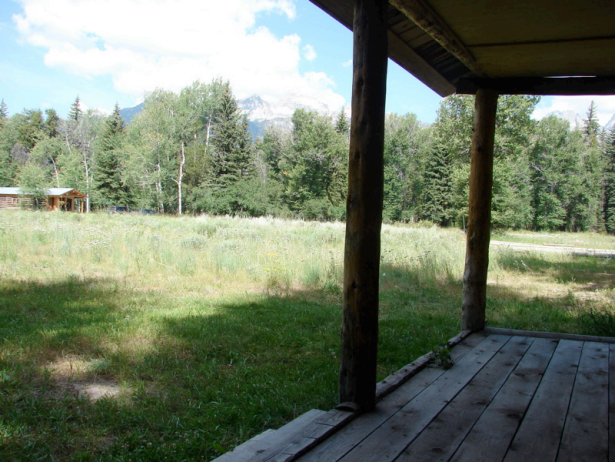
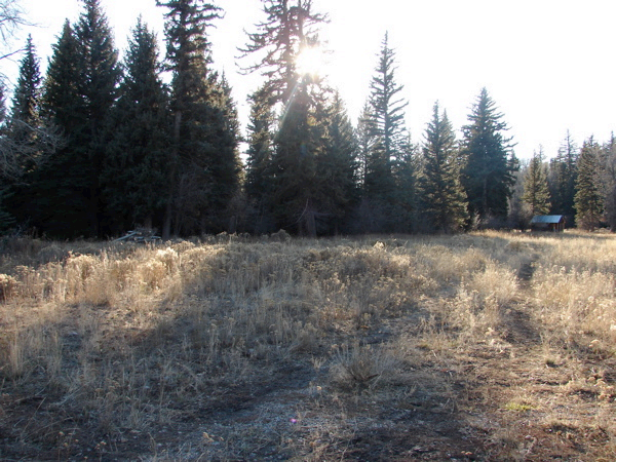
Views illustrating strongly defined spatial edge
Left: view looking north from Murie studio into space A
Right: view looking west across space B from Garage

The spatial organization of the site is essentially intact from the period of significance and as described by Mardy. Although the edge of the enclosing forest is dynamic and constantly changing, the overall clearing size and shape has changed little from the Murie period. The built elements along the edge of the site reinforce the natural spaces, but the space lost some of its definition through removal of structures. Overall, these losses are minor in a spatial sense, due to the strong edge formed by vegetation.

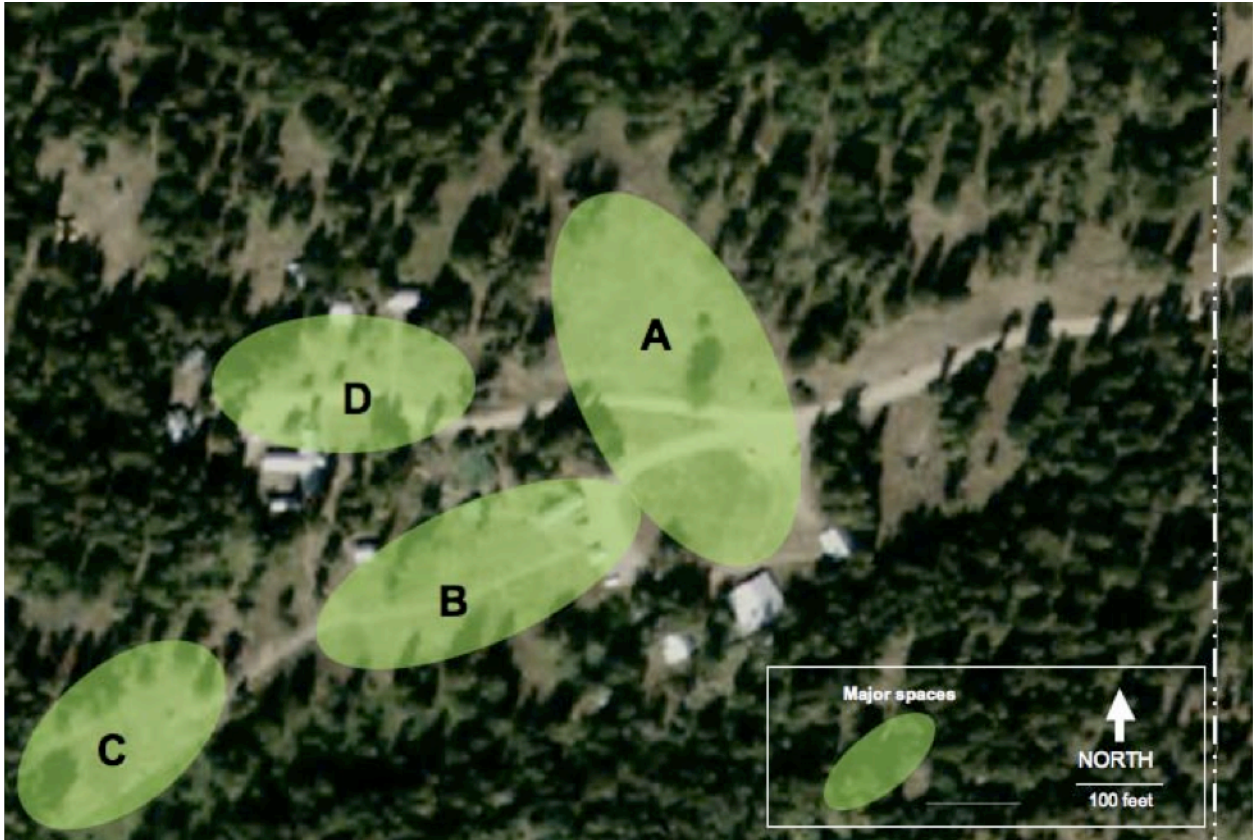
Spatial Map, showing four primary spaces on site. Space A is in front of the Murie cabin, B is west of the garage (A & B are essentially sub-spaces of one larger space), C is the former barn site, and D is the main cabin circle.

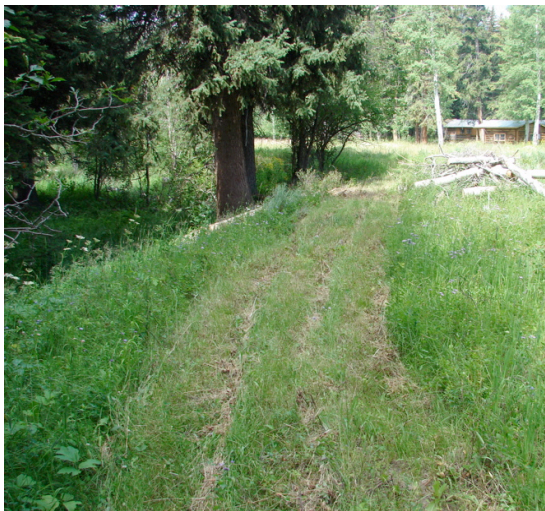
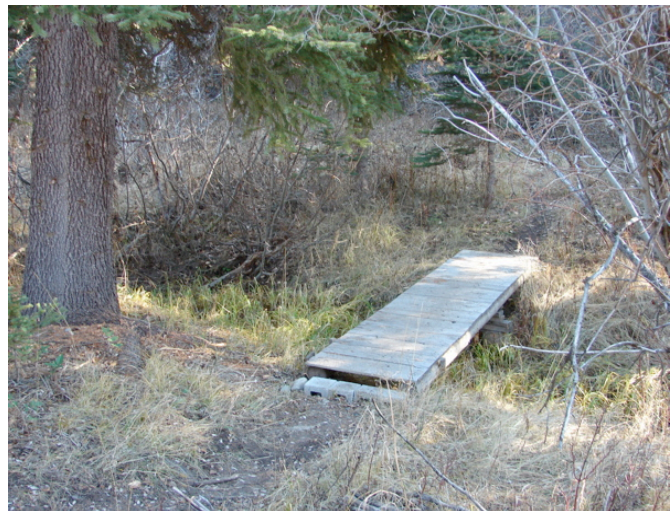
Left: slope separating flat part of site of main ranch area (right side of image) from former braided river channels

Right: Typical former river channels occupying lower part of site, south and west of main ranch area.

Murie Ranch is situated in the broad valley of Jackson Hole, a graben valley further shaped by valley glaciation. The site itself is situated in the flat glacial outwash plain, comprised of sediment deposited by melting glacial runoff. This area was subsequently acted on by the eroding, flooding, and depositional activities of the dynamically meandering Snake River, creating the topographic features present on the site today. The main historic ranch area occupies a flat surface adjacent to the Snake River flood plain, at an elevation of approximately 6445' above sea level.

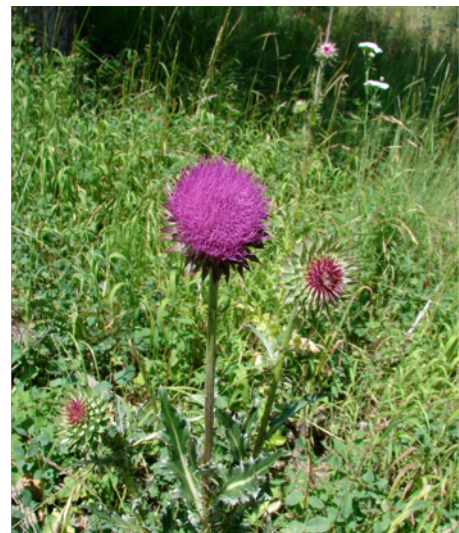
Invasive exotic species in GRTE threaten the viability of native plant communities, and pose long-term issues for sustainable ecosystem management. The park conducts educational and eradication efforts to control the spread of these species, and has mapped known occurrences of invasive plant species. Species identified on the Murie Ranch property include musk thistle (*Carduus nutans*), Canada thistle (*Cirsium arvense*), bull thistle (*Cirsium vulgare*), common sowthistle (*Sonchus oleraceus*), hounds tongue (*Cynoglossum officinale*), and yellow toadflax (*Linaria vulgaris*). (Teton County GIS website)

Invasive musk thistle growing on Murie Ranch site, August, 2009

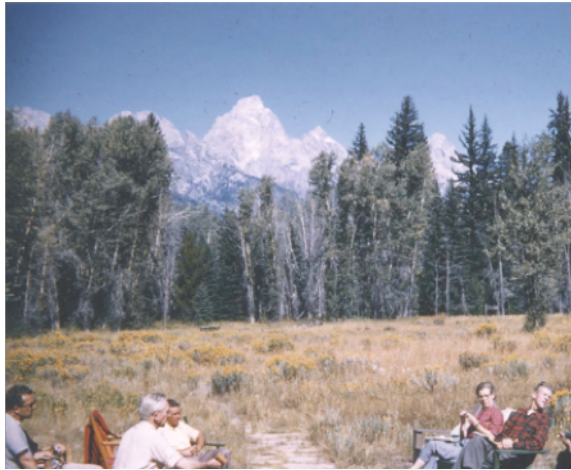
trim those trees like that?’ The explanation for the openings I have still to find” (*Thus at Moose*, 4). It is apparent from photographs of gatherings at the ranch that many informal meetings occurred in the front of this cabin, in full presence of the looming Grand Teton. Significant growth of vegetation across the meadow from the cabin, confirmed by comparative photographic analysis and first hand account by Louise Murie MacLeod, has gradually minimized this view, concealing all but the very tip of the peak today. The significance of this vista will require management to prevent it from disappearing.

View from front porch of Murie Cabin in 1955, left, and 2009, right. White line indicates vegetation growth since 1955 (Historic photo courtesy of the Murie Center Archives; cropped image)
