A CULTURAL RESOURCE INVENTORY OF PORTIONS OF THE ABIATHAR PRESCRIBED BURN UNIT, YELLOWSTONE NATIONAL PARK

Project Number WY-18-07
RM-CESU Cooperative Agreement Number H1200040001
University of Wyoming Task Agreement Number UWY-71
NPS Account Number 1580-0053-CZA
National Park Service Research Permit NumberYELL-2002-SCI-1850

REPORT TITLE (include client name, undertaking name, survey project type, and report number): A CULTURAL RESOURCE INVENTORY OF PORTIONS OF THE ABIATHAR PRESCRIBED BURN UNIT, YELLOWSTONE NATIONAL PARK.

DESCRIPTION OF UNDERTAKING: Fuels Reduction

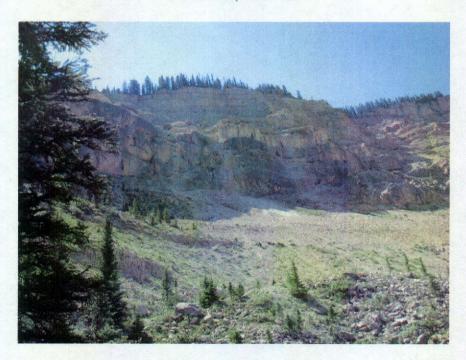
Figure 4. Project area photographs.

Paleozoic sequence above talus field.

The talus field is largely devoid of vegetation and is composed of angular to sub-angular rock clasts (Figure 4) that radiate from a series of coalescing cones situated at the base of chutes worn into the overlying cliffs. The field resides on or about the same elevation (8200 ft) as outcrops of upper Cambrian (i.e., Gallatin, Gros Venture) age, although these were largely hidden from view by debris. Immediately above the talus field, Ordovician Bighorn Dolomite, Missippian Madison limestone, and Pennsylvanian Amsden shale formations are in plain view, with the Eocene volcanic contact visible near the top of the sequence (Figure 4). Unmodified chert nodules were observed infrequently in the talus field (Figure 5). The nodules probably originated in either the Bighorn or Madison formations. Even though toolstone quarries have been noted on the opposite side of the Soda Butte Creek Valley in rock of similar age (Ann Johnson, Archaeologist, Yellowstone National Park, Personal Communication), no evidence of quarrying or use of the naturally occurring cherts was observed in this area. Several rock shelter localities were located at the base of the vertical cliffs, although these were in exceedingly dry, exposed, and relatively harsh settings (Figure 5). No evidence for any human activity was observed in or around the talus field. No sites of any kind were found.

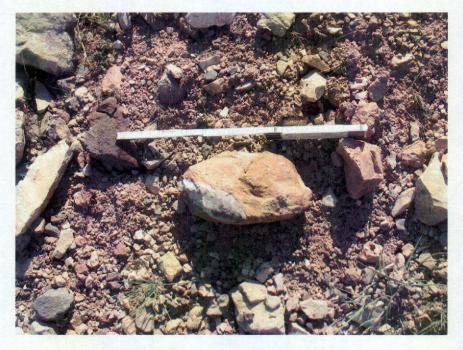
Chert nodule.

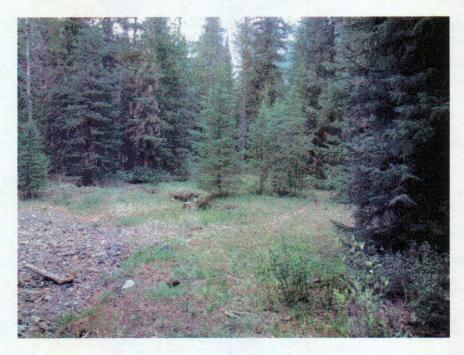
Figure 10. Photographs of 48YE873.

Trash scatter area, view SE.

Rubble pile.

NATIONAL REGISTER STATUS: The site consists of an eroded trash dump, rubble pile, and machinery part. The site does not possess unique historic artifacts. The site may be related to a maintenance area (#226) shown on the Landscape Alterations Map (NPS-YNP 1967). No evidence of a structure was observed in the project area. The site has little potential to yield any significant scientific information regarding the history of the area or region. The site is recommended as not eligible for nomination to the National Register of Historic Places.

IMPACTS: Present impacts are stream erosion. Future impacts are a prescribed burn.

RECOMMENDATIONS: No further work.

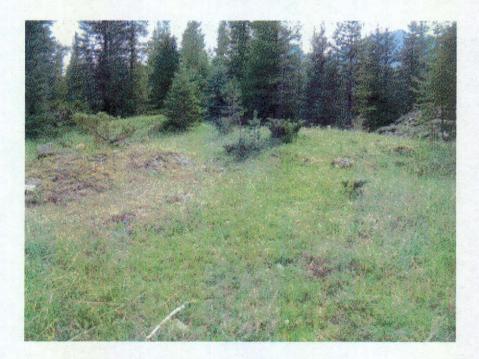
Figure 12. Photographs of site 48YE1721.

This two-track wagon road varies in appearance across the landscape. In meadows it is characterized by a shallow swale varying from about 1.4 to 2 m wide and from a few cm to 10 cm in depth (Figure 12). Distinct ruts were not observed in open-meadow settings. The wagon road is usually more distinct in timbered settings and is often marked by a thick, linear growth of evergreen saplings (Figure 13). Double wheel-ruts are often visible, with outside rut-to-rut width about 1.7 m, with depth often as much as 15 cm. The full, outside width of the road ranges from about 2.4 to 3 m. Corridors cut through timber can be as wide as 5 m. Construction-related modifications include "cut-fill" sections, built-up with either fine sediments and/or limestone rubble, rubble berms (Figure 14), as well as linear boulder piles, probably accumulated through road clearing activities. Blasting of large boulders may have occurred at certain points of the road. One spur and three detours were also noted (see below). The spur apparently dead-ended after fording Soda Butte Creek. The three detours were not as apparent on the landscape as what is considered the main wagon

Wagon road section in meadow, road goes between trees.

Wagon road section in meadow.

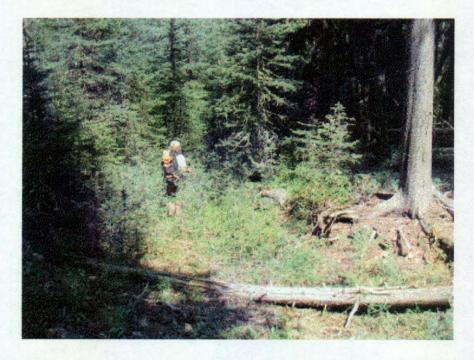
Figure 13. Photographs of site 48YE1721.

Wagon road cut in timbered setting.

Wagon road cut in timbered setting, note evergreen saplings favoring wagon ruts.

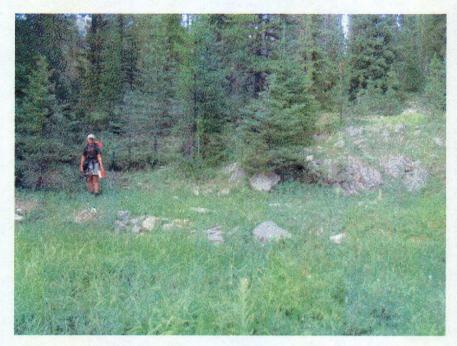
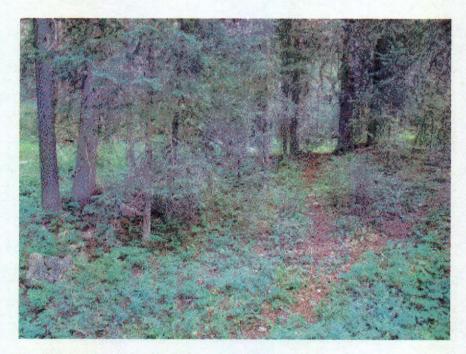
Figure 14. Photographs of site 48YE1721.

Linear rock berm on downslope side of wagon road.

Linear rock pile (on left edge of road) probably resulting from road clearing.

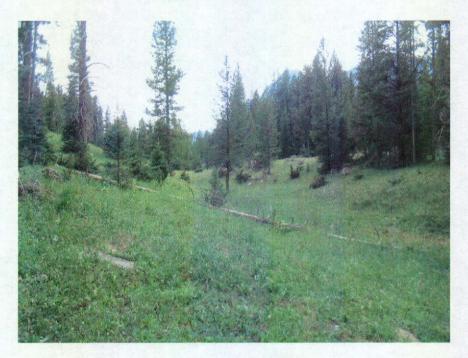
Figure 16. Photographs of site 48YE1721.

Cut-fill ramp descending to Soda Butte Creek ford.

Portion of Detour 2.

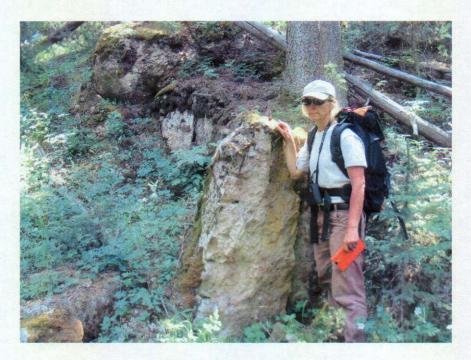
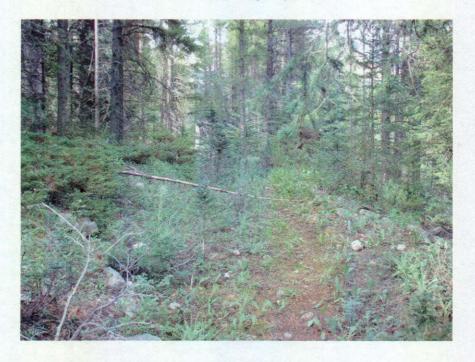
Figure 18. Photographs of site 48YE1721.

(Figure 18); thus the detour route may have only been used at times when the ground was sufficiently dry or frozen to permit passage. This is also suggested by the remains of a probable cribbed-log bridge pier (see below) associated with the nearby main road track.

Drilled boulder in quarry area.

Main "cut and bermed" wagon track west of Detour 2.

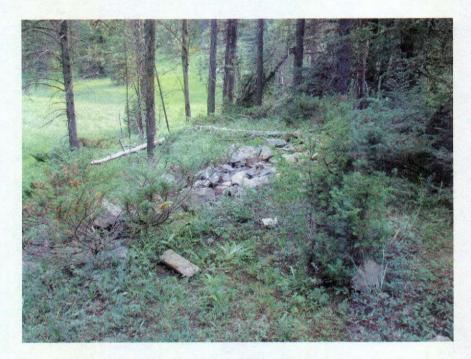
Figure 20. Photographs of site 48YE1721.

Rubble pile associated with Detour 2.

Rubble pile associated with Detour 1.

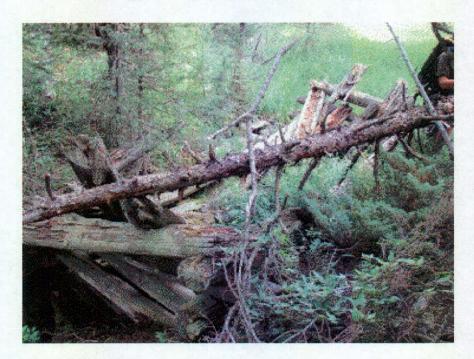
Figure 21. Photographs of crib log bridge pier at 48YE1721.

This feature consists of a deteriorated log structure located in a spring-fed gully that heads in the open meadow through which Detour 2 passes (Figure 17). The rough dimensions of the structure are 6' wide, 14' 6" long and 4' 6" high (Figure 21). The structure is made of saw-cut round logs with saw and axe-cut saddle-notched joints. No nails were observed. At least two log courses extend below the waterline and rest on what appears to be a limestone rubble foundation. Several timbers formerly spanning the structure have rotted through and collapsed into the structure's interior. This configuration indicates the structure may be remains of a cribbed-log bridge piling with the collapsed timbers being remnants of decking. The positioning of the structure in a gully, along the main road segment would support this assessment (Bob Flather, Yellowstone National Park Archivist, Personal Communication).

Crib log pier with possible collapsed deck remnant.

Crib log pier side wall view.

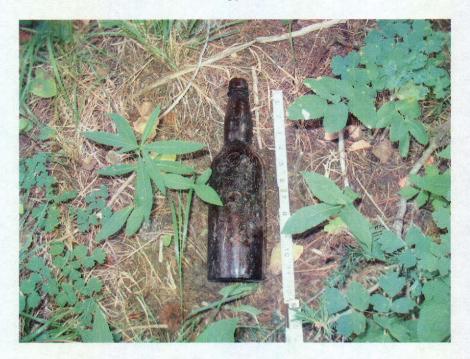
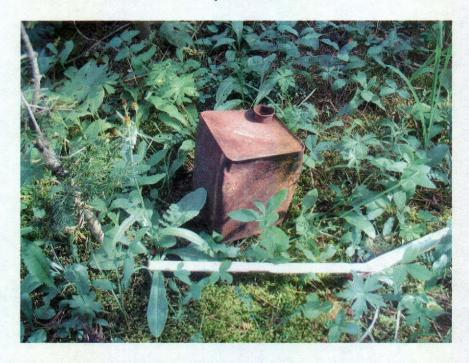
Figure 22. Photographs of site 48YE1721.

Field specimens 1, 2, 5, and 8 are export beer bottles having three different basemarks. Two bottles were complete, two were missing the finish portion (Figure 22). Neither of the complete bottles possess a crown finish, adopted by the beer industry in the early 1900s (Lockhart 2007). Field specimens 1 and 8 possess an 'M 8' makers mark. Toulouse (1971) associates this mark with a post 1916 date, interpreted here as too recent. Herskovitz (1978) recovered a high number of beer bottles at Fort Bowie, in Arizona, having the 'M' basemark with mold designations 1-8. Fort Bowie was occupied from 1862 to 1894, and beer was not available in bottles prior to 1873 (Lockhart 2007). Therefore this type may date at least as late as 1894. Field specimen 2 possesses the 'WOOSTER 8' basemark, again with the 8 being a probable mold designation. Toulouse (1971) assigns this basemark a date of circa 1900-1904. Field specimen 5 possesses a 'W&Co' basemark, which Toulouse (1971) assigns a late 1880s association.

Field specimen 3 is a crushed solder patch food can found on the wagon road (not photographed). The side seam was not visible. Field specimen 4 was found on the wagon road and is a mostly intact, square fuel can having a tapered spout and solder side seam (Figure 22). A scar is visible at the top of the can where a bail was probably attached. Field specimen 6 is a piece of riveted leather found on the wagon road (Figure 23). In its desiccated condition the specimen is about 39 cm (15 in) long and 5 cm (2 in) wide.

FS#5, export beer bottle.

FS#4, fuel can.

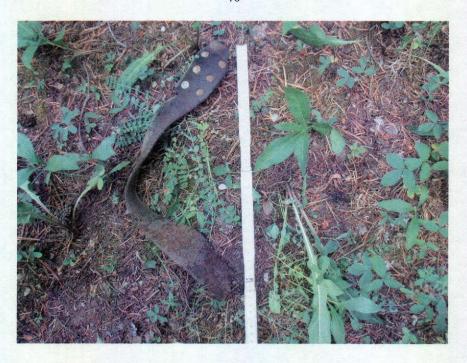
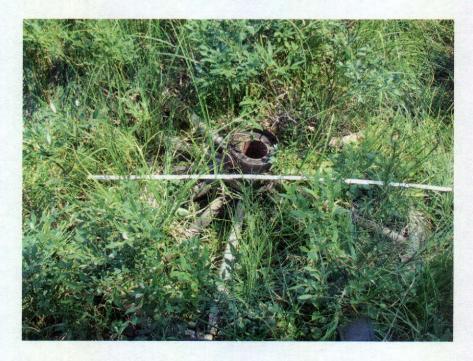
Figure 23. Photographs of site 48YE1721.

Field specimen 7 includes two partial wooden-hub wagon wheels and a portion of a wagon wheel rim. The two partial wagon wheels were found adjacent to one another immediately below the wagon road

FS#6, riveted leather.

FS#7, wagon wheel.

in the high grass of a boggy area on the Soda Butte Creek flood plain (Figure 23). An additional fragment of an outer, wooden wheel rim was found on the slope midway between the wagon road and the wheels. Much of the hub/spoke/rim portions of both wheels are buried in muck and covered by moss. The better preserved wheel retains most of its spokes (still seated in the hub) and at least fifty percent of the outer, wooden rim. The outside diameter of the wheel is 54" (4' 6") with a 3.5" diameter opening for the axle. The other wheel is of the same or similar size although most remaining spokes have pulled away from the hub and most of the outer wooden rim is missing. Neither wheel is associated with an iron rim or tire. This type of wheel was commonly used on freight wagons, carts, and coaches well into the 20th century (Spivey 1979). Their presence just off the wagon road is consistent with its continued use in the late 19th century.

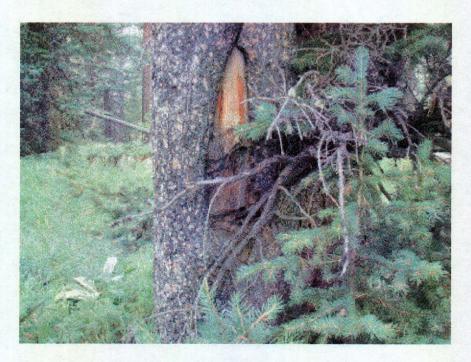
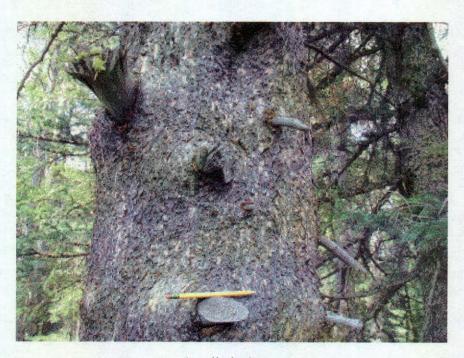
Figure 24. Photographs of site 48YE1721.

A number of blaze and axe-trimmed trees were observed along the wagon road. As these were relatively ubiquitous, no attempt was made to document all of them. The blaze trees have had their outer bark removed, probably with an axe, presumably to mark the preferred wagon road route (Figure 24). Many of the scars are being engulfed by new tree growth. If the precise history of the Cooke City Miner's Wagon Road were ever to be researched, blaze marks on still living trees might be the best source for concise dendrochronological dating.

Blaze tree.

Axe-limbed tree.

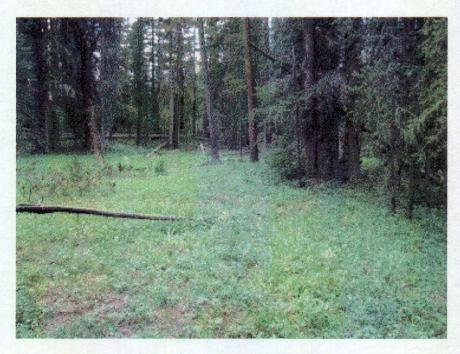
Figure 27. Photographs of Isolated Resource 1.

DESCRIPTION: Isolated Resource 1 consists of one obsidian tertiary flake. The artifact is not temporally diagnostic.

NATIONAL REGISTER STATUS: Isolated resource 1 is located in a small (15 x 20 m) clearing on a glacio-fluvial terrace above Soda Butte Creek. This isolated resource is not eligible for nomination to the National Register of Historic Places and no further work is recommended.

Isolated resource setting.

Isolated Resource 1.
