Associated Project Name **Complete Determination of National Register of Historic Places Eligibility for Helene Wittmer Property, Hartgrave/Halpin Property and the Rudd Property**

Site Name **Rudd Property** Temporary Field Number _____

8F. HISTORIC ARCHITECTURE COMPONENT DESCRIPTION

Common name: **Rudd House**

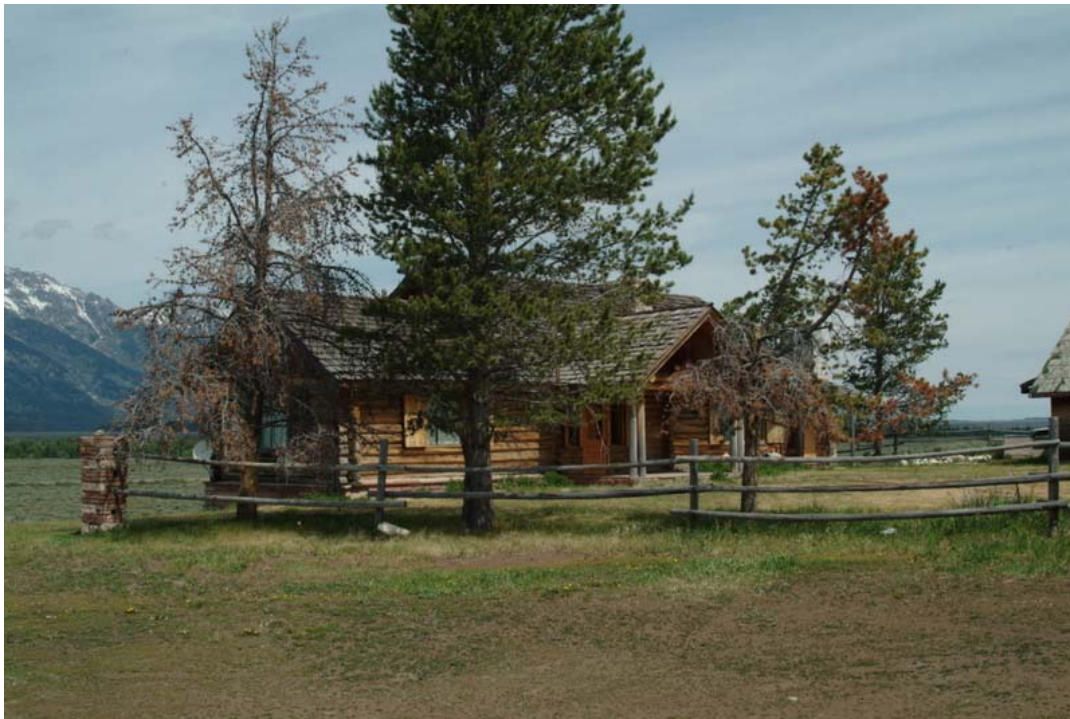
Rudd Property, view looking northwest (Mary Humstone, 2007)

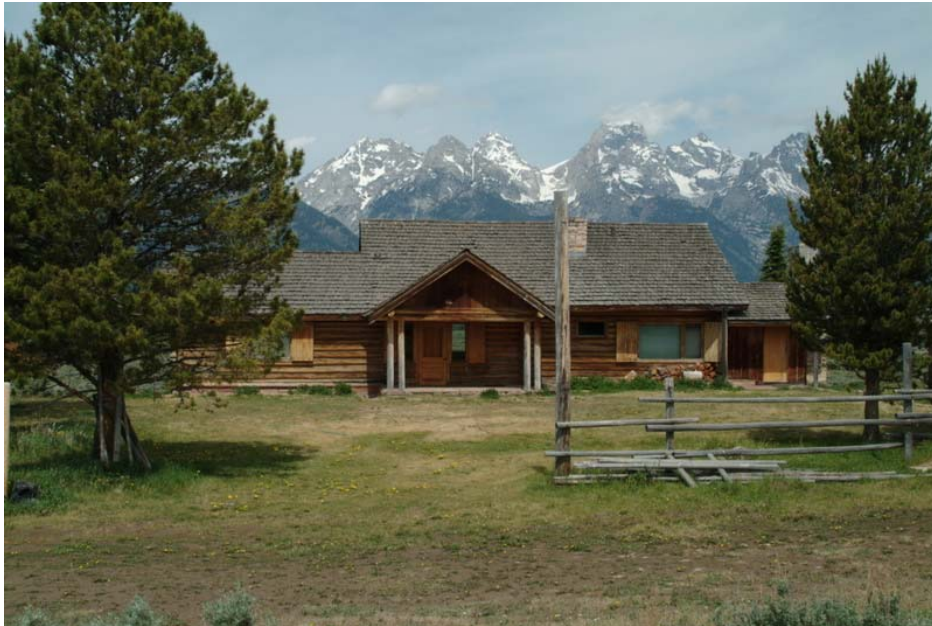
An 18'-by-9' porch is roughly centered on the façade. It has an intersecting gable roof supported by paired posts at the northeast and southeast corners and has vertical wood siding in the gable end. The porch roof has open eaves and the ceiling of the porch is tongue-and-groove, knotty-pine paneling. The porch deck is red flagstone. The flagstone used here and elsewhere on the property is from a quarry in Lyons, Colorado (Rudd). A flagstone drip edge and gutter runs along the south end of the porch and the south section of the façade. A low flagstone wall creates a planting/wood-storage area on the north section of the façade. A flagstone walkway runs in front of the house north of the porch. The front door is constructed of varnished, vertical, flush boards and has a wood screen door. Flanking the door are vertical stationary-sash windows (approximately 2/3 the door length) with wood trim and operable, tongue-and-groove-pine shutters.

To the north of the porch, the façade is recessed 3 feet. There is a horizontal stationary-sash window immediately north of the porch, and, to its north, a window consisting of a large stationary sash and a single casement window, with operable shutters. The wide soffit of this section is finished in wood with recessed lighting. To the south of the porch is a single, large, stationary-sash window.

Rudd House, east elevation (Mary Humstone, 2007)

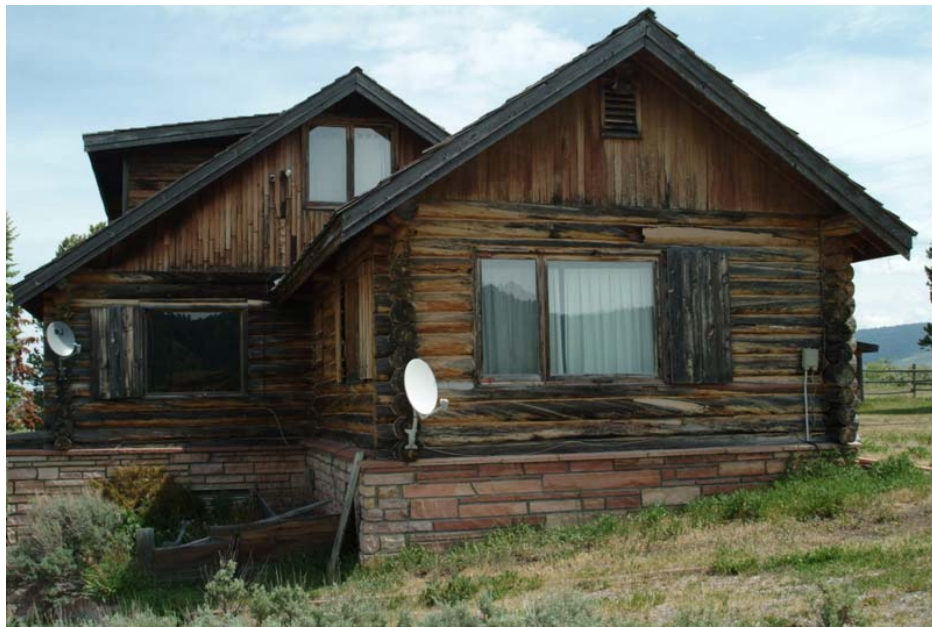
The southernmost section of the house is approximately 16 feet wide, and its roofline is slightly lower than that of the rest of the house. Offset slightly to the west of center on the south elevation of this section is a two-part window consisting of a large stationary sash and a single casement window. A wood, louvered vent is in the gable end, which is sided with vertical, flush boards. The rest of the house extends above and to the west of the south section. On its south elevation is a square, stationary-sash window with a shutter and a large, double, casement window in the gable end.

Rudd House, south elevation (Mary Humstone, 2007)

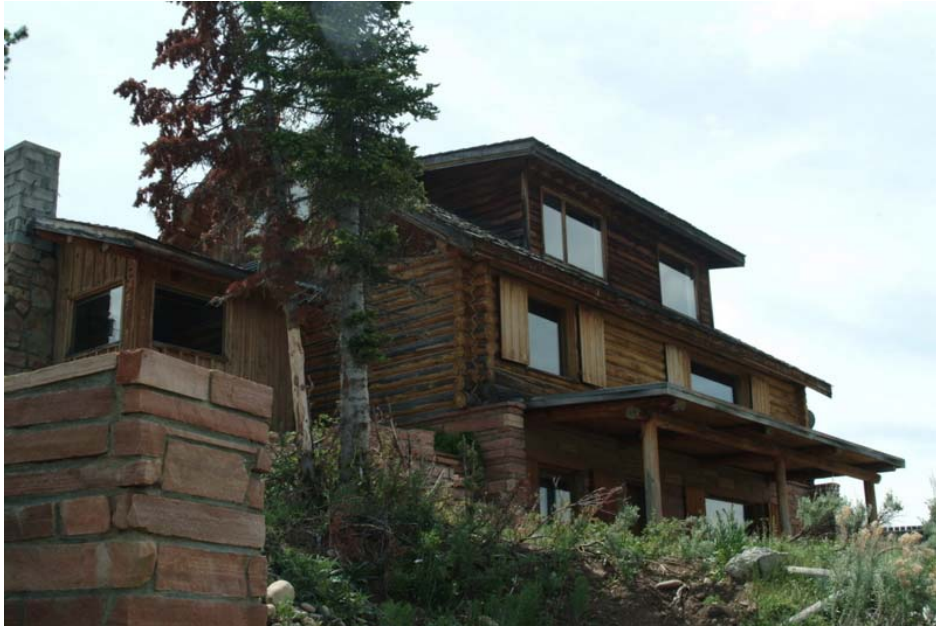
The west elevation of the south section has a large stationary-sash window that matches the one on the east elevation. A second window is covered with a wood shutter. To the north, the ground falls away to reveal a ground-level basement. A shed-roofed porch supported by three log posts and a log beam extends 27 feet at the basement level. The porch has log rafters and shelters a red-flagstone patio. A door constructed of narrow, vertical, flush boards with a wood screen door is offset to the north of center. To the south of the door is a very large picture window, with a standard-sized picture window to the north. Red-flagstone steps lead from the north end of the porch up to the level of the front (east) yard. The upper (first) story of the west elevation has the same window configuration as that of the basement. A shed-roofed dormer is centered on the western slope of the roof. It has one standard picture window and a paired window consisting of a standard picture window and a casement.

The north gable end of the house has two casement windows and vertical wood siding. Most of the north elevation is covered by an addition constructed by Clayton Rudd's son, Bob, in the 1970s. The addition is frame construction with board and batten siding. There are large, square, stationary windows in the west and north elevations of the addition. A massive, exterior, concrete-block chimney rises from the east end of the north elevation of the addition. The lower two-thirds of the chimney is faced with stone. On the east elevation of the addition is a recessed, open porch supported by two posts. The porch shelters a flush-board door.

Rudd House, north and west elevations (Mary Humstone, 2007)

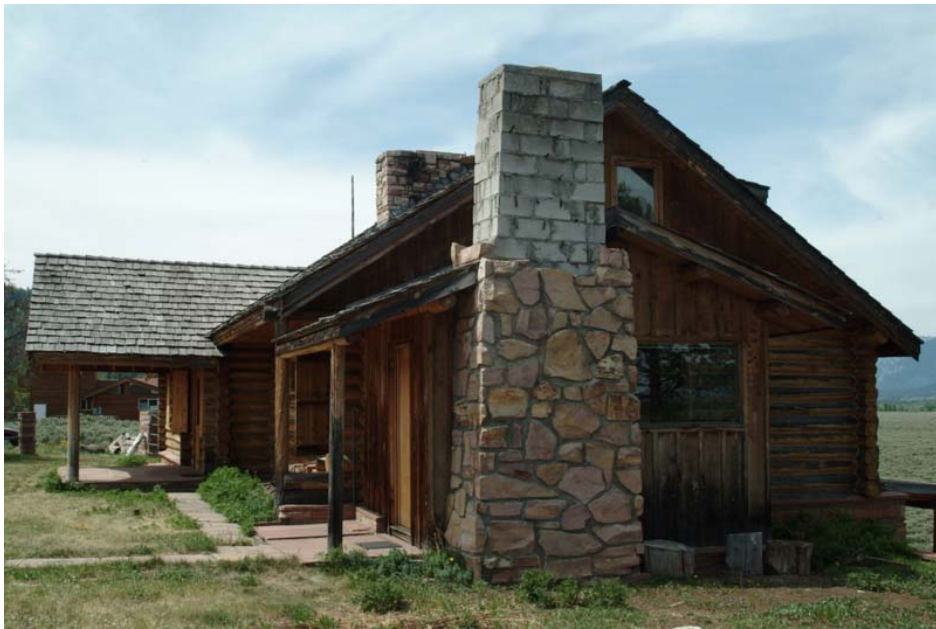
Rudd House, east and north elevations (Mary Humstone, 2007)

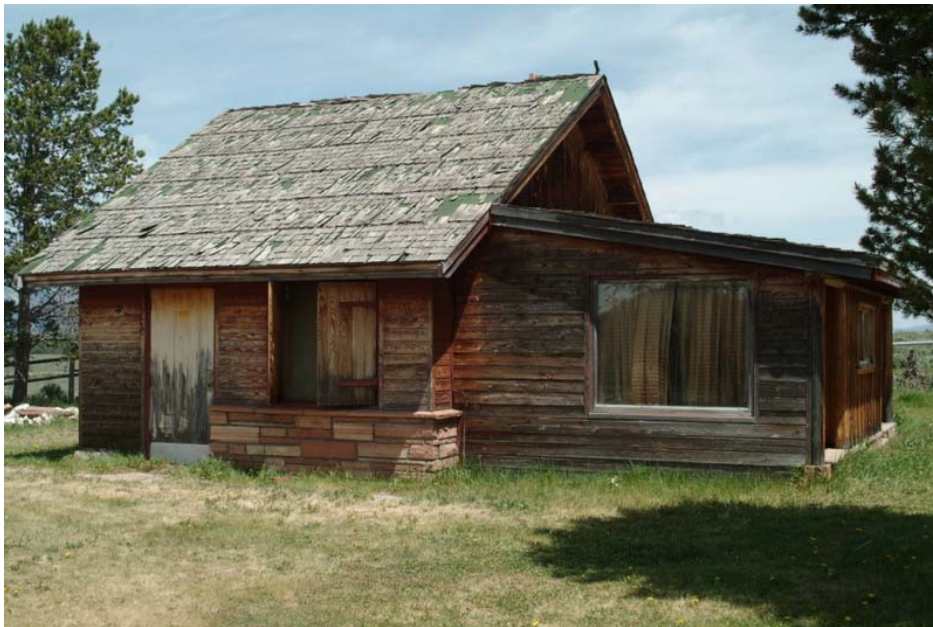
The south (shop) section (24' NS by 12' EW) has a medium-pitched gable roof with an east-west ridgeline. A brick chimney rises from the north slope of the roof. This section is wood framed and sheathed with shiplap siding, with vertical siding in the gable ends. There is a wood door with deteriorating veneer and an interior screen door in the west bay, and a large picture window with shutters in the east bay of the south elevation. The section of wall to the east of the door is faced in stone from the foundation to the level of the window sill.

At the juncture of the two sections of the building, a shed-roofed extension projects to the east. This extension is sheathed in vertical boards, some of which have battens. A door is on the north elevation of the extension. The east elevation of the extension has a 1-by-1 sliding window and two large openings that have been in-filled with plywood. The function of this room is unknown.

Rudd Garage/shop, south and east elevations (Mary Humstone, 2007)

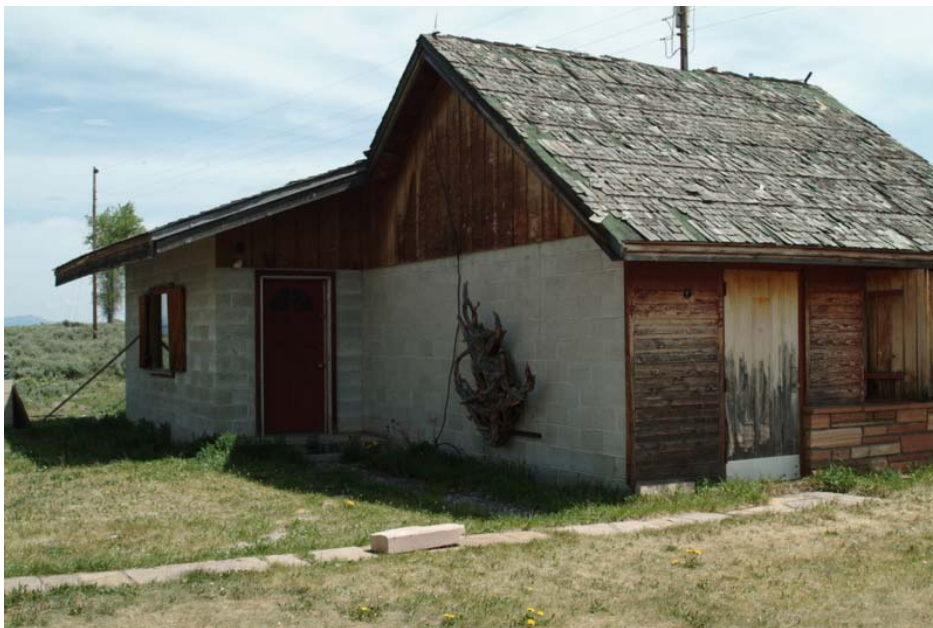
The entire west elevation of the building is approximately 50 feet long and is constructed of concrete block. The concrete-block garage section (24' NS by 18' EW) projects 8 feet to the west behind the shop portion, and has a low-pitched gable roof with the ridge running north-south, and vertical siding in the gable ends. In the projecting area is an east-facing wood door with a semicircular arch with four lights above two small square panels and two long vertical panels, and a west-facing picture window with shutters. The north elevation has two vertical, stationary windows trimmed in 2-by-4 boards. The east elevation has a two-leaf garage door constructed of tongue-and-groove pine, that serves as a shutter over a wood, overhead, garage door.

Rudd Garage/shop, south and west elevations (Mary Humstone, 2007)

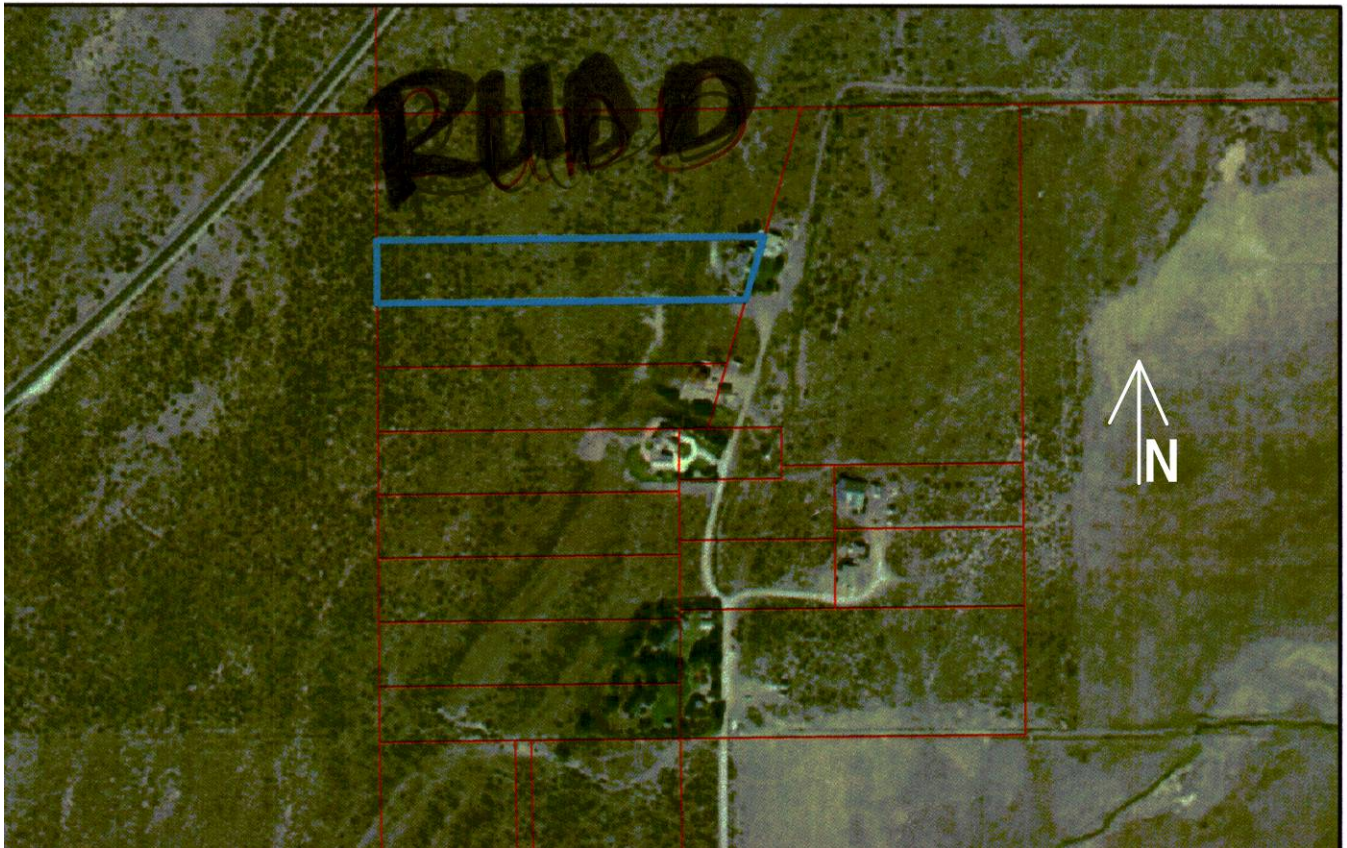
RUDD PROPERTY SITE PLAN

The yard is marked with a post-and-rail fence in poor condition. Mismatched stone gateposts mark the entrance to the garage at the north end of the property, as well as the northeast and northwest corners of the yard. Two stone pillars also mark a driveway entrance south of the house. A partial retaining wall and a wooden fence with vertical boards are located at the southwest corner of the property. The wall extends southward to become part of a stone patio that features a flagpole and two stone benches. Vegetation outside of the yard is primarily sagebrush. Vegetation within the yard consists of grass and several ponderosa pines.
