NATIONAL REGISTER OF HISTORIC PLACES
REGISTRATION FORM

historic name Grand Canyon of the Yellowstone Historic District
other names/site number

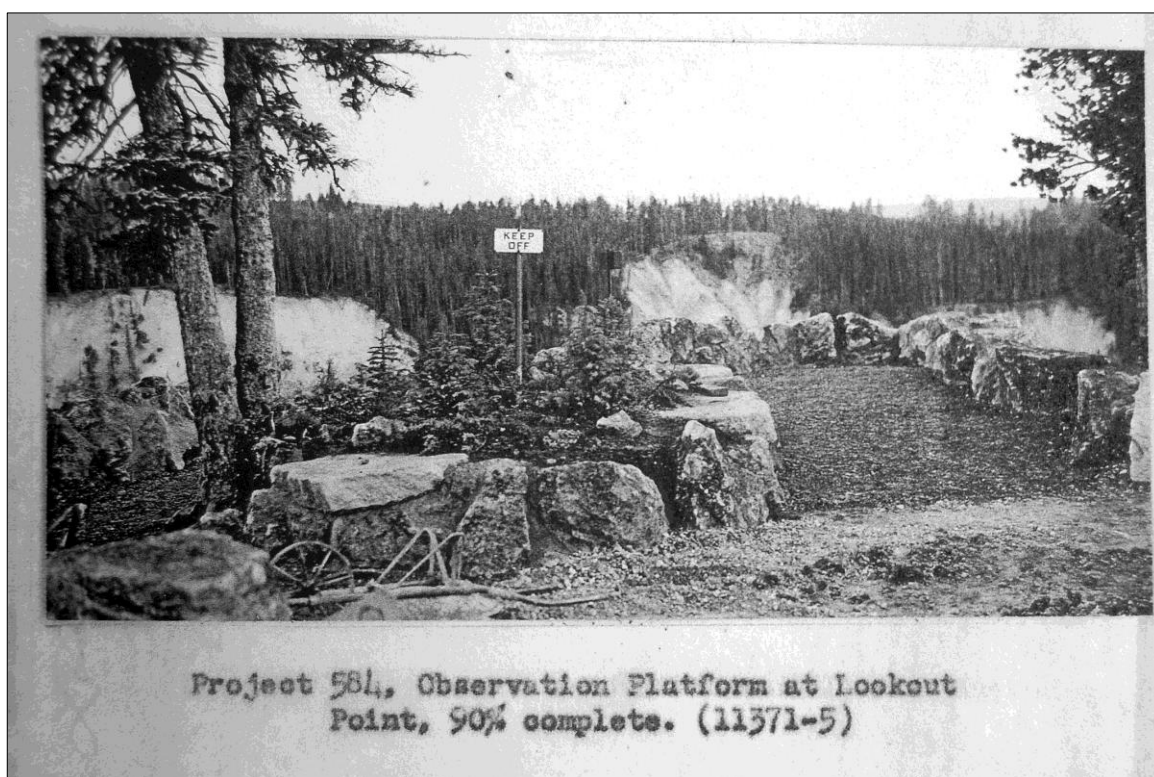
Lookout Point Overlook (Source: *Final Report Point Lookout Trail – Canyon, Project No. 584; Box L-8, by Phillip Wohlbrandt, 1943. Heritage Research Center, Yellowstone National Park.*)

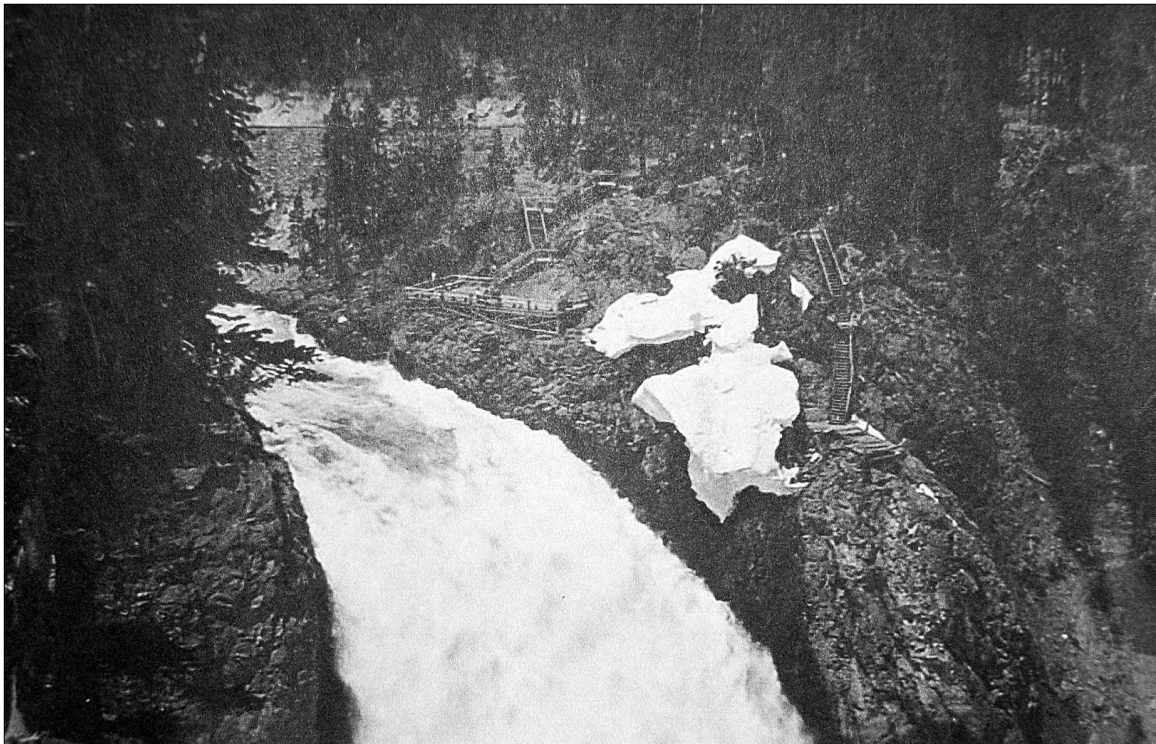
Brink of Upper Falls Overlook. "Project site before start of construction." During the winter of 1935-1936, massive snow slides demolished much of the two wooden walkways that led to views of the Upper Falls, and they were soon replaced. Today's stone retaining wall is visible at upper left and center; the steps at center have been replaced, and the steep staircase and rickety platform at the bottom right were eliminated. (Source: *Final Report Reconstruction of Observation Platform – Canyon, Project FF 601*, by C.A. Lord, Park Engineer, 1937. Box K-30, File D66, Heritage Research Center, Yellowstone National Park)

Wooden steps and viewing platform upper falls of Yellowstone in Canyon Area completely demolished by snowslide and wash. Essential it be replaced at early date. Estimated cost six thousand dollars using concrete and steel in accordance approved plans for observation platform this area. Time required approximately sixty days. Request PW or emergency funds be made available for this reconstruction.⁴²

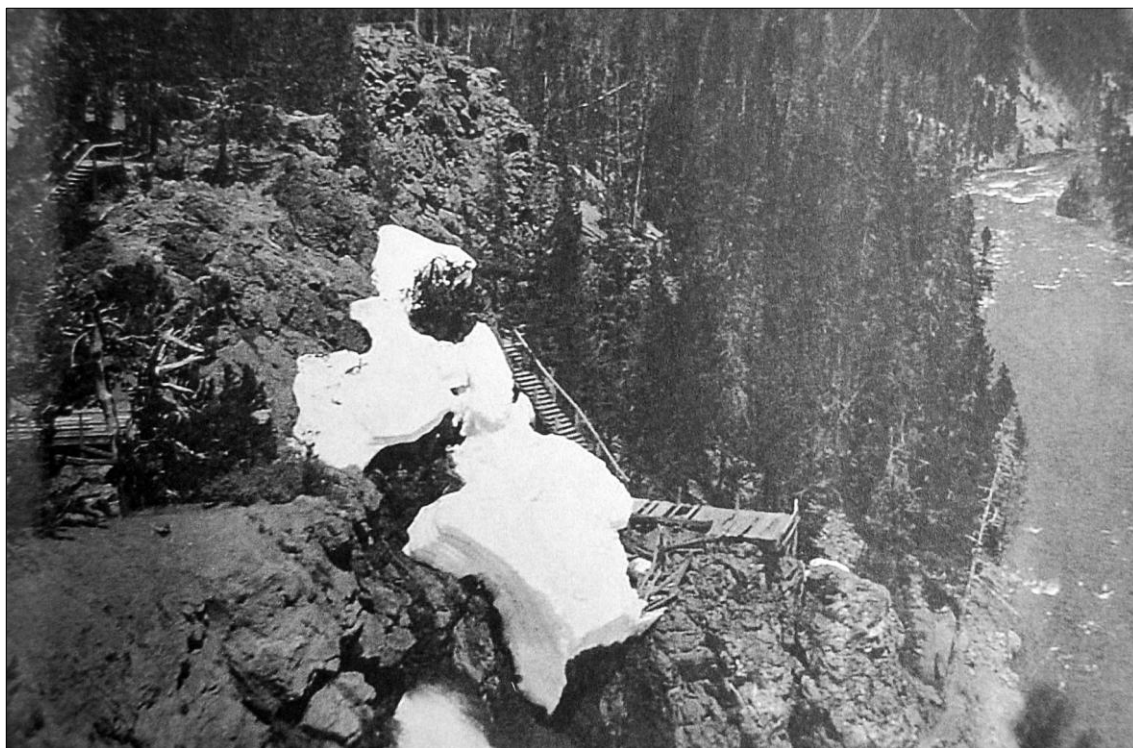
Brink of Upper Falls Overlook. "Project site before start of construction." At center is the steep staircase that was not rebuilt after the snow slide in 1936. (Source: *Final Report Reconstruction of Observation Platform – Canyon, Project FF 601*, by C.A. Lord, Park Engineer, 1937. Box K-30, File D66, Heritage Research Center, Yellowstone National Park)

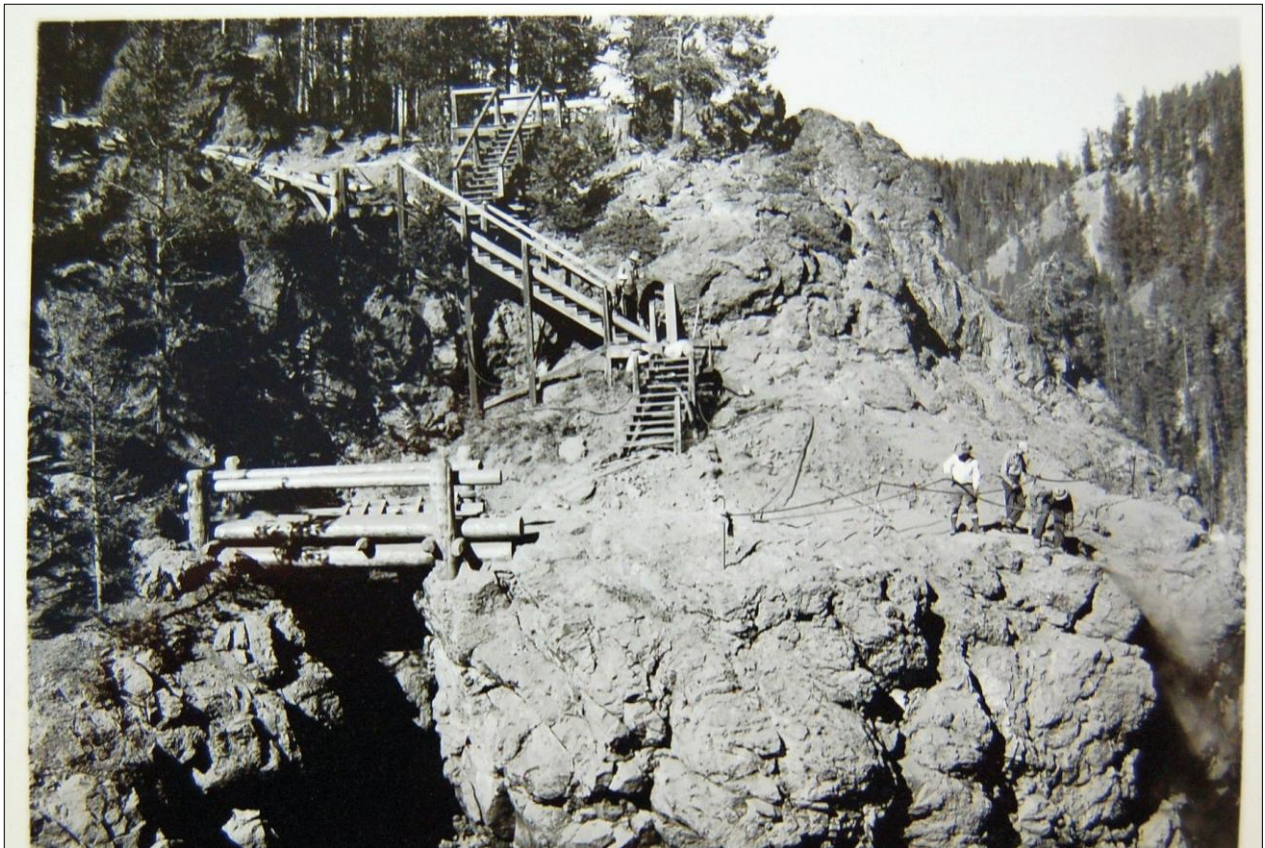
Brink of Upper Falls Overlook. "Trail bridge constructed and preparing site for parapet and platform." (Source: *Final Report Reconstruction of Observation Platform – Canyon, Project FF 601*, by C.A. Lord, Park Engineer, 1937. Box K-30, File D66, Heritage Research Center, Yellowstone National Park)

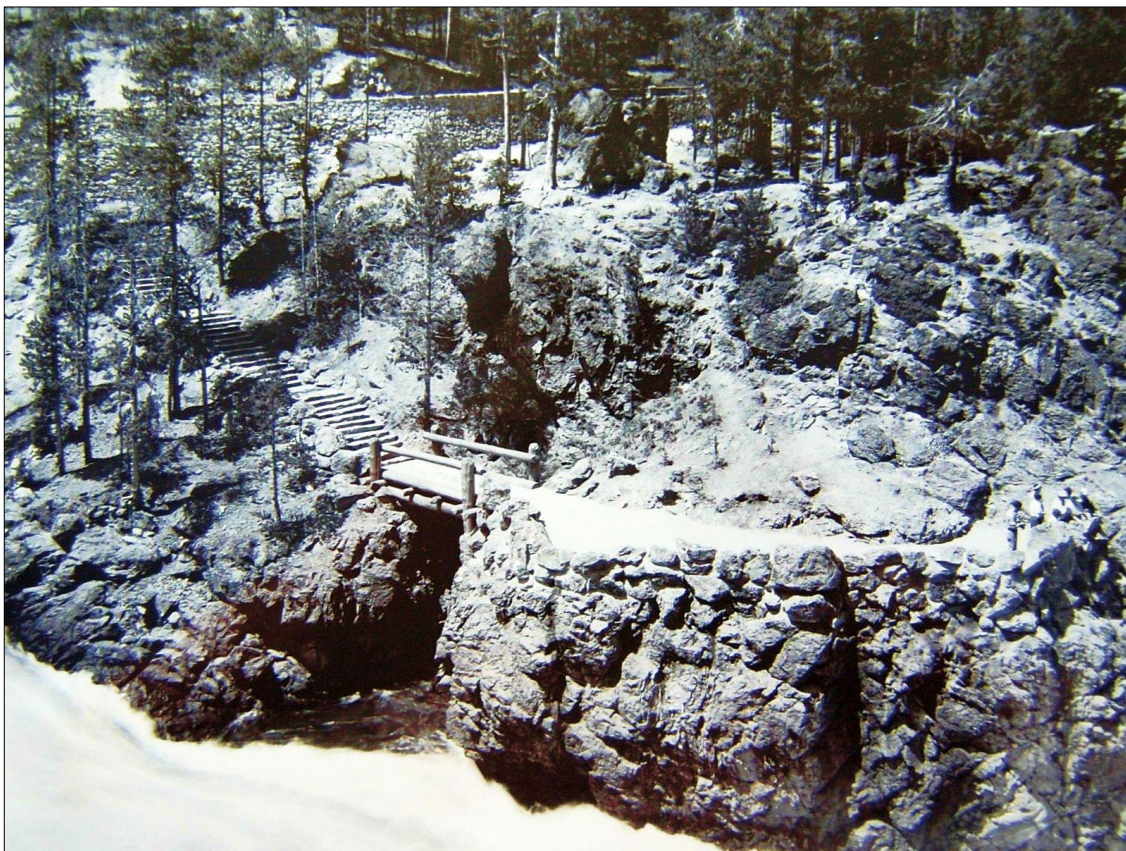
Brink of Upper Falls Overlook. "Completed Project." (Source: *Final Report Reconstruction of Observation Platform – Canyon, Project FF 601*, by C.A. Lord, Park Engineer, 1937. Box K-30, File D66, Heritage Research Center, Yellowstone National Park)

Brink of Upper Falls Overlook retains integrity of location. The integrity of design, materials, and workmanship is rated as good. The observation platform and walkway were reconstructed in 1936-37, replacing a wooden structure from 1906. The integrity of setting is rated as good due to the site's continued use as an observation point on the North Rim of the Grand Canyon of the Yellowstone. Integrity of feeling and association is rated as good because the site still retains its essential rustic character as built in 1936-37. The overlook continues to provide the original essential views of the Upper Falls of the Grand Canyon of the Yellowstone.
