# Hydrologic Regime, Vegetation, Impact Analysis, and Restoration Concepts for the Rodeo Beach Wetland complex: Golden Gate National Recreation Area, California

David J. Cooper, Ph.D., Evan C. Wolf, M.S.  
Department of Forest, Rangeland and Watershed Stewardship  
Colorado State University, Fort Collins, CO 80523

*September 2008*

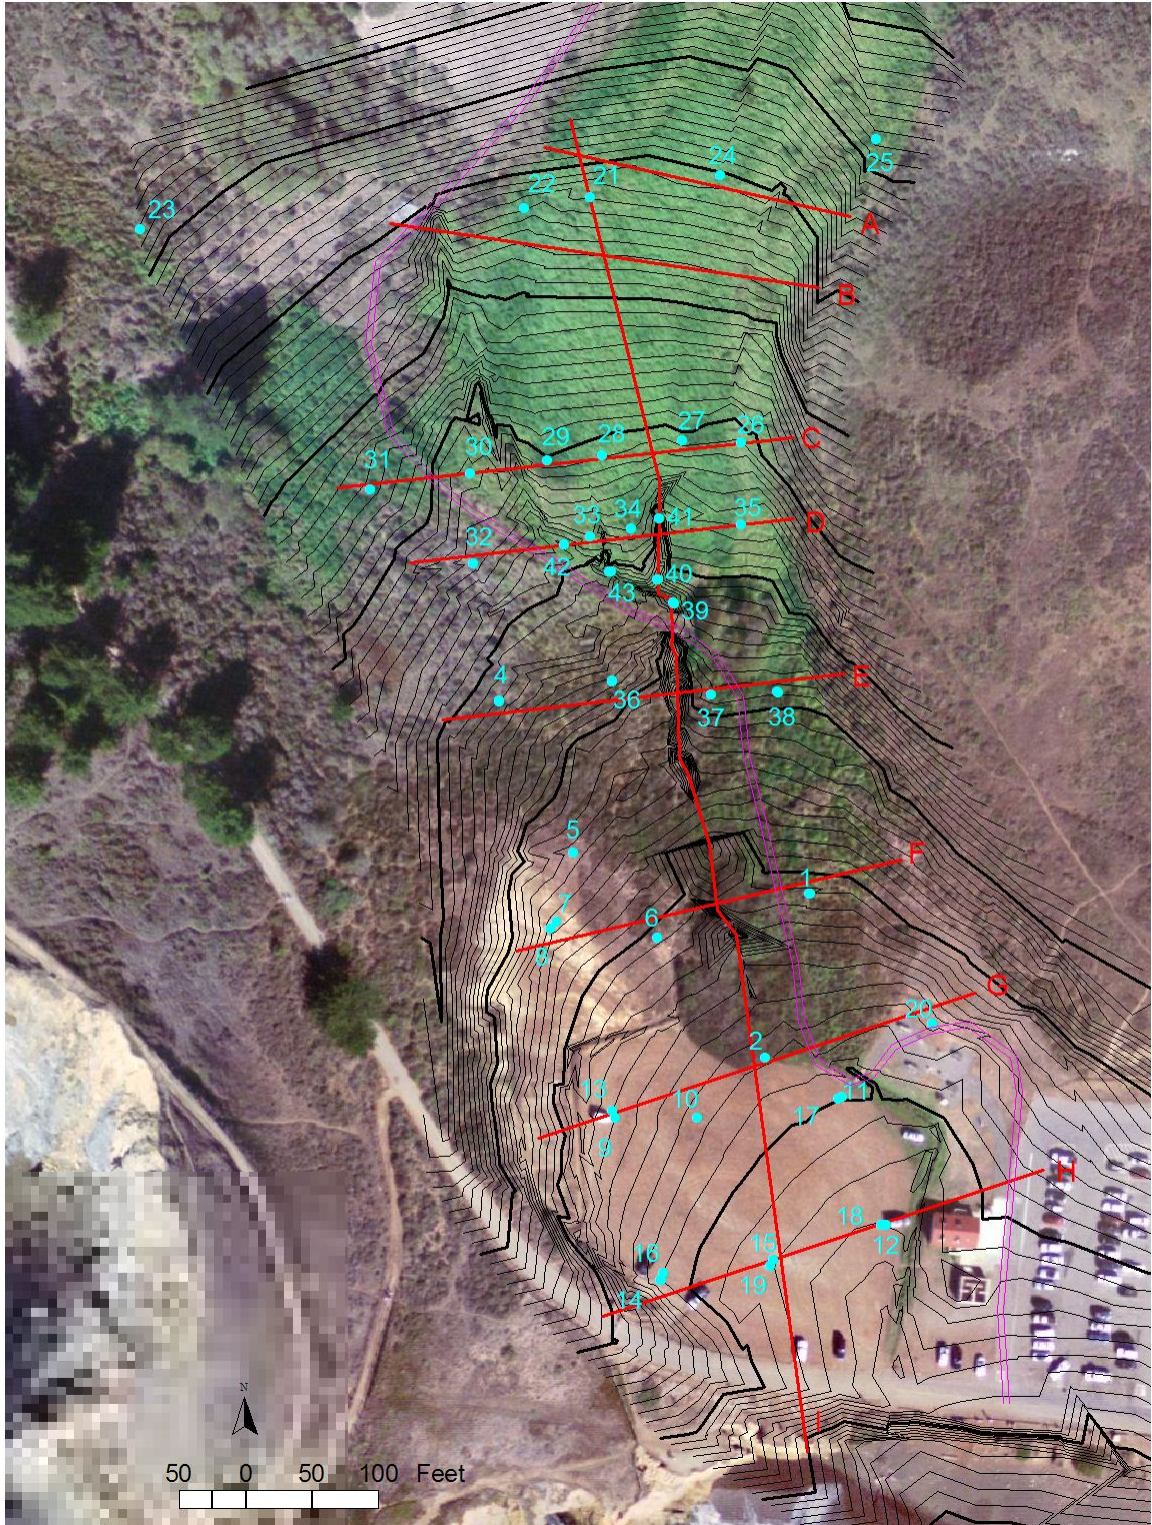
**Figure 7.** Existing topography and location of monitoring wells and staff gauges (blue dots and numbers) in the study area. Red lines and letters indicate transects described later in this report. The double purple line indicates the location of the former ranch road. A concrete headwall with culvert is located along this road just south of staff gauge 39.

Topographic data were used to create a detailed map of the existing topography (Figure 7). We accurately surveyed ditches, channels, areas of incision, culverts and other obstructions or changes to water flow. We compared well hydrographs for the relatively intact area above the head-cuts and ranch road to areas below the head-cut and road to identify hydrologic changes that have occurred due to channel incision and other hydrologic impacts. Cross sections A and B (Figures 7 and 8) are through the largely intact upper meadow and wells along these transects show relatively small water level ranges throughout the 16 month sampling period. Cross sections C and D are above the ranch road and headwall but cross several headcutting channels that have eroded into the upper wetland. Staff gauges 41 and 42 show relatively constant shallow water flowing in these channels (although these hand-read data did not include analysis during rain events, see Figure 10 for a discharge curve showing peak flows). Several wells in transect C and all but the easternmost well in D, well 35, have water level ranges of 3 feet or more. The water table at these transects drops further due to the presence of the headcutting channels, which rapidly drain the surrounding soil. A relatively intact sheet flow system with no major channels persists along the east side of the meadow and maintains high water levels in well 35. Cross sections E and F are located below the ranch road and headwall and cross the gully that formed below the headwall culvert. The water level on the east side of the gully is higher than on the west, indicating that the eastern sheet flow system maintains higher water levels than occur on the west side of the gully. On the west, water levels drop up to 8 feet below the surface due to the ranch road intercepting sheet flow from the upper meadow, which would have irrigated this western area, and directs this water through the culvert and into the gully. Profiles G and H cross
