# **Wetland Restoration Pilot Project at Florissant Fossil Beds National Monument**

David J. Cooper and Jeremy Sueltenfuss  
Department of Forest and Rangeland Stewardship  
Colorado State University, Fort Collins, CO 80523

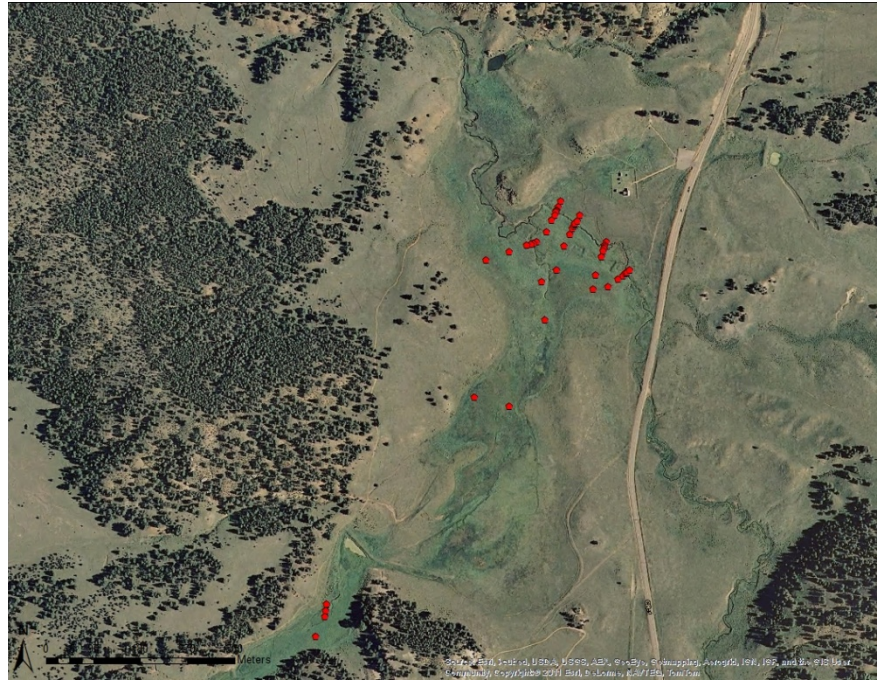
study area (Figure 1). Wells were installed along four primary transects perpendicular to the incised channels. One well was located in each channel, with wells installed along the transect at increasing distances from the channels, such that the density of wells was greatest near each channel. Two wells were also installed uphill of all channels to identify a suspected water source from the hillside. One meadow, uphill of all channels and dams was identified as a reference meadow. Four wells were installed within this meadow for an understanding of the hydrologic regime in the absence of channels or dams.

Figure 1. Well locations within the Hornbeck Meadow at Florissant Fossil Beds National Monument. Wells were installed in transects perpendicular to channels and in other locations of possible groundwater discharge, leading to 46 total wells within the study area.

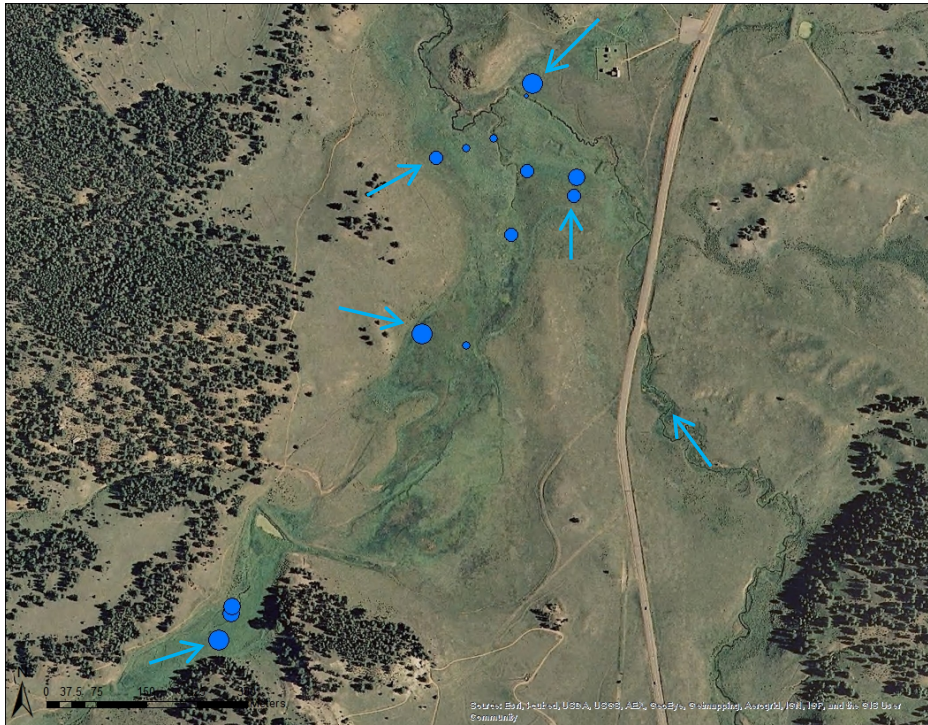
Rain samples collected had an  $\delta^{18}\text{O}$  of 0.94, consistent with the heavier isotopic signature of summer rain. Water samples collected from monitoring wells had  $\delta^{18}\text{O}$  ranging from -1.36 to -0.45. Six locations of water discharge were identified by isotope values (Figure 5). More negative isotope values indicate locations near where water discharges into the meadow from a source. Water samples collected from each channel had the most evaporatively enriched samples, indicating they originated from further away.

Figure 5. Isotope results with locations of apparent water discharge into the meadow. Circles indicate locations where water was collected for stable oxygen isotopic analysis. Larger circles indicate more negative values, which identify discharge points.

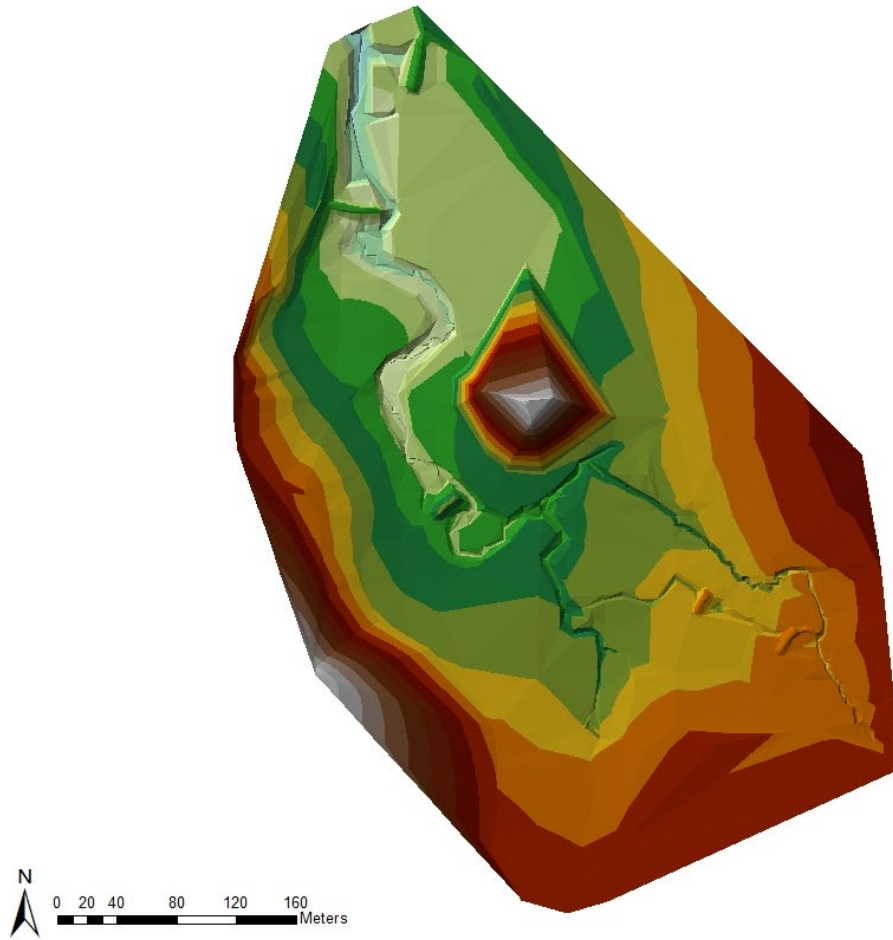
A total of five dams and three channels were part of the surveyed landscape (Figure 6). Three dams with a total volume of 400 m<sup>3</sup> were identified to be removed as part of this pilot restoration project (Figure 7).

Figure 6. Triangulated Irregular Network (TIN) generated from surveyed points. Colors indicate locations of similar elevation, with each color representing 1m in elevation.
