# Restoration Plan for the Flagg Ranch, John D. Rockefeller Memorial Parkway, Wyoming

David J. Cooper<sup>1</sup> and Lindsay Patterson<sup>2</sup>

**January 2007**

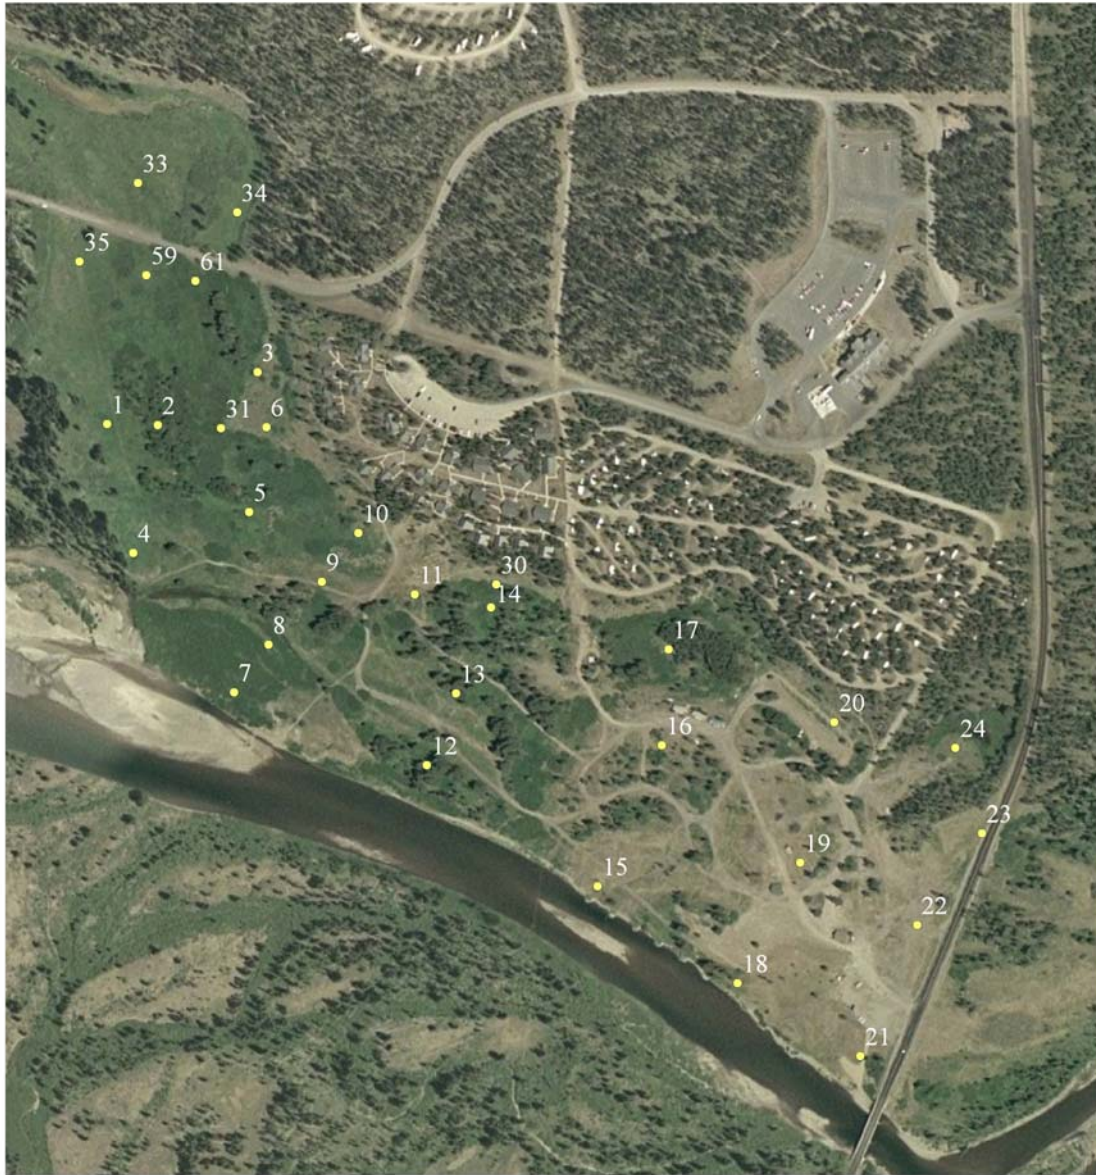
● Well Site

**Figure 2.** Location of monitoring wells on the Flagg Ranch used in this study.

**Location of Fill and Site Hydrologic Analysis.** The locations of filled sites were identified both on air photographs and ground surveys. We installed ground water monitoring wells to investigate the ground water levels across the site. The wells were hand slotted PVC pipe that were placed into backhoe-excavated trenches. In these trenches we also investigated the thickness of fill, if any, had been placed onto the former natural landscape. The locations for backhoe pits were areas where we suspected fill had been placed and also formed well transects that would allow us to investigate hydrologic patterns and processes of the entire site. In each trench soil stratigraphy was analyzed to identify the original ground surface, the current ground surface, and the thickness of fill. Depth to the water table was measured in each monitoring well using an electronic tape approximately biweekly from June through September 2006. A number of hand augered wells were also installed into the wetland area along the northwestern project area. A total of 31 monitoring wells were installed in 9 transects that ran generally north to south or west to east (Figure 2). All wells and staff gauges were topographically surveyed to determine the elevation of the ground, and elevation of the water table relative to the ground surface.

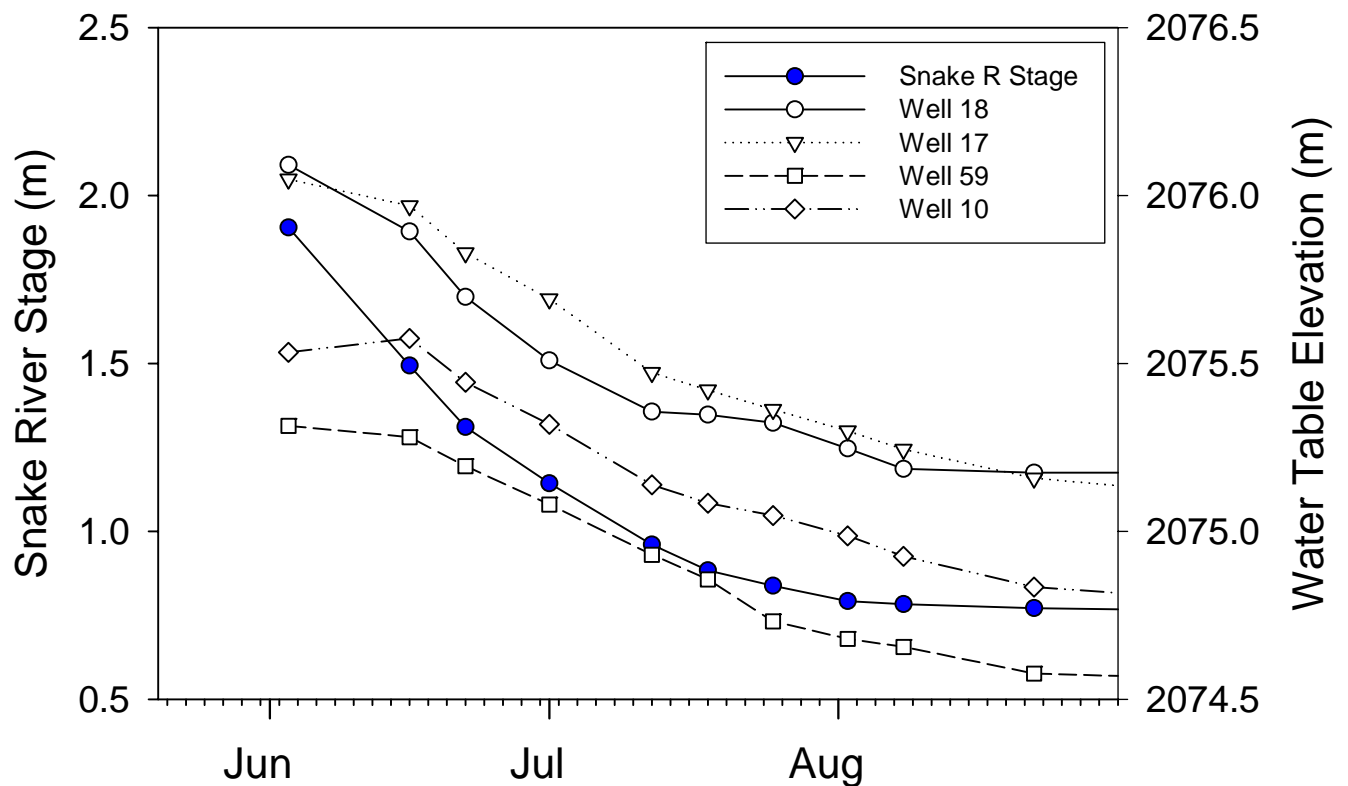
**Figure 4.** Snake River relative stage (m) and ground water elevation (m) for wells 10, 17, 18 and 59 for June-August 2006.

The water table elevation for four typical ground water monitoring wells, 10, 17, 18 and 59 are plotted in Figure 4 along with the relative elevation of Snake River stage. River stage has a relatively constant decline during the sample period, and water levels in the wells followed this pattern. There is a very high correlation of ground water elevation with Snake River stage (well 10,  $r = 0.9072$ ; well 17,  $r = 0.9449$ ; well 18,  $r = 0.9894$ ; and well 59,  $r = 0.9216$ ). The highest correlation is for well 18 located near the Snake River in the southeastern portion of the study area. The weakest correlation is for well 10, located at the toe of the bluff. The high correlations suggest that the Flagg Ranch ground water flow system is connected to the Snake River, or that due to snowmelt being the driver for all surface and ground water flow processes in the area, all water levels decline seasonally due to the reduced availability of snowmelt water.

All monitoring wells follow the same general pattern, being highest in the early summer, and lowest in the fall. No significant rises due to summer rain were found. The wells in the northwestern portion of the site (eg. well 59) had a lower water table in early June than mid June, suggesting either a distinctly different water source, or that the effects of high Snake River stage are diminished by the time it reaches this area.

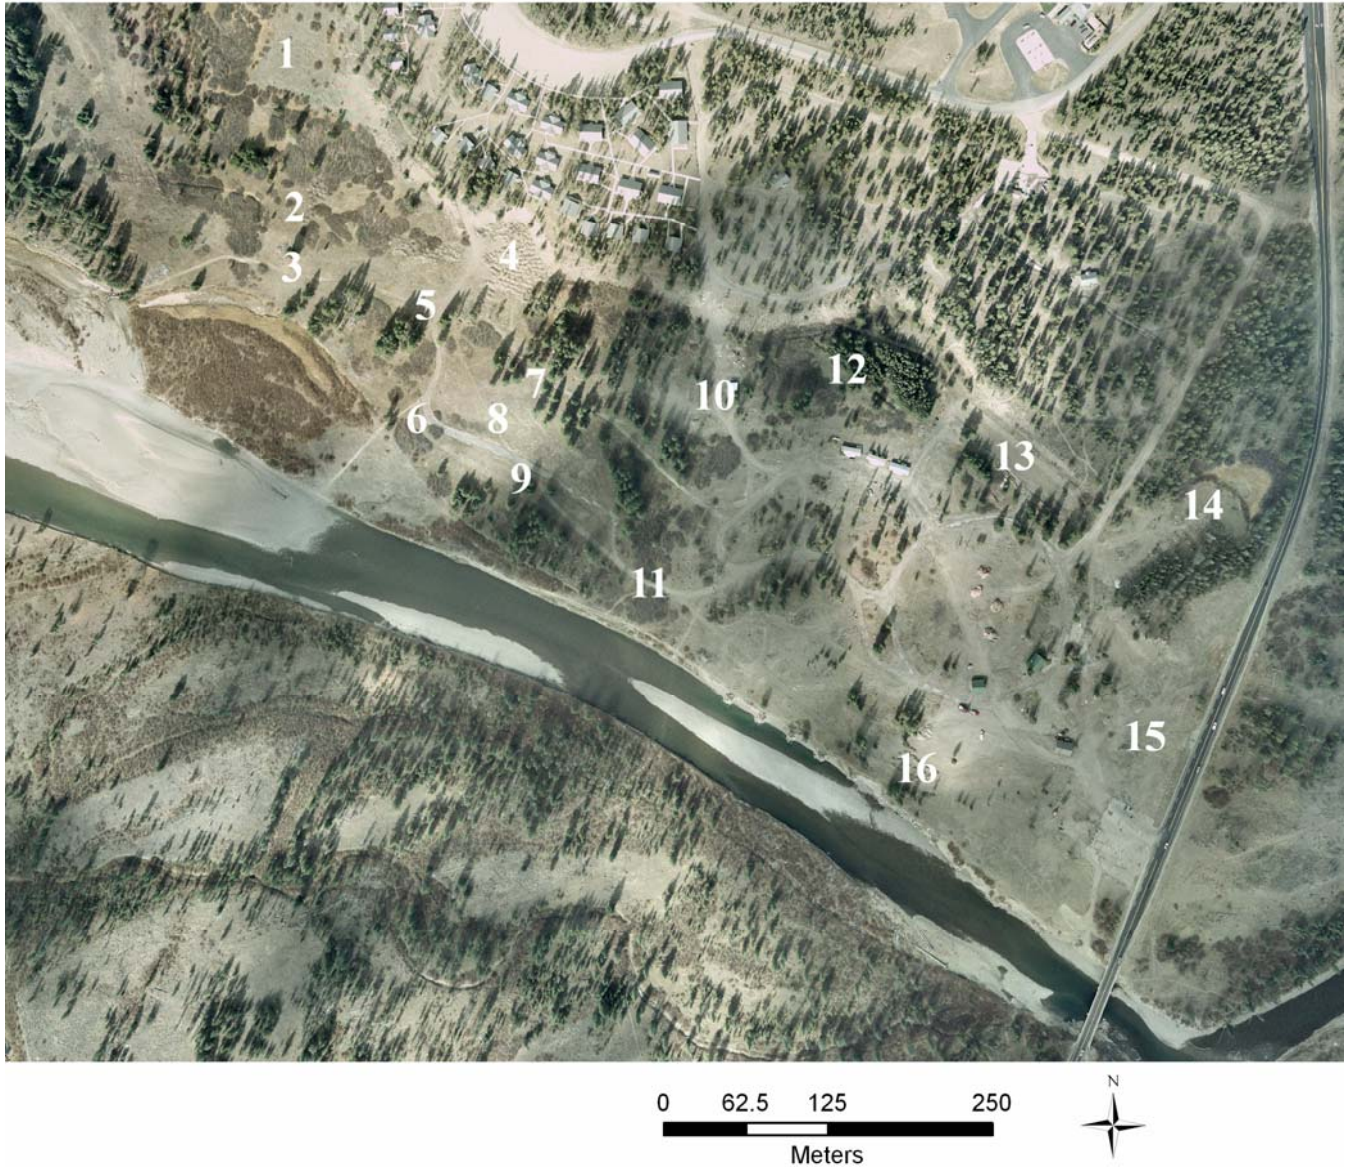
**Figure 11.** Location of the 16 project sites overlain on a high quality air photograph.

Disturbances to the Flagg Ranch site include filling, vegetation removal, and ground disturbance. We have identified 16 areas that were disturbed and where restoration could occur. Each is identified in Figures 11 and 12, and discussed here. In Table 2 we identify the restoration area, fill thickness and fill volume.

Site 2 is a small area of fill (0.13 acre) (Table 2) that has hummocky fill piles that were dumped by trucks (Figure 11). Willow removal also occurred. The fill should be removed, and the site planted to wetland vegetation similar to site 1.
